Final Report
Maintenance Problems
With
Small Breakaway and Yielding
Sign Supports
TSD-490-81

**TRAFFIC and
SAFETY
DIVISION**

By
Weldon L. Borton

December 1981

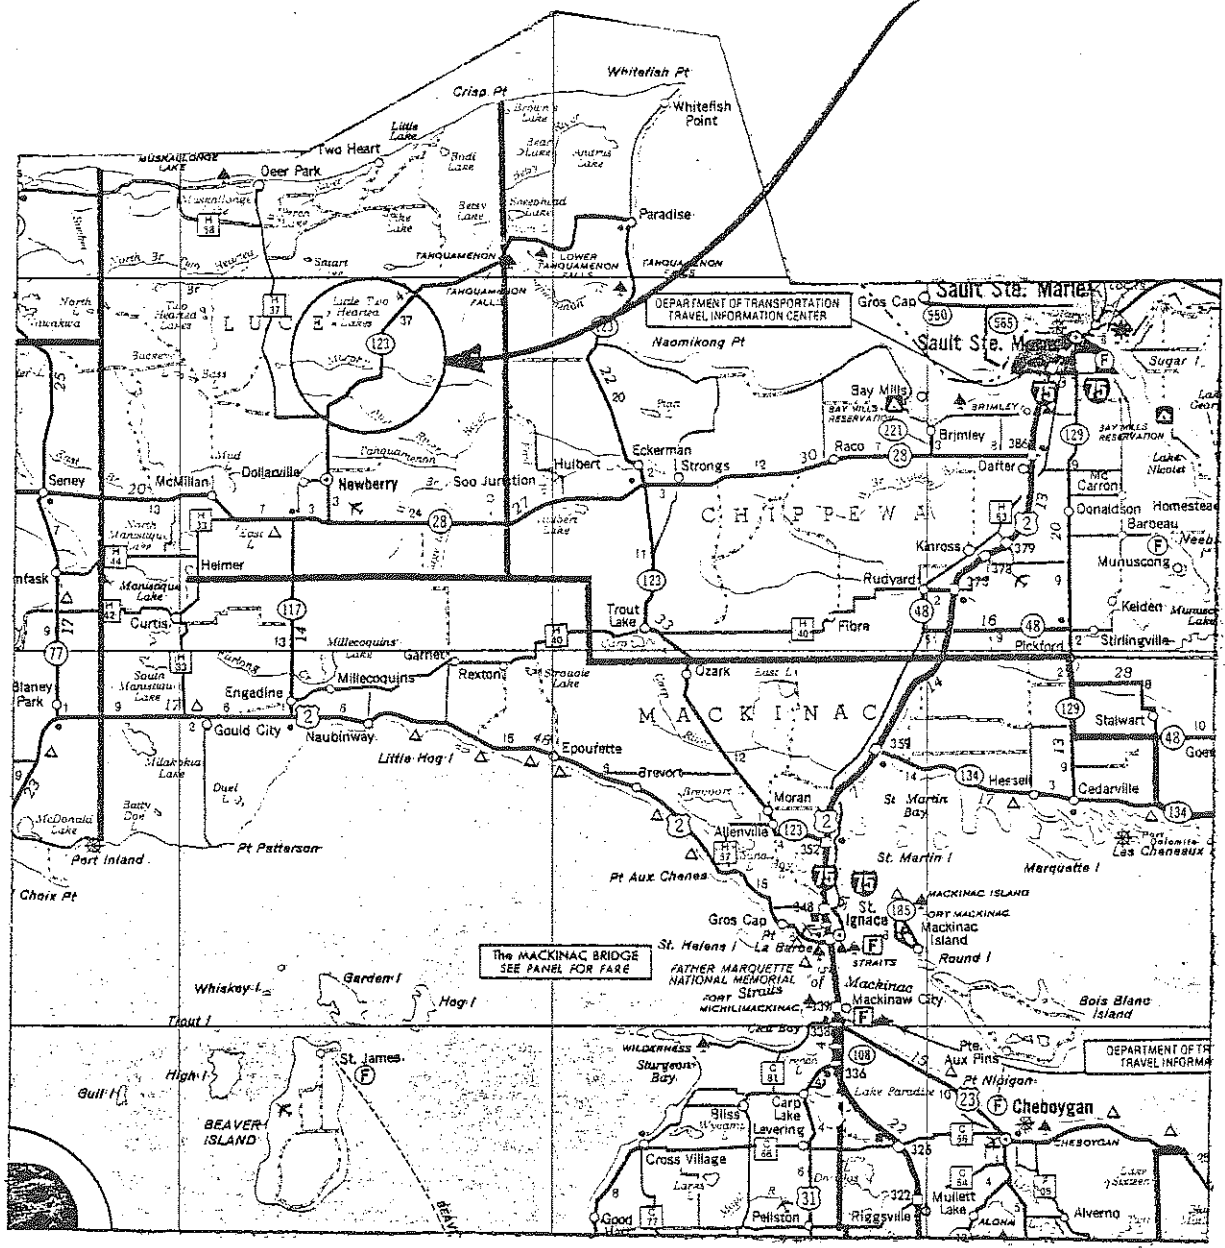
Figure 2: Test site for small sign supports

In order to ensure uniform exposure of supports to snow removal operations, a 12-mile section of M-123 in Luce County (Figure 2) was chosen for the erection of six different types of supports. All supports and signs were erected by June 28, 1979. A breakdown of the number of each type support and station locations are outlined in Tables A-F (pages 11-17). Of the six supports tested, it should be noted that U-Channel and wood supports are operational and have been used extensively by the MDOT for some time. Following is a listing of the six types tested together with manufacturers' names for those not operational:
