PERFORMANCE EVALUATION OF  
CONCRETE PAVEMENT OVERLAYS  
Final Report

**J. E. Simonsen  
A. W. Price**

**Research Laboratory Section  
Materials and Technology Division  
Research Project 83 F-162  
Research Report No. R-1303**

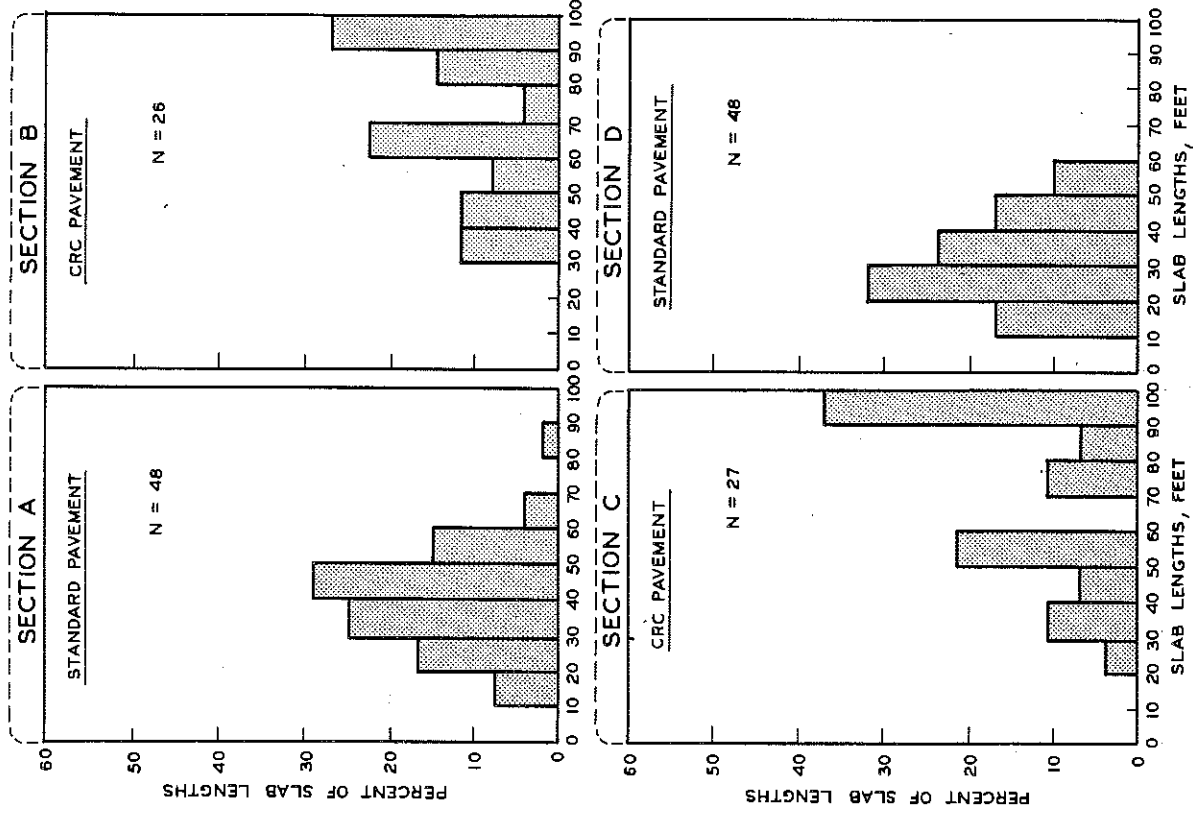
Figure 5. Distribution of slab lengths in the traffic lane contributing to movement at cracks and joints in the overlaid standard concrete pavement on US 23.

Other factors promoting cracks in concrete slabs are low base support values and large volumes of heavy trucks. It is speculated that the northbound roadway carries heavier truck loads than the southbound roadway which may explain why cracking in the overlay is absent in Section A on southbound US 23 although the underlying pavement was cracked and deteriorated more than that in Section D (Fig. 5 and Table 1).

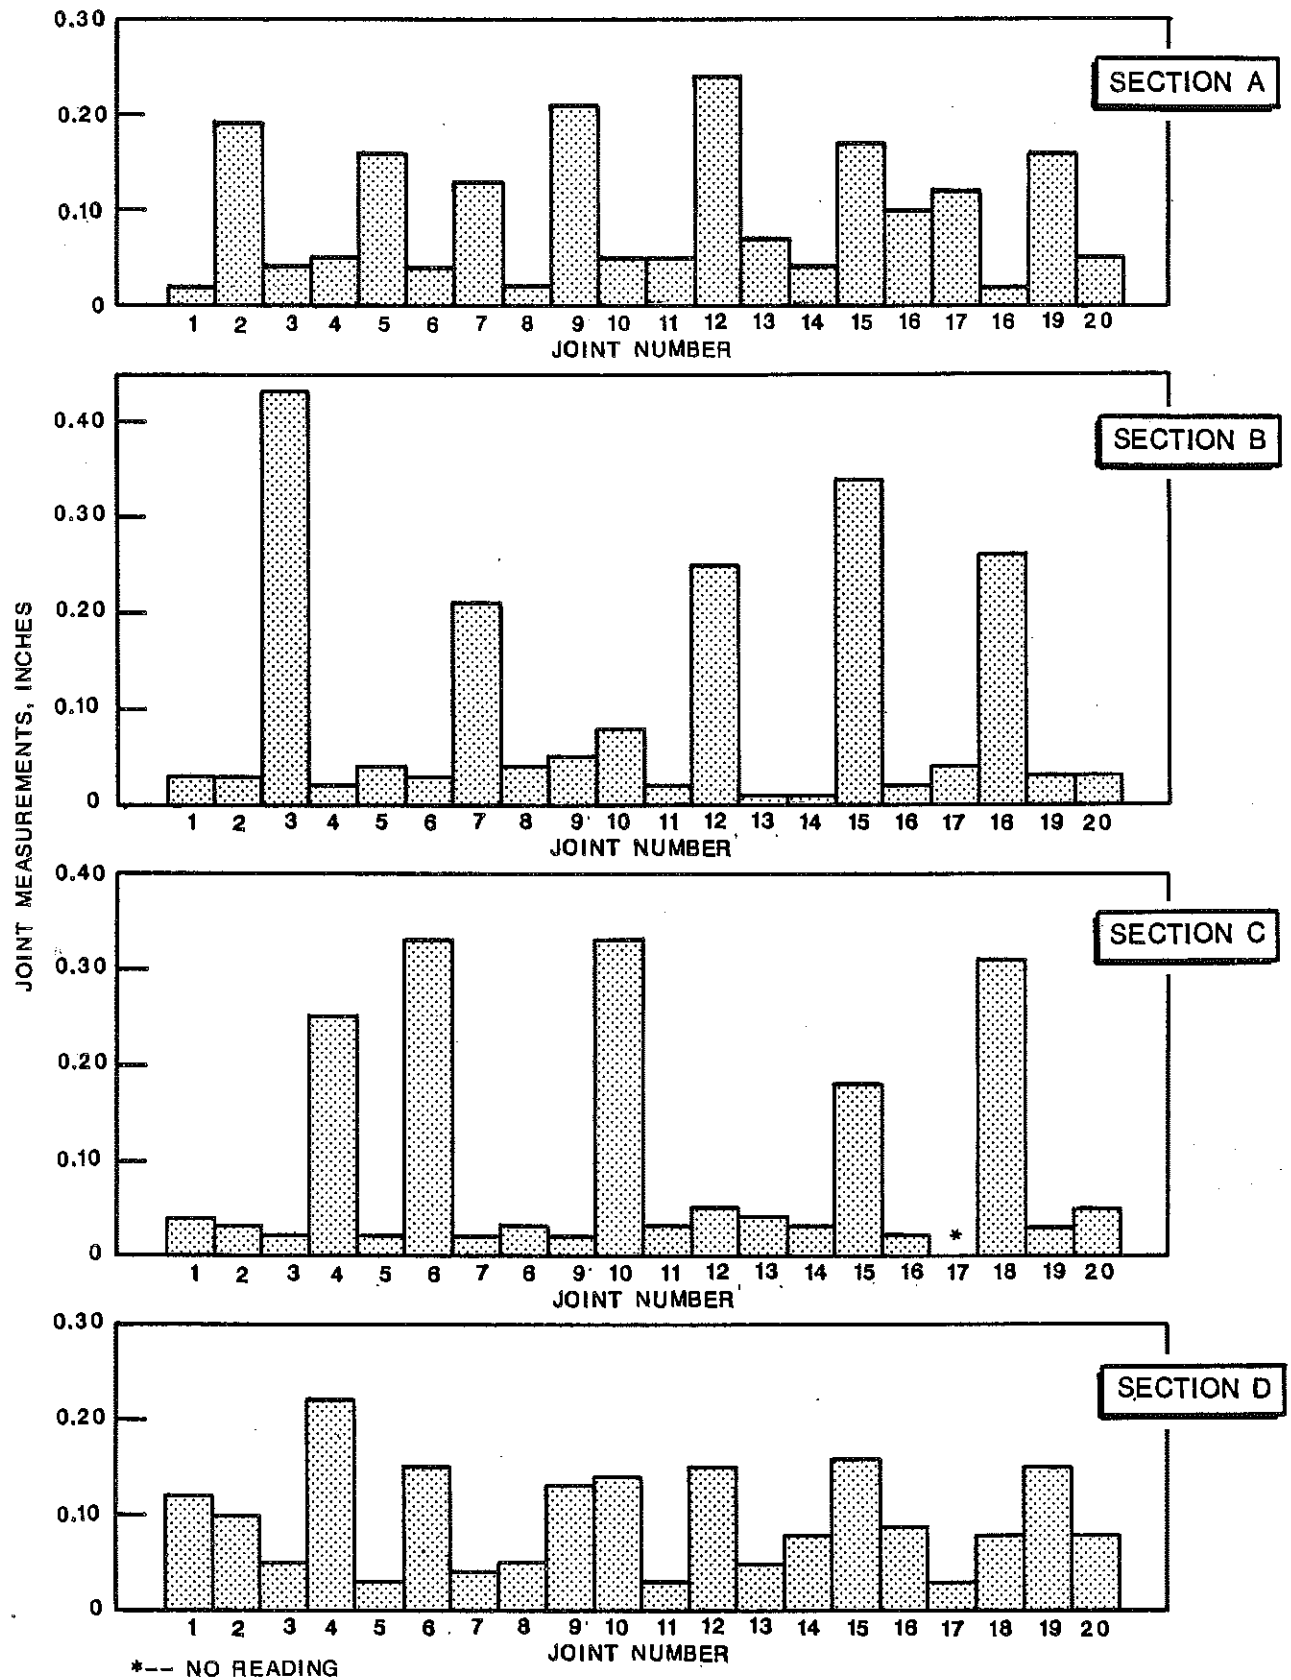
Figure 13. Joint width changes on the I 96 test sections caused by a 56 F temperature change.

Measurements of the joint openings in the instrumented sections have been made on a summer-winter schedule. These measurements indicate non-uniformity in the movements of the 20 consecutive joints. This variation is shown graphically in Figure 13 for the four test sections on I 96 and in Figure 14 for the US 23 sections. The joint width changes (openings) shown are the difference between the 1988 summer measurements and the 1989 winter readings.

It will be seen that the largest variations have occurred on Sections B and C on I 96 where the overlay was placed on the CRC pavement which was sawed into 100-ft slab lengths. To determine the cause of these variations, the saw cuts or repairs (free floating) were plotted with respect to location and then the overlay joint locations were superimposed on the layout (Fig. 15). The joint movements shown for Section B on Figure 13 have been written next to joints 1 through 20. In all cases the large movement always occurred where the overlay joint was close (3 ft minimum) to a free-moving joint or saw cut in the underlying pavement.

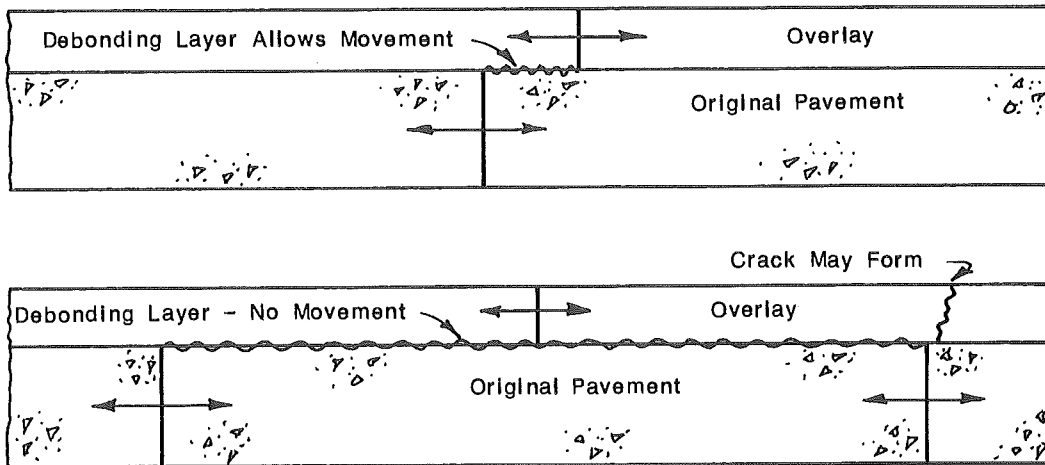
Figure 16. Sketch showing complementary (top) and opposing (bottom) movements in the two concrete slabs.

The reason for the large movements is shown in Figure 16. As can be seen the movement (contraction) of the bottom and top slabs complement each other when the joints are near each other, whereas when the joints in the two slabs are far apart they oppose one another.

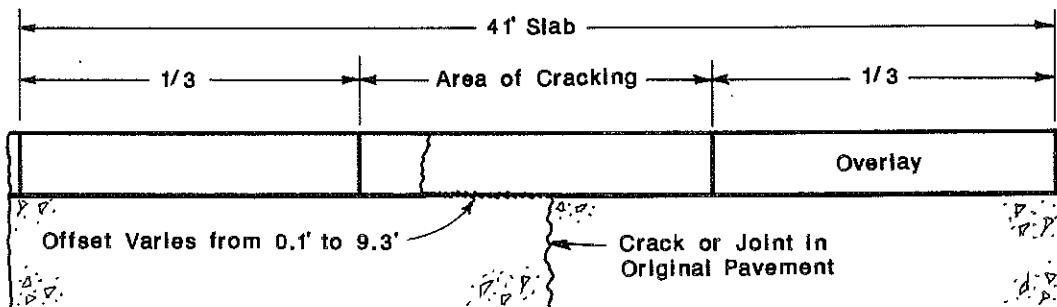
Figure 18. Sketch showing location where cracks most likely will occur.

From the table and Figure 18, the cracks in the overlay, with the exception of one, always occurred in the mid-third of the 41 ft slabs.
