Report TSD-266-73

A TRAFFIC ACCIDENT ANALYSIS  
AND A TRAFFIC CONTROL DEVICES INVENTORY  
IN BERRIEN COUNTY

Michigan Department  
of  
State Highways and Transportation

April 1974

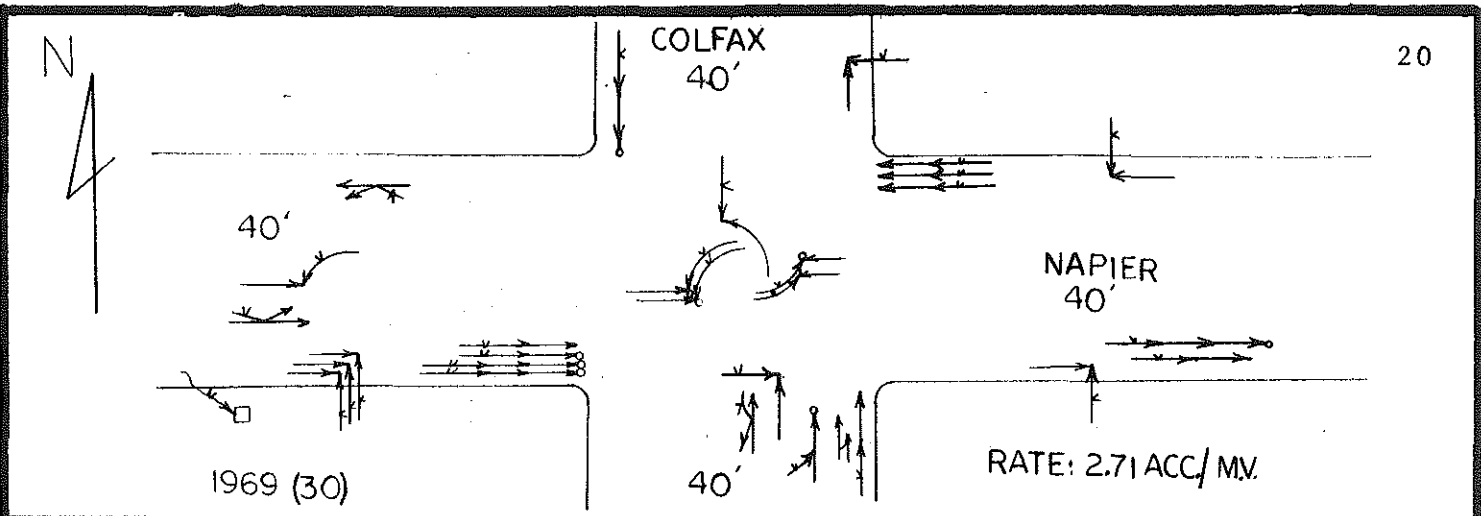
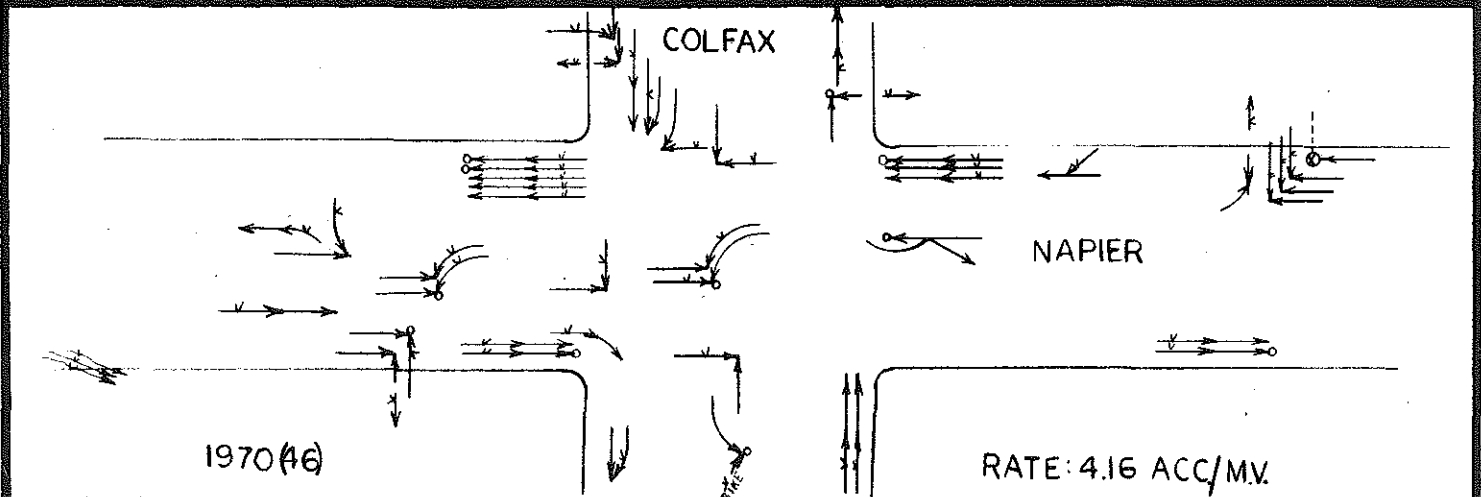
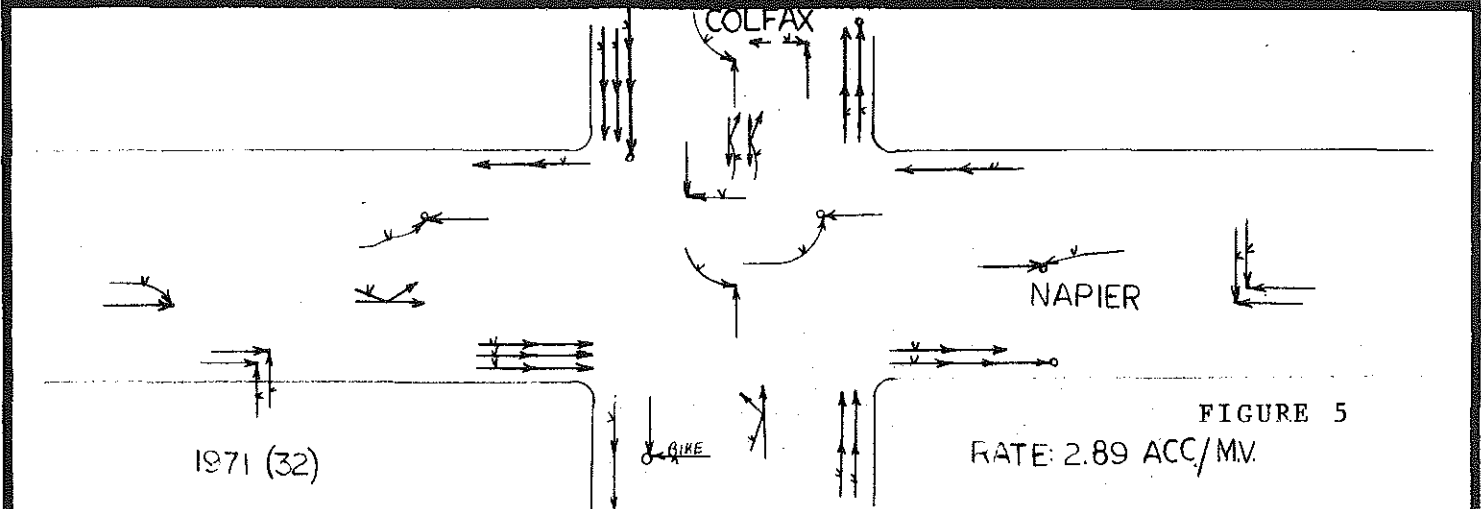
Thirty-four of the accidents occurred on wet pavement. Seventy-five percent of the right-angle accidents involved vehicles exiting and/or entering driveways and were not involved with the operation of the intersection.

Since only one lane is available for thru and right turn movement on each approach leg, there has developed a capacity deficiency at this location.

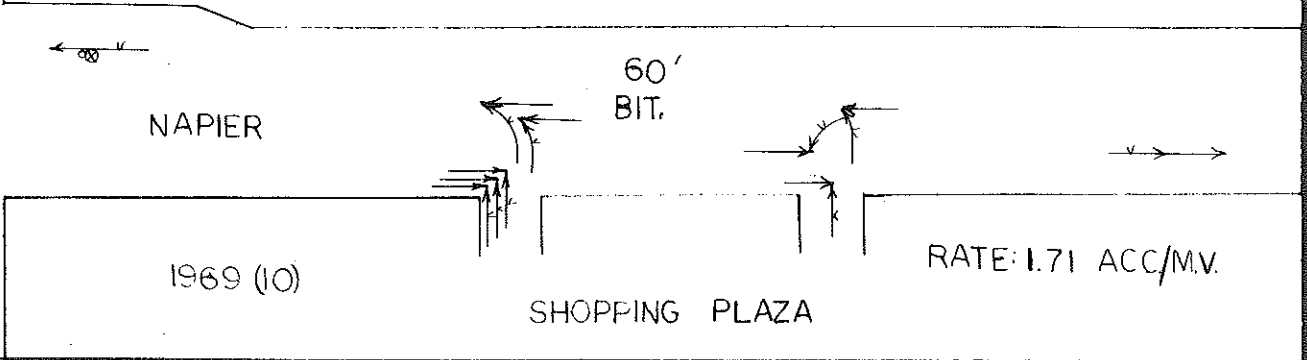
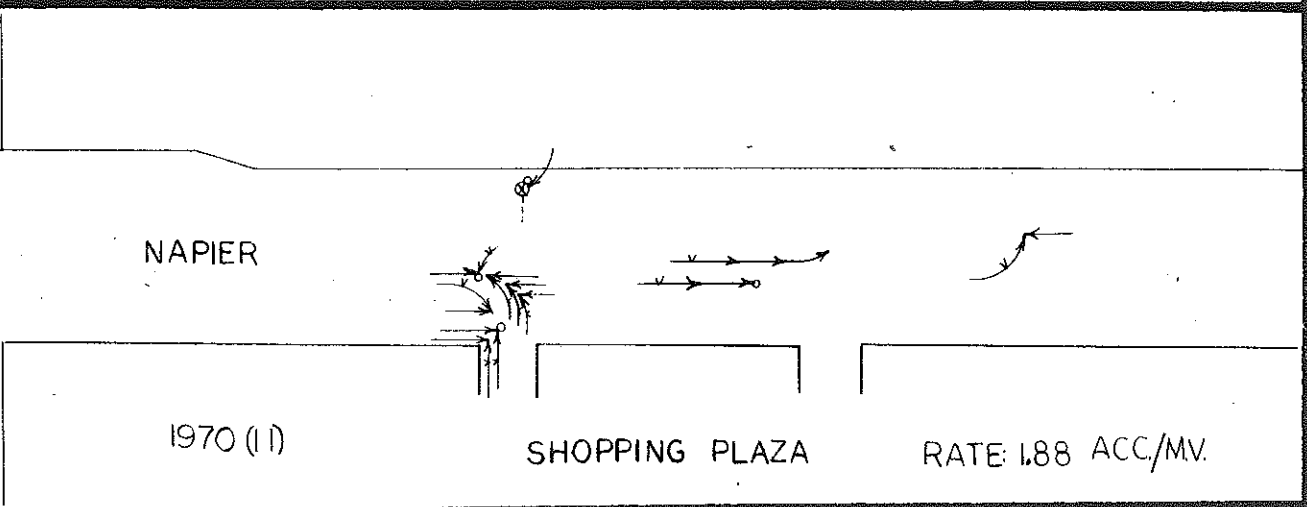
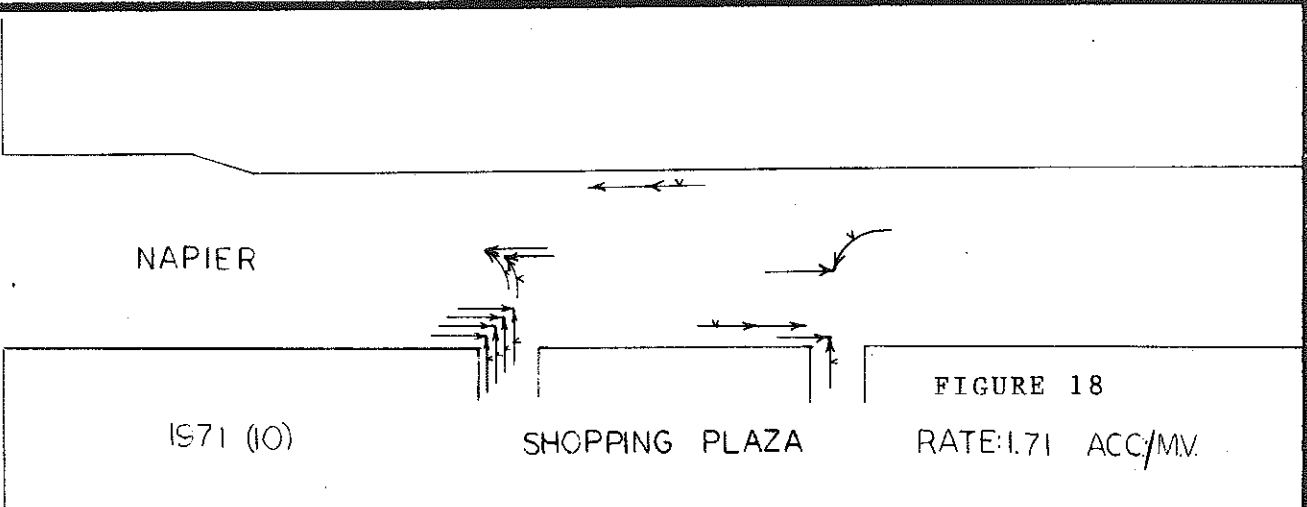
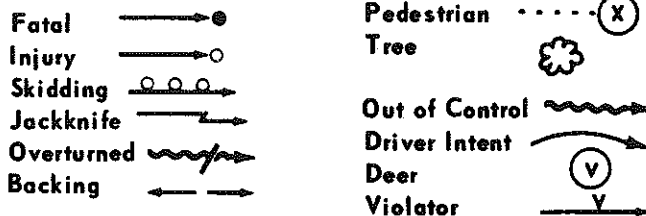
Location NAPIER AVE, E. OF M-139  
BERRIEN CO.

Period: 1969 THRU 1971 1.76 ACC/M.V.  
 Accidents - Total 31 P.D. 26  
 Injury 5 ( ) Fatal 0 ( )  
 C.S. \_\_\_\_\_ Miles \_\_\_\_\_ Drawn DJM  
 Plan No. LOCATION Date 9-28-73

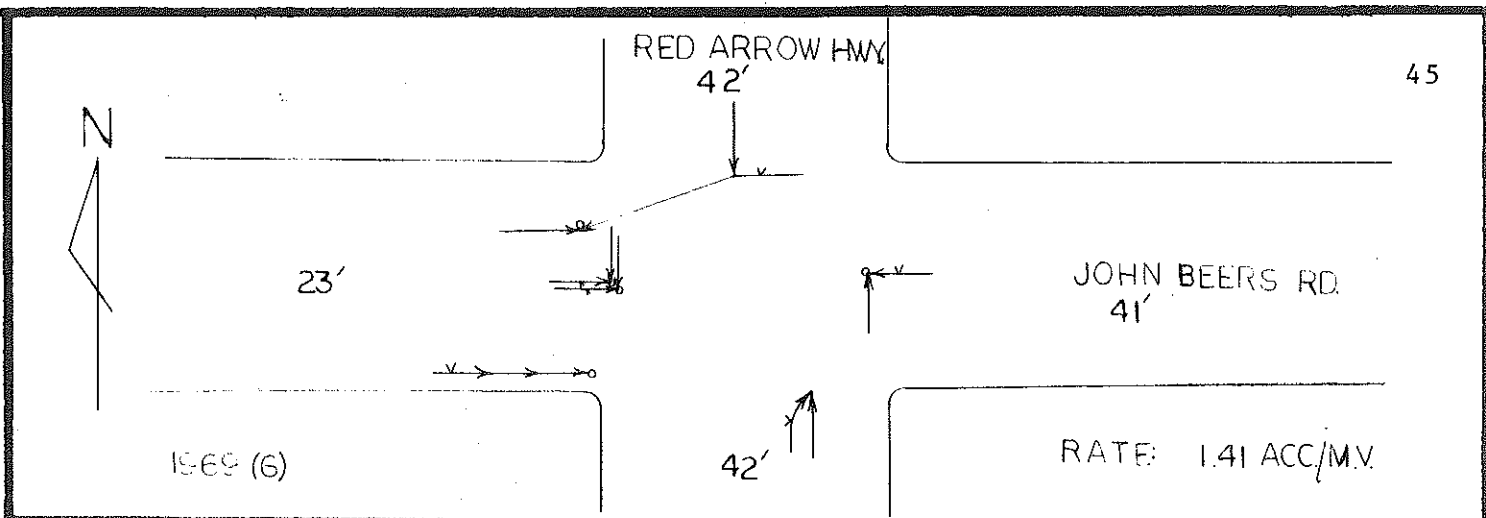
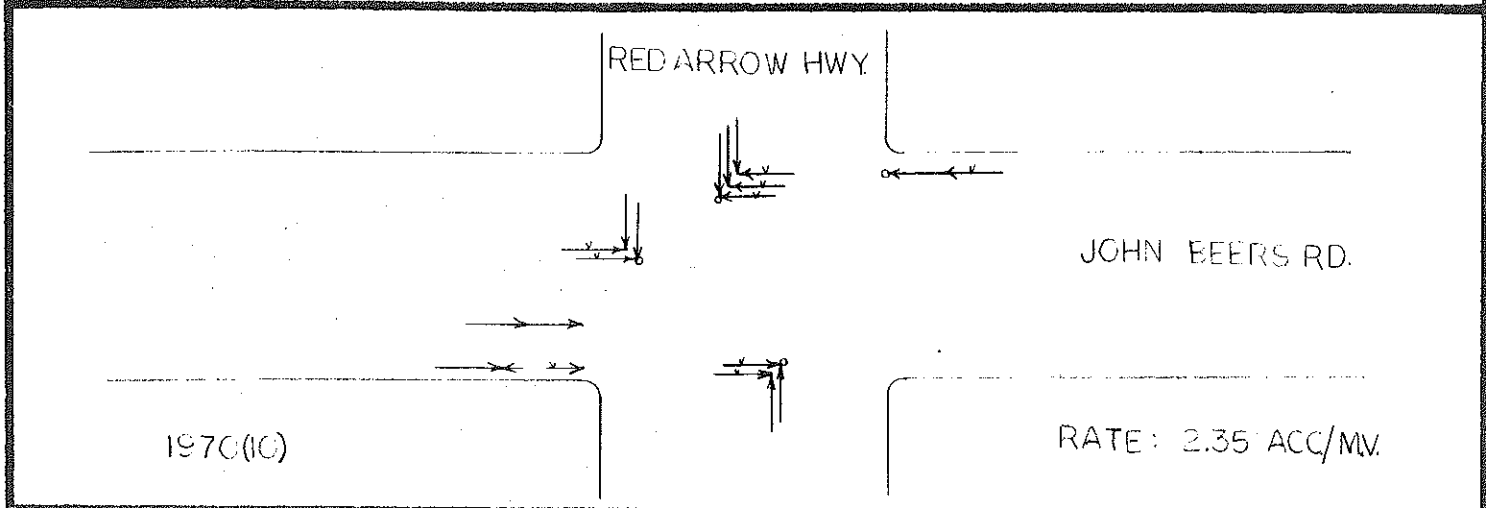
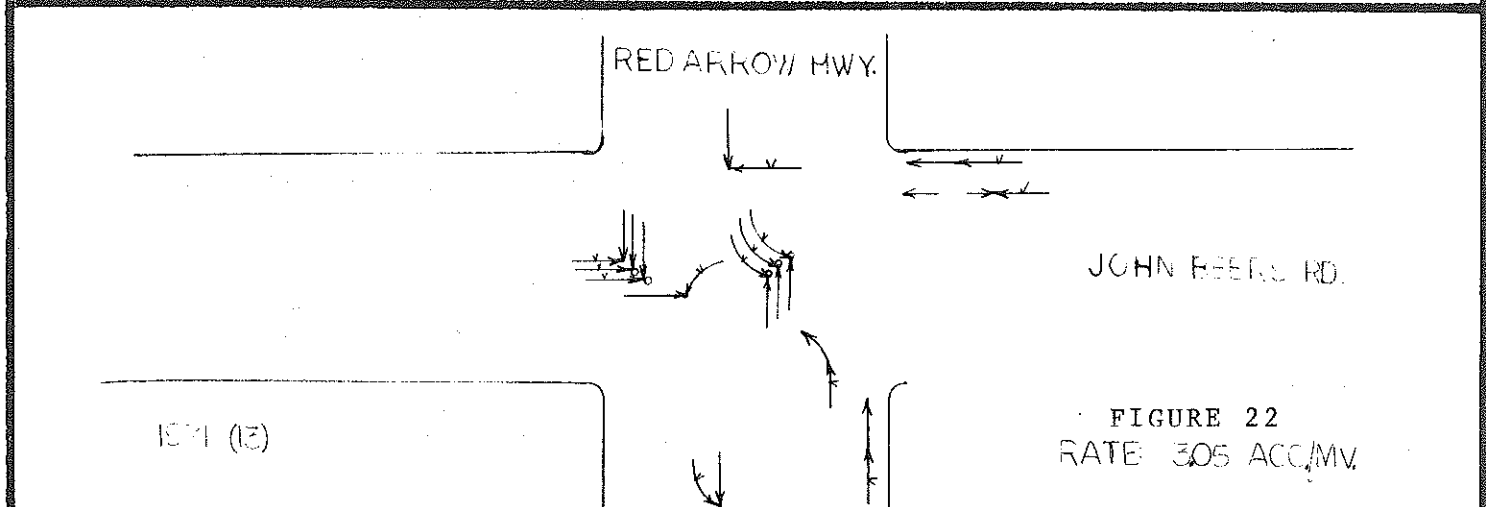
FIGURE 22  
RATE: 305 ACC/MV

<u>Type</u>	<u>1969</u>	<u>1970</u>	<u>1971</u>	<u>Total</u>
Right Angle	4	7	4	15
Rear End				
Red Arrow Highway	--	--	2	2
John Beers Road	1	2	1	4
Misc.	1	1	6	8
	<hr/>	<hr/>	<hr/>	<hr/>
Total	6	10	13	29

The miscellaneous types include four head on-left turns, two improper turns and two improper backing accidents. The accident rate at this intersection was 2.3 acc/MV during the study period.

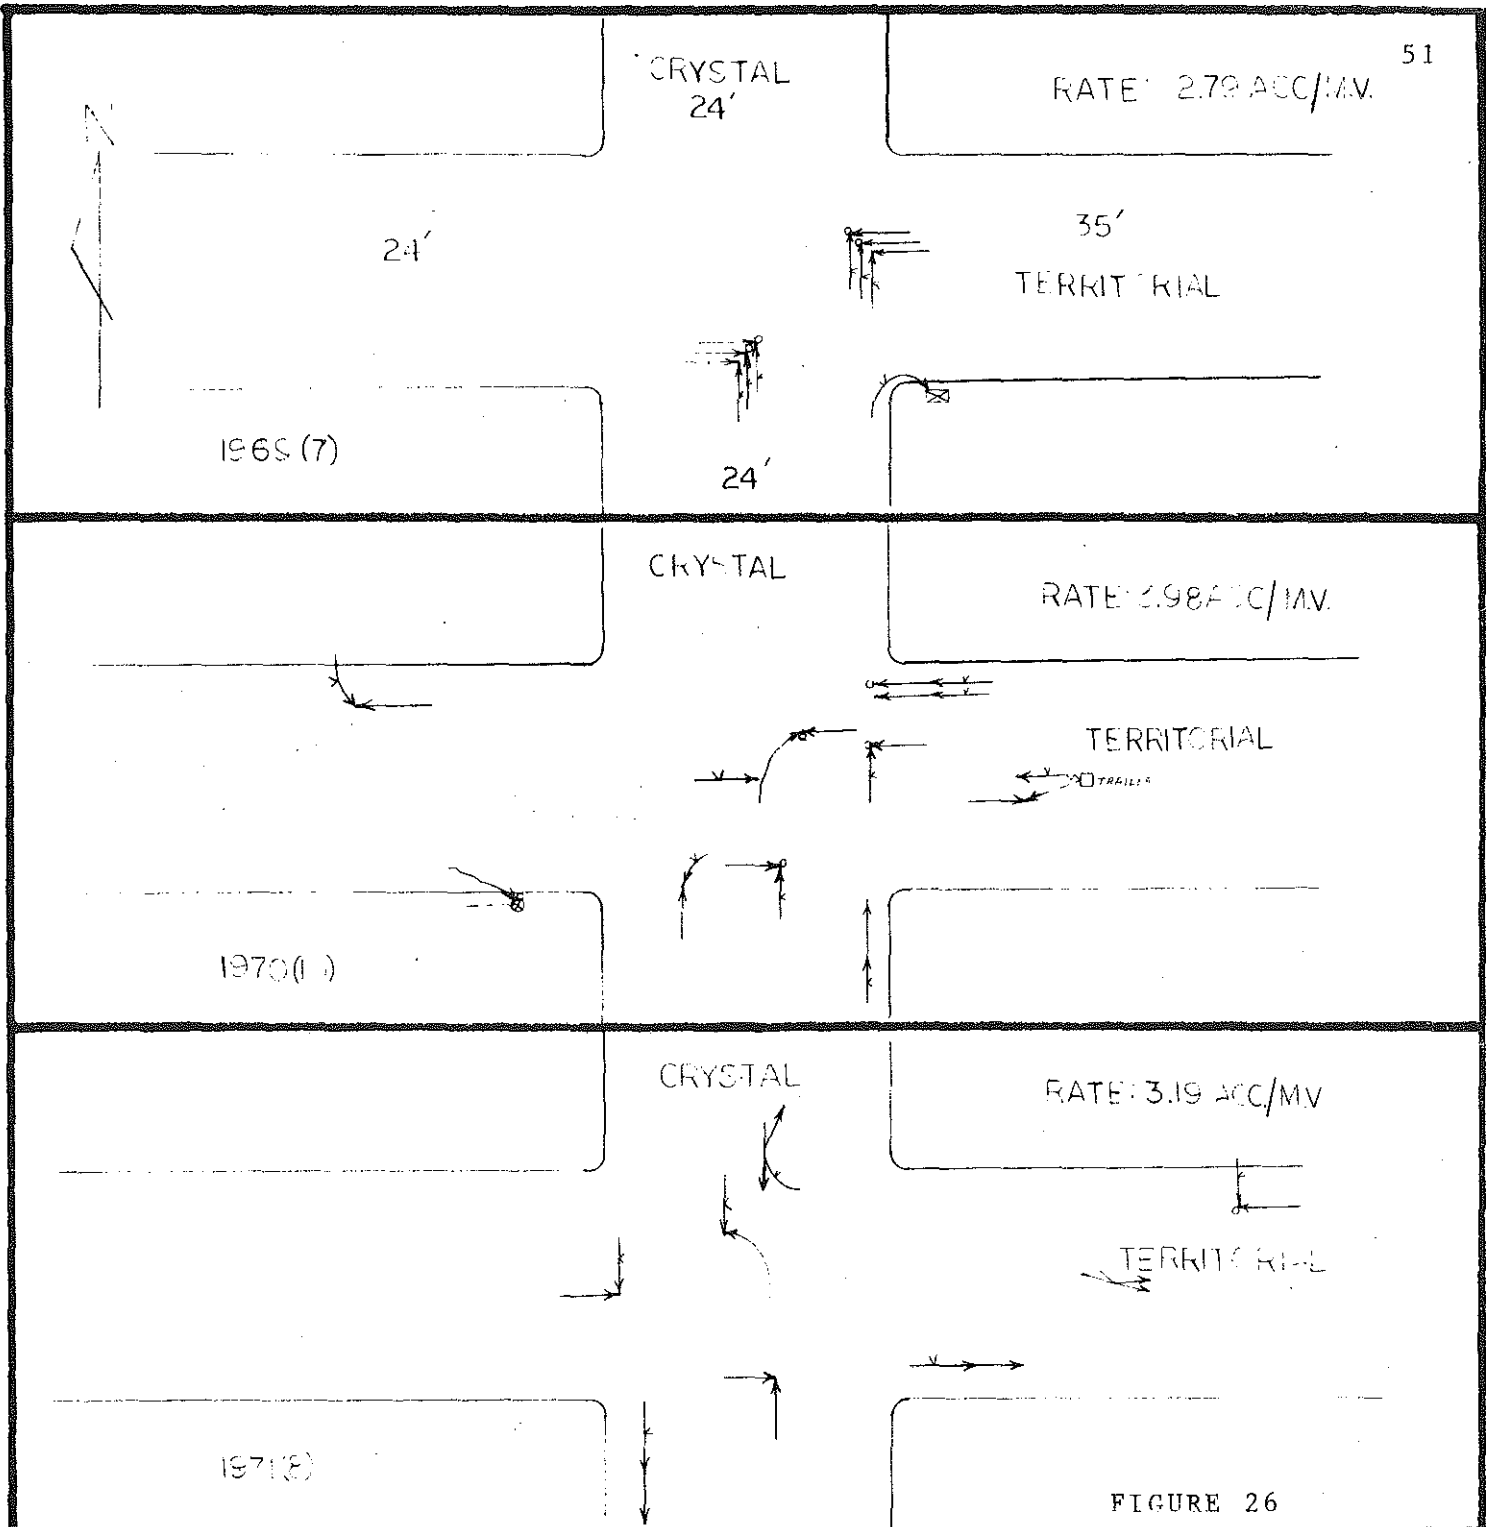
<u>Type</u>	<u>1969</u>	<u>1970</u>	<u>1971</u>	<u>Total</u>
Right Angle	6	3	3	12
Rear End	1	3	2	6
Misc.	--	4	3	7
	<hr/>	<hr/>	<hr/>	<hr/>
TOTAL	7	10	8	25

The miscellaneous types include three improper turning, two side-swipes, one head on-left turn and one ran off roadway accident. The accident rate at this location was 3.3 acc/MV during the study period.
