Pavement Demonstration Program Project Finalization Thin Unbonded Concrete Overlay Projects – M-3 & M-1 (MDOT Job Numbers 72407 & 79673)

Final Technical Report

Report No. OR23-304, A

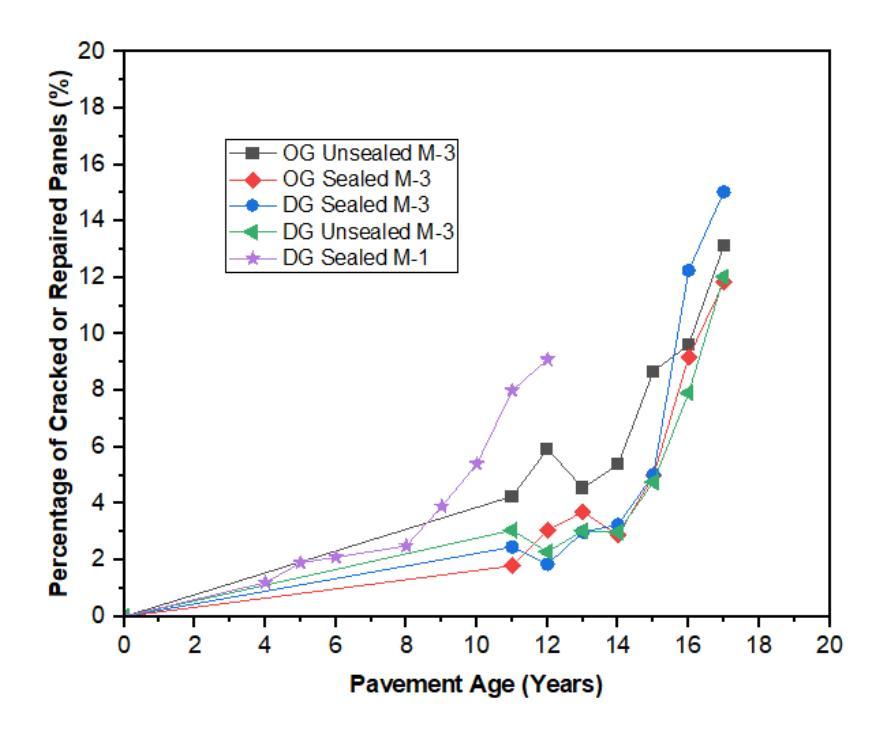
Figure 10. Percentage of Cracked or Repaired Panels Per Pavement Age of M-3 and M-1 for each Test Section

Figure 10 shows the percentage of panels cracked or repaired for each combination of HMA separator and joint sealing method used on M-3 and M-1. For the sections on M-3, the DG HMA separator with sealed joints experienced the highest crack and repair activity. The OG sealed HMA separator has the lowest crack or repair; hence, it is the best-performing section. However, the difference in crack and repair percentage of the lowest and highest performing sections is only 3%. Therefore, all sections can be deemed to have comparable performance. Moreover, as the pavement approaches the design life of 15 years, there is a sharp rise in cracks and repairs. This trend may suggest that the thin unbonded concrete overlay can provide adequate performance for 15 years but may require more maintenance or major rehabilitation and/or reconstruction thereafter.

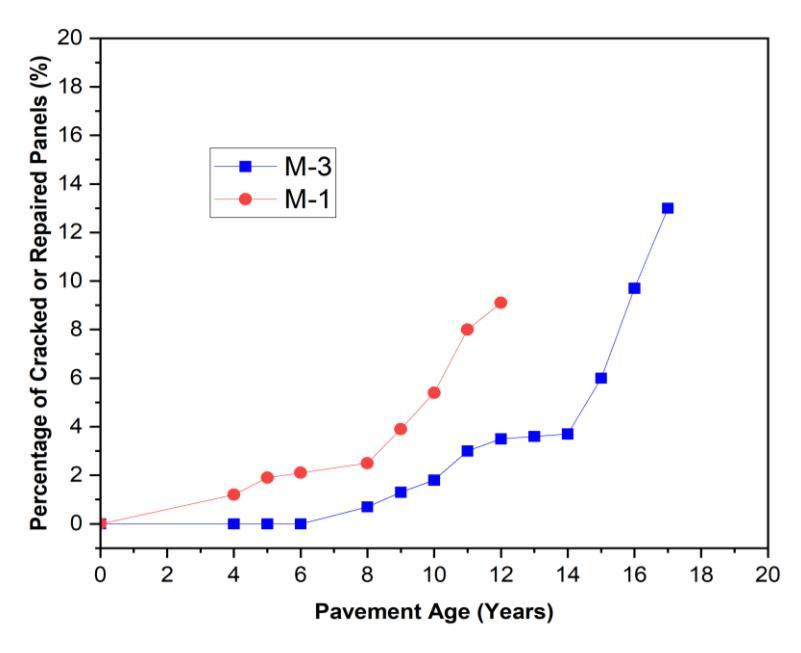
Figure 11. Percentage of Cracked or Repaired Panels Per Pavement Age of M-3 vs M-1

Figure 11 compares the overall crack and repair percentage for the entire routes, M-3 and M-1. At a similar pavement age, M-1 appears to have more cracks/repairs when compared with M-3.

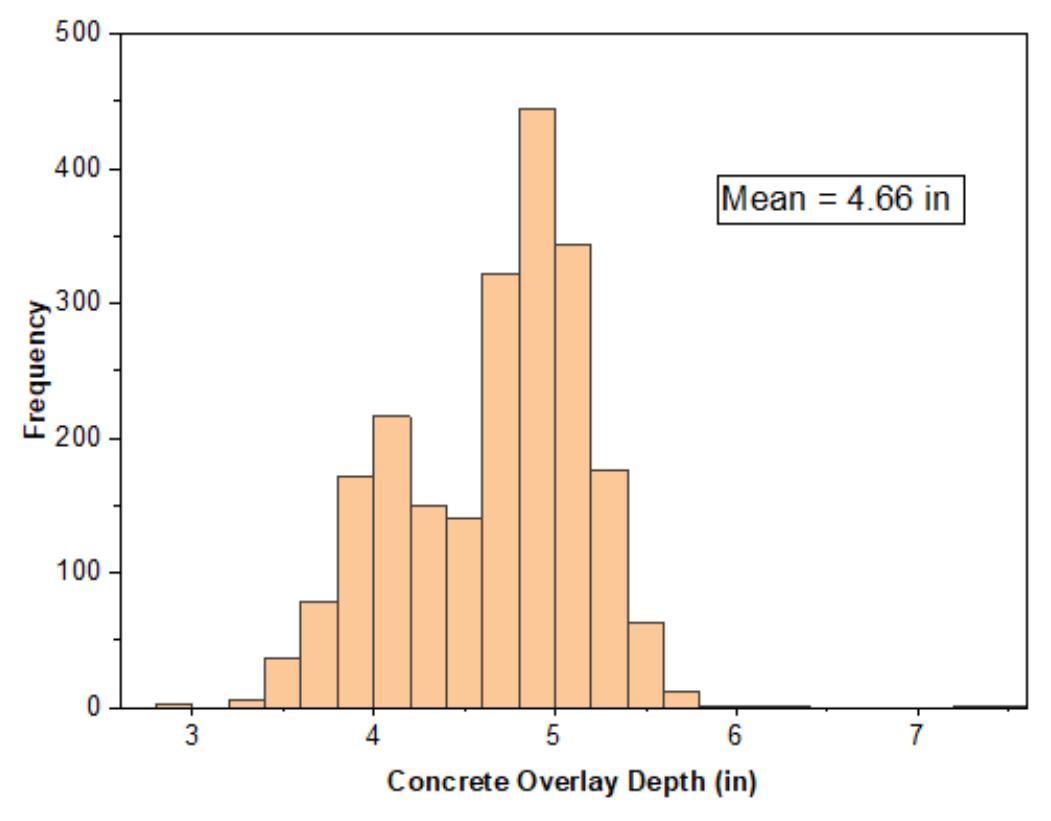
Figure 17. Overlay Depth for Northbound Middle Lane M-1

Ground penetrating radar (GPR) data were obtained for M-1 and M-3 in 2015 to assess the thickness of the thin concrete overlay data. It should be noted that limited concrete cores were available, so the GPR measurements cannot be confirmed. The GPR measurements can be used for estimation based on these limited available cores. The mean thickness of thin unbonded concrete overlay on M-3 and M-1 is summarized in Table 12. Variable concrete overlay depths were observed for different lanes, and in general, the mean depth is approximately 4 inches or above, with some lanes having concrete depths of less than 4 inches. A frequency histogram of pavement thickness is presented in Figures 17 and 18. A detailed frequency histogram for all lanes is presented in Figures C1 to C9 in Appendix C.

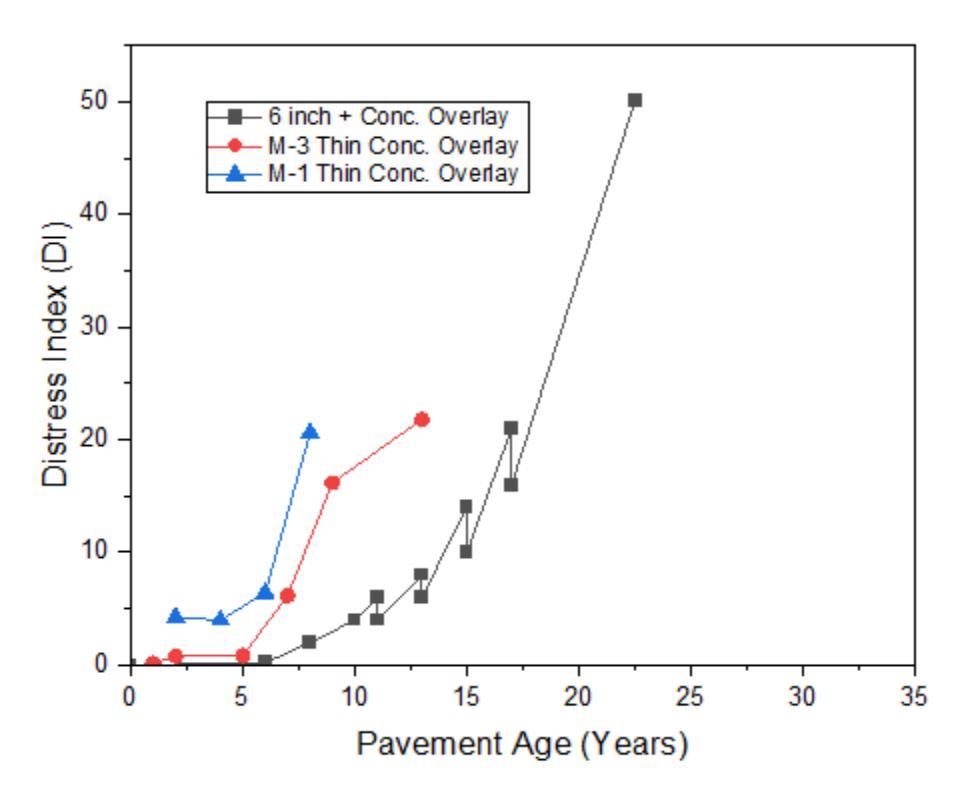
Figure 24. Deterioration Curve of Pavement Preservation Strategy

The DI values of the demonstration projects and the average DI performance curve for standard concrete overlays are shown in Figure 24. Since the DI values of the demonstration projects are not a broad average of statewide project values, these will have more variability. Therefore, it is difficult to estimate their growth trends compared with average performance curves. Nevertheless, the DI trends for the thin concrete overlay demonstration projects are anticipated to be slightly worse than the standard thickness fix type because their design life is 5 years less (15 years vs 20 years). Furthermore, as previously noted, the estimated service life of the standard concrete overlays is 23 years (when a subsequent R&R would occur). M-3 and M-1 are anticipated to meet or exceed a service life of 23 and 17 years, respectively. Although an R&R project may be initiated prior to these timeframes, the pavements have performed satisfactorily, and there are currently no plans for R&R projects at either location within the next five years.

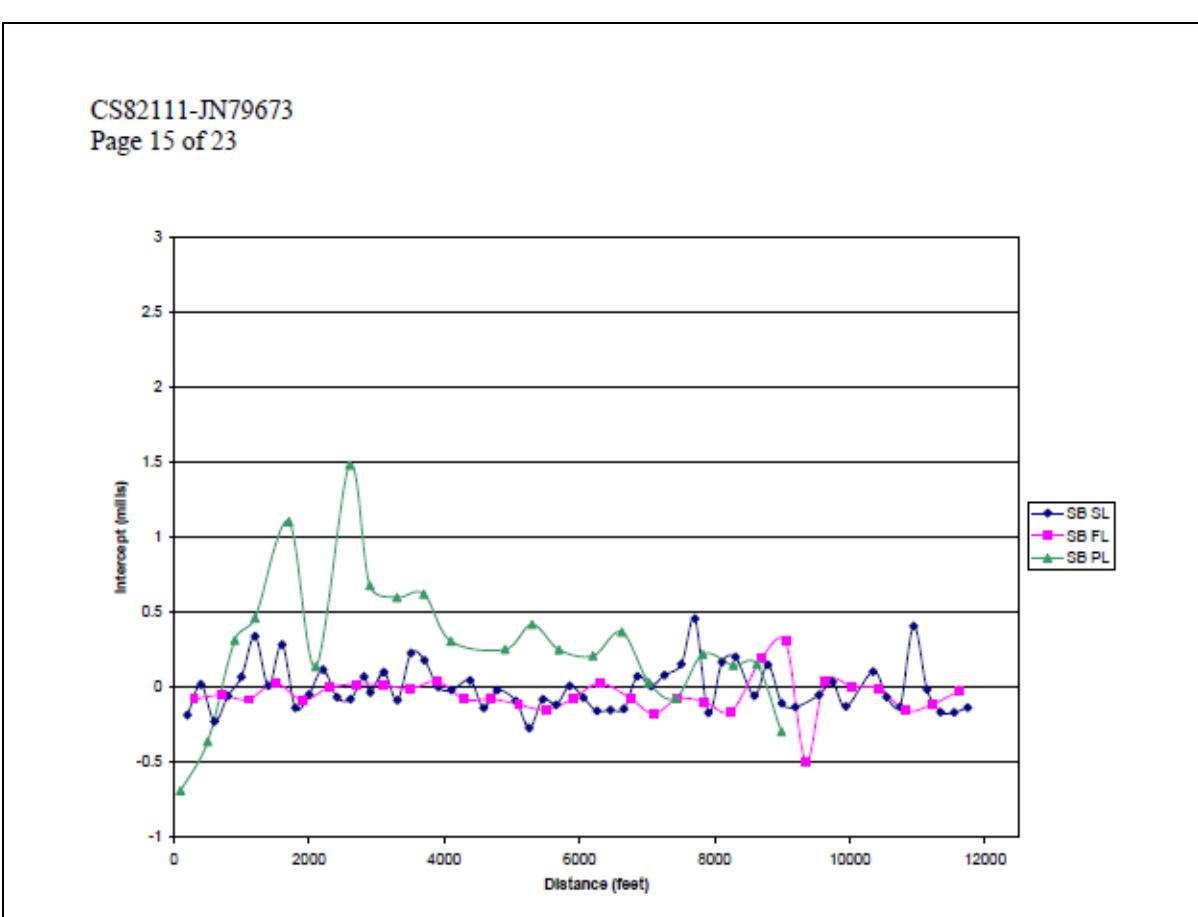
Figure 16: SB M-1 Void Determination Profile

It can be seen for the Figures 15 and 16, typically the intercept values along both NB and SB M-1 are less than 2 mills indicating no suspected voids beneath the pavement.

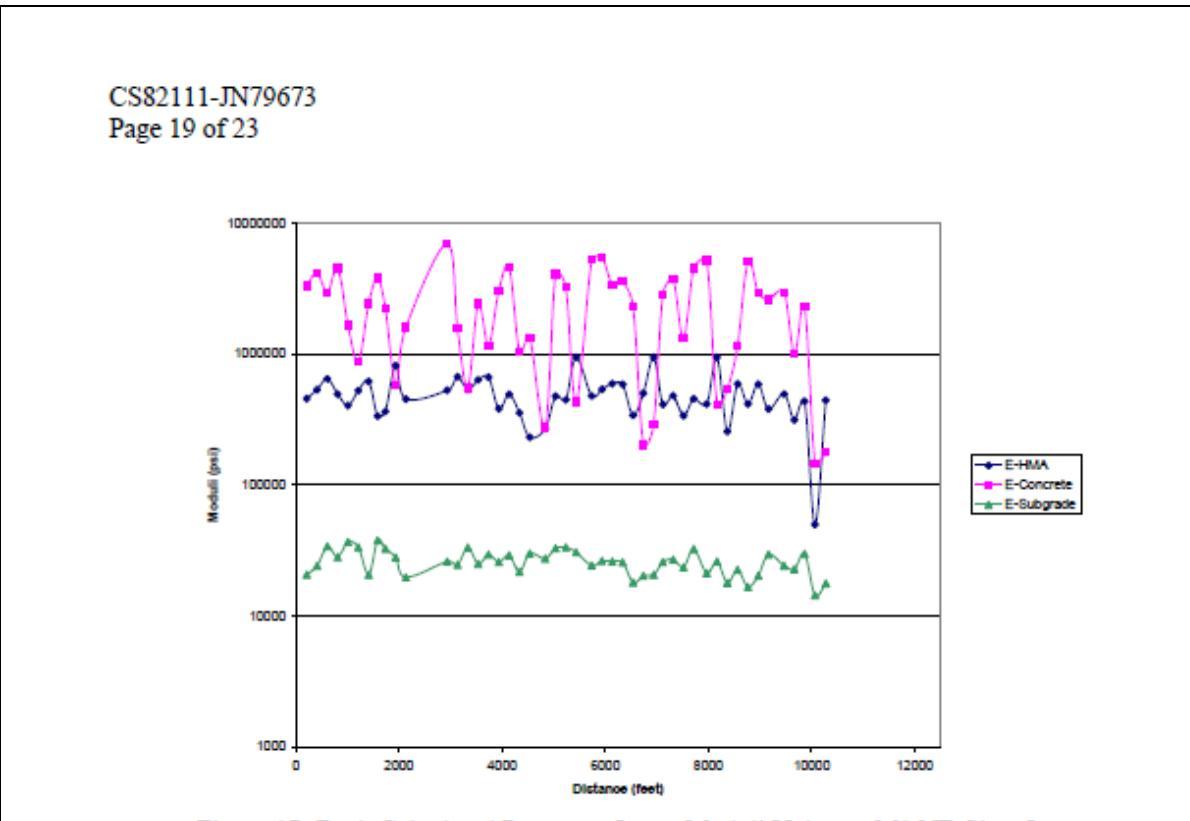
Figure 17: Back Calculated Pavement Layer Moduli Values - M1 NB Slow Lane

As seen in Figure 17 and Table 3, the back calculated HMA layer moduli varies from 50,000 psi (minimum default value used in the back calculation) to 941,607 psi with an average of 495,497 psi. The variation of the HMA moduli along the lane seems within the acceptable range except at few isolated locations. The concrete moduli range from 143,834 psi to 6,999,984 psi with an average of 2,479,162 psi with high variability along the lane. Concrete moduli values were less than 500,000 psi for approximately 14% of the pavement area showing deteriorated concrete. The subgrade moduli vary from 10,449 psi to 37,817 psi with an average value of 24,592 psi showing good subgrade support for the pavement structure.

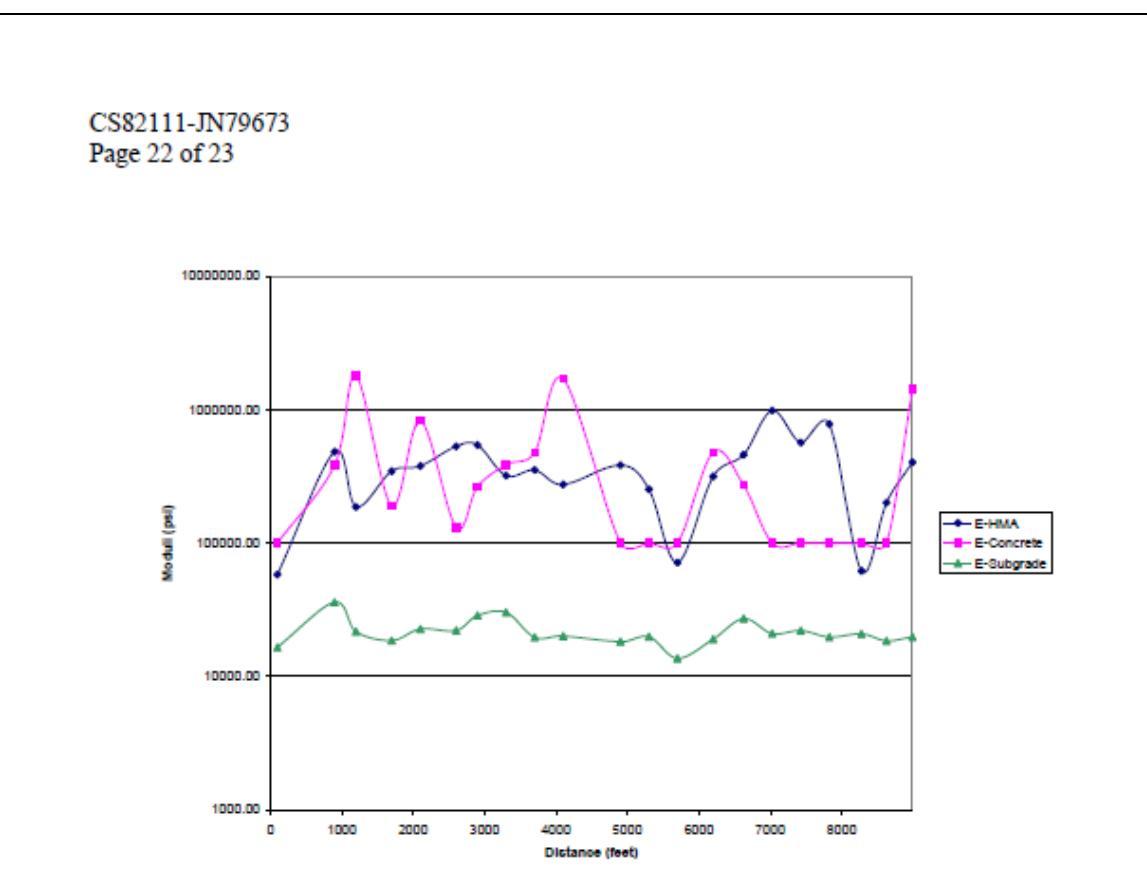
Figure 23: Back Calculated Pavement Layer Moduli Values - M1 SB Parking Lane

As seen in Figure 23 and Table 3, the back calculated HMA layer moduli vary from 57,977 psi to 984,230 psi with an average of 378,982 psi. The variation of the HMA moduli along the lane seems within the acceptable range except at few isolated locations. The concrete moduli range from 100,000 psi (minimum default value used in the back calculation) to 1,796,350 psi with an average of 439,974 psi, which can be considered as very low moduli for concrete. Approximately 79% of the concrete moduli values are less than 500,000 psi showing deteriorated concrete. The subgrade moduli vary from 13,653 psi to 35,999 psi with an average value of 21,688 psi showing good subgrade support for the pavement structure.
