EVALUATION OF LOW PROFILE LIGHTS
FOR PAVEMENT DELINEATION

Report TSD-TR-106-69

Traffic Research Section
Traffic & Safety Division

January 1969

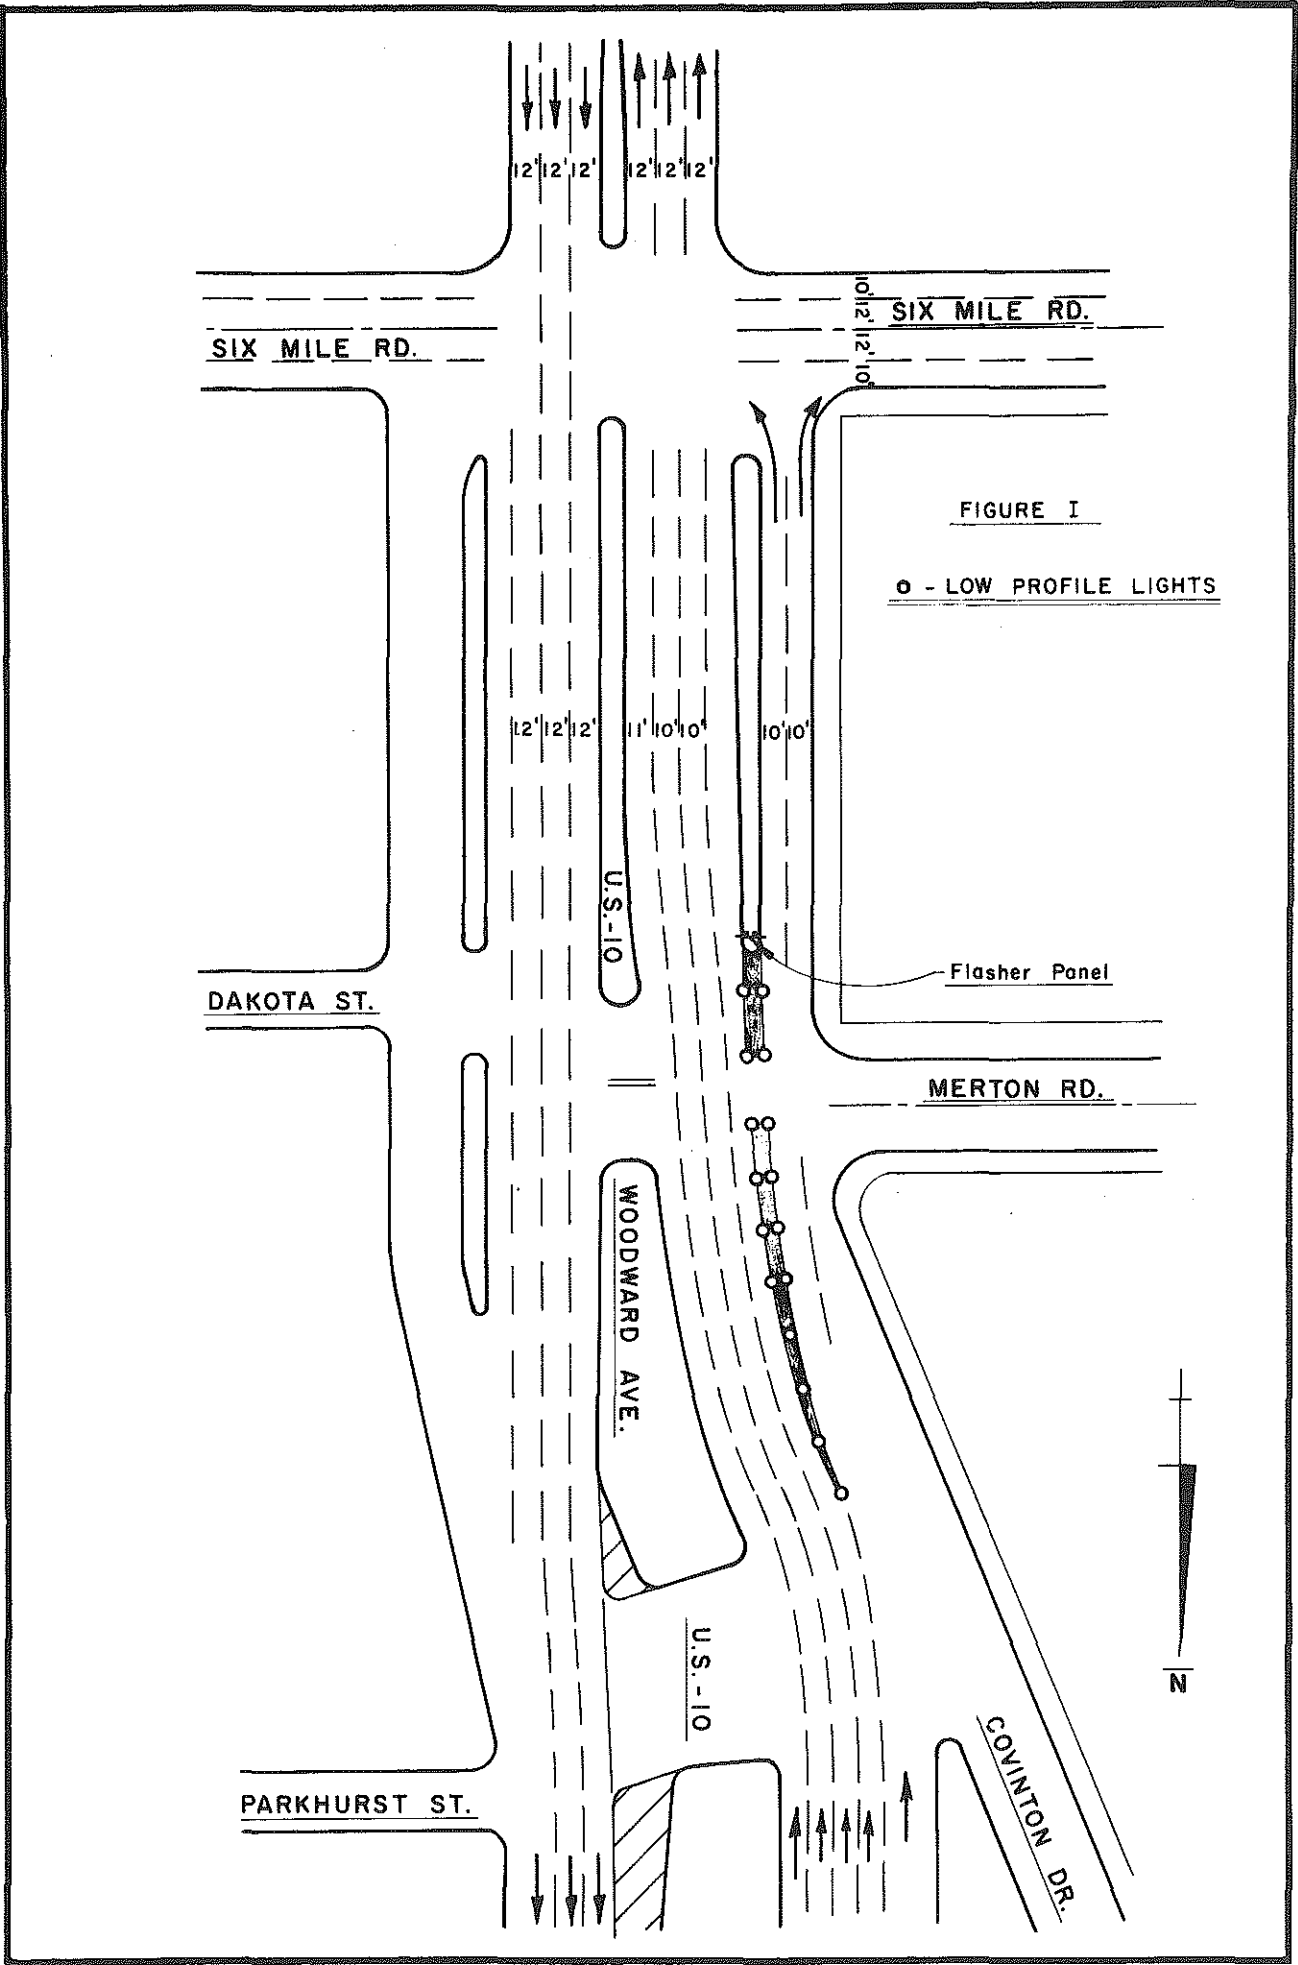
FIGURE I

The location used for this experimental installation was southbound US-10 (Woodward Avenue) at Merton just north of Six Mile Road in the City of Detroit. Figure I is a schematic of the roadway showing the geometrics of the location. You will notice there are five lanes entering on a curve and becoming six lanes with an island separation. The two lanes to the right of the island are designated: One for "left turns only" and one for "right turns only" onto Six Mile Road. At Six Mile Road southbound, Woodward Avenue becomes only three lanes, which indicates a large amount of traffic using the turn lanes to the right of the traffic island.

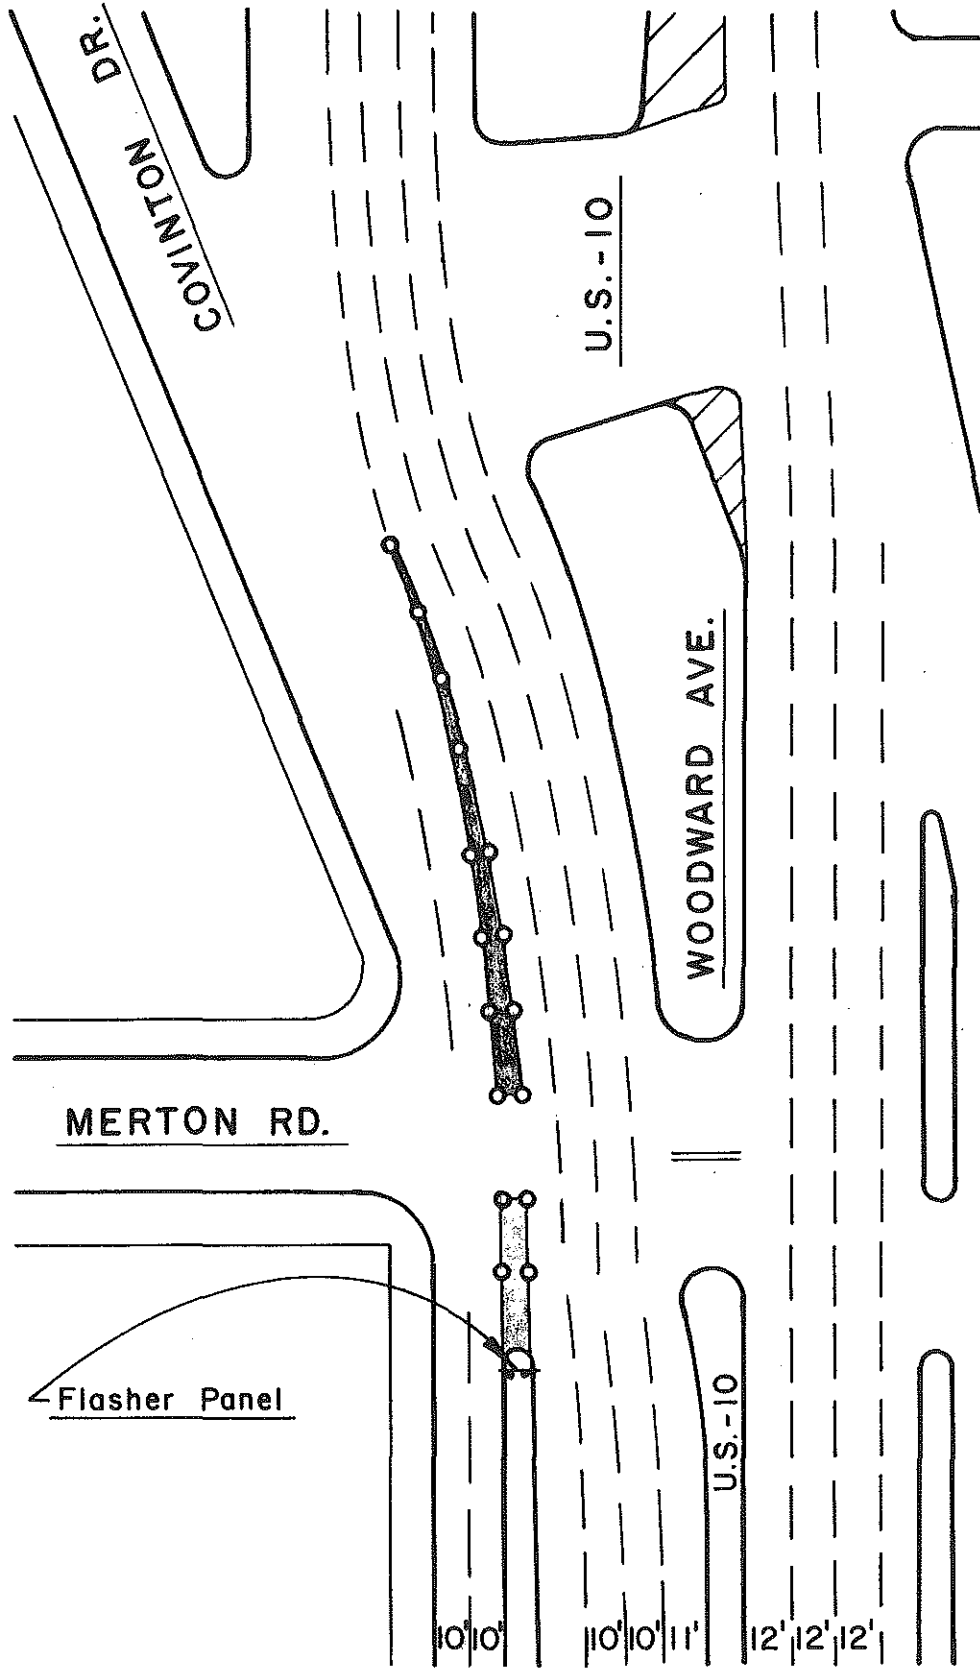
Figure II is a schematic showing the positioning and spacing of the low profile lights used for delineation of the traffic island.

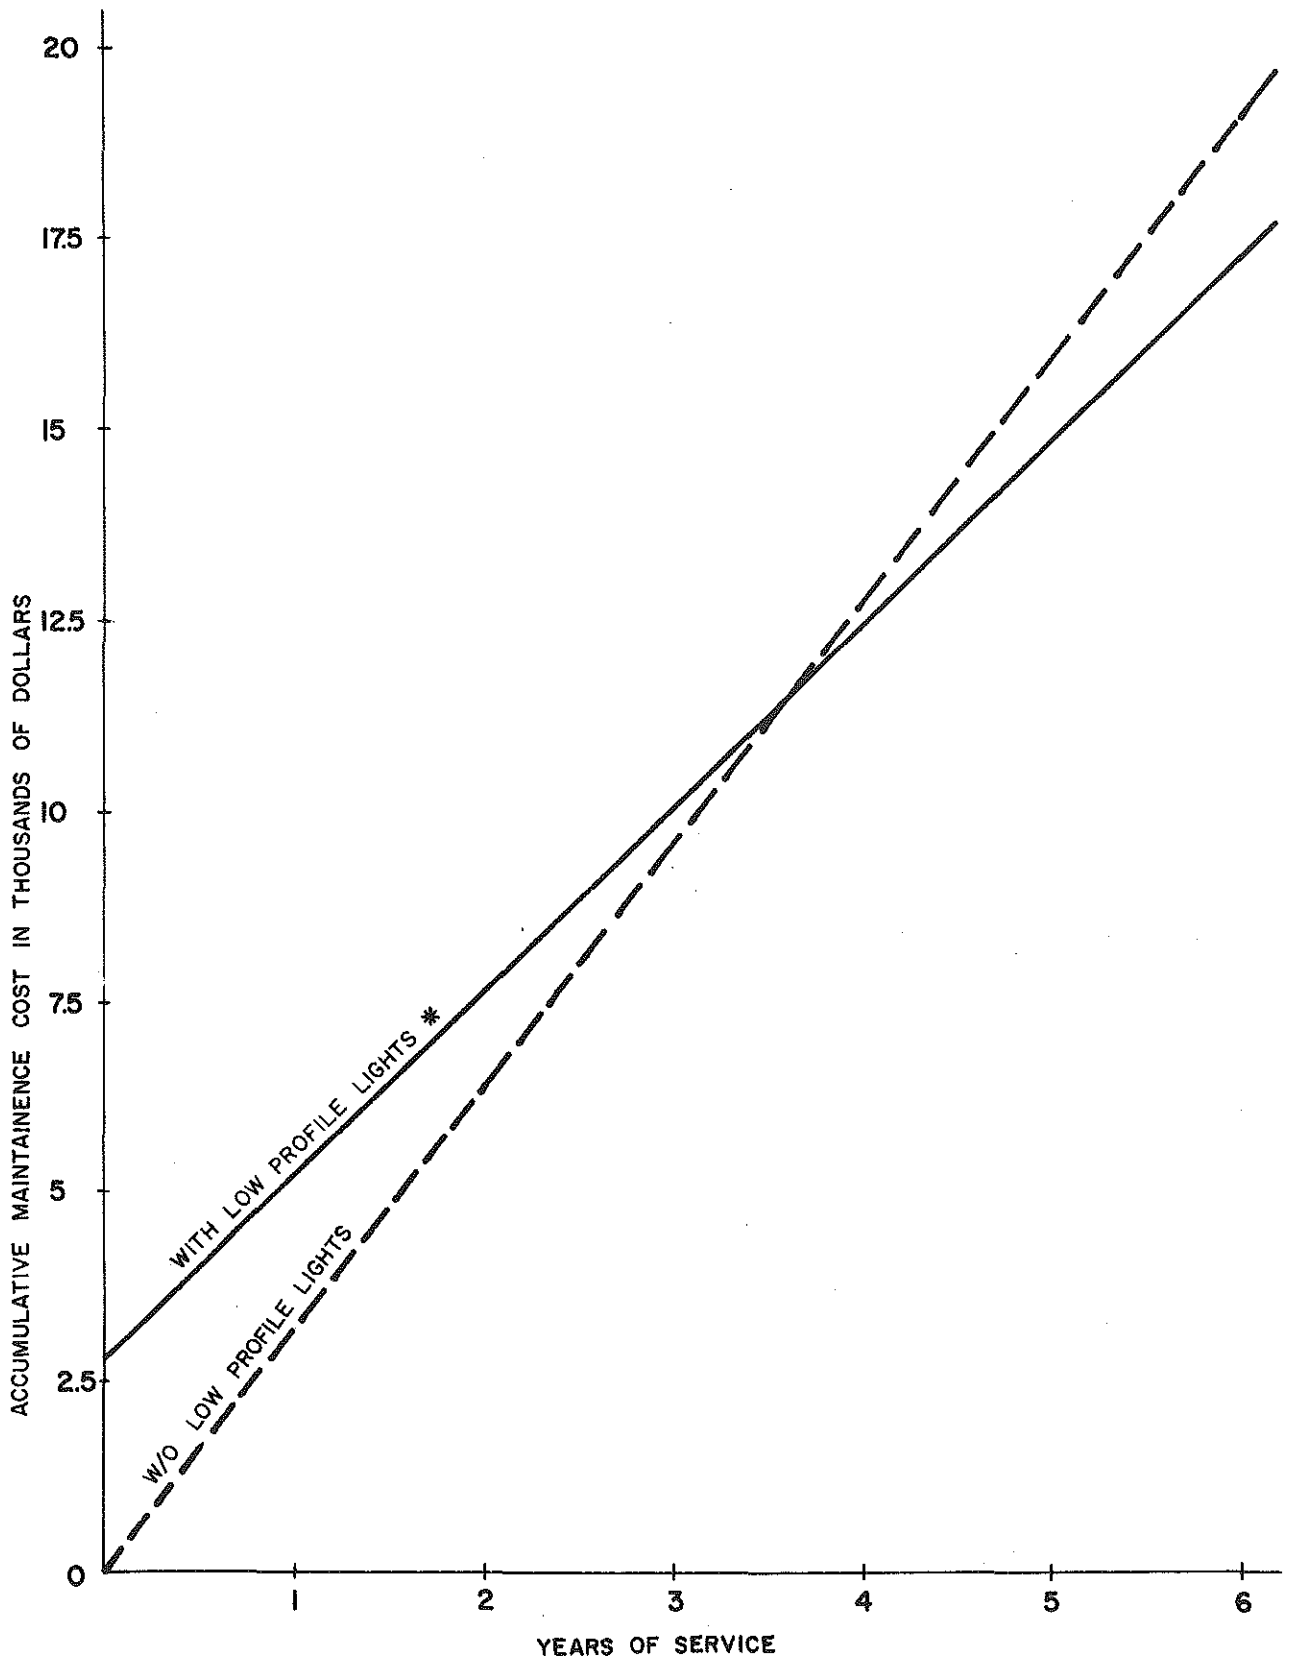
FIGURE V

MAINTAINENCE COST COMPARISON WITH AND WITHOUT LOW PROFILE LIGHTS
