BRIDGE DECK REPAIR AND DEVELOPMENT
OF PROCEDURES FOR EPOXY INJECTION
GROUTING OF BRIDGE DECK DELAMINATIONS
(Capital Avenue over I 496 in the City of Lansing,
S10 of 33044D)

MICHIGAN DEPARTMENT OF
STATE HIGHWAYS AND TRANSPORTATION

Research Laboratory Section
Testing and Research Division
Research Projects 73 NM-381
and 74 F-141
Research Report No. R-1012

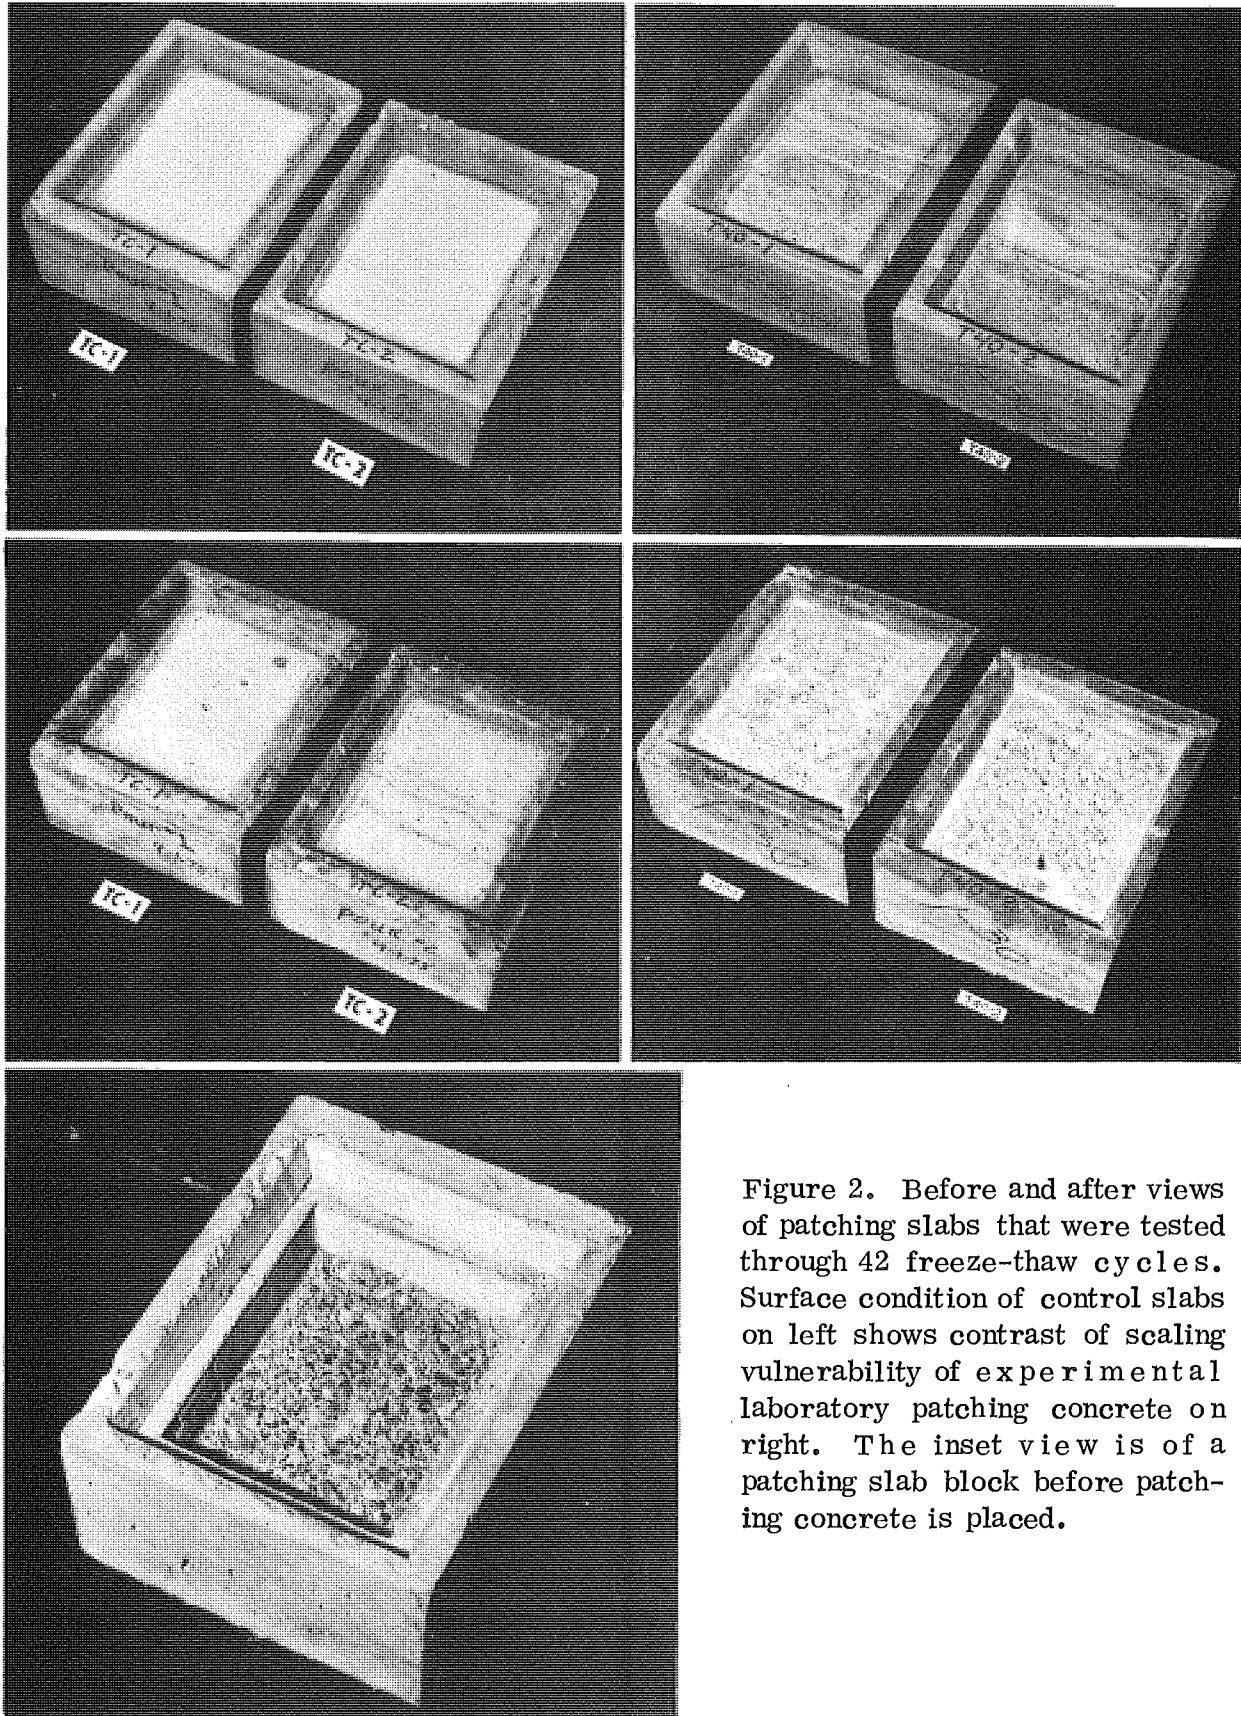
Figure 2. Before and after views of patching slabs that were tested through 42 freeze-thaw cycles. Surface condition of control slabs on left shows contrast of scaling vulnerability of experimental laboratory patching concrete on right. The inset view is of a patching slab block before patching concrete is placed.

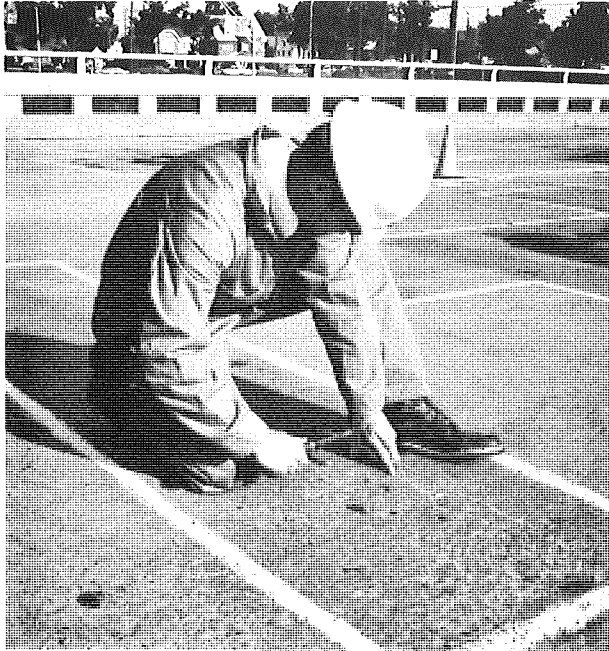
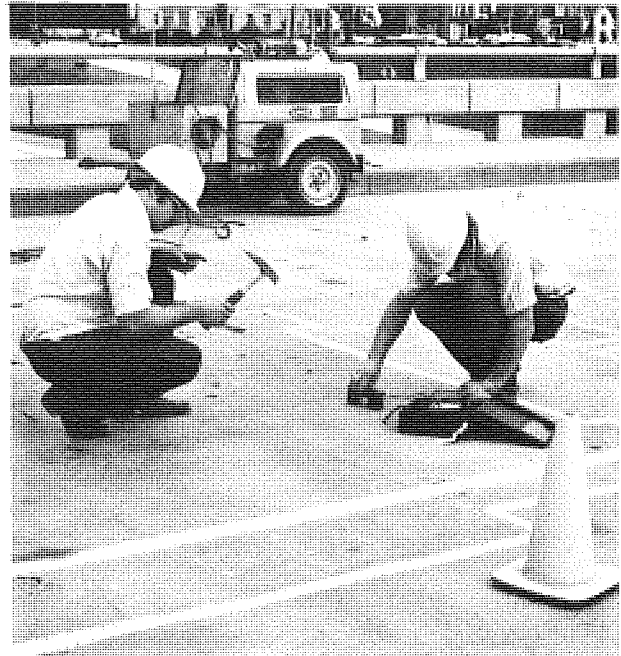
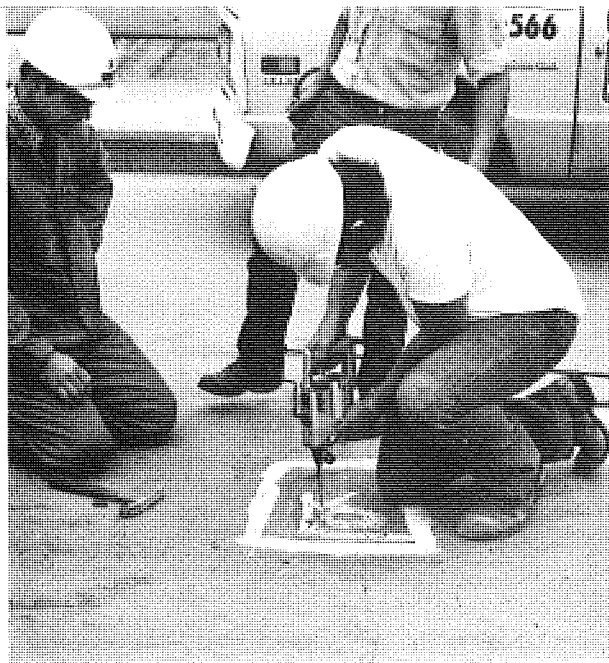
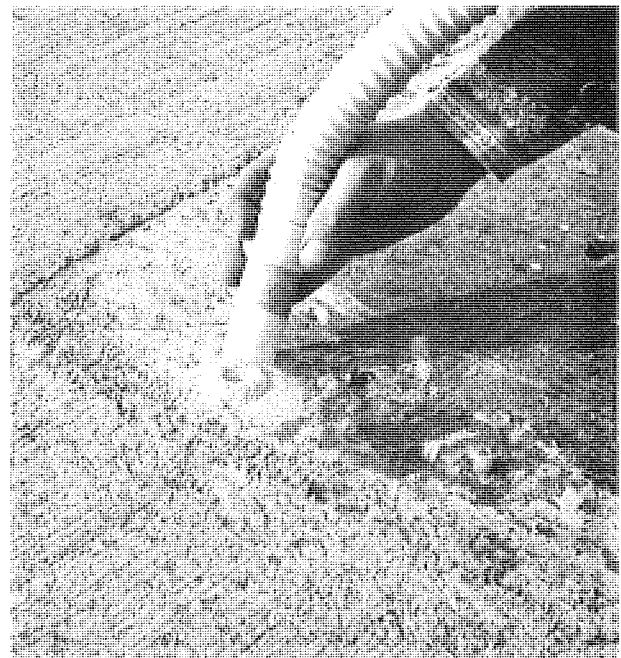
Figure 6. Sequence of operations for epoxy grouting procedure.

Locating position of reinforcing bars in delaminated area. ▶

◀ Sounding for delaminated or 'hollow' areas.

A vacuum cleaner is used to remove drill dust from around ports. ▶

◀ Three-eighths in. holes are drilled for injection and vent ports.

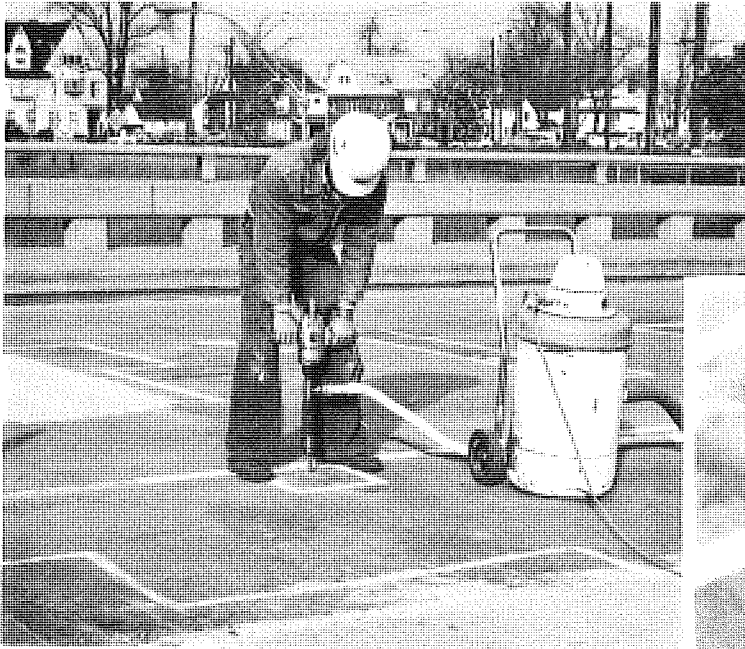
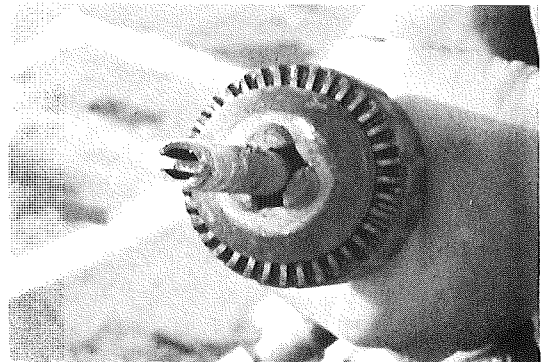
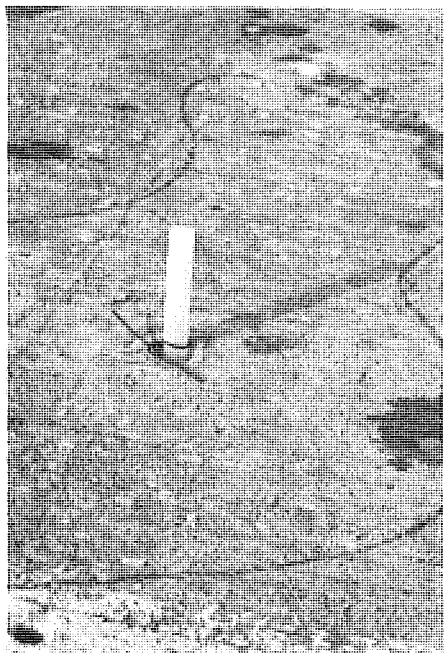
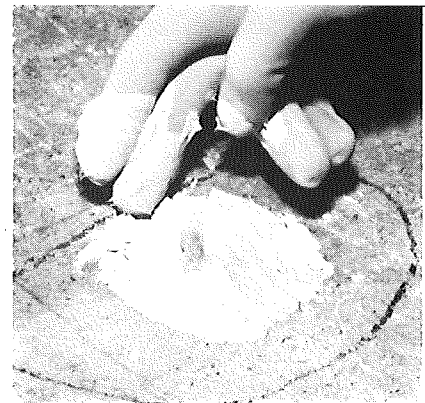
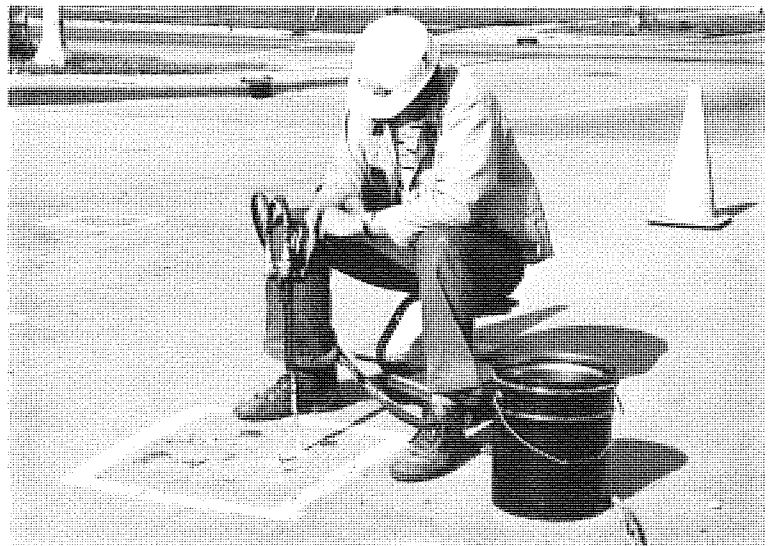
Figure 6 (Cont.). Sequence of operations for epoxy grouting procedure.

Injection ports are reamed with a 1/2-in. hollow bit vacuum drill to prevent plugging of the opening.

The polyethylene 'tee' is held in place with a support wire.

The polyethylene 'tee' is grouted with epoxy bonder.

Operator pumps grout into 'tees.'

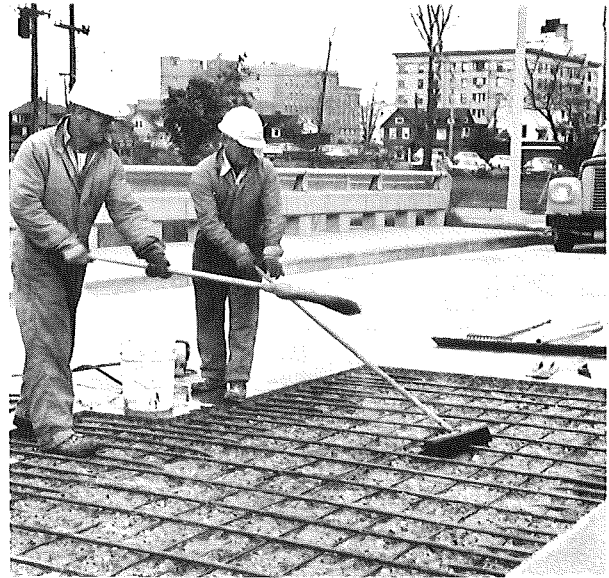
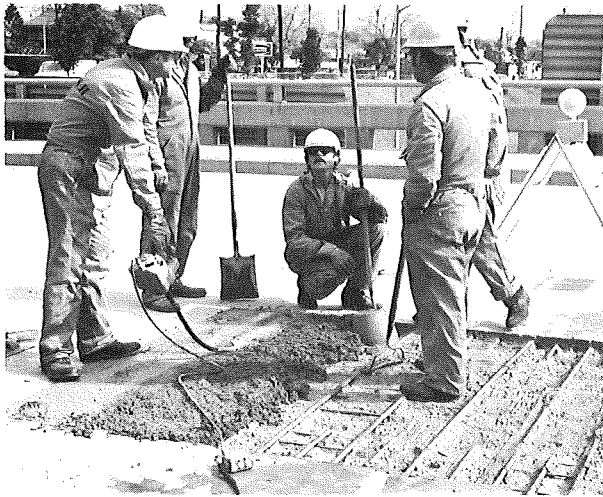
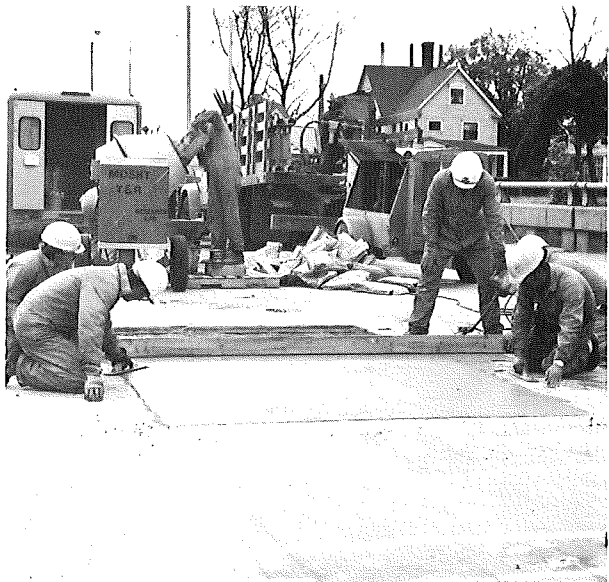
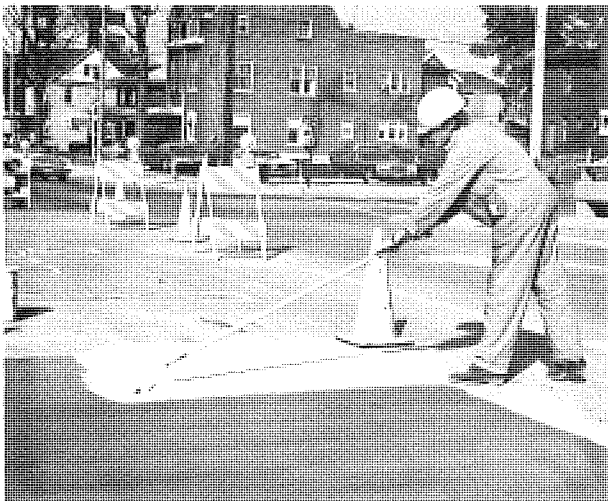
Figure 9. Concrete placement and finishing operations.

Substrate is wetted with brooms. ▶

◀ Reinforcement and substrate are sand-blast cleaned.

Surface is screeded, floated, and troweled. Crown curvature was cut into the screed board. ▶

◀ When consolidating the low slump Em-beco 411A mortar, the vibrator is pulled between rebar locations to free any air entrapped beneath the bars and completely surround the bars with concrete (note the initial priming mortar).

◀ A white membrane curing compound was applied three hours after brooming.
