**Pavement Demonstration Program Project Finalization
Perpetual Hot Mix Asphalt Pavement Over Rubblized
Concrete Project –
I-75
(MDOT Job Number 90279)**

Final Technical Report

Report No. OR23-304, C

July 2024

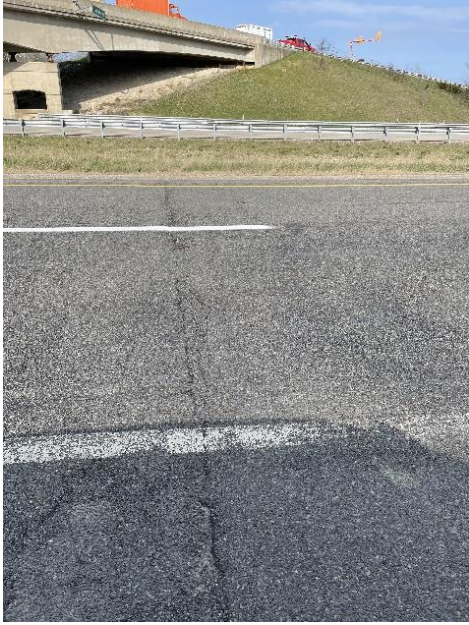
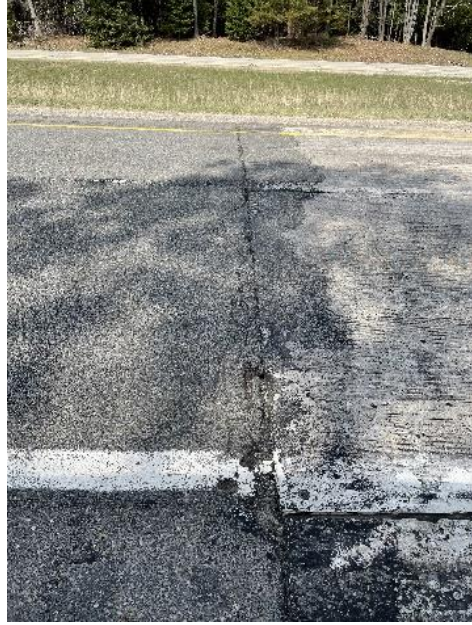
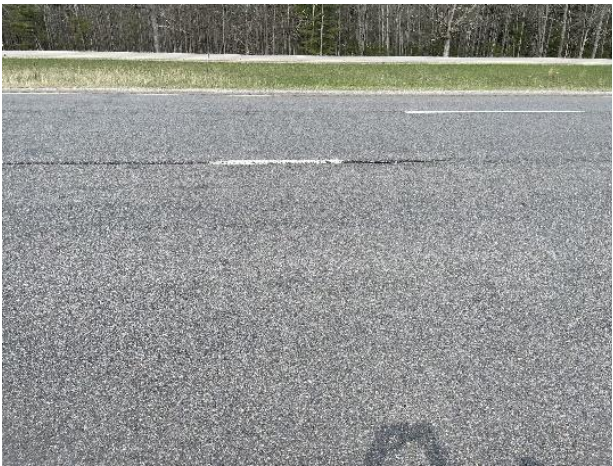
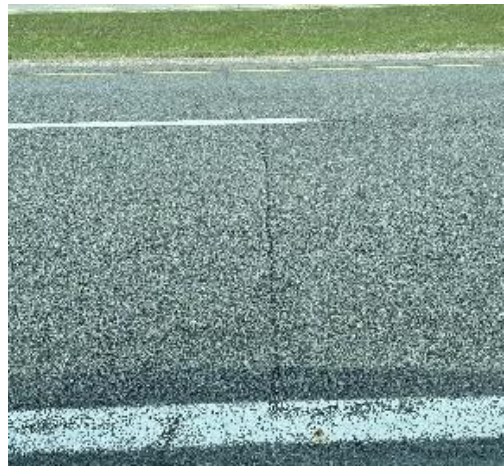
Figure 53. Field evaluation on 05-10-2022

Conclusions:		
Cracking increased from 9 to 11 transverse locations in the left lane but stayed the same in the right lane (9 locations). However, this is still minimal and the transverse cracking per mile is very low at ~48 ft/lane-mile. The longitudinal joint between the rightmost lane and shoulder has only a few locations showing separation (up to 2"). The past noted potholes and delamination of the surface at the north and south end transitions of this project remain but was improved due to the maintenance project.
