MDOT RC-1412  
CSD-2002-02

# CAUSES & CURES FOR PRESTRESSED CONCRETE I-BEAM END DETERIORATION

AUGUST 2002

TESTING AND RESEARCH SECTION  
CONSTRUCTION AND TECHNOLOGY DIVISION  
RESEARCH REPORT NO. RC-1412

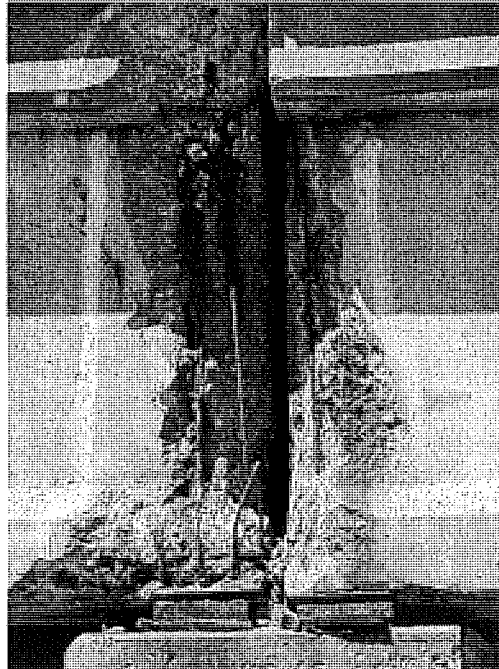
Work performed by others has concluded that in midwestern states, such as Michigan, corrosion is more pronounced in older bridges near the beam-ends (Whiting et al, 1999). This is likely due to the beam-ends being located below poorly maintained deck joints and thus exposed to deicing salts draining from the deck surface. Photo 1-1 shows an example of the end deterioration problem that some of Michigan's prestressed concrete I-beam bridges face.

Photo 1-1. End deterioration of prestressed concrete I-beam ends

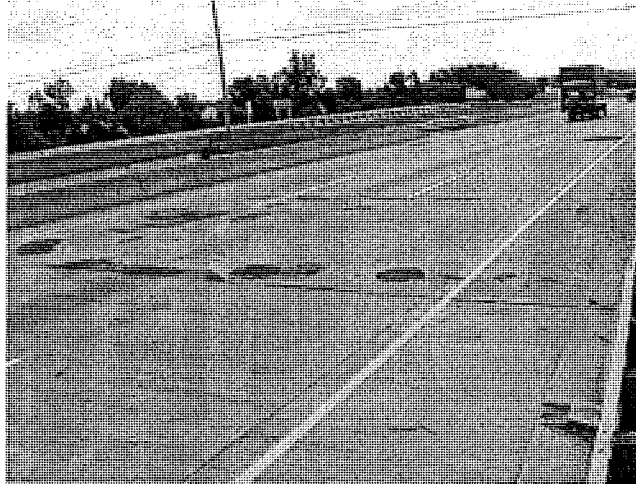
Deck shoulders are covered with debris. Main span deck is in good condition. Side span decks have cracks and potholes with some rust and efflorescence stains. Expansion joints have leakage. Spalls are noted along construction joints. The construction joint filler is missing at the barriers. Drainage system is clean and operable. The general view of the deck is shown in Photo 3-1.

**Photo 3-1. Deck Condition of 41029 S23**

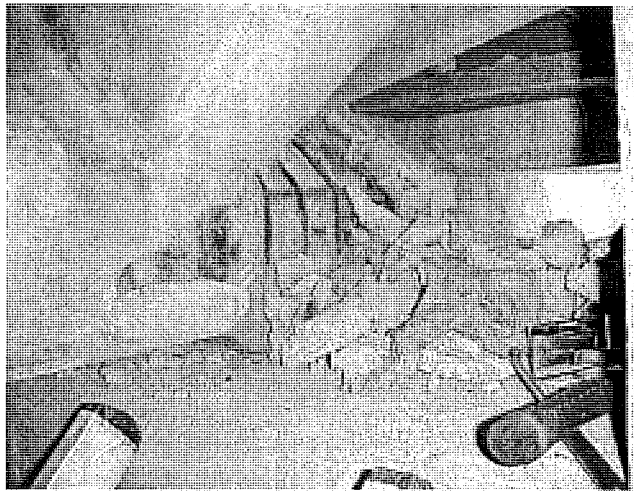
Most beam-ends display cracking and minor spalling, rust and/or efflorescence stains. At some of the beam-ends shear reinforcement is exposed. Examples of the typical beam-end conditions are shown in Photo 3-2 and Photo 3-3:

**Photo 3-2. View of beam-end condition with exposed rebars**

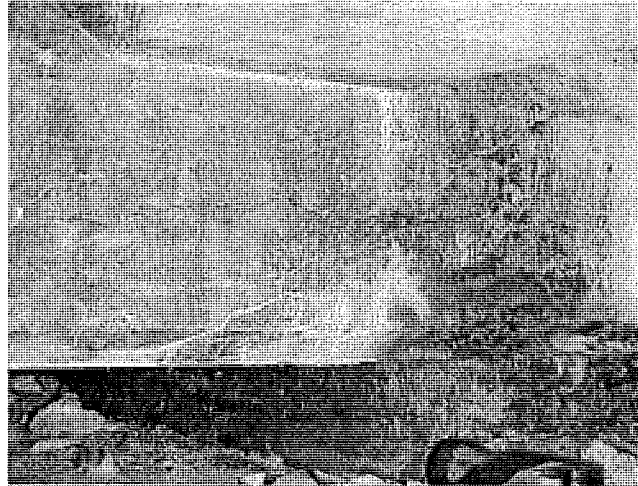
**Photo 3-3. Close view of the beam-end condition - note cracking and efflorescence**

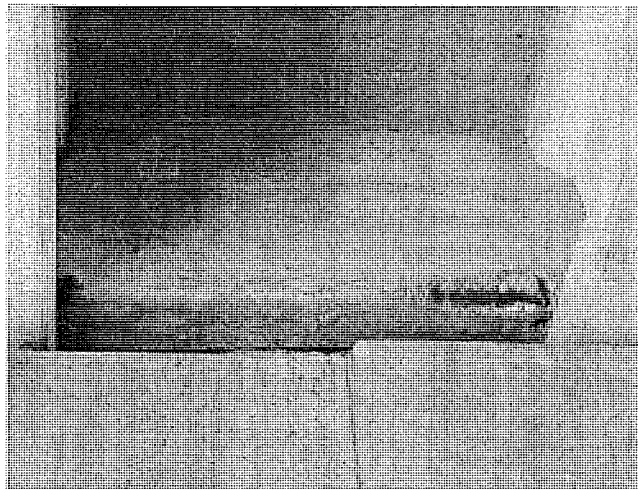
Most of the sole plates on the piers are rusted. Several diaphragms on both piers are cracked and delaminated. One concrete diaphragm between beams W5 and W6 on pier S1 was partially spalled with exposed shear reinforcement (see Photo 3-4).

**Photo 3-4. Diaphragm condition with exposed rebar**

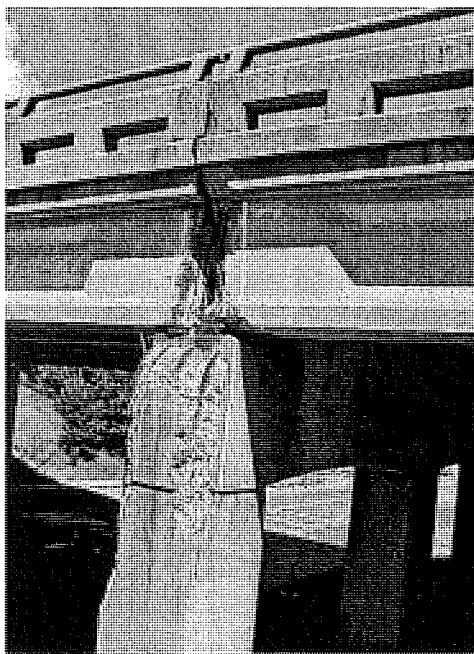
Both abutments have a few vertical cracks. All piers have random cracks, spalls, delamination, and rust stains. Heavy rust stains and exposed reinforcement are observed on the east fascia of pier S1 and west fascia of pier S3. The severe pier and stringer conditions are shown in Photo 3-5.

**Photo 3-5. Documenting severe deterioration of the pier and beam end**

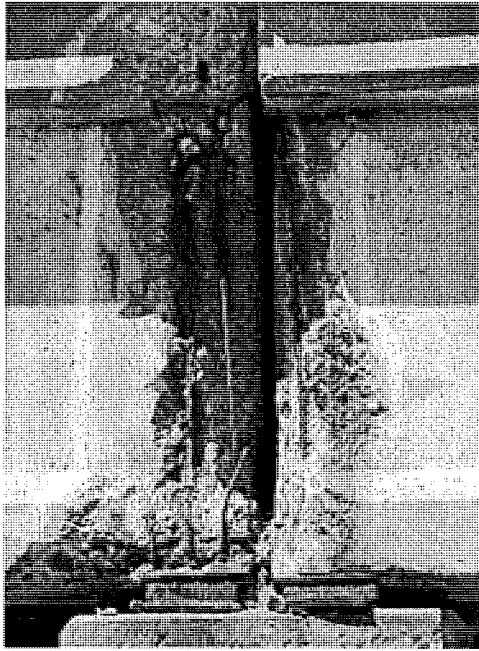
Most of the beam-ends are partially delaminated and spalled showing exposed shear reinforcement. The example of severe beam-end deterioration is shown on Photo 3-6:

**Photo 3-6. Severe deterioration of beam-end**

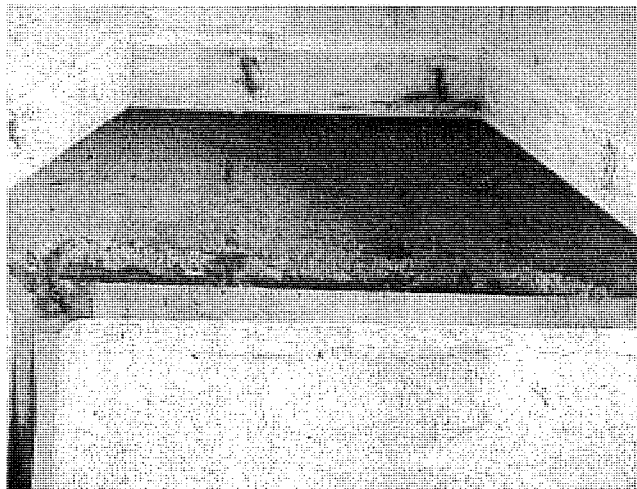
The diaphragms on both piers are cracked, spalled, and delaminated. The concrete diaphragms on pier W1 between beams S4 and S5 and on pier W2 between beams S2 and S3 are heavily spalled with exposed shear reinforcement (see Photo 3-7).

**Photo 3-7. Diaphragm condition with some deterioration**

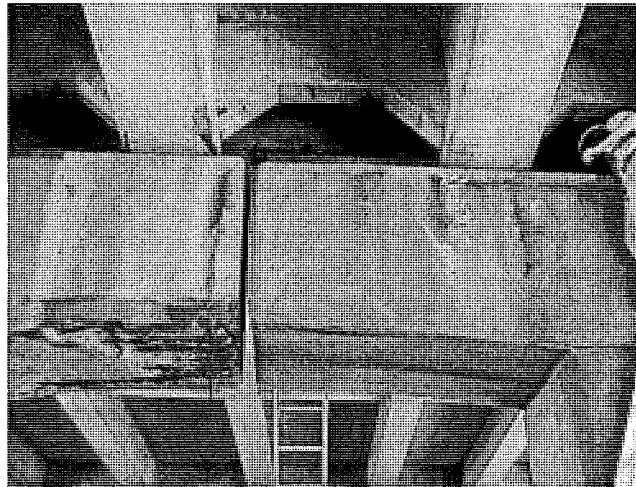
The abutments have a few vertical cracks and minor water and rust stains. Elastometric bearings are deformed. Piers have cracks, spalls, rust, and water stains. Shear reinforcement is exposed, and concrete has spalled at the bottom of the pier cap W1 (see Photo 3-8). Also, notice the difficulty of accessing the beam end behind the diaphragm for visual inspection.

**Photo 3-8. Exposed reinforcement and some spalls at piers, beam-end and diaphragms**

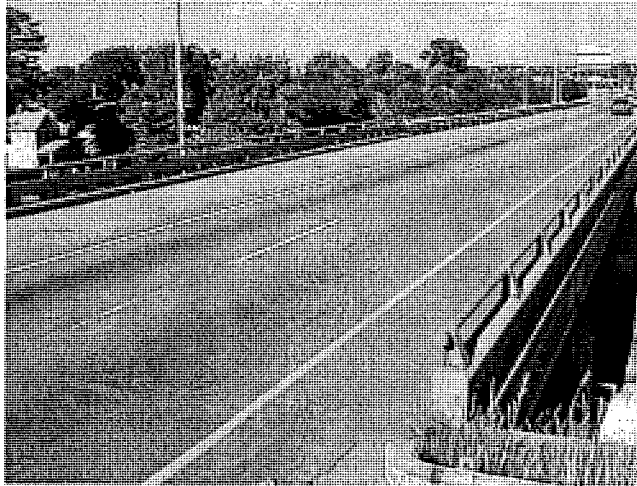
The deck is overlaid with asphalt (see Photo 3-9)

**Photo 3-9. General view of the deck**

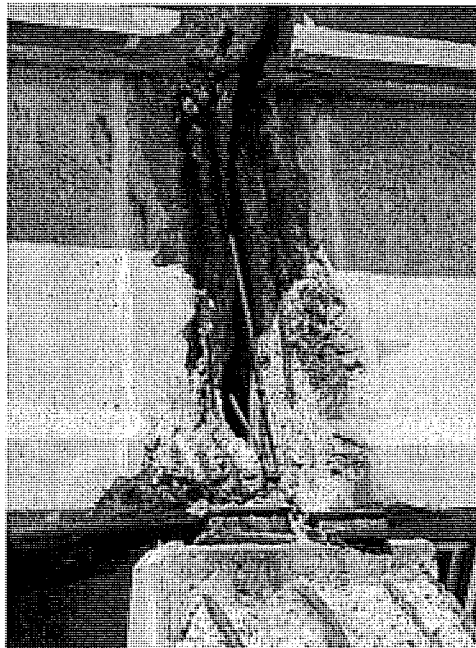
Most of the beam-ends display major cracking and spalls, rust and/or efflorescence stains, and exposed shear reinforcement. An example of the most severe deterioration of a beam-end and pier cap is shown in Photo 3-10:

**Photo 3-10. Beam-end and pier cap deterioration**

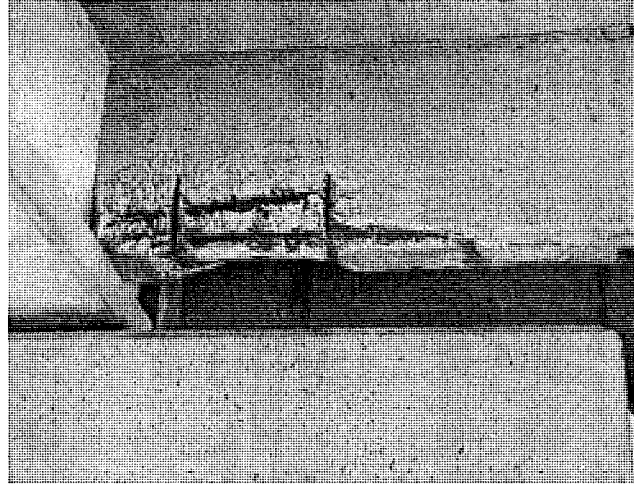
Some of the sole plates are corroded and neoprene pads deformed with the ends curling. Some diaphragms have cracks, spalls and delaminations. The concrete diaphragm on pier W1 between beams S2 and S3 shows spalls with exposed shear reinforcement (see Photo 3-11).

Photo 3-11. Spall with exposed reinforcement at diaphragm

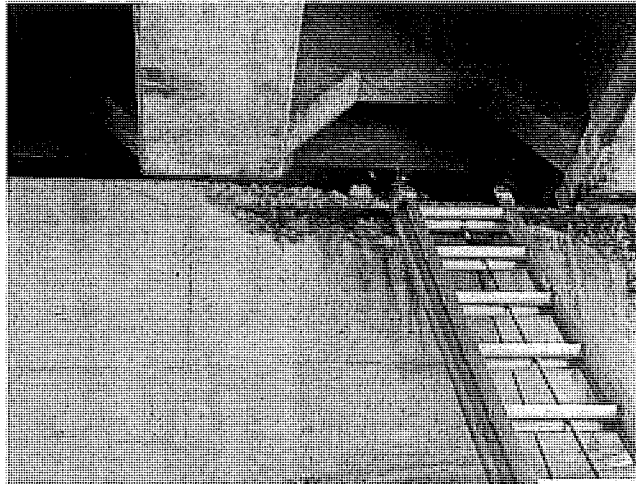
Pier S1 has rust stain, delamination, spalls and rusty cracks. The north fascia of the pier is spalled with exposed reinforcement as shown in Photo 3-12.

**Photo 3-12. Spall at the North fascia of pier S1**

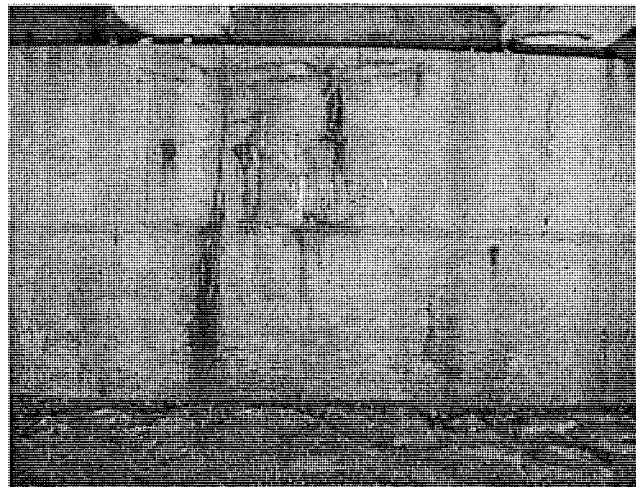
The east abutment has some vertical and horizontal cracks, delamination, and rust, water and efflorescence stains. The sole plates are corroded. The severe condition on the east abutment and delamination at the end of beam S3 are shown in Photo 3-13.

**Photo 3-13. Condition of east abutment**

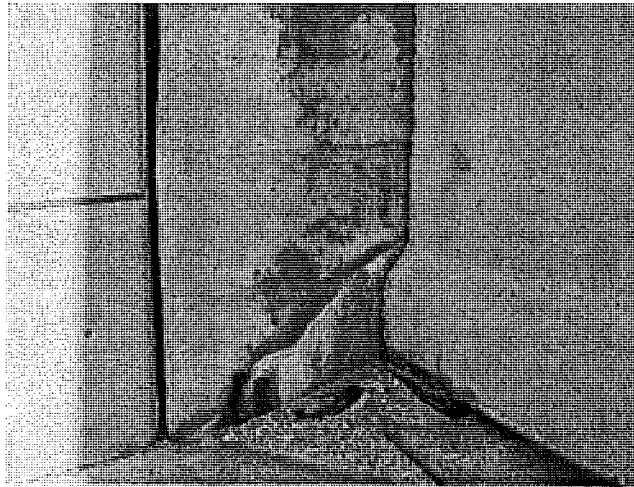
The diaphragms at pier W1 are patched and have delamination, rust stains, and exposed reinforcement. The diaphragms at pier W2 show cracks, exposed reinforcement, and rust. The diaphragms at pier W3 are in good condition with minor areas of delamination at the bottom.

The example of the most severe deterioration of beam-end and diaphragm is shown in Photo 3-14.

Photo 3-14. Beam-end and diaphragm condition

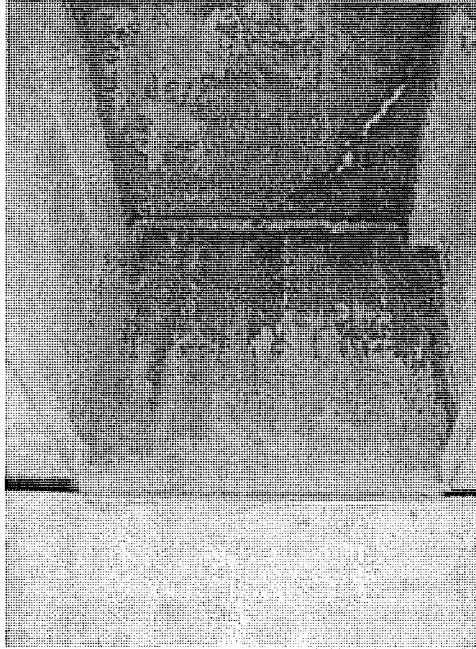
Both abutments have a few hairline vertical cracks through all retaining walls. Rust and efflorescence stains, spall and delamination noted. Efflorescence stain is noted at the bottom of the deck next to abutment as shown in Photo 3-15.

**Photo 3-15. Rust and efflorescence stain on the deck**

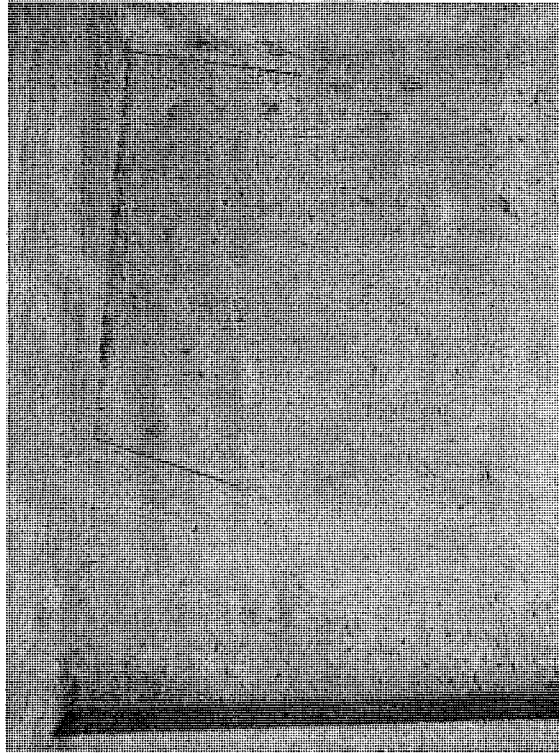
Most of the beam-ends display minor cracking, spalls and rust stains. The common crack pattern is as shown in Photo 3-16.

**Photo 3-16. Beam-end common crack pattern (cracks outlined in blue)**

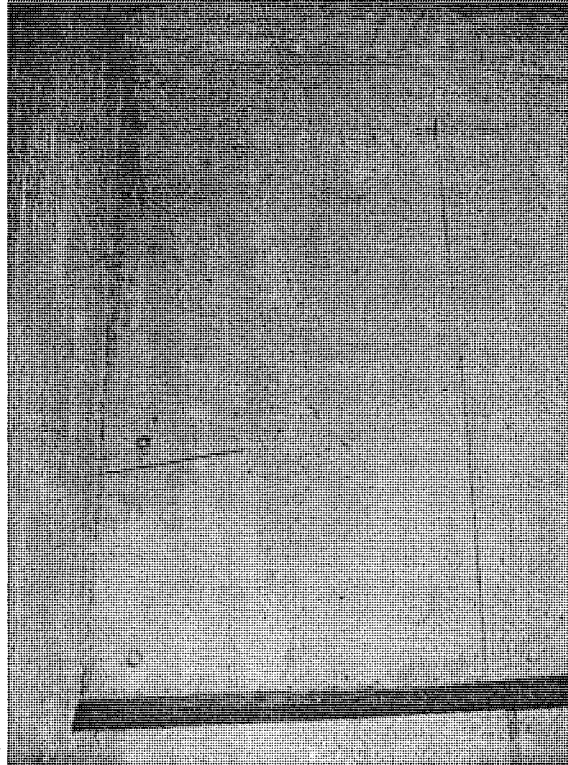
Most of the beam-ends display minor cracking, spalls, rust and water stains next to the bearings. The common crack pattern is as shown in Photo 3-17.

Photo 3-17. Beam-end common crack pattern (cracks outlined in blue)

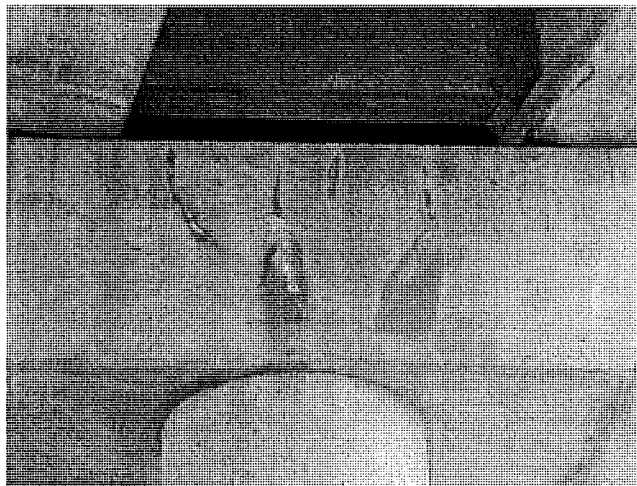
Cracks, efflorescence, rust and water stains are noted at the piers caps. All pier caps are sealed with resin. The pier columns do not display any kind of deterioration. The common pier condition is shown in Photo 3-18.

**Photo 3-18. Pier condition with leaching from stress cracks**

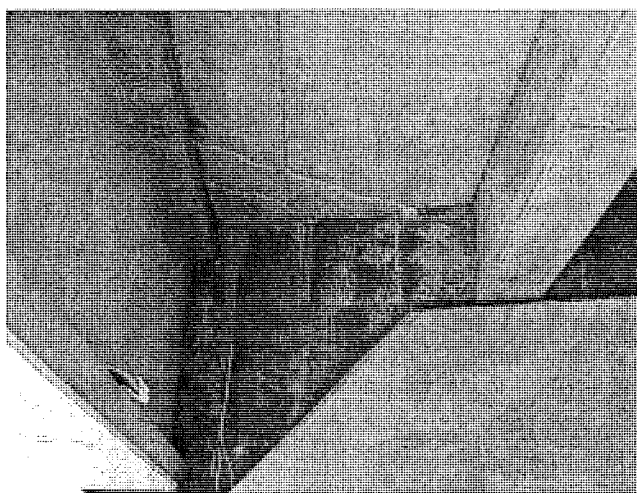
The bottom of the deck has some efflorescence staining mostly near the back wall as shown in Photo 3-19.

**Photo 3-19. Efflorescence stain at bottom of the deck**

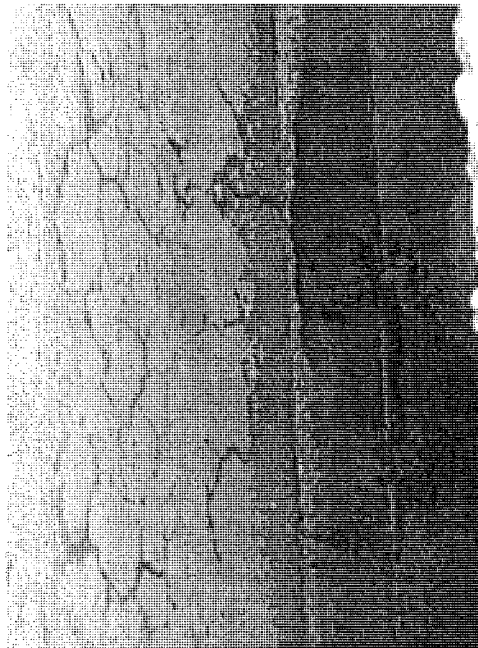
Most of the beam-ends display minor water and rust stains and micro and hairline cracks. The example of map cracking is shown in Photo 3-20.

**Photo 3-20. Example of map cracking at a beam-end**

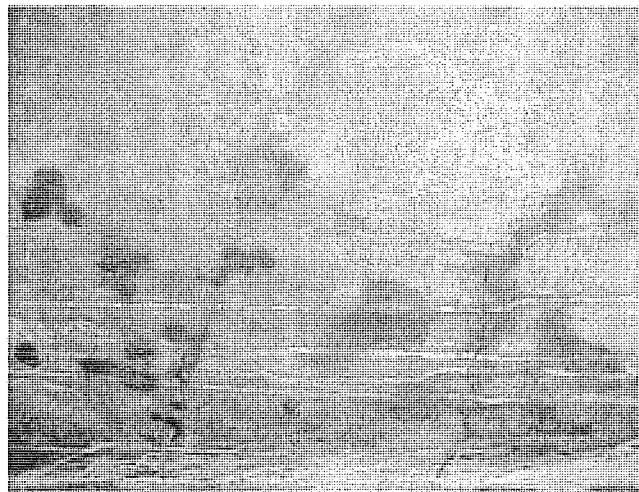
Most of the beam-ends display hairline cracks. The examples of hairline cracks are shown in Photo 3-21 and Photo 3-22 (The crack is traced with purple chalk).

**Photo 3-21. Example of hairline cracks**

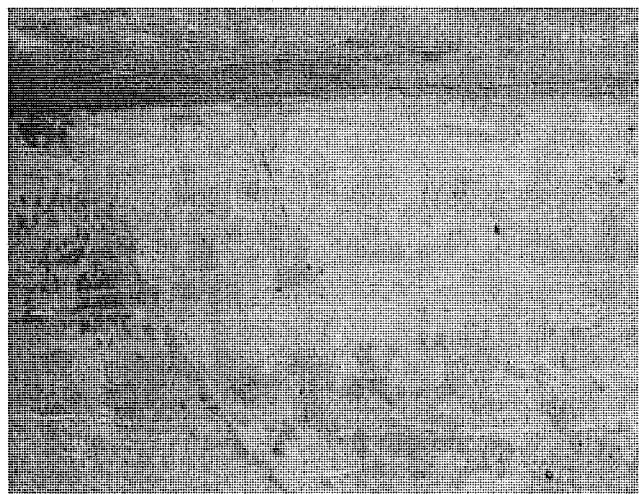
**Photo 3-22. Example of hairline cracks**

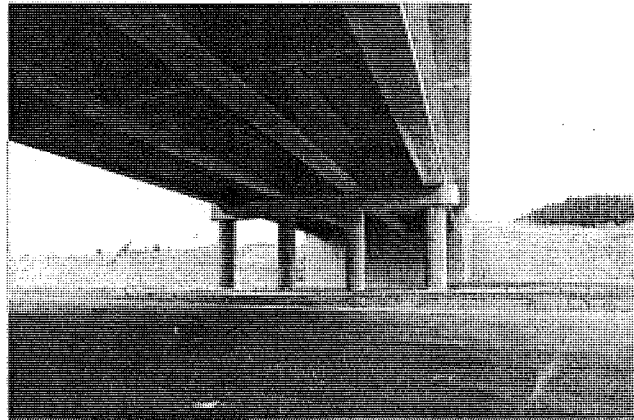
Water stain and few patches are noted on both the West and East fascias at the caps of the middle pier. Several pier columns have water stain (see Photo 3-23).

**Photo 3-23. Water stain on the piers and caps**

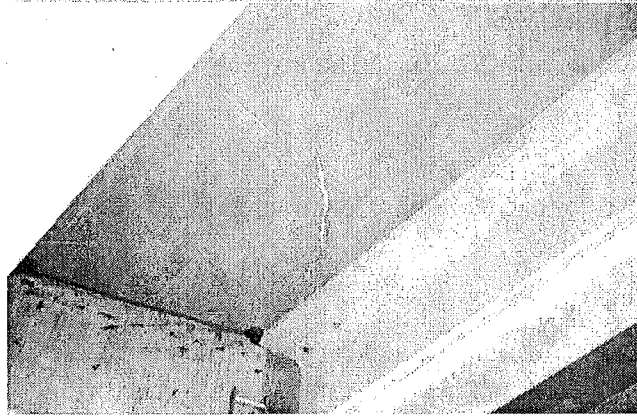
The bottom of the deck has efflorescence stain at the South corner of the West abutment and the North corner of the East abutment (see Photo 3-24).

**Photo 3-24. Efflorescence stain at South corner of West abutment and deck**

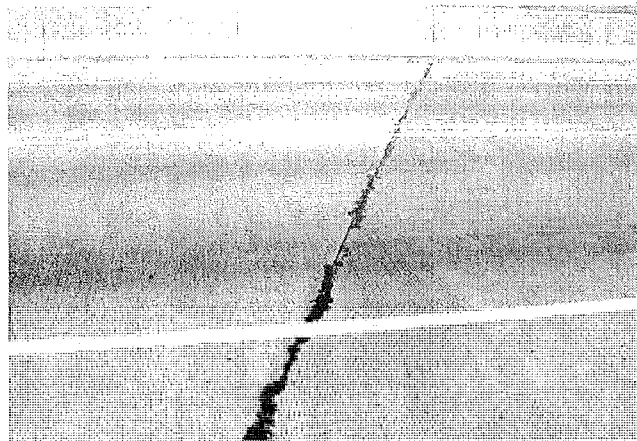
The construction joints are cracked and filled with sand. An example of a control joint with hot-pour joint sealant is seen in Photo 3-25.

**Photo 3-25. Condition of Deck Control joint**

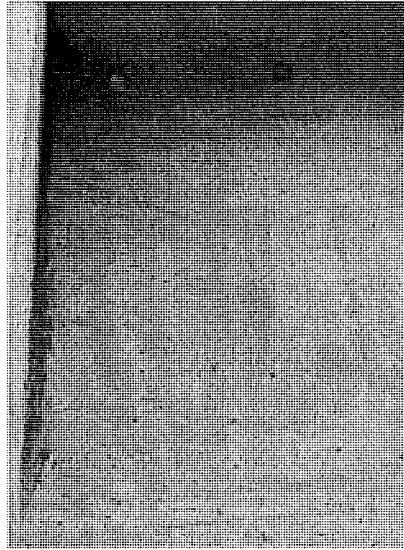
Most of the beam-ends display microscopic and hairline cracks as shown in Photo 3-26.

**Photo 3-26. Hairline cracks at beam-end**

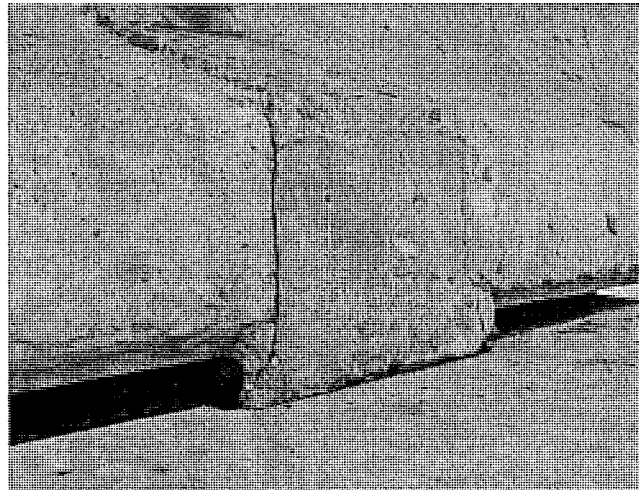
Some of the beam-ends have incipient spalls as shown in Photo 3-27.

**Photo 3-27. Beam-end restraint detail**

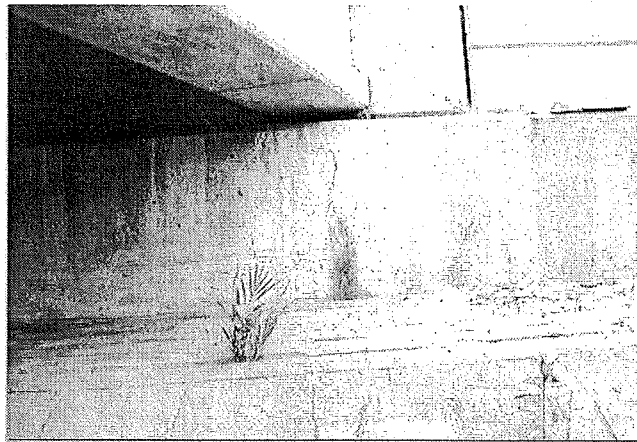
The West abutment has several vertical cracks with water and rust stains (see Photo 3-28).

**Photo 3-28. Vertical crack with moisture and rust stain at West abutment**

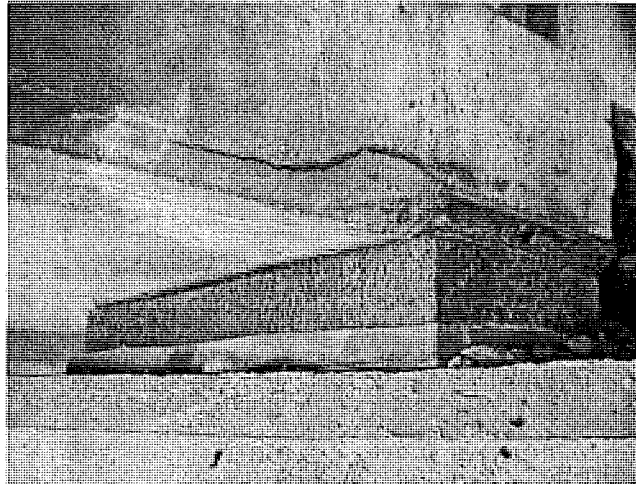
Most of the beam-ends are delaminated, cracked, spalled and some exhibit exposed shear reinforcement as shown in Photo 3-29 and Photo 3-30 (at pier W1, beam S1; at pier W2, beams S1, S2, S4 and S6; at pier W3, beams S2 and S6).

**Photo 3-29. Delamination at the beam-end and bearing with sole plate**

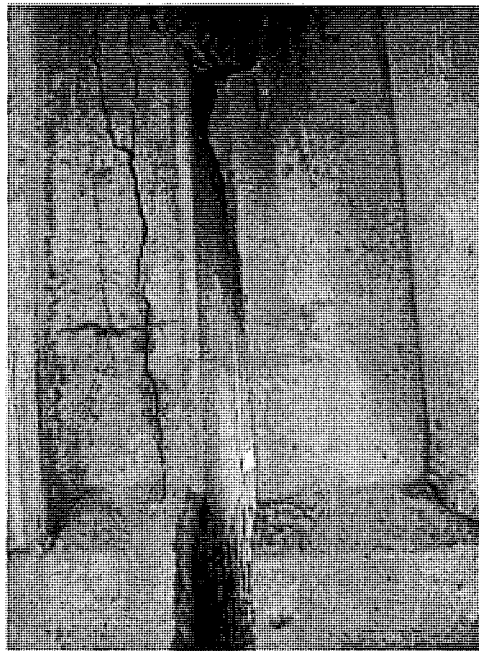
**Photo 3-30. Beam-end cracking**

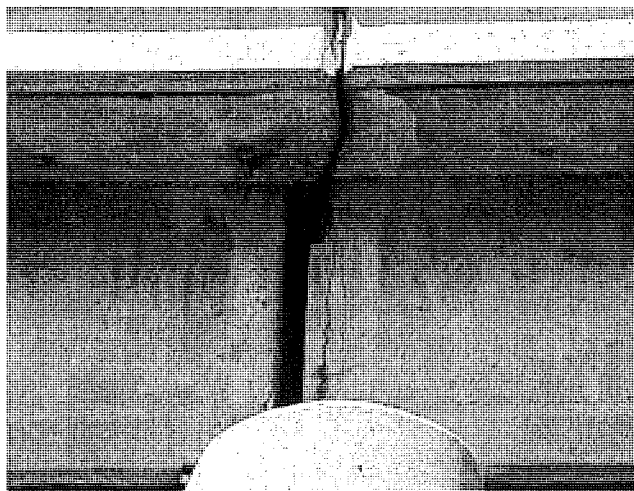
The beam-ends are cracked, delaminated, and spalled. Also, there is evidence of rust, water and efflorescence stains. The beam-ends of eight beams out of 22 are spalled with exposed shear reinforcement evident. The beam-ends at the abutment have hairline cracks with some rust and water stain. The sole plates are rusted and the pads appear to have lost flexibility and are deformed. The diaphragms between beams S5, S6 and S7 at pier W1 are delaminated. The diaphragm between beams S1 and S2 at pier W3 is delaminated at the bottom and partially spalled with exposed reinforcement. The condition at the beam-ends at the pier caps is shown in Photo 3-31.

Photo 3-31. Condition at the beam-ends at the pier

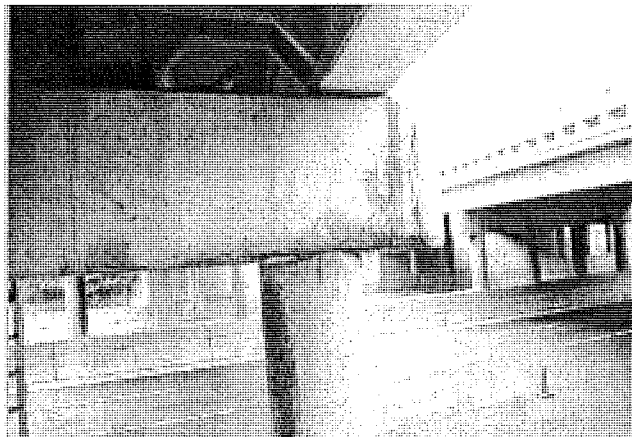
All of the pier caps have water and rust stains. Delamination, cracks, and rust stains are noted at the fascia and bottom of all pier caps (see Photo 3-32).

**Photo 3-32. Delamination, cracks and rust stain at pier and pier cap**

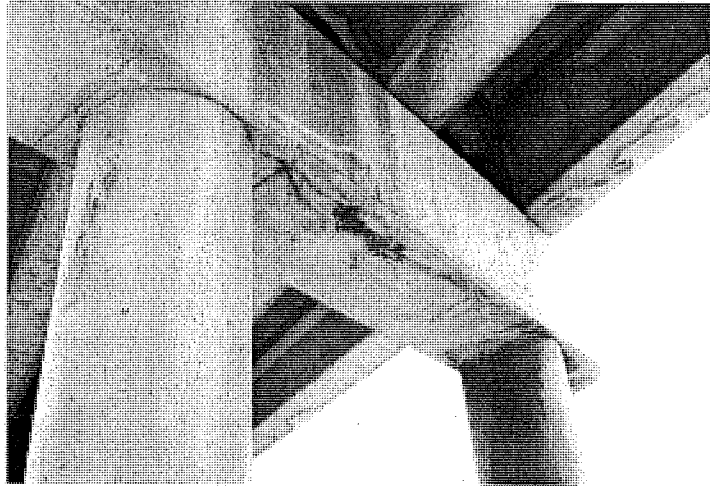
The bottom of pier W1 is spalled showing exposed reinforcement (see Photo 3-33).

**Photo 3-33. Exposed reinforcement at the bottom of the pier W1**

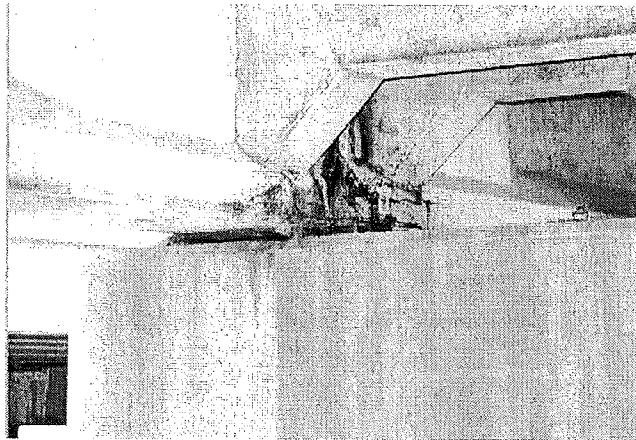
All of the beam-ends are cracked. Many of the beam-ends have moisture leaching from the cracks. Some of the beam-ends are delaminated or spalled showing exposed shear reinforcement as shown in Photo 3-34.

**Photo 3-34. Deterioration at the beam-ends in between diaphragms**

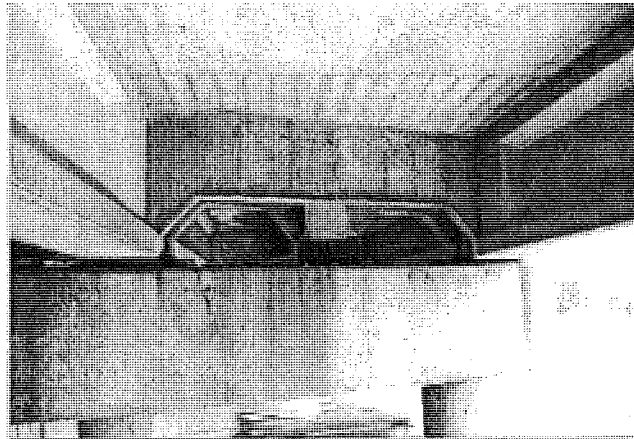
Pier W1 has minor rust and water stain, spalls and cracks at both fascias (see Photo 3-35).

**Photo 3-35. Rust and water stain, spalls and cracks at Pier W1**

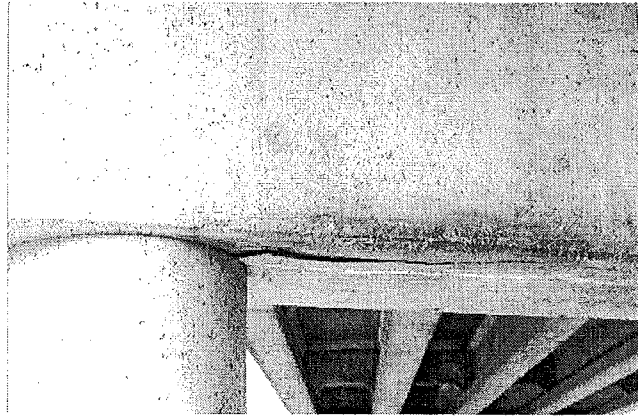
The East fascia of pier W1 has areas of delamination, cracks, and efflorescence stains. Piers W2 and W3 have water and rust stains. Pier W3 displays crack and delamination at the bottom of the pier cap (see Photo 3-36).

**Photo 3-36. Crack and delamination at the bottom of the pier W3**

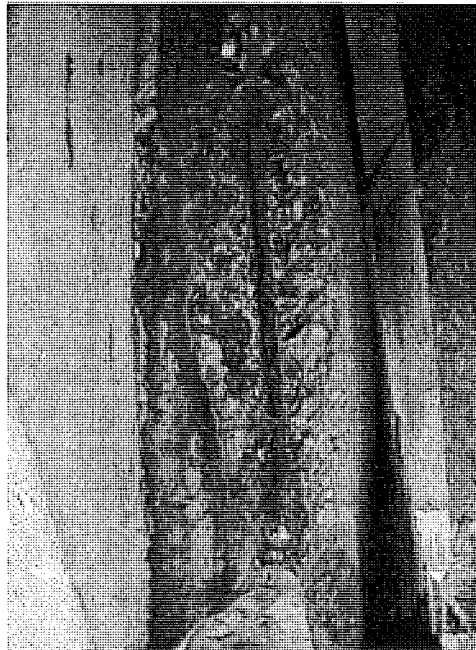
The beam-ends at the piers are cracked, delaminated and spalled. Some of the beams have rust and efflorescence stain. Eleven beams out of twenty are spalled with exposed reinforcement. The beam-ends at the abutments have hairline cracks, water, and rust stains. The typical beam-end condition is shown in Photo 3-37.

**Photo 3-37. Beam-end exhibiting significant deterioration**

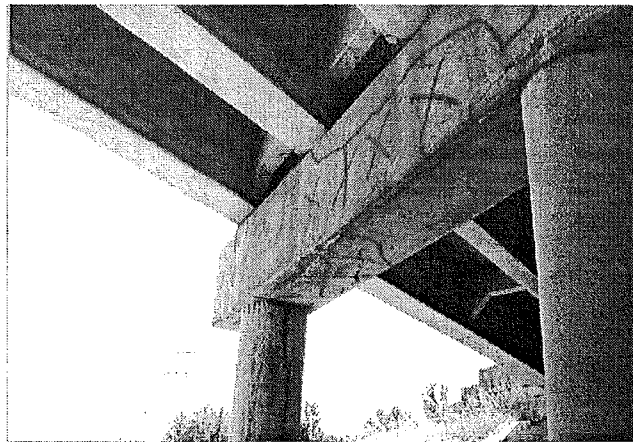
All pier caps have delamination, rust, and water stain. The worst condition at the piers is shown in Photo 3-38.

**Photo 3-38. Condition of pier and pier cap**

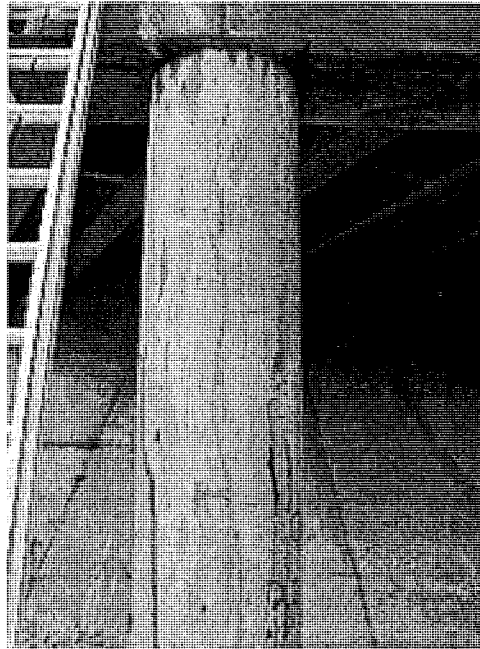
The corners of the pier caps at piers W4 and W5 are spalled and showing exposed reinforcement and efflorescence stains (see Photo 3-32). Some of the piers are cracked and patched. Most of the pier columns have water and rust stains. Column S4 of pier W1 has several wide vertical cracks thought all column height (see Photo 3-39).

**Photo 3-39. Vertical cracks at column S4 of the pier W1**

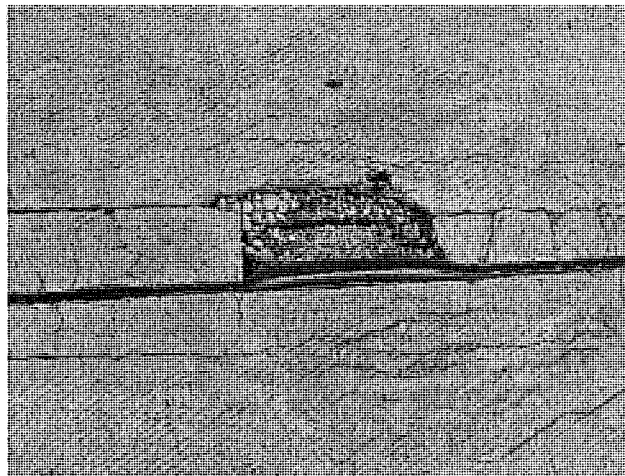
The surface of the concrete deck has many areas with cracks and efflorescence. The bottom of the deck is cracked with efflorescence and water stains next to both abutments. The deck sidewalks are covered with sand and gravel. Delamination, cracks, efflorescence, and rust are noted on the barriers. Some joints are filled with the sand. Several spalls and patches are noted along the joints. One joint has a spall with exposed reinforcement visible as shown in Photo 3-40.

**Photo 3-40. Spall with exposed reinforcement at the deck joint**

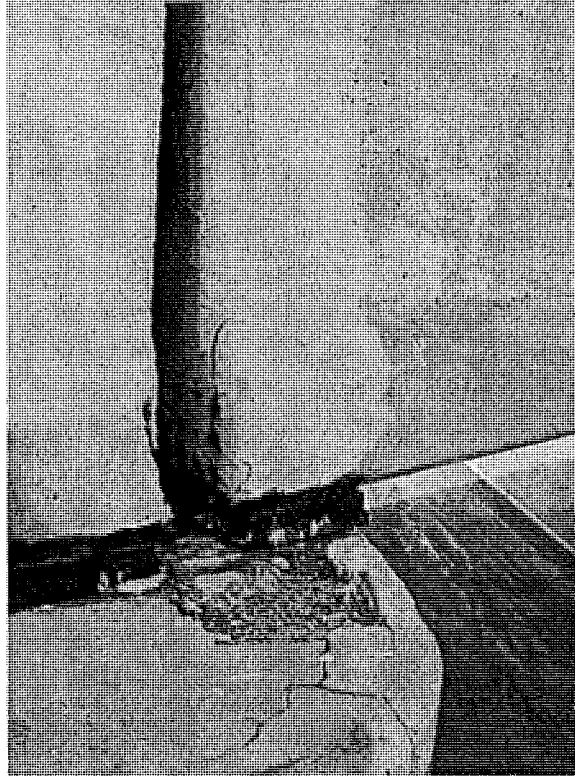
Vertical and horizontal cracks of various widths, from hairline to wide, are noted at the beam-ends (see Photo 3-41). Also, some beam-ends had been patched, but they were noted to have delaminations.

**Photo 3-41. Cracks at the beam-end and pier cap**

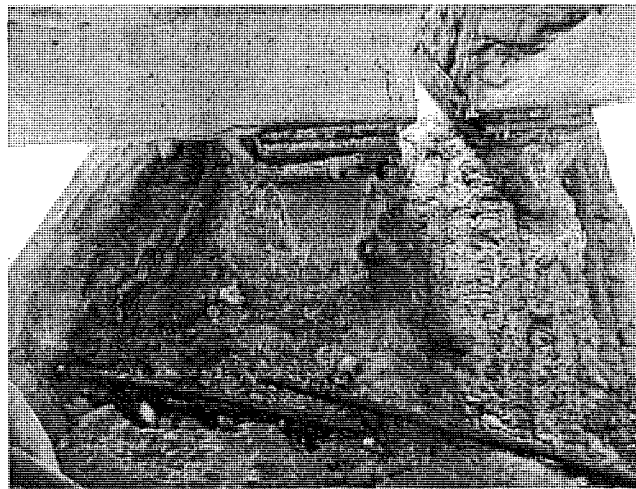
Some of the beam-ends have rust, water, and efflorescence stains and exhibit exposed shear reinforcement (see Photo 3-42). Sole plates are corroded. The diaphragms at the abutments are cracked. Most of the diaphragms at the piers are cracked and delaminated at their bottom and exhibit some rust stains and exposed reinforcement.

**Photo 3-42. Delaminated beam-end and pier**

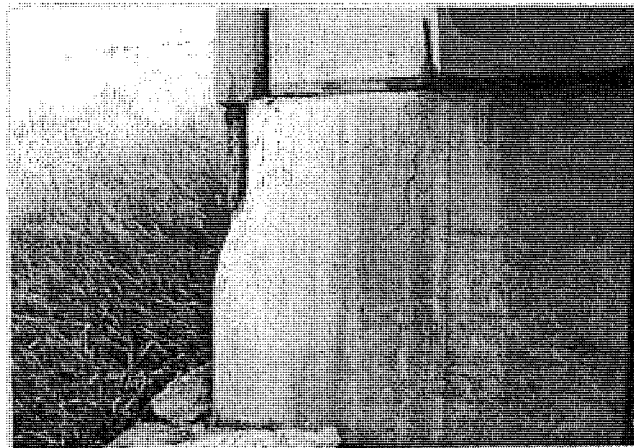
Both abutments have several cracks through the entire wall. The West and East abutments have rust and water stains at the North and South corners. The North corner of East abutment spalled showing exposed reinforcement as shown on Photo 3-43.

**Photo 3-43. Spall at North corner of East abutment**

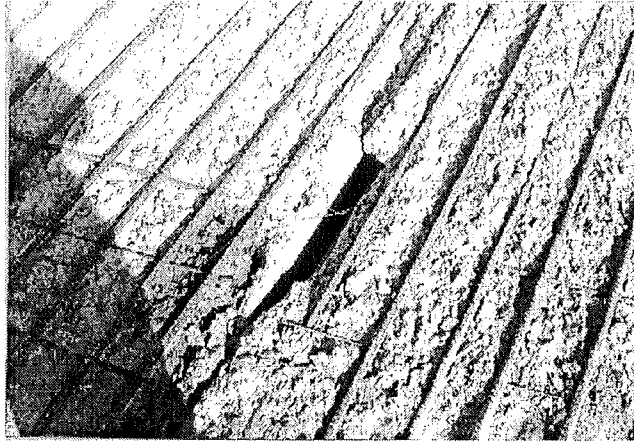
The deck is under replacement. New concrete overlay is being placed on the East approach and main deck. Concrete on the West approach is removed up to the reinforcement. The shoulders are cracked. Cracks, some areas of water and efflorescence stains are noticed at the deck bottom. The concrete barriers are cracked at several locations. The hole through the entire width of the deck depth is noticed at the West approach (see Photo 3-44).

**Photo 3-44. Hole at the deck West approach**

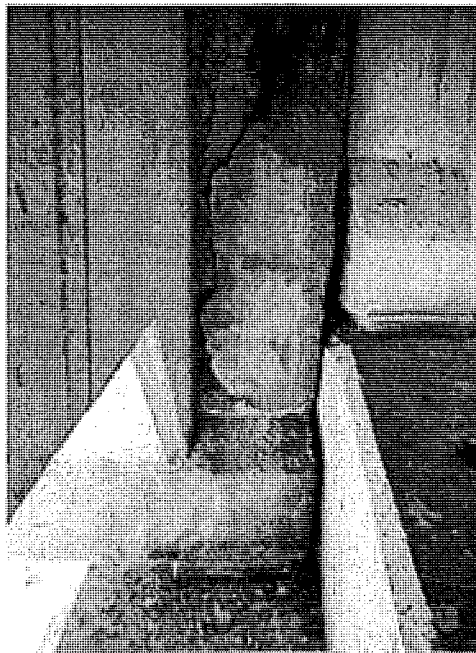
Major spall occurred at one of the beam-ends (Beam S5, Pier W3) and minor spalls are noticed at several others. Vertical and horizontal cracks are noted at the ends of beams. The typical beam-end condition is shown on Photo 3-45.

**Photo 3-45. Typical beam-end condition**

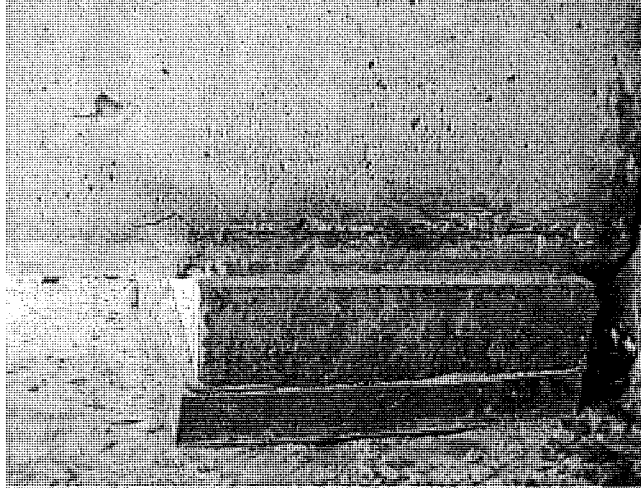
Spalls occurred at most of the beam-ends next to the bearings. The sole plates are rusted, and the neoprene pads are deformed and sometimes broken. An example of the beam-end condition is shown in Photo 3-46.

**Photo 3-46. Rust crack at beam-end**

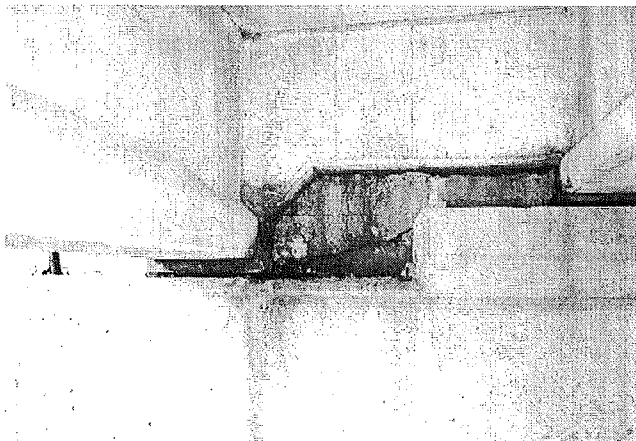
The North abutment has water stains, heavy rust stains and areas of delamination and spall (see Photo 3-48).

**Photo 3-48. Condition of North abutment and diaphragm**

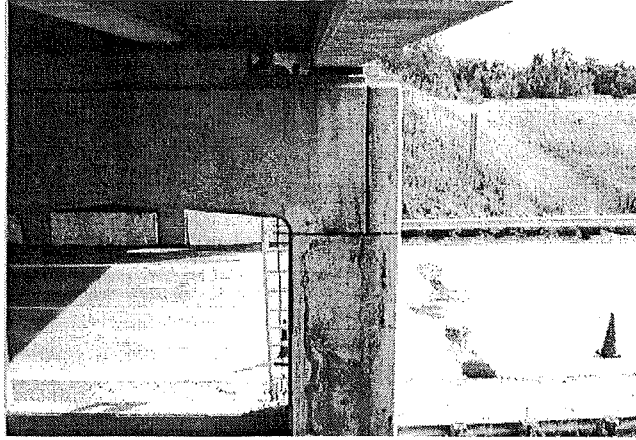
Several vertical cracks are noticed throughout entire wall. Very wide diagonal crack noted at West side of the abutment. The sole plates are rusted. The elastomeric pads are in good condition. The pier caps have rust and water stains. Few cracks and some areas of delamination are noticed at pier W2 (see Photo 3-49).

**Photo 3-49. Deterioration observed at pier W2**

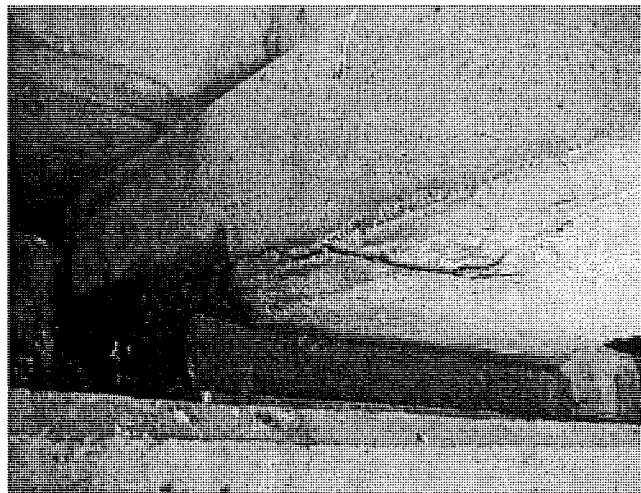
Most of the beam-ends display cracks, some rusted, spalled and delaminated areas, and efflorescence and water stains (see Photo 3-50). The sole plates are discolored and deformed with ends curling. Some of the diaphragms at the piers are cracked and show rust and efflorescence stains. The diaphragms at the abutments have horizontal narrow cracks and small areas of rust and efflorescence stains.

**Photo 3-50. Rust and spall at beam-end**

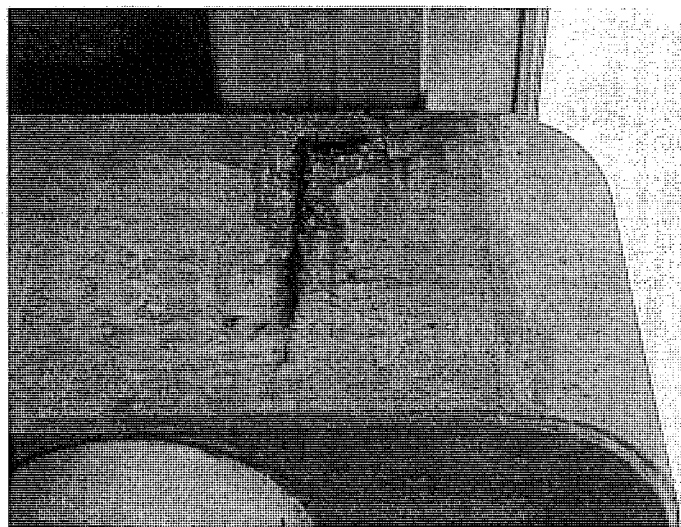
Both abutments have vertical crack through the center of the abutment and wet cracks with efflorescence stain at East and West corners. The North abutment has rust and water stains. The South fascia of pier S1 has heavy rust stains under beam W1. The North fascia of pier S1 has rust and water stains, delamination with spalls and exposed shear reinforcement. The worst condition observed was under beam W1 as shown in Photo 3-51.

**Photo 3-51. Spall with exposed reinforcement at pier S1 under beam W1**

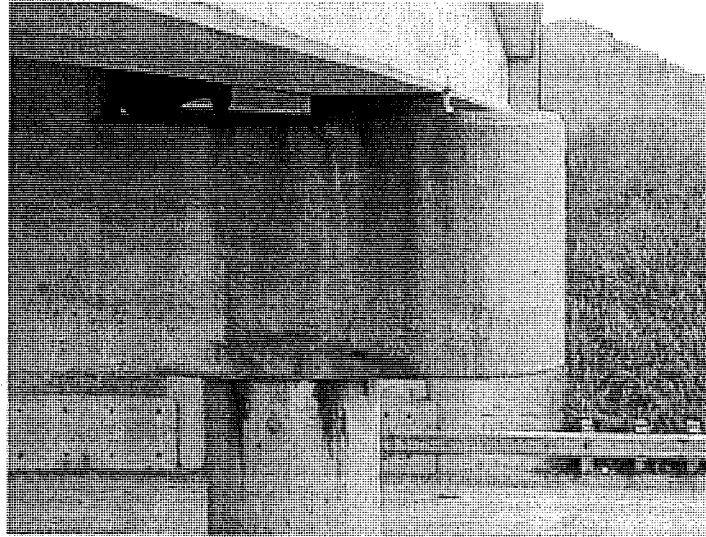
Both fascias of pier S2 have rust and water stain (see Photo 3-52).

**Photo 3-52. Rust stain and wet spots at pier S2**

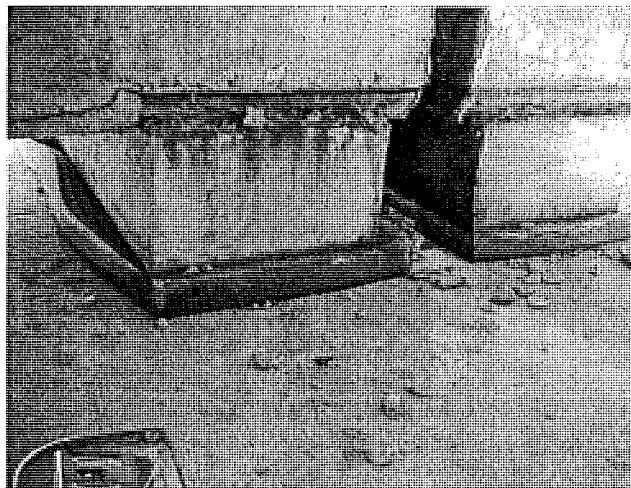
The beam-ends at the piers display cracks, minor rust stain, and spall next to the bearings. Most of the sole plates are rusted and pads are deformed (see Photo 3-53).

**Photo 3-53. Condition of the bearings on pier**

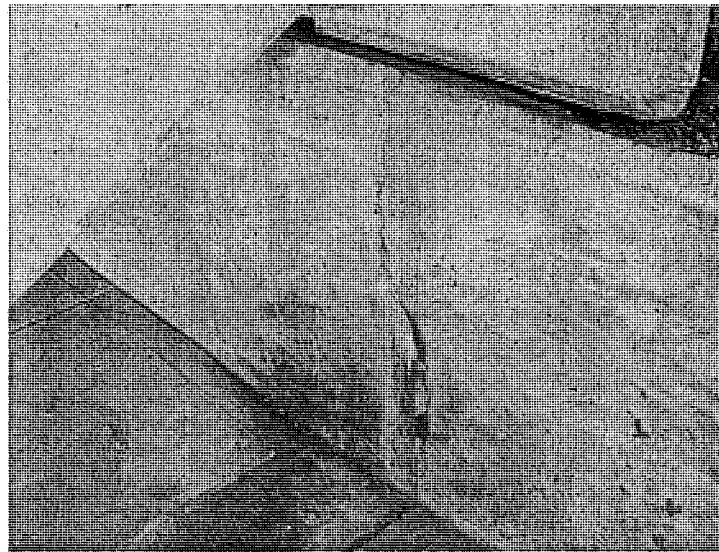
The west abutment has several hairline vertical cracks. The North side of the abutment has wet and leaching cracks (see Photo 3-54).

**Photo 3-54. Leaching crack at the North side of West abutment**

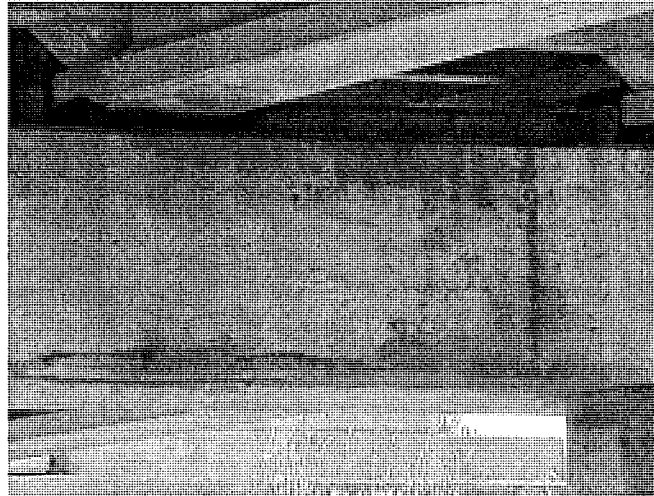
Pier W1 has vertical and horizontal cracks, rust and water stains. Large area of delamination noted under beams S4 and S3 at the East fascia of pier W1. The West fascia of pier W1 exhibits

heavy rust stain and exposed reinforcement. Pier W2 has rust and water stain. Wet cracks, areas of exposed reinforcement and delamination noticed. The typical condition at the piers is shown in Photo 3-55:

**Photo 3-55. Typical pier cap beam condition**

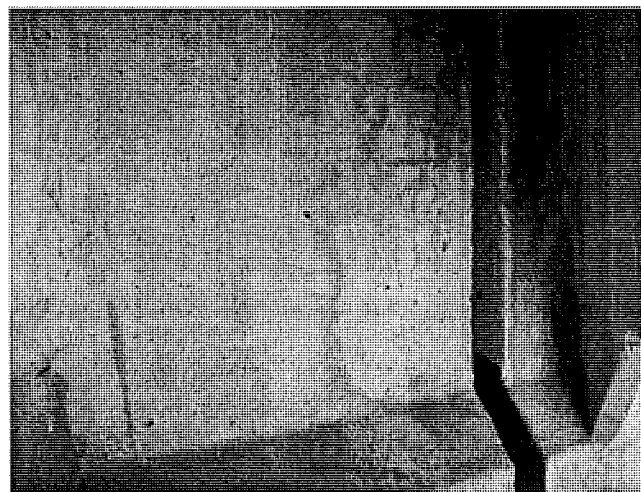
The beam-ends display cracks, spalls, delamination, rust, water, and efflorescence stains (see Photo 3-56).

**Photo 3-56. Cracks and water stain at the beam end**

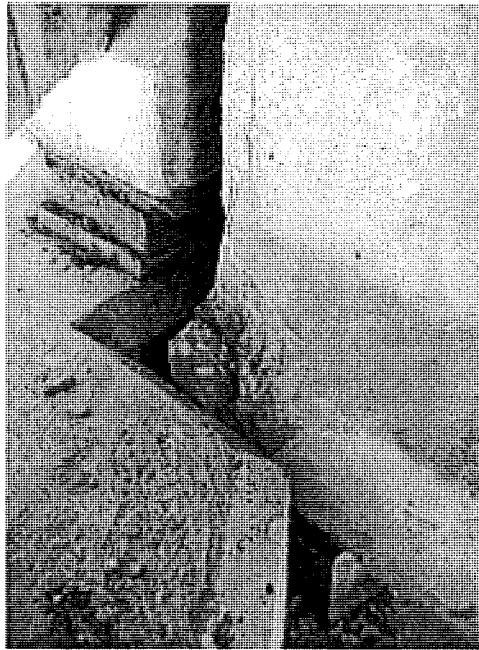
Some of the spalled beam-ends showed exposed reinforcement (see Photo 3-57).

Photo 3-57. Cracks, spalls and exposed reinforcement at some of the beam-ends

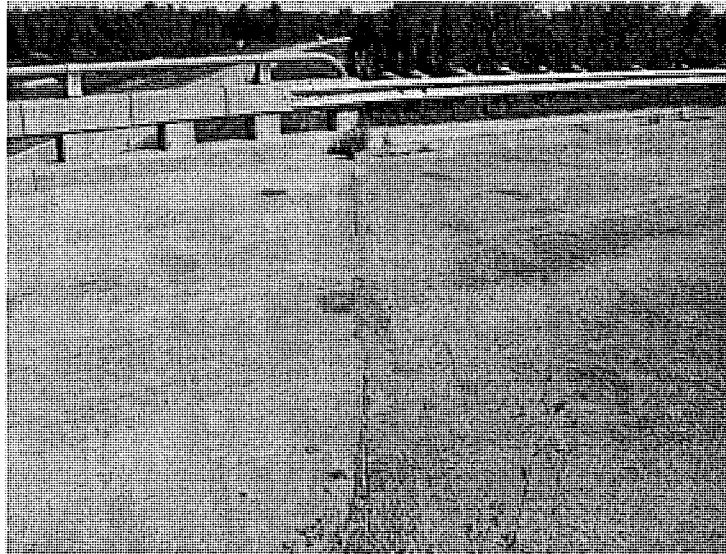
The concrete deck of the main span is in good condition. Both approaches have asphalt patches and potholes. The construction joints are partially broken as it shown in Photo 3-60.

**Photo 3-60. Construction joint between deck and approach**
