MDOT RC-1412  
CSD-2002-02

# CAUSES & CURES FOR PRESTRESSED CONCRETE I-BEAM END DETERIORATION

AUGUST 2002

TESTING AND RESEARCH SECTION  
CONSTRUCTION AND TECHNOLOGY DIVISION  
RESEARCH REPORT NO. RC-1412

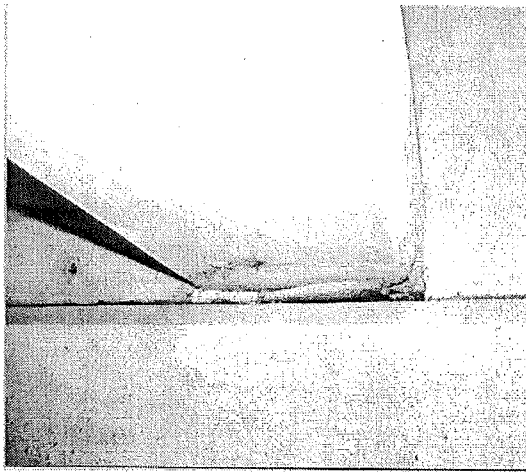
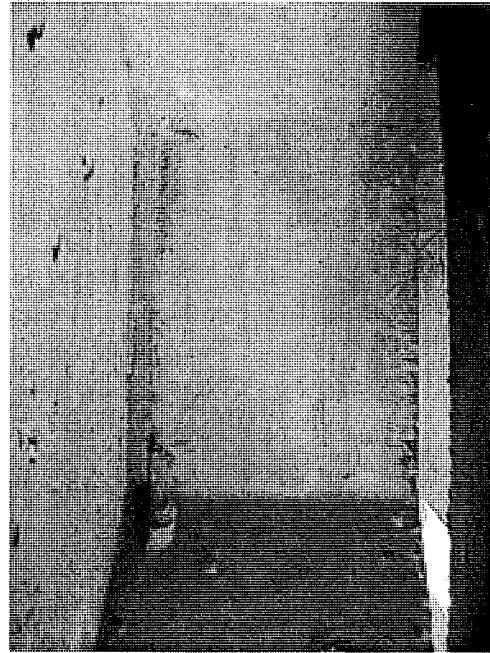
**Photo 6-1. Condition State 1—No cracks observed, no staining (a) E1-S4-E-U from 25132 S34 and (b) S1-E2-N-E.2 from 06111 S04**

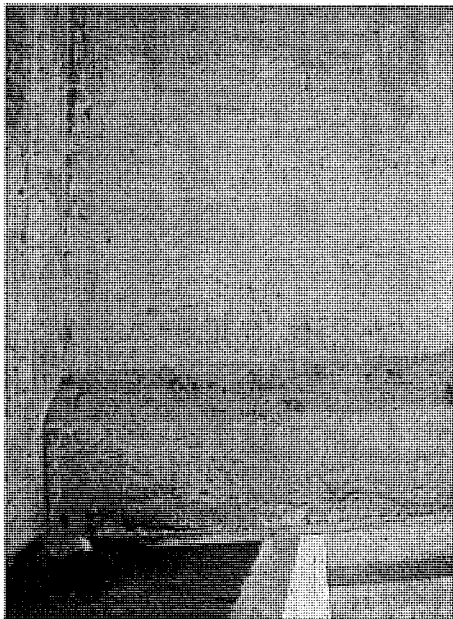
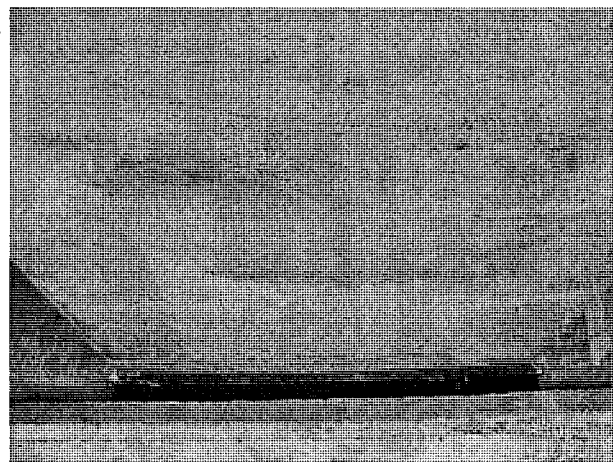
**Photo 6-2. Condition State 2—Efflorescence, water-stains, and/or corrosion (a) E4-S5-W-B from 53034 S05 and (b) S1-E2-N-U from 67016 S09**

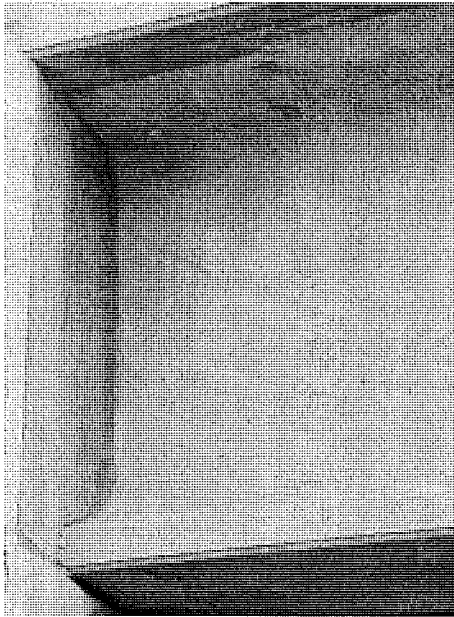
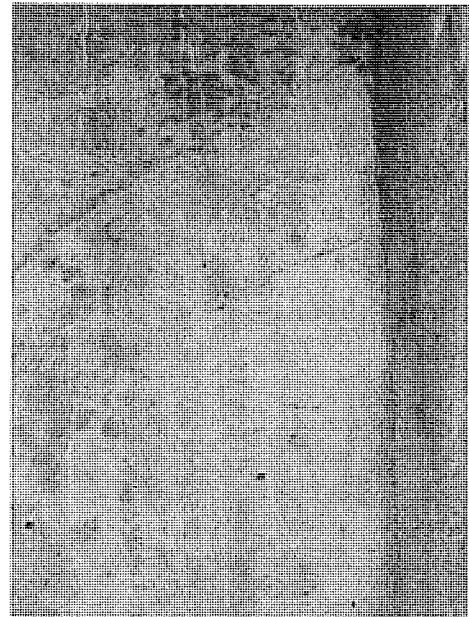
**Photo 6-3. Condition State 3—Hairline Cracks. They can be horizontal, vertical, and/or diagonal (a) E1-S1-W-S.3 from 83033 S06 and (b) E1-S8-W-N.2 from 83033 S06**

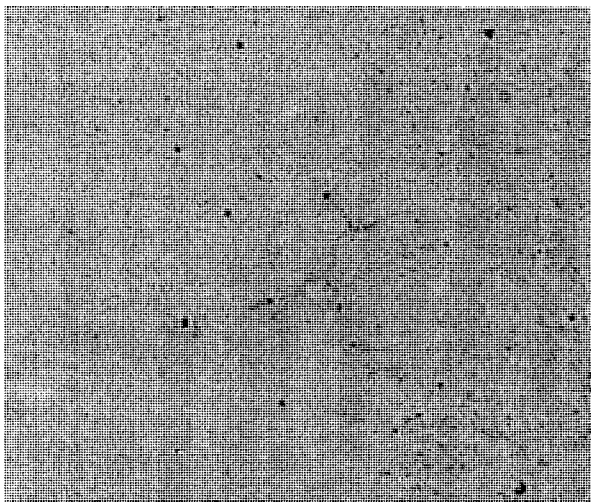
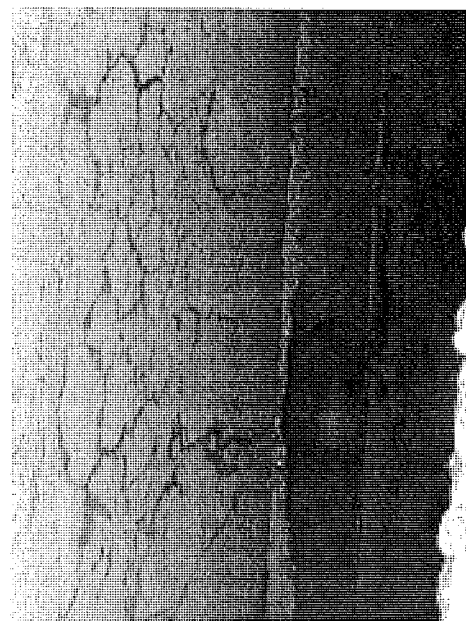
**Photo 6-4. Condition State 4—Map Cracks (a) E2-S3-E-S from 25132 S34 and (b) E4-S1-E-R from 53034 S05**

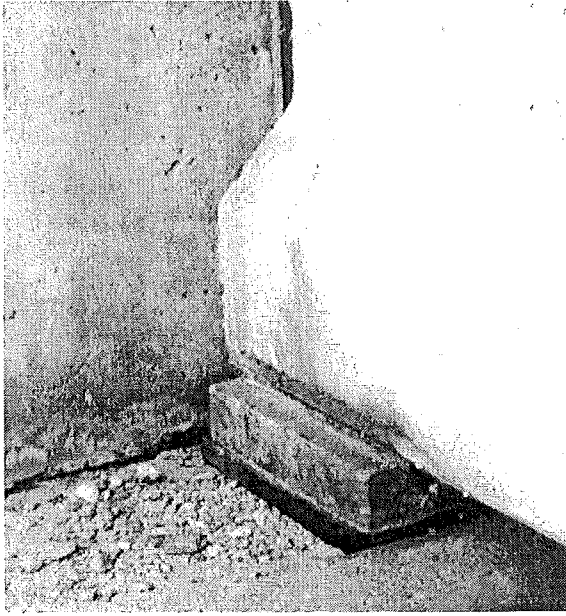
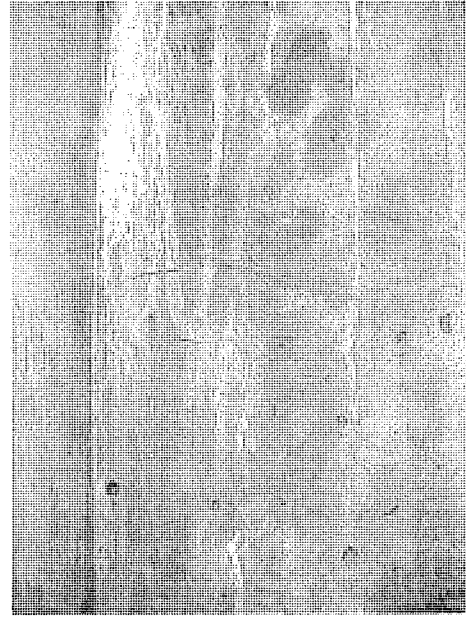
**Photo 6-5. Condition State 5—Hairline Cracks with efflorescence, water-stains, and/or corrosion with a horizontal crack propagating from the sole plate (a) S3-E9-N-E.1 from 29011 S03 and (b) E1-S8-W-S.1 from 83033 S06**

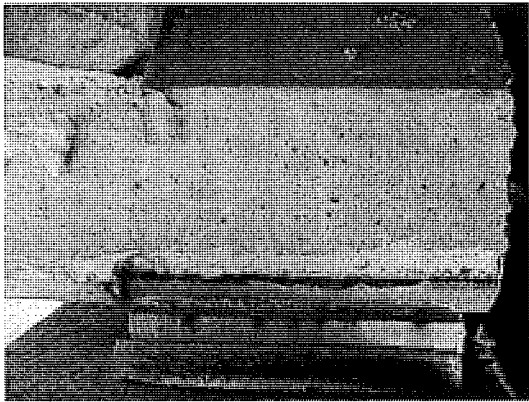
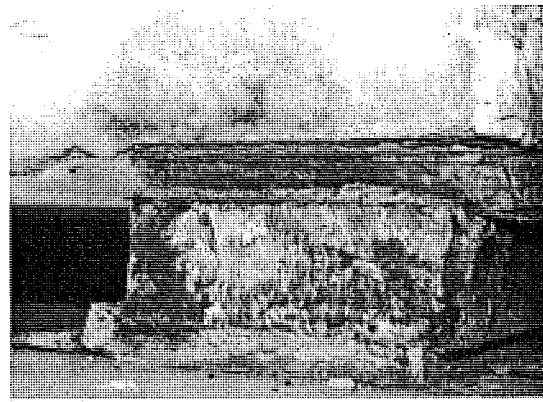
**Photo 6-6. Condition State 6—Cracked and Deformed Neoprene Pad, probably non-functional (a) S1-E2-N-B from 06111 S04 and (b) E1-S2-W-N from 41029 S16-3**

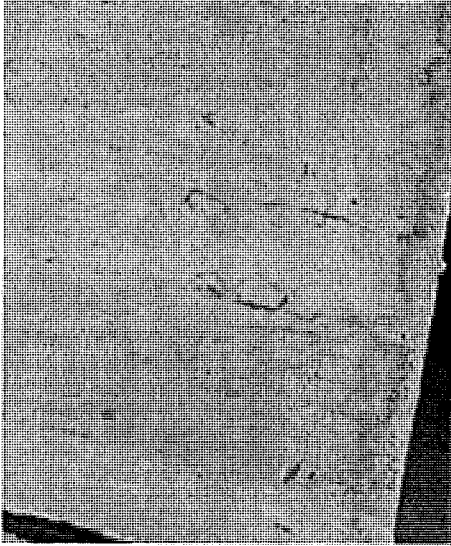
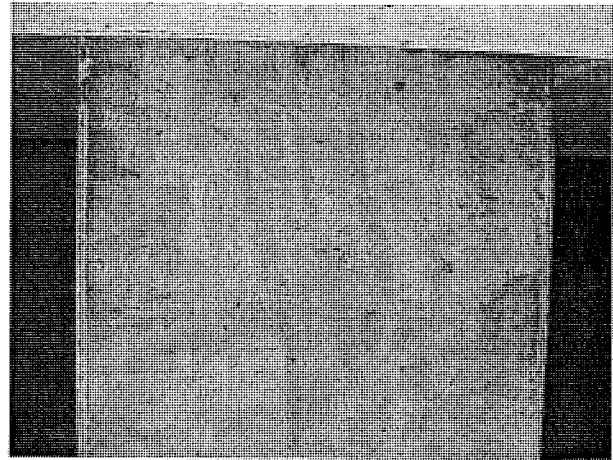
**Photo 6-7. Condition State 7—Moderate Cracks (a) E4-S1-E-S from 53034 S05 and (b) S1-E3-N-U from 67016 S09**

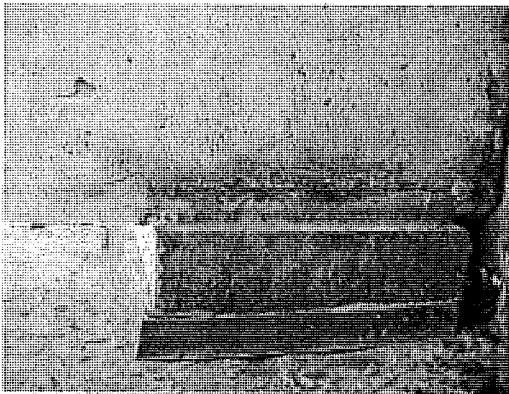
**Photo 6-8. Condition State 8—Moderate Cracks with efflorescence, water-stains, and/or corrosion (a) E2-S3-E-B from 25132 S34 and (b) E2-S8-E-S.2 from 41029 S16-4**

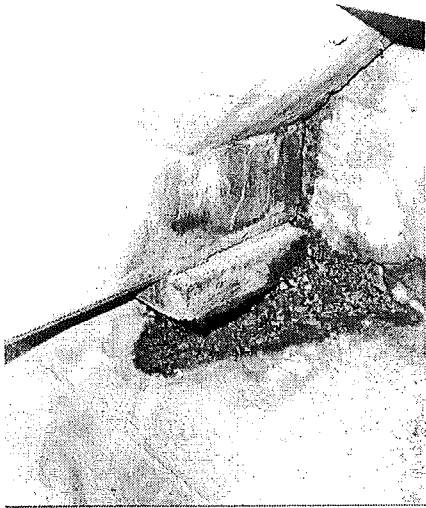
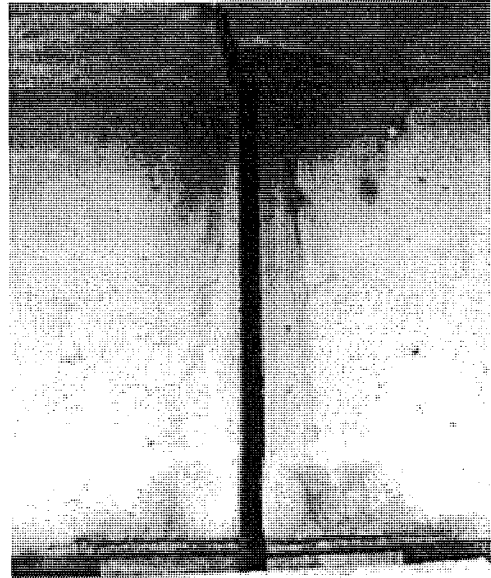
**Photo 6-9. Condition State 9—Major Cracks with efflorescence, water-stains, and/or corrosion (a) S3-E9-N-W.2 from 29011 S03 and (b) S2-E9-N-W from 29011 S03**

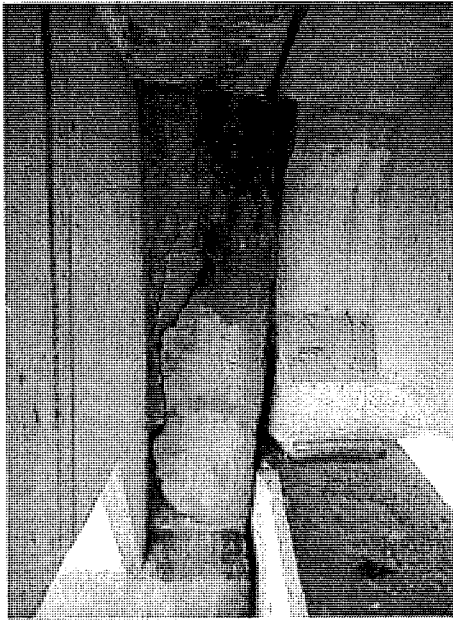
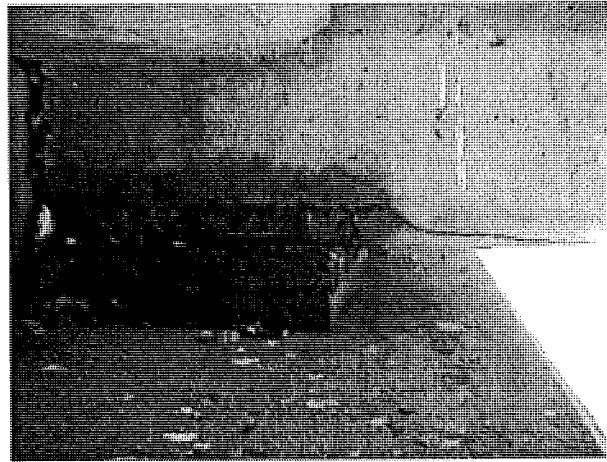
**Photo 6-10. Condition State 10—Delamination with Moderate and/or Major Cracks (a) E2-S5-E-S.1 from 25132 S34 and (b) S2-E8-N-W from 29011 S03**

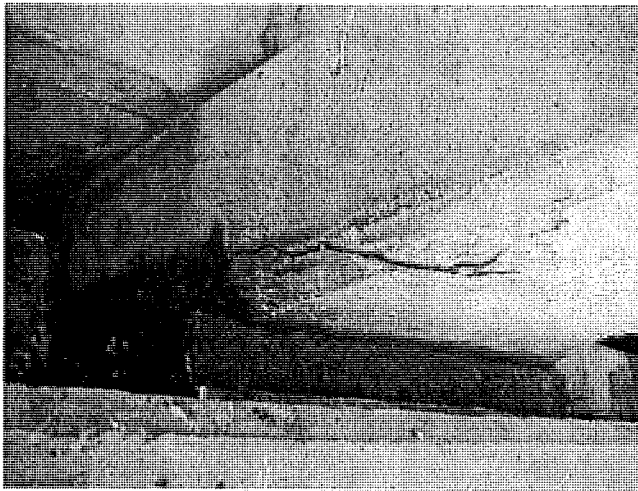
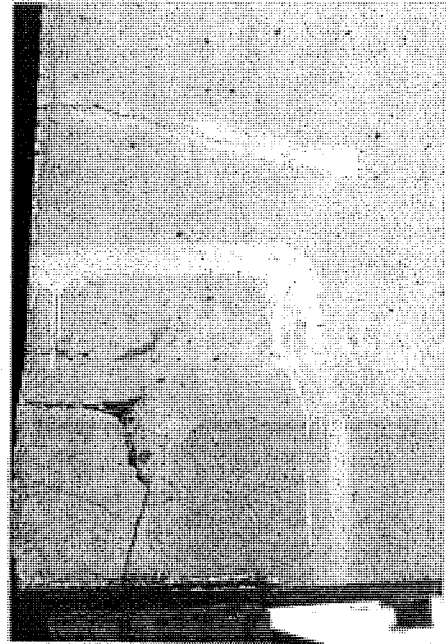
**Photo 6-11. Condition State 11—Spall, Delamination, Corrosion, and Cracks (a) S2-E7-N-U from 29011 S03 and (b) E2-S8-E-N.6 from 41029 S16-4**

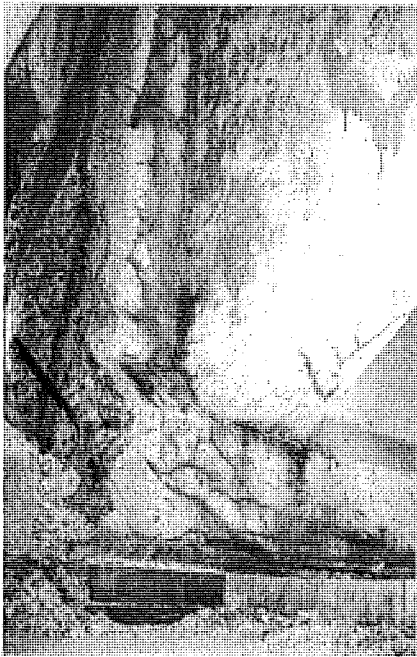
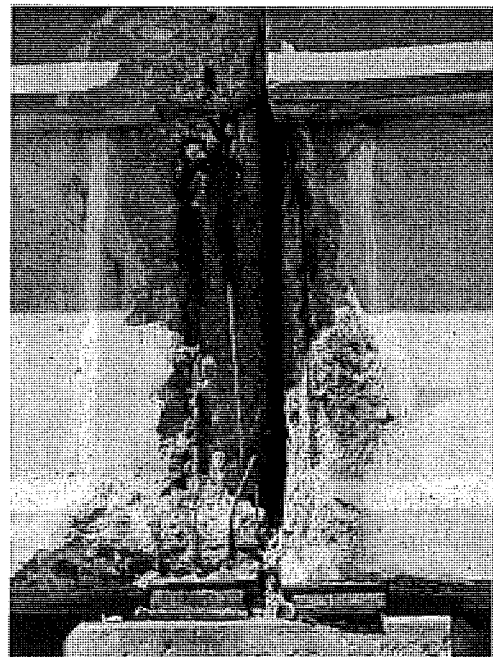
**Photo 6-12. Condition State 12— Spall, Exposed Reinforcement, and Corrosion (a) E3-S1-E-N.2 from 41029 S16-4 and (b) E2-S1-W-S.3 from 41029 S16-4**

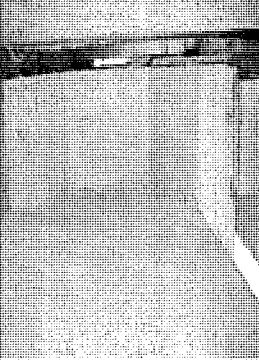
Condition State	Photos Demonstrating the Condition States		
1) No cracks observed, no staining

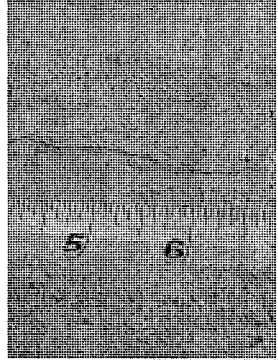
3) Hairline Cracks. They can be horizontal, vertical, and/or diagonal

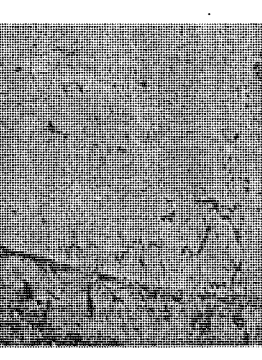
4) Map Cracks

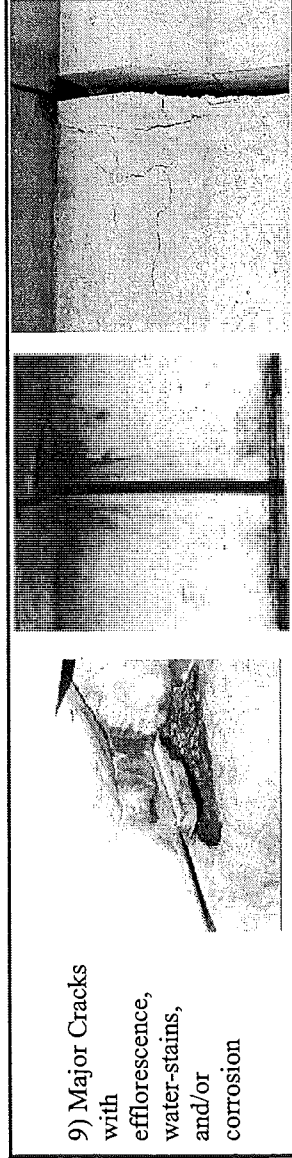
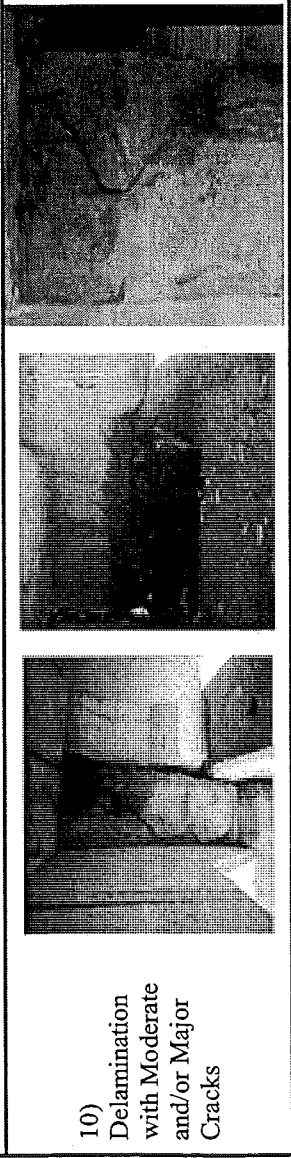
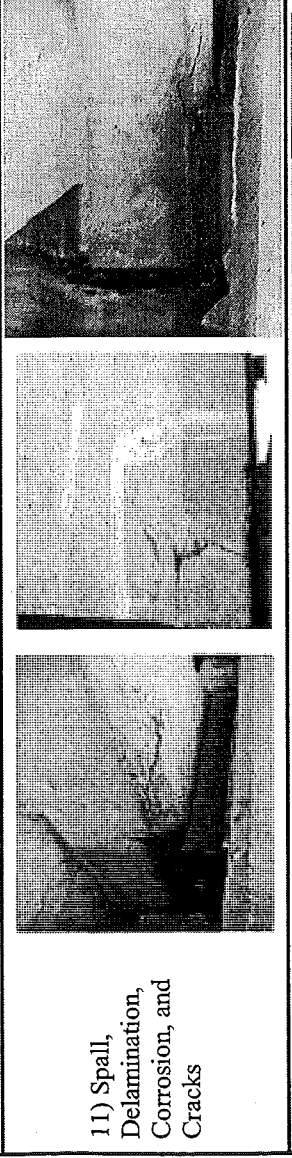
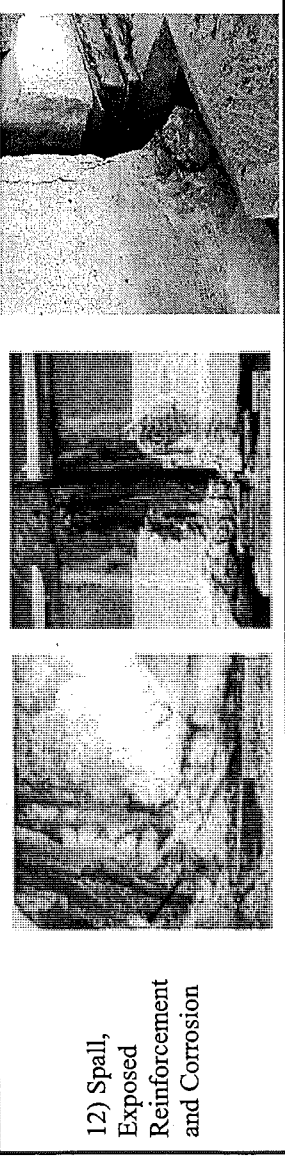
<p>9) Major Cracks with efflorescence, water-stains, and/or corrosion</p>

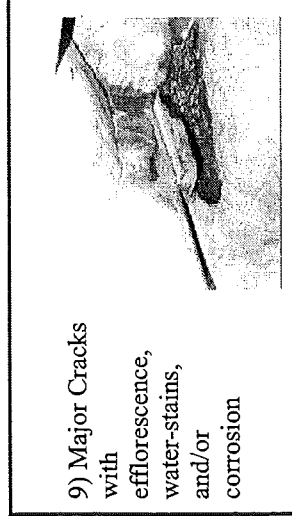
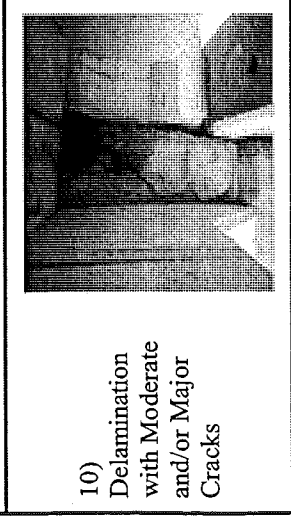
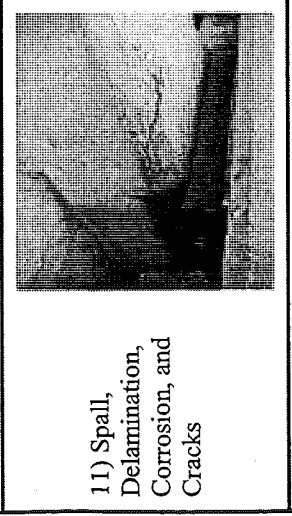
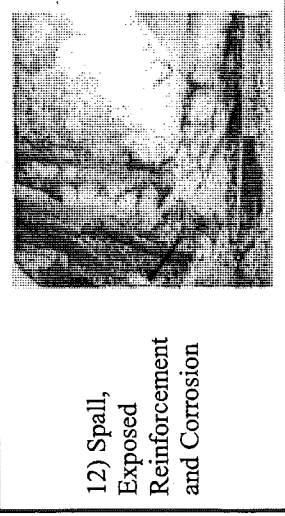
<p>10) Delamination with Moderate and/or Major Cracks</p>

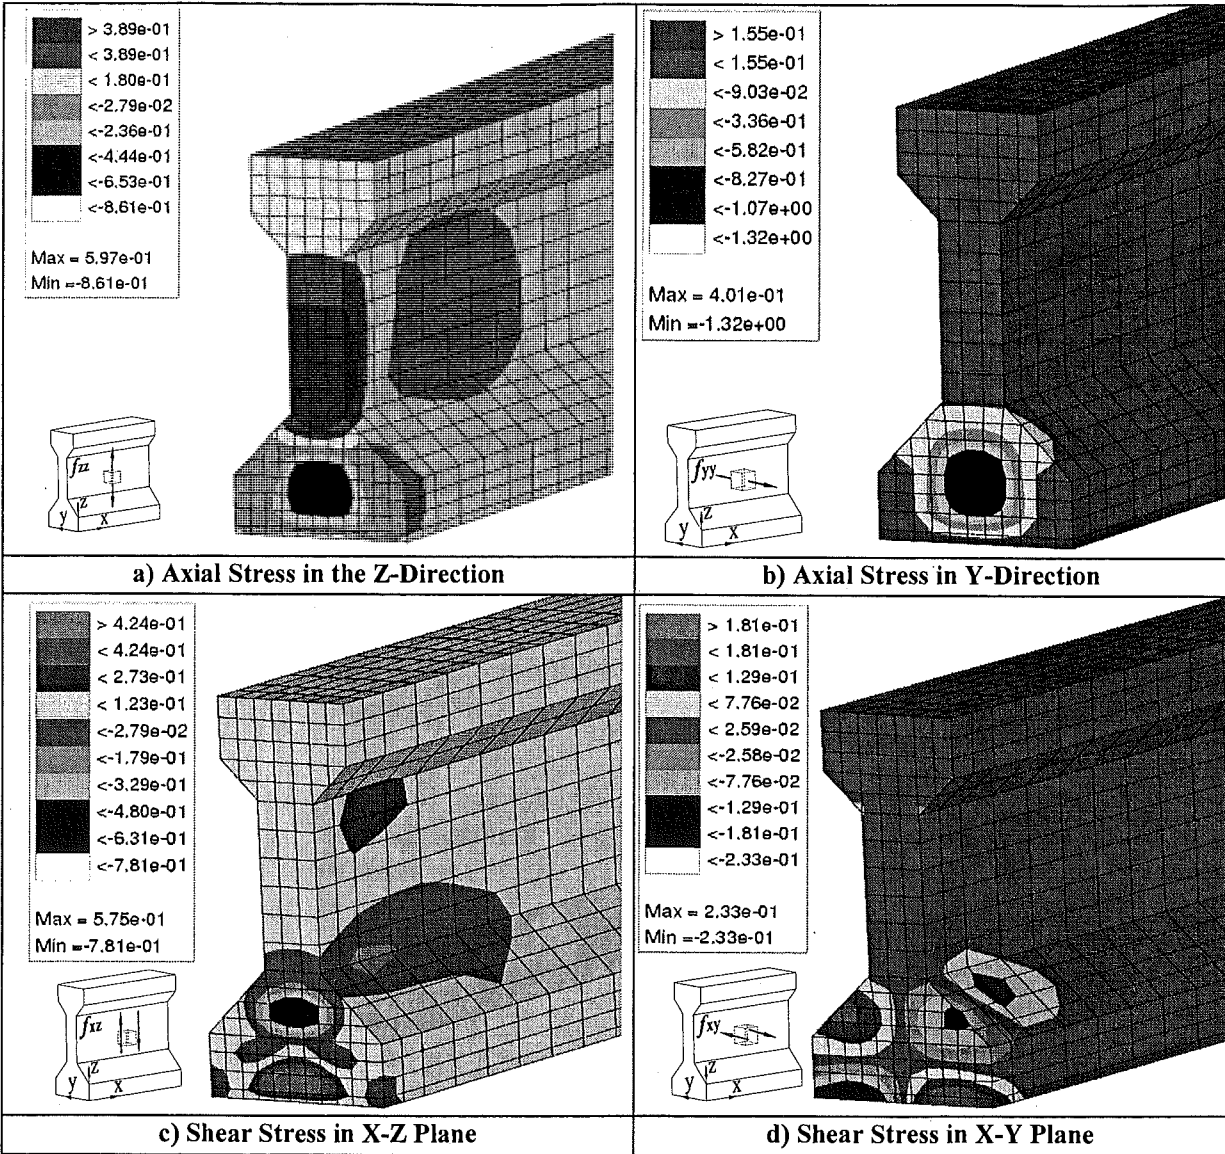
Figure 10-15. Stresses (ksi) Observed near the End of the Girder with Straight Tendons

The axial stress distributions in the z and y directions are shown in Figure 10-15-a and Figure 10-15-b, respectively. In Figure 10-15-a and Figure 10-15-b, the zones under tensile stress may initiate cracking. Level of tensile stress that is of significance is only seen in Figure 10-15-a within the web zone, around 390 psi. During field inspection and plant visit, web cracking at the same location was observed (see Figure 10-2-a, -b, -c, and -d).

The shear stress magnitudes on x-z plane shown in Figure 10-15-c are significant. The maximum values are at the bottom flange, within the proximity of the web. The shear stresses on x-y plane seen in Figure 10-15-d are not significantly lower than the shear stresses on the x-z plane.

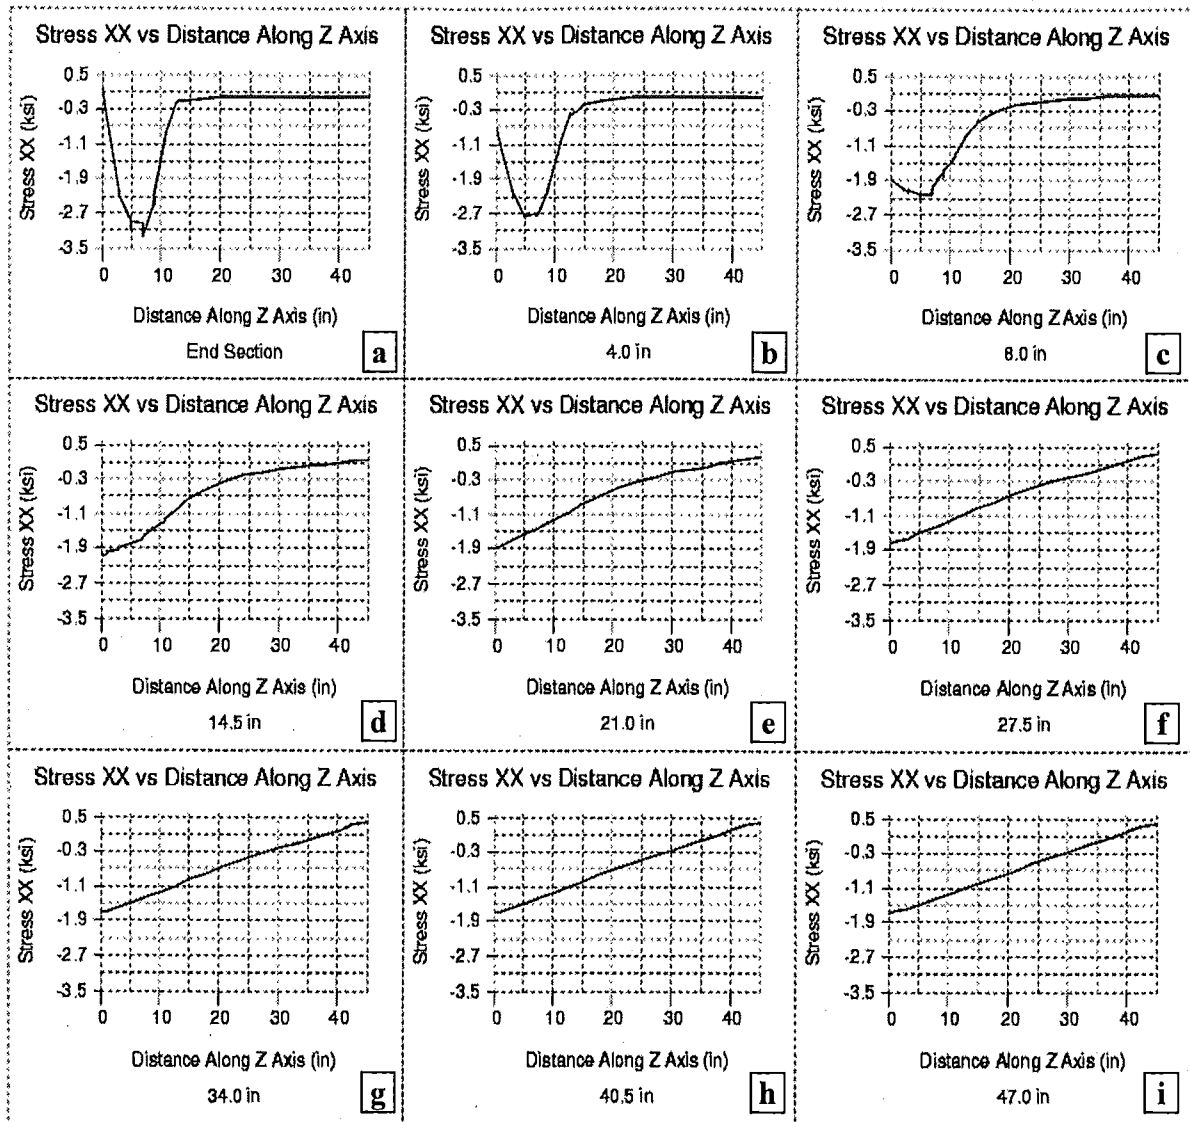
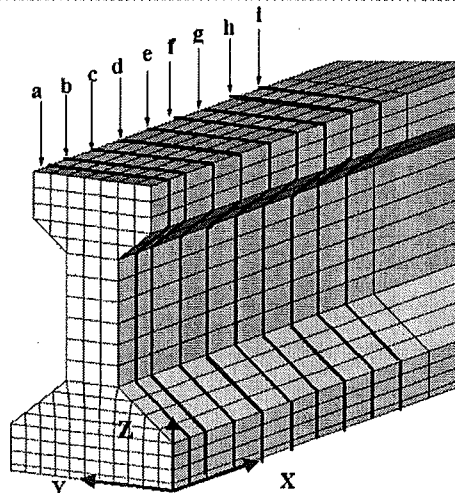
Figure 10-16. Shear Stress Distribution within the Web Projection at Selected Sections near the End Zone under Prestressing Loads

The shear stress development on x-z plane is also studied at selected sections along the beam axis as shown in Figure 10-16. In the figure, "Distance Along Z Axis" is along the depth of the beam. Figure 10-16-a to Figure 10-16-i shows the changes in shear stress distribution at sections along the beam starting from the beam-end. The section locations are also defined in the figures by the numerical value of "Distance Along Z Axis." In Figure 10-16, the distance from the beam-end to the location where the shear stress fully diminishes is 47 inches. A closer inspection shows that shear stress is insignificant starting at a distance from the beam-end just beyond 27.5 inches, which designates the point at which the prestressing forces in the tendons are fully developed. It is also important to specify the length at which shear stress remains in excess of allowable. The zones where the shear stress is in excess of  $3.5 \cdot \sqrt{f'_c}$  or 247 psi will define the portions of the beam with high cracking potential by ACI (ACI, 2002). However, this does not mean that the zones with high shear stress crack. This information can be useful to define the critical zones. In Figure 10-16, shear stress is in excess of 500 psi on the section 8 inches from beam-end, which is significantly high. In Figure 10-17, the axial stress (flexural stress) variation in the x-direction shows non-uniformity similar to the shear stress distribution seen in Figure 10-16.

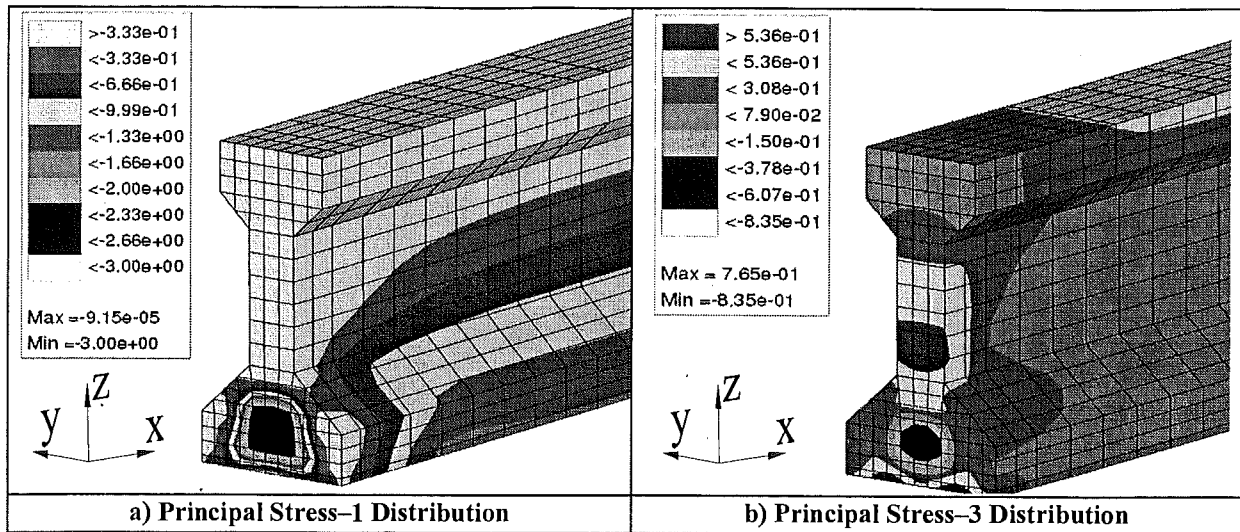
Figure 10-19. Principal Stresses (ksi) near the Girder-end under Prestressing Load

The sign convention for the principal stresses is defined such that compressive stress is negative and tensile stress is positive. Principal stress (compressive) contour for  $f_{\theta 1}$  is shown in Figure 10-19-a, with a magnitude of reaching a compressive stress of 3000 psi. Principal stress (tensile)  $f_{\theta 3}$  shown in Figure 10-19-b is of significance to cracking. The maximum tensile stress magnitude reaches 400 psi near the beam-end on the web. The critical region seen in the principal stress analysis is the web to bottom flange transition area. The region from the bottom flange to the top flange through web, diagonally decreasing towards the end of the transfer length, is under relatively lower stresses (see Figure 10-19-a). The  $f_{\theta 3}$  distribution indicates the vulnerability of the mid-web zone to cracking as shown in Figure 10-19-b.

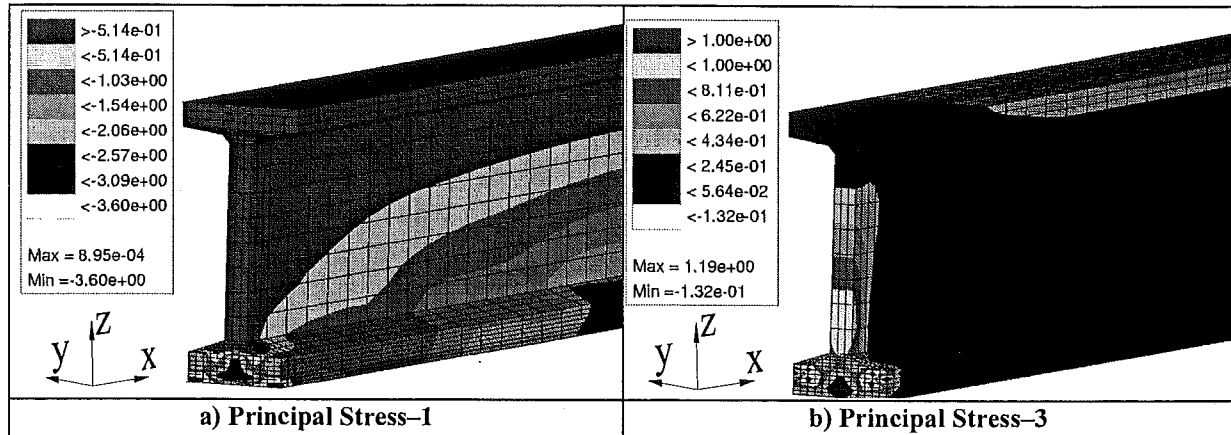
Figure 29. Principal Stresses (ksi) near the Beam-end under Prestressing Load for the Beam with Bond-breakers

The shear stress cracking pattern may be described by the principal stresses. The maximum and minimum principal stresses for the beam with bond breakers are shown in Figure 29-a and -b. The maximum principle stress is 3.6 ksi around the tendons and the ends of debonding as shown in Figure 29-a. This stress is compressive and well below the compressive strength of concrete. The minimum principle stress, shown in Figure 29-b, is around 1.2 ksi. This tensile stress may be the main reason for the shear cracking. Because the stress value found exceeds the tensile strength of concrete, which is 424 psi. As it is seen in Figure 29-b, the web zone is prone to cracking due to excessive tensile stress.

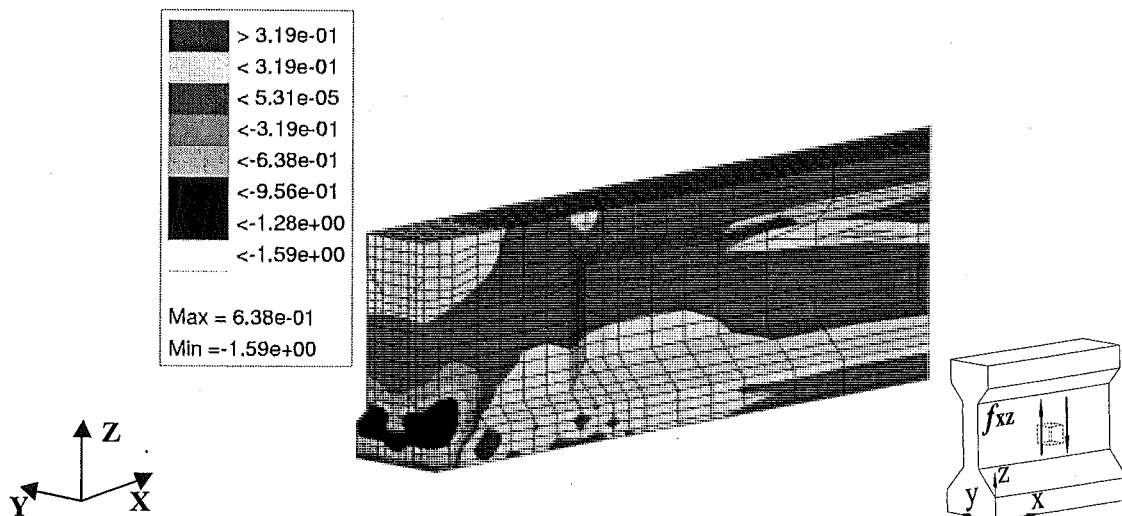
Figure 10-32. Shear Stresses (ksi) in Beam Model with Draped Tendons on X-Z Plane

The axial stress distribution in x-axis is shown in Figure 10-31 and the shear stress distribution on the x-z plane is shown in Figure 10-32. As seen in Figure 10-32, the change in effective prestressing force within the transfer length results in shear stresses generated near the top flange within the end block and near the zone where the end block is gradually discontinued. The shears stress near the girder-end exceeding 600 psi shows the vulnerability of these girders to cracking. The shear strength of the concrete is around 247 psi, according to AASHTO (AASHTO, 1998)

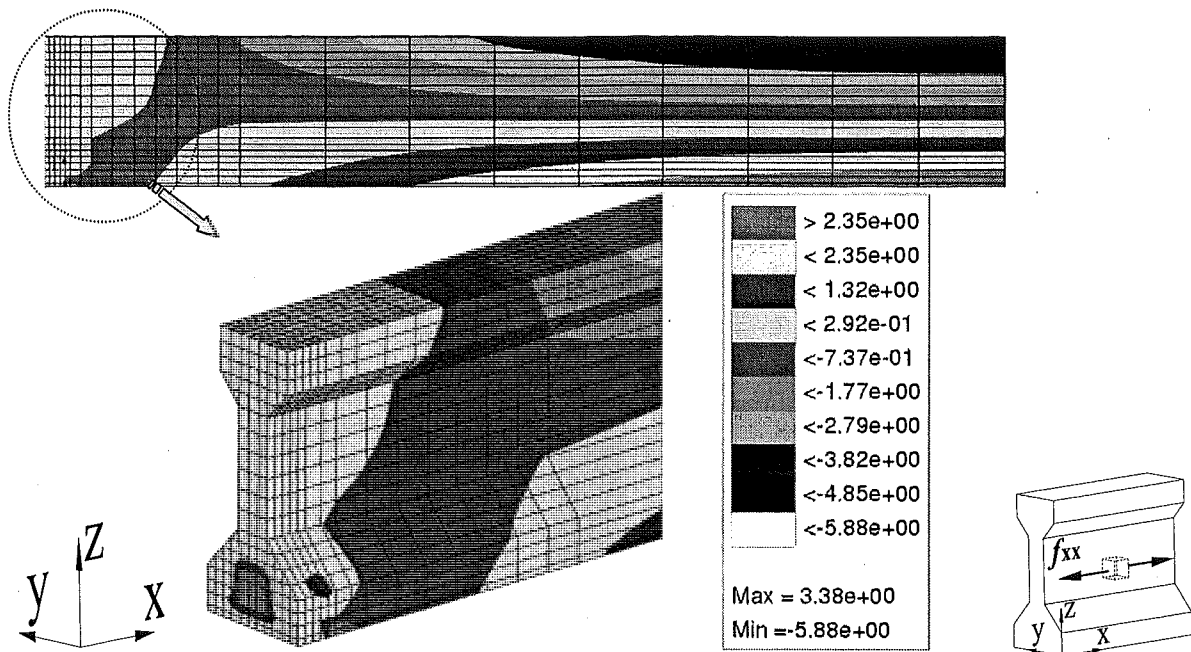
Figure 10-35. Axial Stress (ksi) in the Beam under Prestressing and Dead Load

Figure 10-35 shows the axial stress distribution under prestressing and dead loads. It is seen that the tensile stresses are increased at the top flange due to reduction in support area. Negative moment is seen at the top of the support because the beam-end now hangs over the support as a cantilever beam. However, the maximum tensile stress, calculated as 290 psi, is less than the concrete tensile strength, which is 424 psi according to AASHTO given as  $6 \cdot \sqrt{f'_c}$ . Another important result is the stress pattern that describes the load path. The zone on the girder with the stress value of around 740 psi and above compressive stress defines the load path under dead load only. When the live load is included, a similar stress pattern and load path is observed near the end zone. In this case, the load path is defined by the zones of compressive stress of 760 psi and greater (see Figure 10-36). Tensile stresses develop at the beam-end under live load. The accuracy of the stress value is questionable because the deck contribution to load capacity of the beam is not considered in the analytical model.

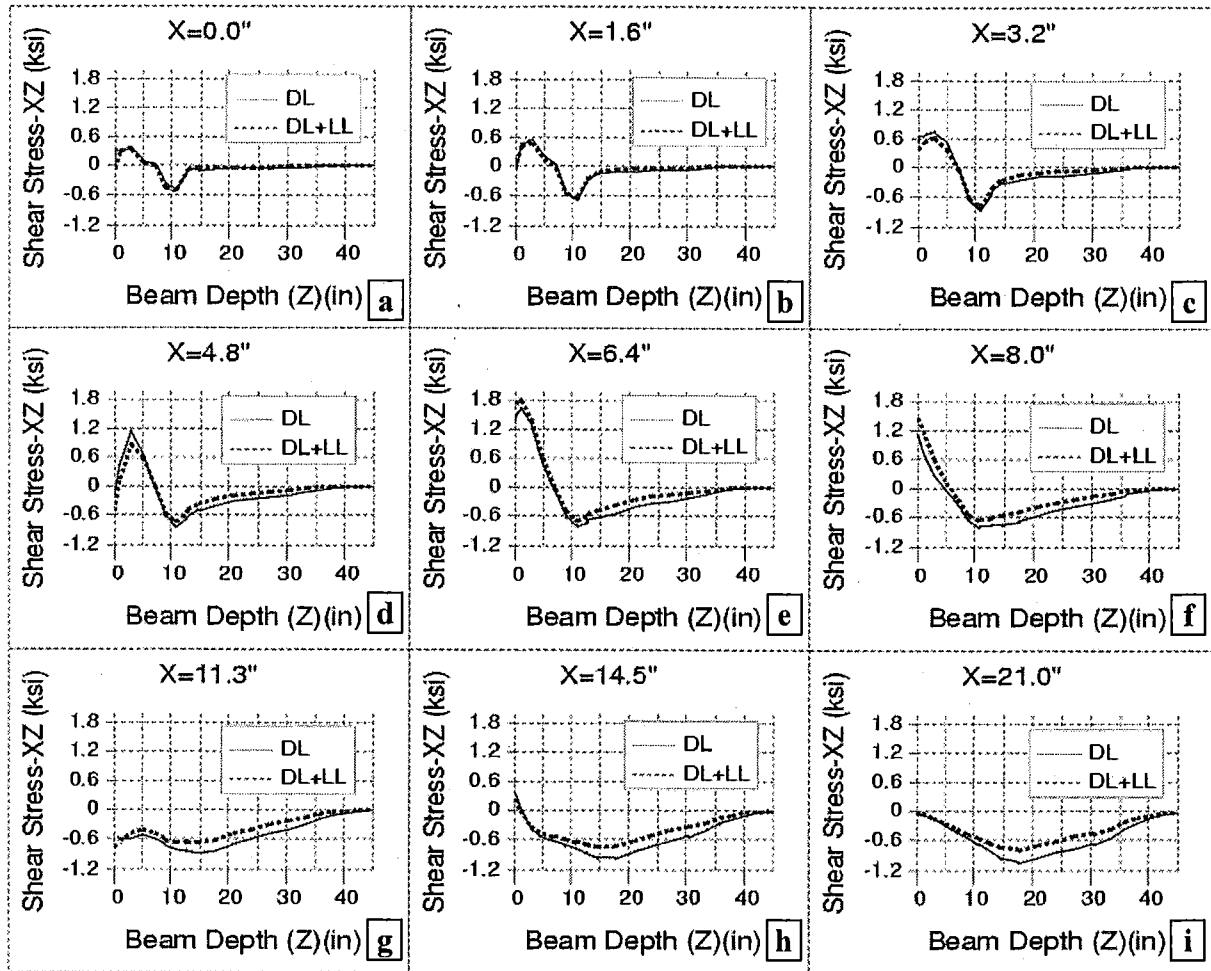
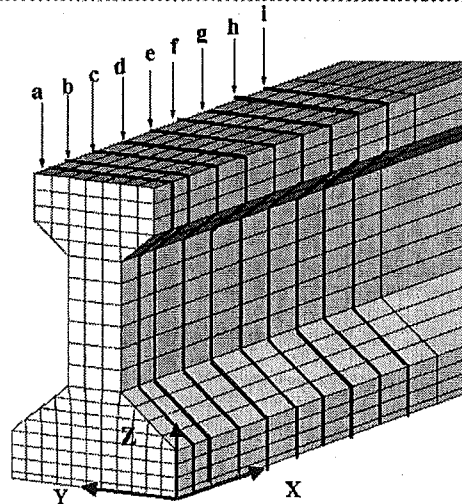
Figure 10-40. Shear Stress Distribution within the Web Projection at Selected Sections near the End Zone under Prestressing, Dead, and Live Loads

The axial and shear stress comparisons under dead and live loads at selected sections near the beam-end are shown in Figure 10-39 and Figure 10-40. The impact of the non-functional elastomeric bearing is also depicted in the figures. As the support area is reduced due to rocking of the bearing plate, consequently the stress intensities are increased. The dead and live loads give similar stress distributions around the support. The beam-end portion near the support under shear stress intensities exceeding 1.2 ksi is vulnerable to cracking as seen in Figure 10-40-f.

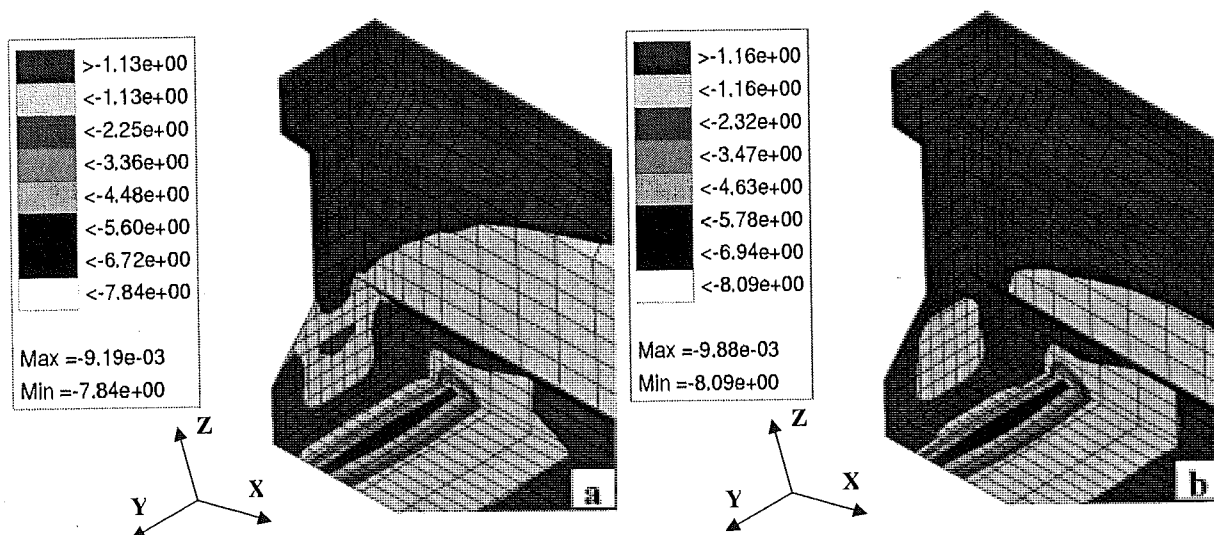
Figure 10-41. Principal Stress (Compressive), a) Under Dead Load (ksi); b) Under Dead and Live Loads (ksi)

The principal stresses generated near the beam-end due to non-functional elastomeric bearing pads are shown in Figure 10-41-a and Figure 10-41-b. As shown in the figures, the stress intensity at the bottom flange is high. In particular, the principal stress intensity around the bearing is significant. The maximum compressive stresses observed under dead and live loads

are 7.84 ksi and 8.09 ksi, respectively. Considering the compressive strength of the concrete described, 5 ksi, principal stress,  $f_{\theta 1}$ , is significant and higher than the compressive strength of concrete.

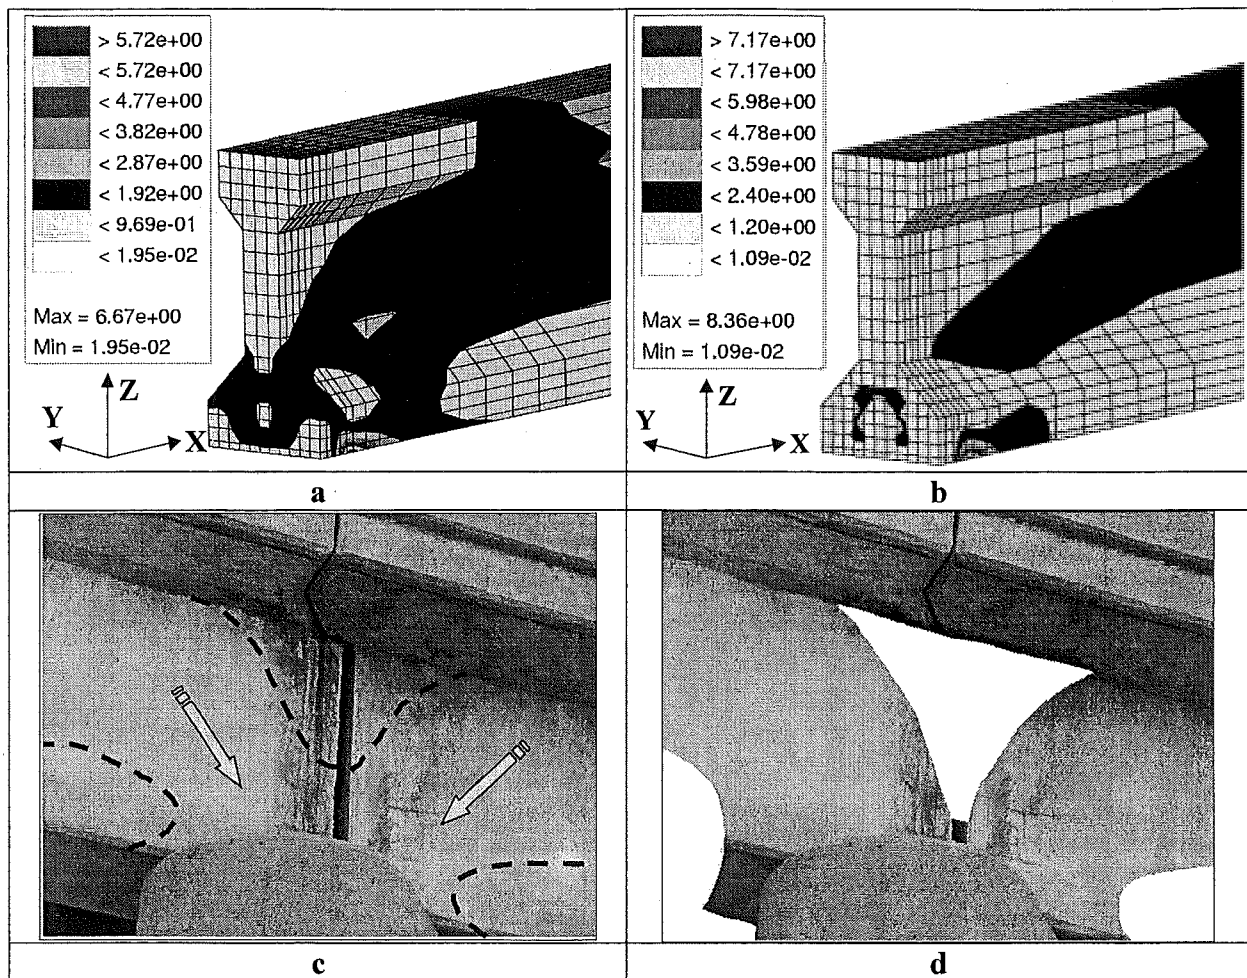
Figure 10-42. a) Von Mises Stress for Dead Load (ksi); b) Von Mises Stress for Dead and Live Loads (ksi); c) Load Path on a Girder; d) Critical Regions on Load Path

The load path in the girder is also investigated to identify the critical zones at the girder-ends. Von Misses stresses in Figure 10-42-a and Figure 10-42-b are utilized for describing the load path near the beam-end. The zones of the beam-end that is within stress contour of 1,920 psi under dead load and 2,400 psi under live load are defined as the load path and shown in Figure 10-42-c and Figure 10-42-d, respectively. The concrete zone shown in Figure 10-42-c defines the load path near the beam-end with non-functional bearing. Any deterioration that intrudes into the load path increases the vulnerability of the beam-end and its load carrying capacity. The beam-end condition may be assessed according to the intrusion of deterioration into the load path. Any kind of deterioration, such as delamination and spall that are not within this diagonal region or reaching the load path, can be repaired using the repair techniques described for condition states of "10" and "11" as given in Table 12-2 in Chapter 12 of this report.

The non-critical zones shown in Figure 10-42-c are removed for Figure 10-42-d, to generate a template for the inspectors to assess the significance of the deterioration at the beam-ends. Any deterioration on the regions shown in Figure 10-42-d is considered at risk.

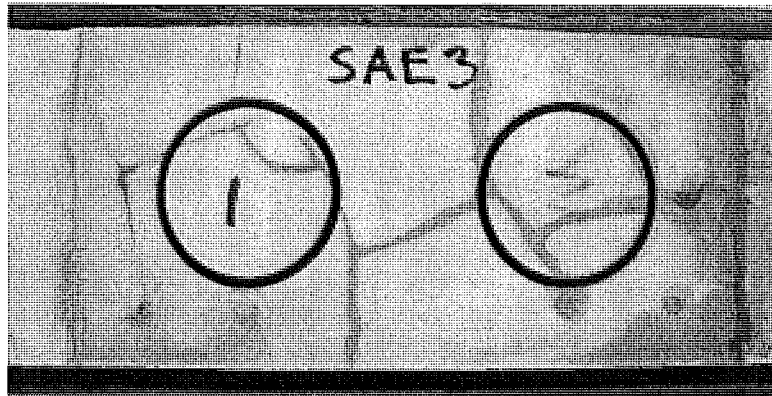
Thirteen specimens were repaired with Brand Y repair material. Most developed pattern cracking at roughly three weeks after installing the repair materials. Deep and shallow repairs made with the Brand Y material exhibited fine openings on the concrete surface that were generally parallel and normal to the length of the specimen (see Appendix H of Kasper, 2002, and Photo 11-26). Pattern cracking on the order of 2 to 3 mils in width was observed on 12 of the 13 specimens that were repaired with Brand Y material. Estimation of crack width was made using a hand-held crack comparator. An example of typical pattern cracking observed is shown in Photo 11-26. Cracks in Photo 11-26 were wetted with water to better show their presence. Reasons for pattern-cracking formation are not specifically known, however, mix proportions (dry to liquid component) and mixing time were similar between specimens that exhibited cracking and the specimen that did not crack.

Photo 11-26. Typical pattern cracking observed on Brand Y specimens

Deep repair specimens exhibited an additional crack at the lift joint between the bottom and top halves of the repair area. Similar to the pattern cracking, the lift joint crack was documented to be on the order of 2 to 3 mils, as estimated by a crack comparator. This crack is due to shrinkage of one or both lifts of repair material. Cracks on the order of 2 to 3 mils were also present on 5 of the 6 of the deep repair specimens at the bottom repair-substrate joint of the vertical specimens.

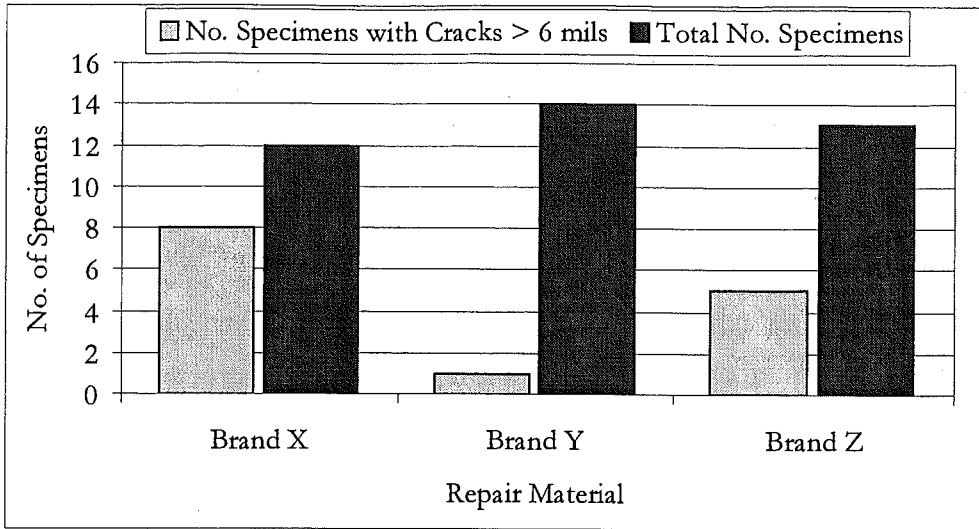
Beam-ends in locations of defective transverse deck joints could be considered to be in a wetting and drying environment. As such, a crack width of 6 mils is considered detrimental to the performance of repair materials, based on the ACI recommendations. This crack width also corresponds to a moderate crack from the vulnerability assessment in Chapter 4. Crack widths or voids greater than 6 mils were observed on 21 of the 39 repair specimens in this study (54 percent of samples), based on visual observations. Deep repair specimens exhibited cracking greater than 6 mils less frequently than shallow repair specimens based on a percentage of the total number of samples in each repair depth category. Deep repair specimens constituted 7 of the 21 specimens that had crack or void widths greater than 6 mils. These cracks are located within the repair itself and at the top and bottom of the vertical specimen. However, the expansion and contraction of the substrate impacts the repair performance in terms of cracking, including the repair-substrate joints. Not considering cracking or voids that were at the repair-substrate joints, surface cracks or voids were present on 14 of the 39 repair specimens fabricated (36 percent of samples). Cracks or voids on these specimens ranged from 7 to 60 mils in width. Comparing the quantity of specimens with cracks or voids in the region outside of the repair-substrate joints, one of the three materials clearly exhibited better performance than the others, as shown in Figure 11-2. However, the Brand Y repaired specimens had fine pattern cracking, as opposed to larger cracks. Fine pattern cracking may be detrimental to future performance if crack widths increase or the integrity of the repair is further reduced by the presence of the cracks.

**Figure 11-2. Number Of Specimens with Cracking Greater Than 6 mils Outside the Repair-Substrate Joint (Per Repair Material)**

- All brands of repair material showed cracking greater than 6-mils in width.
- Those specimens with fine-width (2-mil) pattern cracking generally did not exhibit cracks within the repair greater than 6-mils in width.
- Those specimens repaired with materials produced with a liquid polymer exhibited more cracking than the material mixed with potable water (Figure 11-2).
- Repair depth did not have an impact on frequency of cracked specimens relative to the total number of specimens tested (Figure 11-3). About one-third of each repair depth group exhibited cracking greater than 6 mils.
- Post-curing environment showed 43% of specimens exceeded the 6-mil performance measure, whereas 28% of ambient cured specimens exceeded the measure (Figure 11-4).
