MDOT RC-1412  
CSD-2002-02

# CAUSES & CURES FOR PRESTRESSED CONCRETE I-BEAM END DETERIORATION

AUGUST 2002

TESTING AND RESEARCH SECTION  
CONSTRUCTION AND TECHNOLOGY DIVISION  
RESEARCH REPORT NO. RC-1412

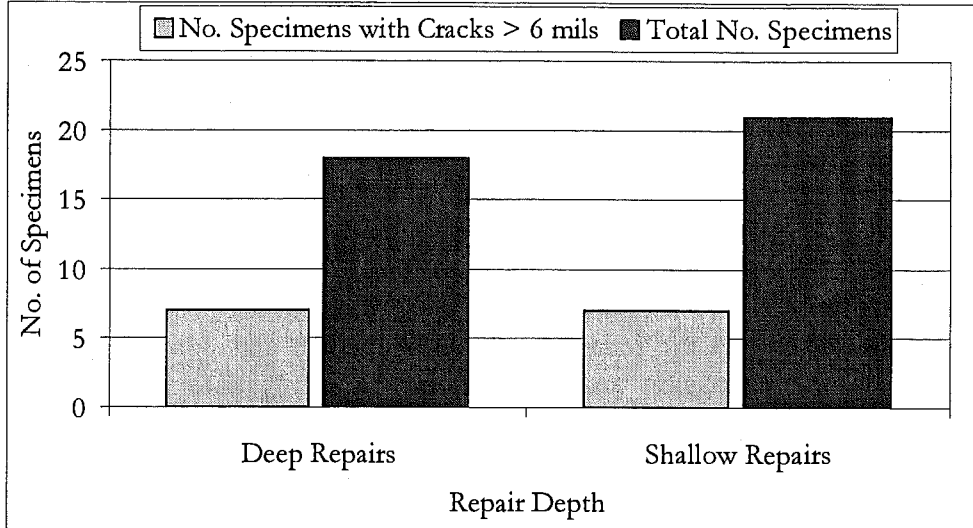
The depth of repair or type of post-curing environment appears to have little effect on the performance of the repairs, in terms of cracks greater than 6 mils in width. This is shown in Figure 11-3 and Figure 11-4.

**Figure 11-3. Number Of Specimens with Cracking Greater Than 6 mils Outside the Repair-Substrate Joint (Per Repair Depth)**

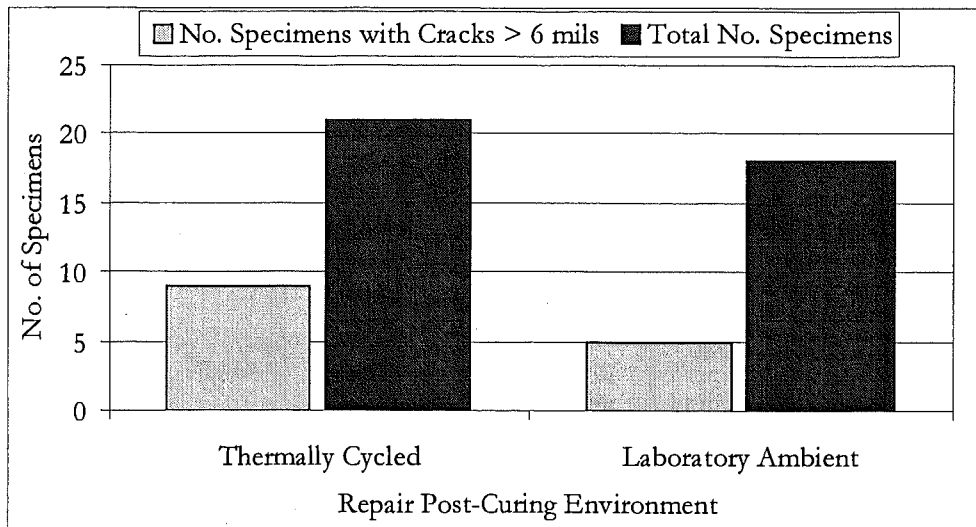
**Figure 11-4. Number Of Specimens with Cracking Greater Than 6 mils Outside the Repair-Substrate Joint (Per Repair Post-Curing Environment)**

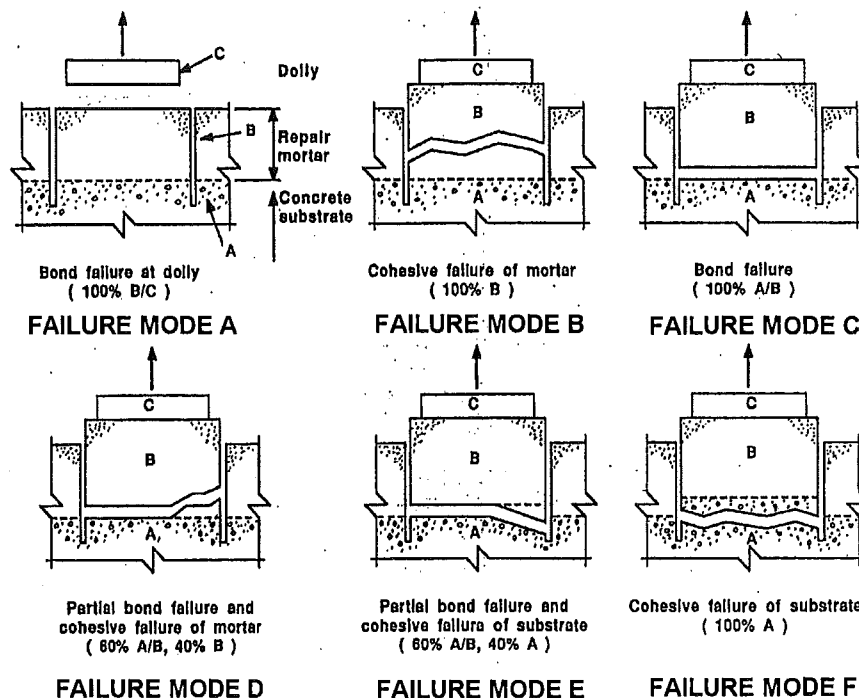
Figure 11-6. Bond Tensile Strength Test Failure Modes (Vaysburd and McDonald, 1992)

Overall, a majority of the bond tensile strength failures occurred at the repair-substrate interface (see Table 11-15). To determine whether the mean failure stress at the repair-substrate interface was lower than the mean failure stress of failures entirely within the repair mortar or substrate, t-tests were performed. The alternate hypothesis was structured such that  $H_A: \mu_1 < \mu_2$  with variable 1 being the mode C-D-E failures and variable 2 being either the mode B or mode F failures. See Figure 11-6 for an illustration of the failure modes.

One of six failure modes is possible for the bond tensile strengths performed in this study (see Figure 11-6). The majority of failures (77-percent) were at the repair-substrate interface. Statistically evaluating the bond tensile strength results on the basis of failure mode, the following conclusions can be drawn:

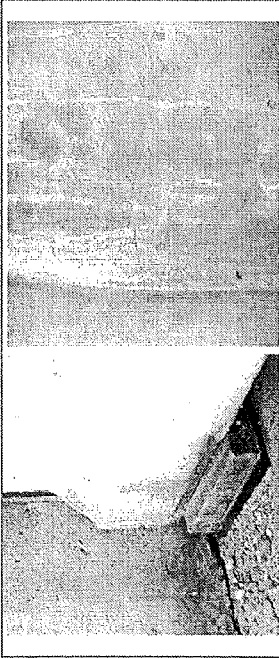
5	Hairline Cracks with efflorescence, water-stains, and/or corrosion with a horizontal crack propagating from the sole plate

<ul style="list-style-type: none"> <li>▪ Surface Insulating Methods (<i>Penetrating, Surface, Sealers, Coatings, and Crack Sealants</i>),</li> <li>▪ Electron Control Methods (<i>Surface Applied Corrosion Inhibitors, Sacrificial Anodes, Impressed Cathodic Protection</i>),</li> <li>▪ Environment Modifying Methods</li> </ul>
6	Cracked and deformed neoprene pad, probably non-functional

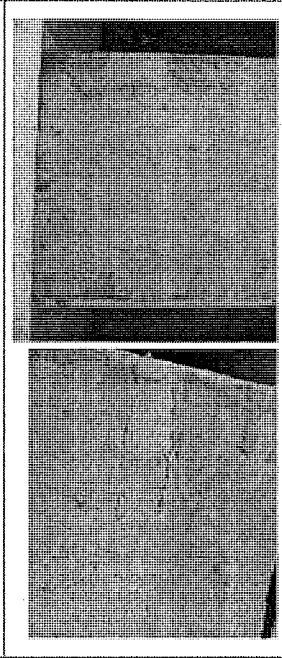
<p>6 - SATISFACTORY CONDITION</p>	<ul style="list-style-type: none"> <li>▪ Remove Rust from Bearing</li> <li>▪ Replace Neoprene Pad</li> </ul>
7	Moderate Cracks

<ul style="list-style-type: none"> <li>▪ Electron Control Methods (<i>Surface Applied Corrosion Inhibitors, Sacrificial Anodes, Impressed Cathodic Protection</i>)</li> <li>▪ Surface Insulating Methods (<i>Penetrating, Surface, Sealers, Coatings, and Crack Sealants</i>),</li> <li>Reinforcement Surface Preparation (<i>Epoxies, Liquid Corrosion Inhibitors, Zinc-rich Paint</i>)</li> </ul>

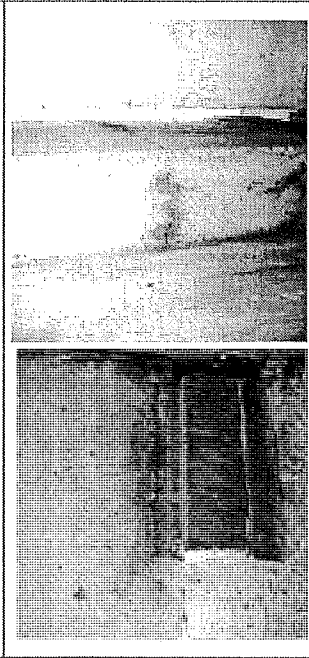
8	Moderate cracks with efflorescence, water-stains, and/or corrosion

<ul style="list-style-type: none"> <li>▪ Secondary Framing Modification (<i>Replace Diaphragms</i>),</li> <li>▪ Surface Sealers,</li> <li>▪ Re-alkalization, Chloride Ion Extraction,</li> <li>▪ Concrete Surface Preparation (<i>Compressed Air, High Pressure Water, Grit and Sand Blasting, Scrubbing, Wire Brushing</i>),</li> <li>▪ Electron Control Methods (<i>Surface Applied Corrosion Inhibitors, Sacrificial Anodes, Impressed Cathodic Protection</i>)</li> </ul>
