INVESTIGATION OF THREE SPALLED JOINTS
Norton-Glade Expressway, Muskegon
US 16 (Project 61-47, C7)

Research Laboratory Division
Office of Testing and Research
Report No. 350
Research Project 39 F-7(14)

Michigan State Highway Department
John C. Mackie, Commissioner
Lansing; February 1961

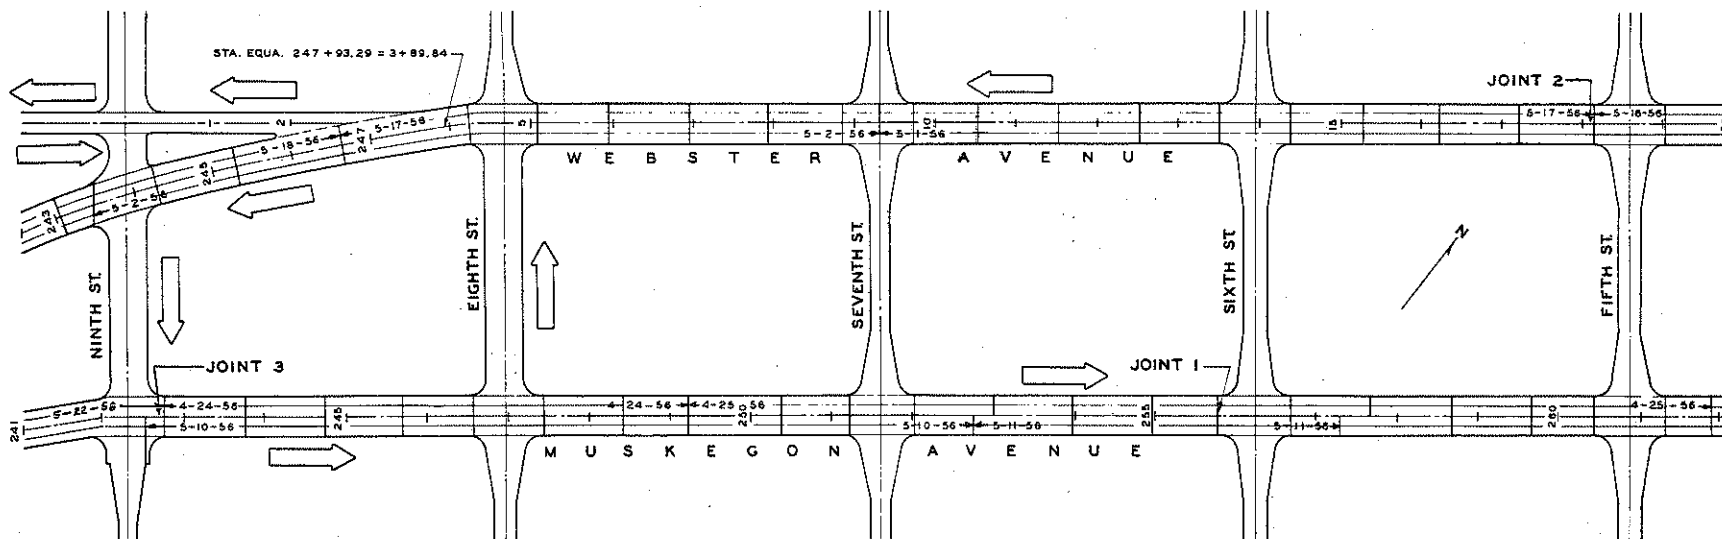
A schematic diagram of the Norton-Glade Expressway from Fifth to Ninth Streets is given in Fig. 1, with the three worst joints specifically labeled. It may be noted that the pavement in question was four years old at the time of the joint repair.

Figure 1. Plan view of a portion of the Norton-Glade Expressway, showing locations of three investigated joints.
