Report TSD-223-73

A TRAFFIC ACCIDENT ANALYSIS  
OF HIGH ACCIDENT LOCATIONS  
IN THE CITY OF MARQUETTE

August 1974

Traffic Engineering Services  
Traffic and Safety Division  
Michigan Department of State Highways and Transportation

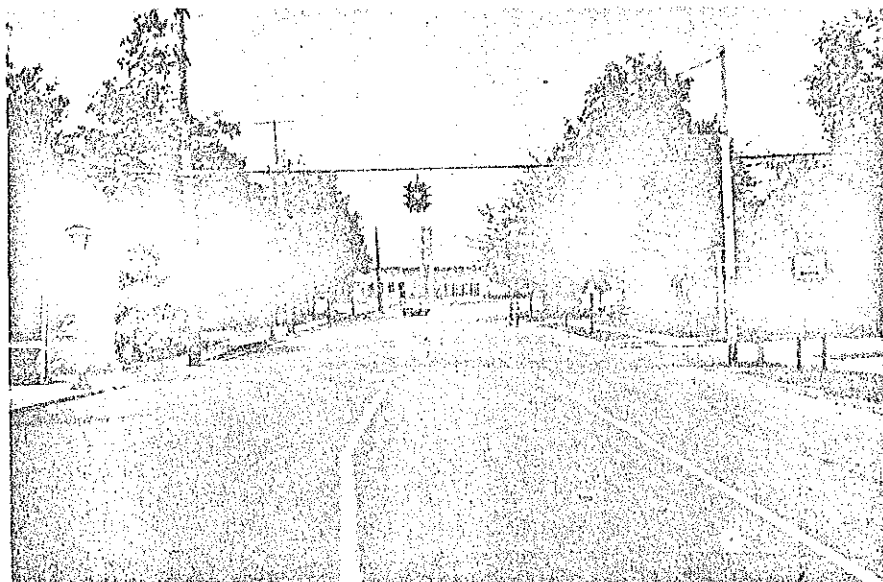
SOUTHBOUND PRESQUE ISLE AVENUE

The critical problem at this intersection involves the high incidence of right angle accidents at a signalized intersection. The existence of a single signal head, the short clearance interval and the standard lens size were all contributing factors to the right-angle pattern. It is mandatory in the 1973 edition of the Michigan Manual that at least two signal faces be provided per approach. Therefore, it is recommended that a second signal head be employed at this intersection and furthermore, that each signal should have 12 in. lenses. The problem involving the short clearance interval will be relieved through the adoption of the 70 second cycle and six percent clearance interval already recommended. If right-angle accidents continue in the future, consideration should be given to incorporating an all-red clearance interval into the signals' cycle length.

Many of the operators indicated that they did not see the signal. The fact that the existing signal head was painted green contributed to this problem. To obtain the best possible contrast with the visual background, it is desirable to paint signal head housings highway yellow. The insides of visors (hoods) and the entire surface of louvers, fins and the front surface of backplates shall have a dull black finish to minimize light reflection to the side of the signals. It is recommended that these paint guidelines be applied to the proposed signal heads.

Another accident pattern at this intersection involves the utility pole on the southeast corner. Three of the four ran-off roadway accidents involved this pole. The fact that this utility pole abuts the pavement makes it a target for errant vehicles. Also, because of the sharp turning radius from northbound Presque Isle Avenue to eastbound College Avenue this pole can be easily side-swiped by a turning vehicle. It is recommended that the utility company be contacted to relocate this pole so it is not a target for moving traffic.

The signals at Presque Isle Avenue and College Avenue should be interconnected with the signals at Lincoln Avenue and College Avenue (Location 2) and the signals at Seventh Street and College Avenue (Location 11). A Time-Space Diagram has been prepared to establish progression through the three intersections (Figure 10, p. 19). At a speed of 27 mph a cycle length of 70 seconds provides College Avenue with the greatest band of green time through the three intersections. Thus, it is recommended that a 70 second cycle with a six percent clearance interval (4.2 seconds) be established at this intersection.

The Michigan Manual indicates that symbol arrows indicating a single mandatory movement shall include the word "ONLY". Thus it is recommended that the word "ONLY" be applied under each Left Turn Arrow on Presque Isle Avenue and the west leg of College Avenue.

Roadside Lane-Use Control signs should be erected on the west leg of College Avenue and on the north and south legs of Presque Isle Avenue. These signs should be erected both in advance of the intersection and at the intersection. These Lane-Use Control signs will supplement the existing pavement markings to better inform the vehicle operator which direction he is allowed to travel from any given lane. A detail drawing of the recommendations at this intersection can be found on p. 18 .

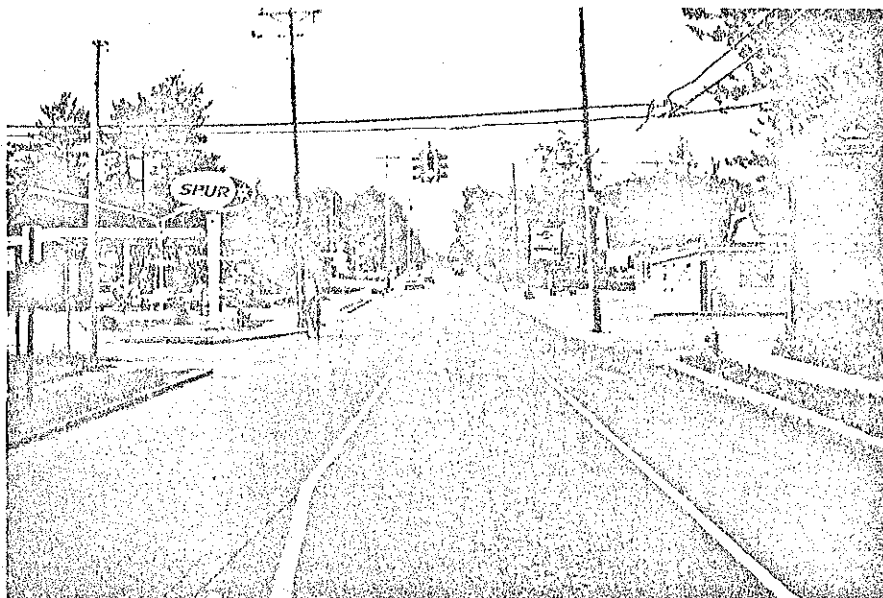
SOUTHBOUND  
LINCOLN AVENUE

The left turn lanes on Lincoln Avenue are offset in relation to each other which creates a sight distance problem for opposing left turning vehicles. The operators of these vehicles cannot see approaching through traffic. To alleviate this situation it is recommended that the left turn lanes be aligned directly across from each other. This can be accomplished by restriping Lincoln Avenue for two 11 ft through lanes and a 10 ft center lane for left turns (Figure 13, p. 24 ). Realigning the left turn lanes will make it necessary to increase the radius in the northeast and southwest quadrants to 40 ft to accommodate right turns from east and westbound College Avenue.

The signals at Lincoln Avenue and College Avenue should be interconnected with the signals at Seventh Street and College Avenue (Location 11) and the signals at Presque Isle Avenue and College Avenue (Location 1). A Time-Space Diagram has been prepared to establish progression through the three intersections (Figure 10, p. 19). At a speed of 27 mph a cycle length of 70 seconds provides College Avenue with the greatest band of green time using the existing cycle split. Thus, it is recommended that a 70-second cycle with a six percent clearance interval (4.2 seconds) be established at this intersection.

It is required in the 1973 edition of the Michigan Manual that a minimum of two vehicular signal faces be provided per approach. It is recommended that the requirements of the Manual be complied with at this intersection by erecting a second signal head.

To accompany the pavement markings at this intersection it is recommended that Lane-Use Control signs be erected at the intersection and in advance of the intersection for both legs of Lincoln Avenue and for the east leg of College Avenue. These signs will supplement the pavement markings by better defining the lanes available to the vehicle operators.

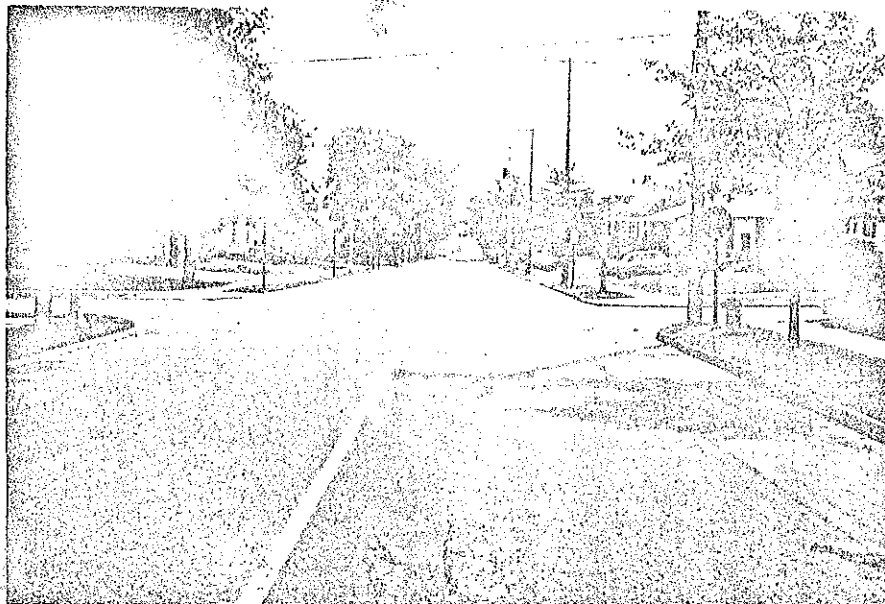
EASTBOUND  
MAGNETIC STREET

The critical problem at this intersection is the occurrence of right-angle accidents. Of the 25 right-angle accidents 12 operators stopped at the "Stop" signs on Magnetic Street and then failed to yield to Seventh Street traffic. Six of these operators indicated that their vision was obstructed by high snow banks while one other operator indicated that a pine tree in the southeast corner obstructed his vision. The remaining 13 right-angle accidents involved operators who ran through the "Stop" signs. It appears from the high number of "Stop" sign violations that a more pronounced warning is needed to inform Magnetic Street traffic of the impending stop at Seventh Street. The minimum accident warrant for a flashing beacon, according to the Michigan Manual, is satisfied when six or more accidents which are susceptible to correction by the cautioning or stopping of traffic occur over a two year period. The highest two-year period occurred between 1968 and 1969 when there were 16 right-angle accidents. The smallest two-year period occurred between 1970 and 1971 when there were nine right-angle accidents. Due to the high number of right-angle accidents at this location it is recommended that a flashing beacon be installed. Furthermore, the flashing beacon should be accompanied by 36 in. "Stop" signs for Magnetic Street.

Almost 27 percent of the accidents at this location occurred on wet pavement. Altogether 73.5 percent of the accidents occurred on wet, snowy or icy pavement. These figures indicate that the pavement at this intersection becomes slippery when wet. For this reason it is recommended that skidometer tests be conducted.

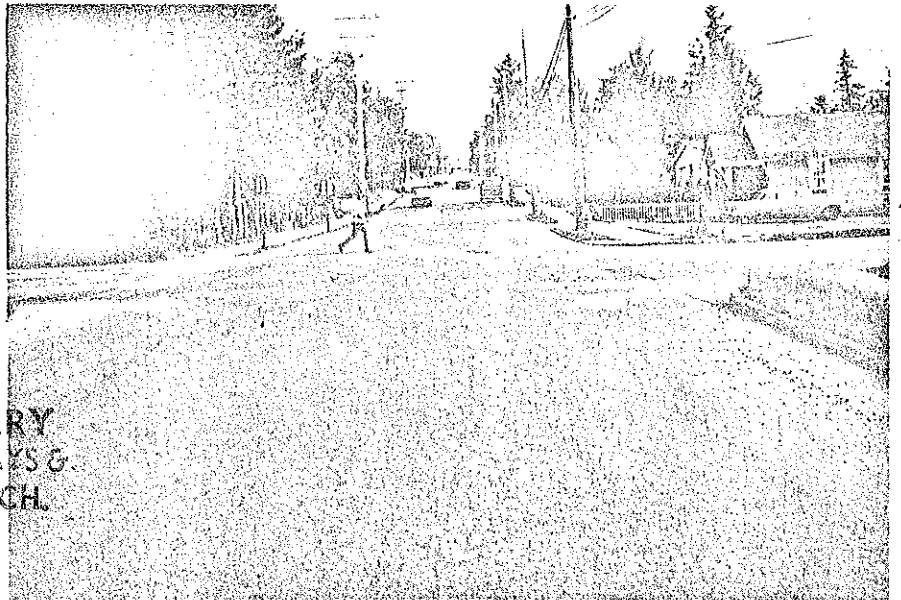
SOUTHBOUND  
LINCOLN AVENUE

The partial centerline for the south leg of Lincoln Avenue should be a broken yellow line instead of a solid white line and it should be applied throughout the entire length of the pavement. It is also recommended that a broken yellow centerline be applied throughout the entire length of the north leg of Lincoln Avenue.

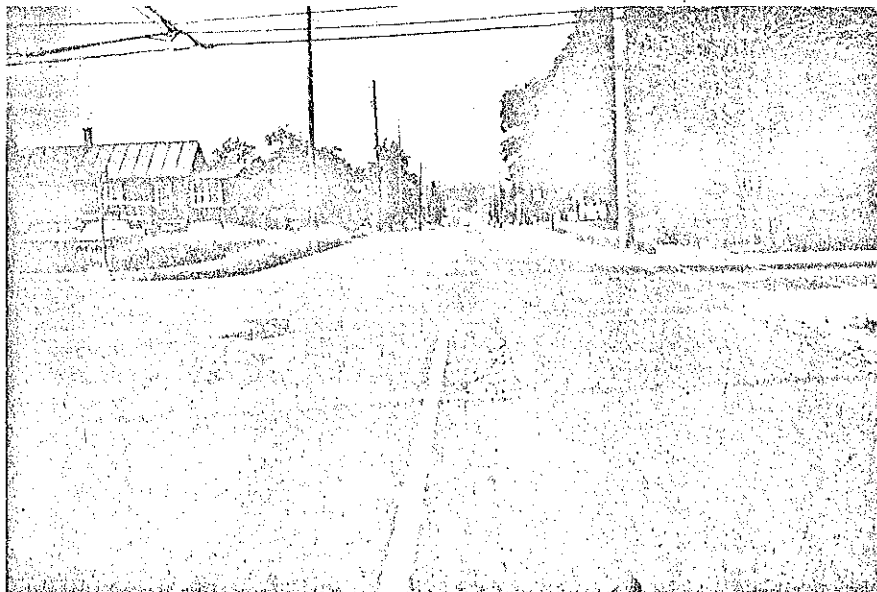
NORTHBOUND  
LINCOLN AVENUE

Right turns can be made from three of the four approaches without any difficulty. However, the right turn from the northbound approach on Lincoln Avenue has to be made into an 11 ft lane on West Fair Avenue. The existing radius is not large enough to accommodate this turn. Thus, it is recommended that the radius in the southeast quadrant be increased to 40 ft.

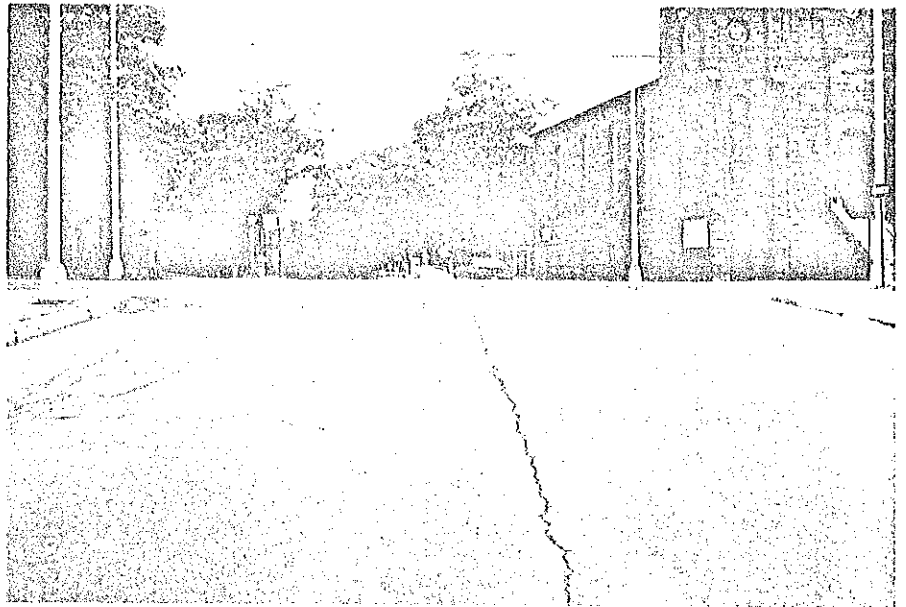
NORTHBOUND  
FRONT STREET

Improper lane usage was involved in six of the accidents at this location. Thus, it is recommended that a broken white lane line be applied on Front Street through the intersection area. This lane line should be carried through the intersection because of the positive gradient that crests at Ridge Street.

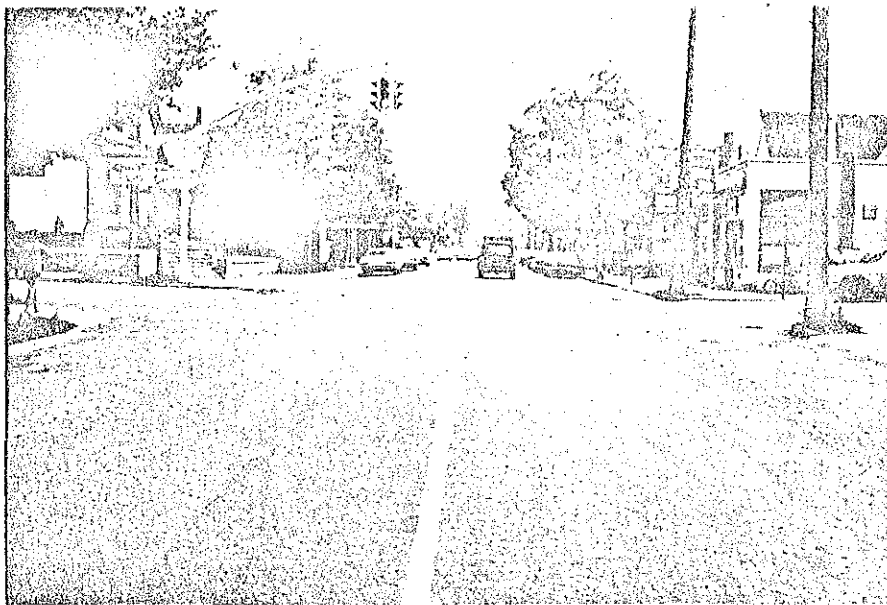
SOUTHBOUND  
THIRD STREET

All seven of the violators involved in the right-angle accidents that occurred after the signal installation indicated that they did not see the signal. The problem involves the unnatural location of the signal over the southeast portion of the intersection instead of the center. To increase the probability that the signal will be seen, it is recommended that a second signal be erected so that it is suspended over the northwest portion of the intersection. The same type of support that is used for the existing signal can be employed to support the proposed signal head. The addition of an extra signal head will provide two signal faces per approach for both roadways.

The existing clearance interval is too long to be very effective. Since the clearance interval should not be longer than 4.5 seconds, it is recommended that a seven percent (4.2 seconds) clearance interval be established.

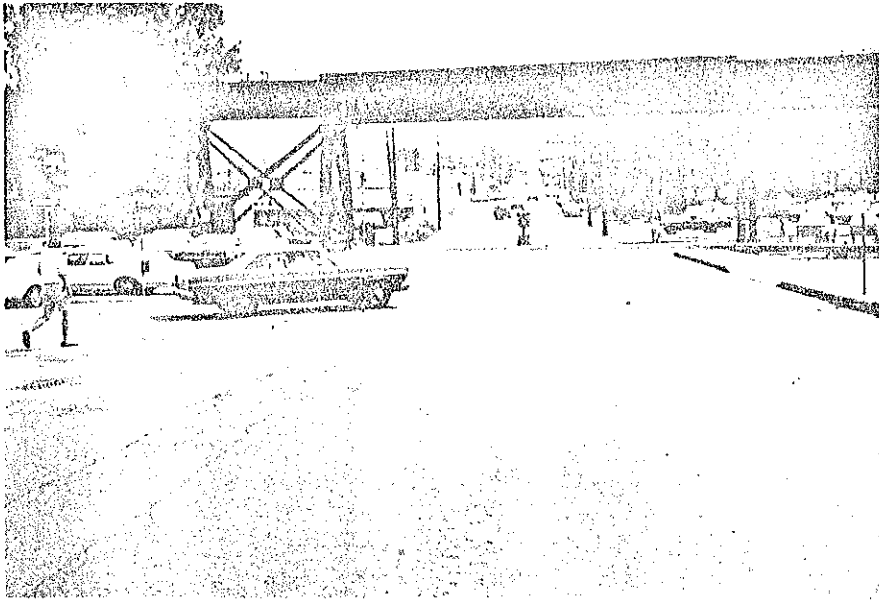
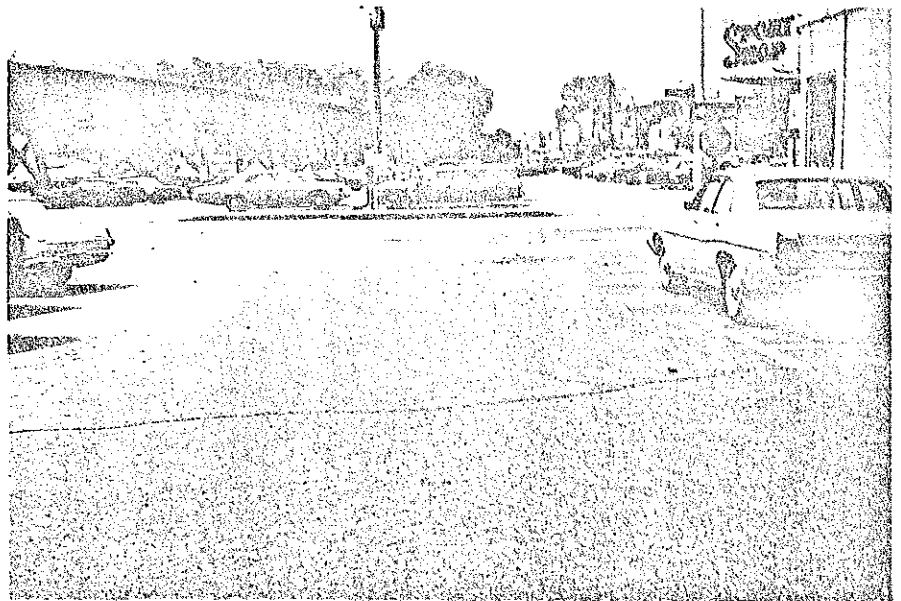
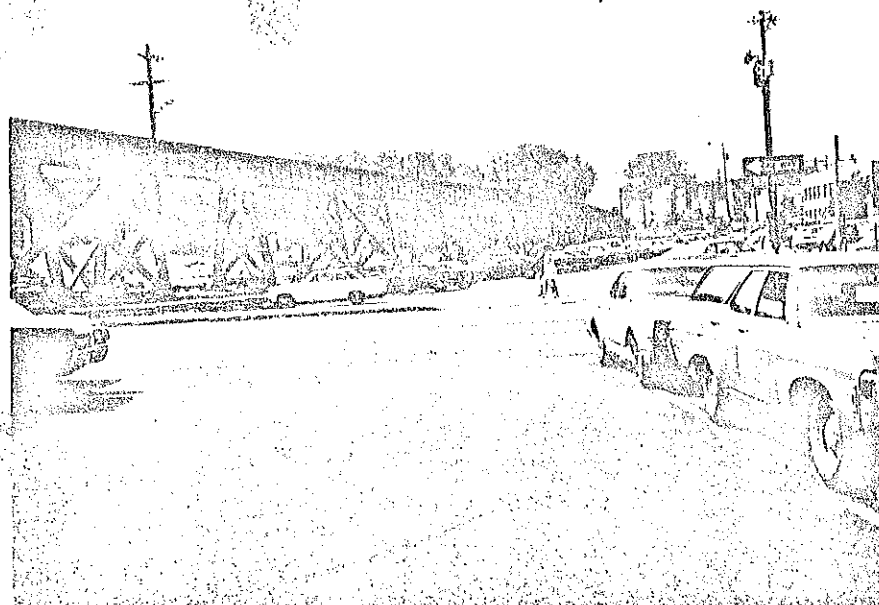
FIGURE 34

The south side of eastbound Main Street has 90 degree angle parking. Vehicles leaving these parking stalls are striking the parallel parked vehicles located along the north side of eastbound Main Street. To alleviate this problem it is recommended that the 90 degree angle parking be changed to 45 degree angle parking. Reduction of the parking angle will provide greater maneuverability for vehicles leaving the parking area. If the parallel parked vehicles continue to be hit in the future it is recommended that the parallel parking be removed.

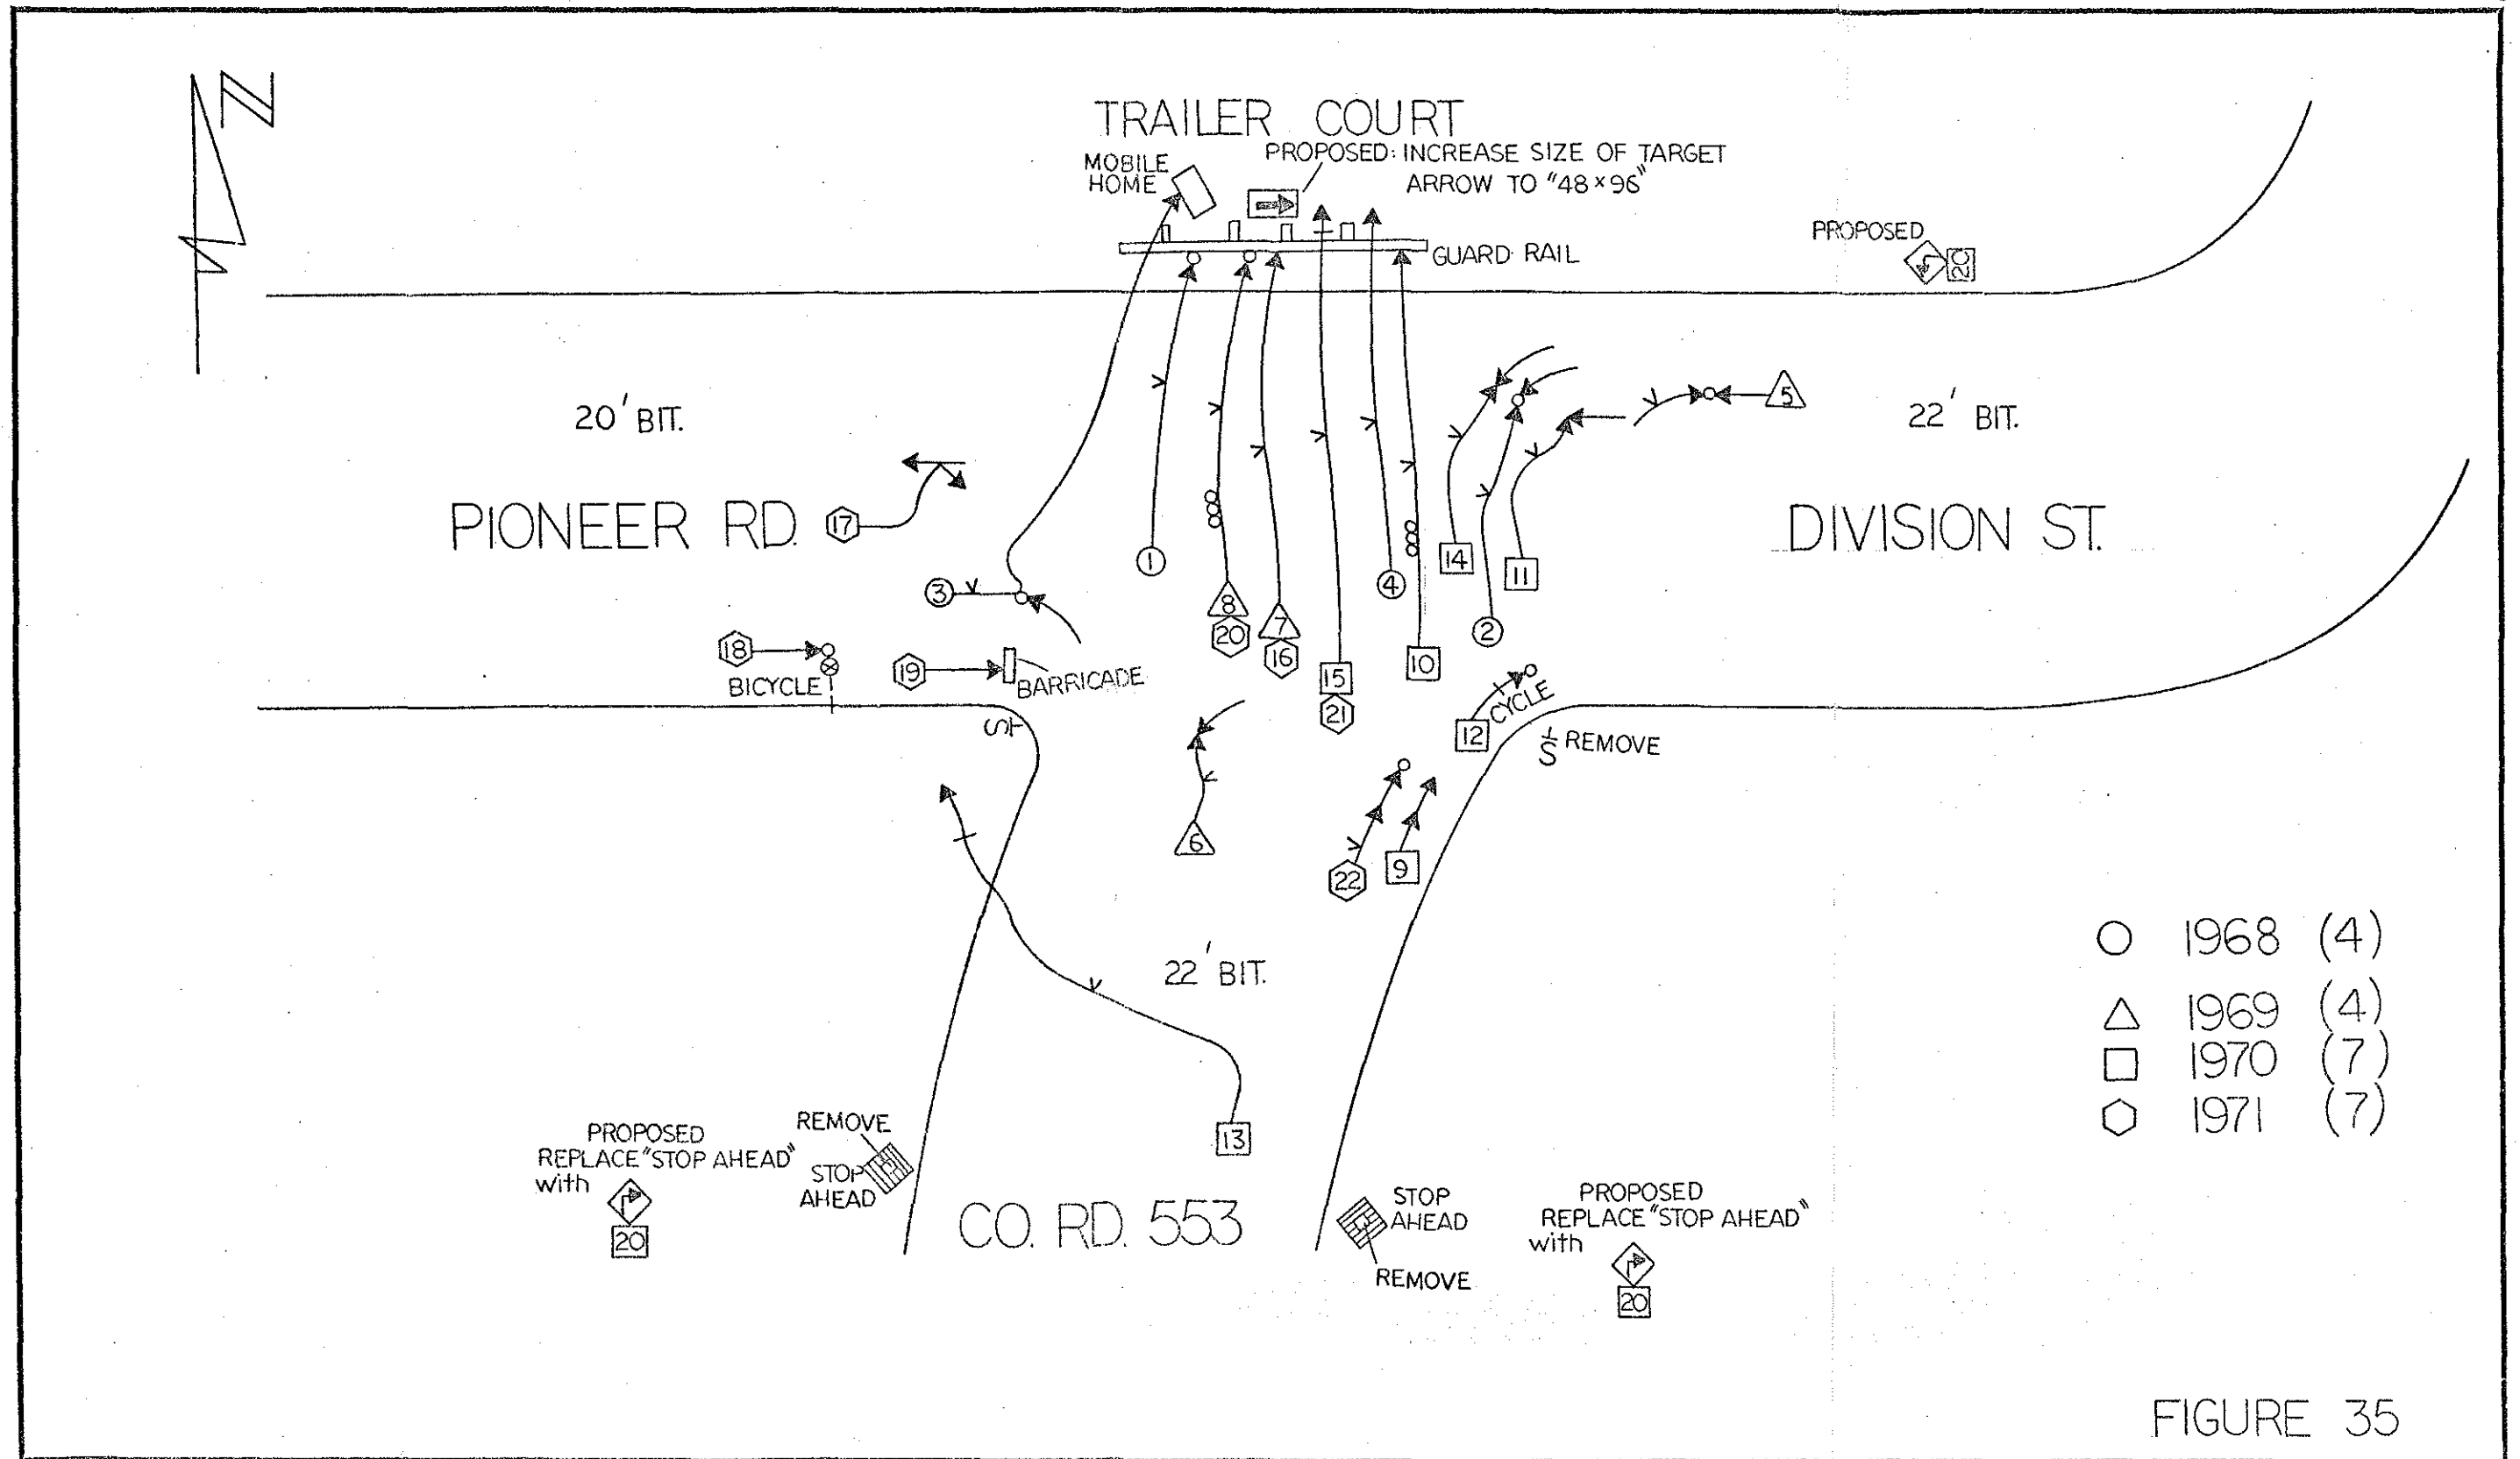
FIGURE 35

Nine of the 10 ran-off roadway accidents involved vehicles that ran through the "Stop" sign on County Road 553, striking the guardrail located on the north side of the intersection. All five right-angle accidents involved vehicles that skidded by the "Stop" sign on County Road 553, striking a westbound Division Street vehicle. In 11 of these 15 accidents excessive speed was reportedly a major factor. It is apparent that the transition from a speed of 65 mph to a stop condition has been difficult for these operators to negotiate. Since the major movement of traffic is from County Road 553 to Division Street and vice versa it is recommended that the "Stop" sign on County Road 553 be removed. It is also recommended that 36 in. Turn signs with accompanying 20 mph advisory speed panels be erected for both sides of northbound County Road 553 and the north side of westbound Division Street. The 20 mph advisory speed was selected on the basis of Devil Level readings taken at this intersection. The Turn signs and speed panels for County Road 553 should be erected on the existing lattice background in place of the "Stop Ahead" signs. The existing 24 in. x 48 in. target arrow located at the end of County Road 553 should be replaced by a 48 in. x 96 in. target arrow.

The removal of the "Stop" sign and the addition of Turn signs and advisory speed panels should reduce the ran-off roadway accidents.

However, if these accidents continue in the future, the radius for the curve would have to be increased to enable motor vehicles to travel at a higher speed. The radius could be increased by moving County Road 553 so that it intersects Division Street east of the present intersection. A larger radius would enable the advisory speed to be increased so that there is less of a transition from the posted speed limit to the safe speed for the curve.

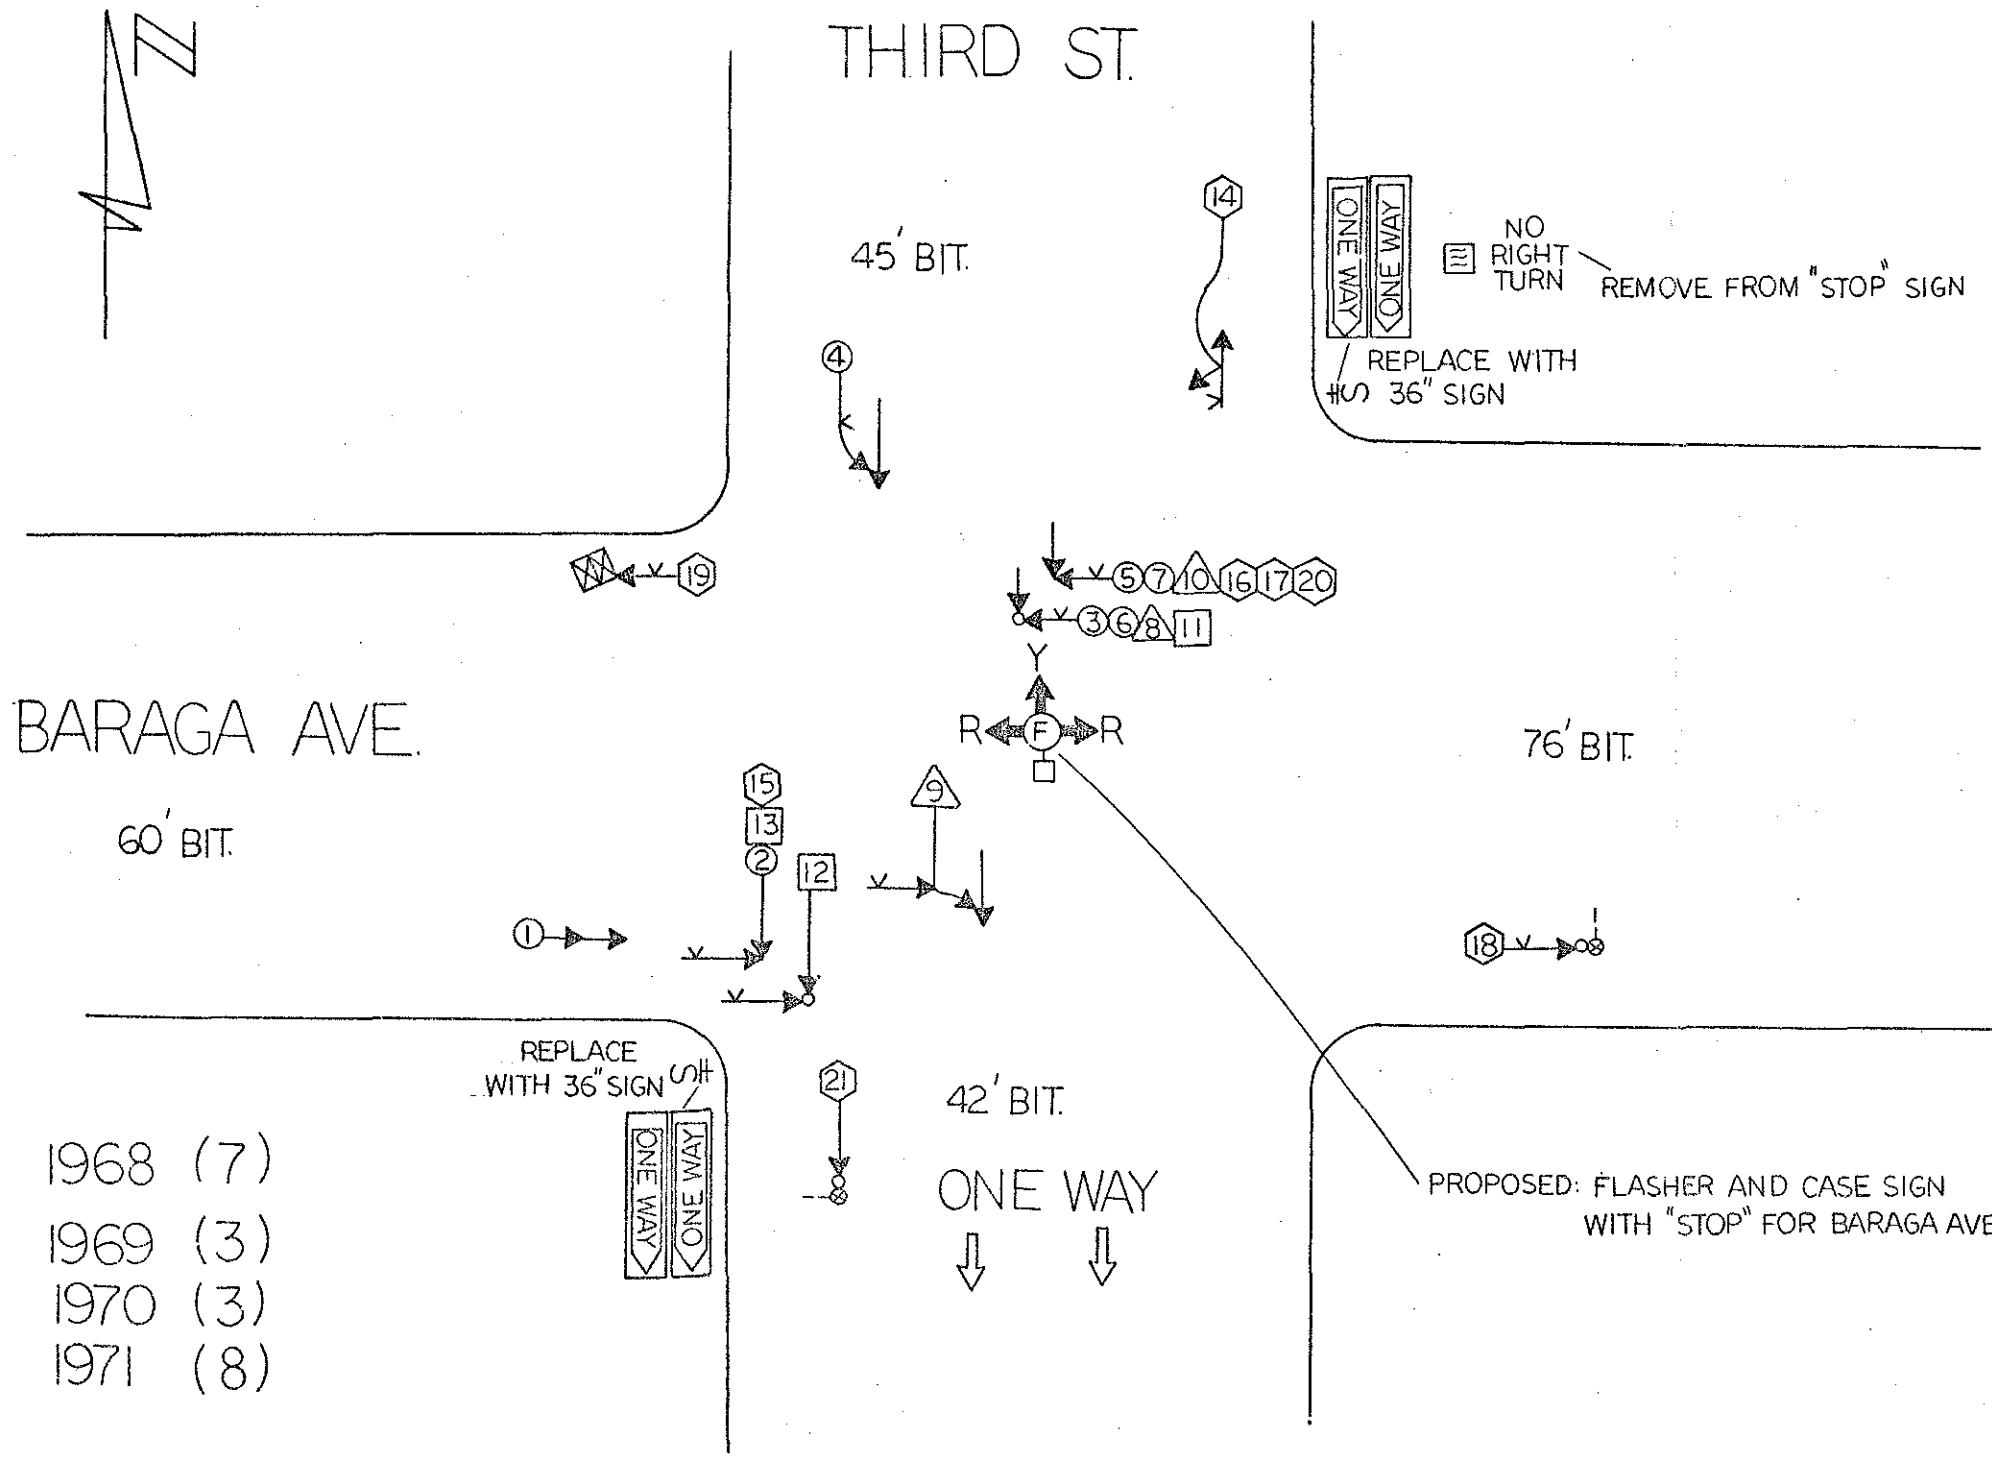
FIGURE 38

The critical problem at this location involves the occurrence of right-angle collisions. There were 15 right-angle accidents during the four year study period from 1968-1971 and 31 right-angle accidents during the six year period from 1966-1971. Eleven of the 15 right-angle accidents during the study period involved operators who reportedly did not see the stop signs. Thus, it is recommended that the existing 24 in. "Stop" signs be replaced by 36 in. signs. Furthermore, it is recommended that a flasher with a 12 in. lens be erected over the center of the intersection to give greater emphasis to the required stop at Third Street. An illuminated case sign reading "Stop" for Baraga Avenue should be suspended from the flasher.

Thirty-eight percent of the accidents at this location occurred on wet pavement. Taken as a percentage of the wet and dry accidents only the percentage of wet accidents increases to almost 53. These figures indicate that the pavement at this intersection becomes slippery when wet. For this reason it is recommended that skidometer tests be conducted.

The Manual indicates that only one additional sign shall be displayed with a "Stop" sign and it shall be either a Street Name sign, a One-Way sign or a sign that restricts a turning movement. Thus, it is recommended that the existing "No Right Turn" sign be excluded from the proposed 36 in. "Stop" sign on the northeast corner. Only the existing "One-Way" arrows can be retained on the proposed 36 in. "Stop" signs.

Third Street has a partial solid white lane line on the north leg. The Michigan Manual indicates that lane lines should be a broken white line. Thus, it is recommended that a broken white lane line be applied throughout the entire length of Third Street. Also, yellow center line markings should be applied on Baraga Avenue to give each operator an indication of the available pavement width for his direction of travel.

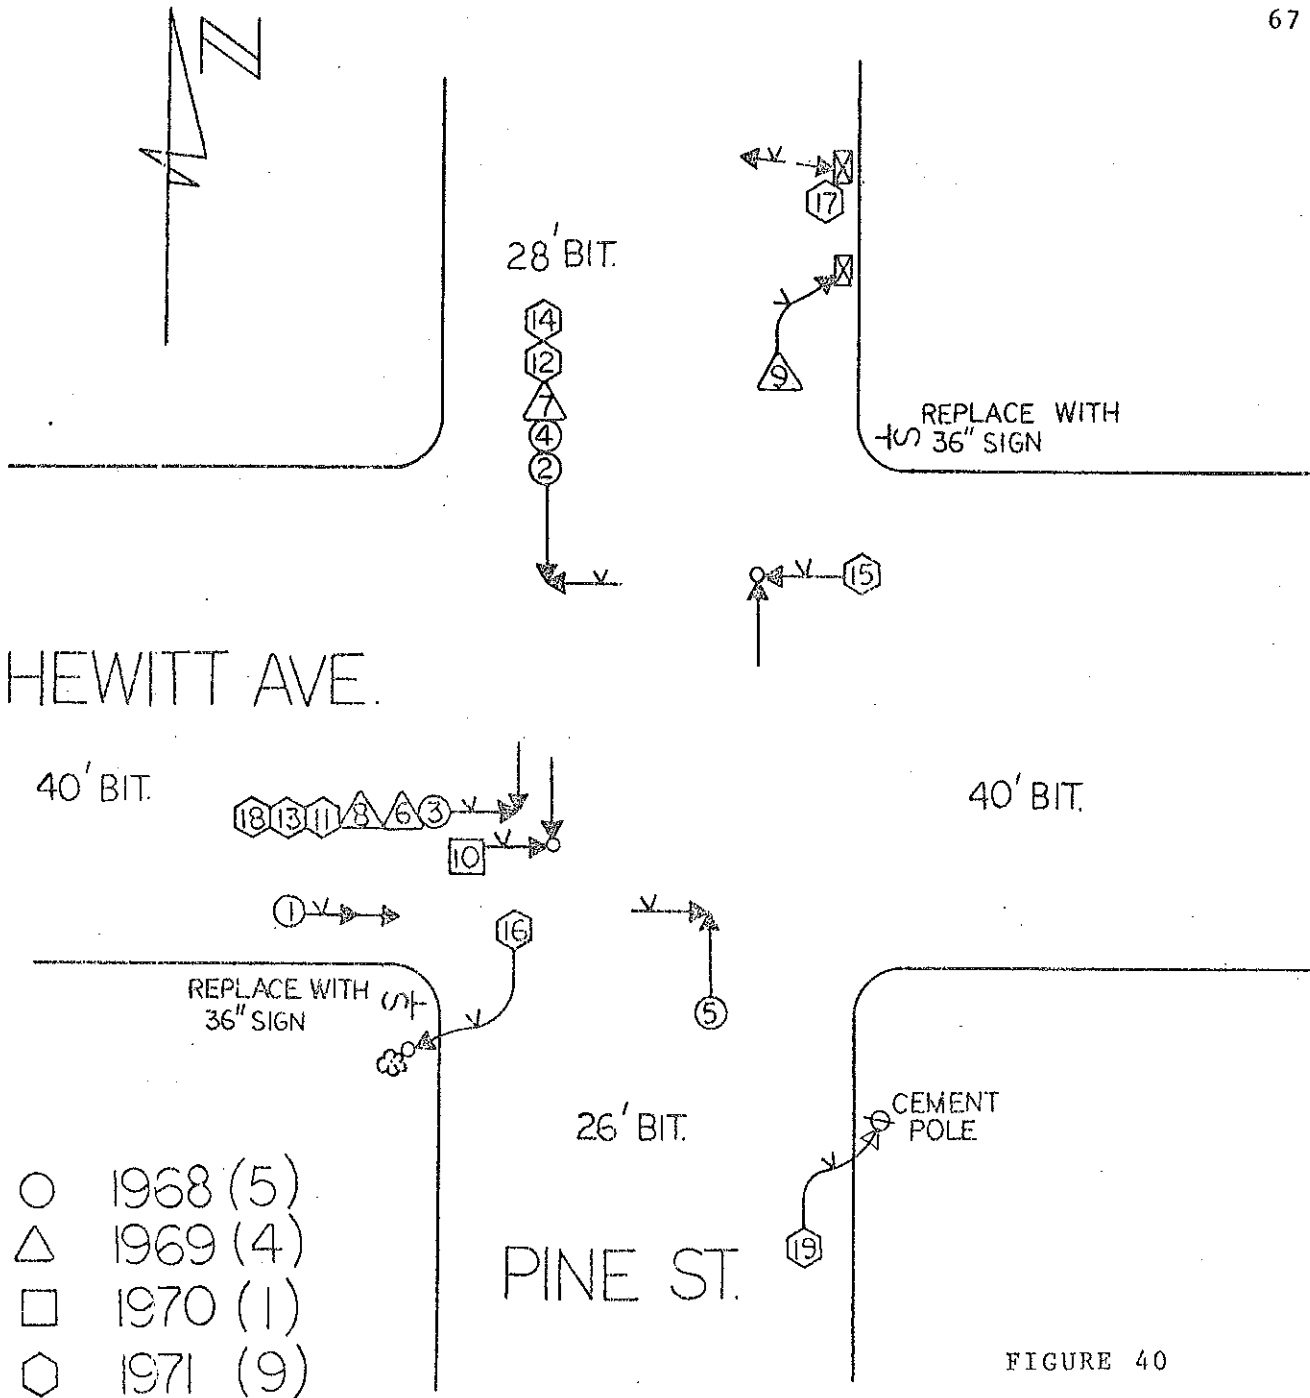
FIGURE 40

Nine of the operators involved in the right-angle accidents indicated that they did not see the "Stop" signs. For this reason it is recommended that the existing 24 in. "Stop" signs be replaced by 36 in. signs.

To ensure that the larger "Stop" signs will be seen, it is recommended that parking on Hewitt Avenue be prohibited a distance of 75 ft from both the northeast and southwest corners. Also, the trees that hang over the roadway should be kept trimmed and the large bush located in front of the "Stop" sign on the northeast corner should be removed.

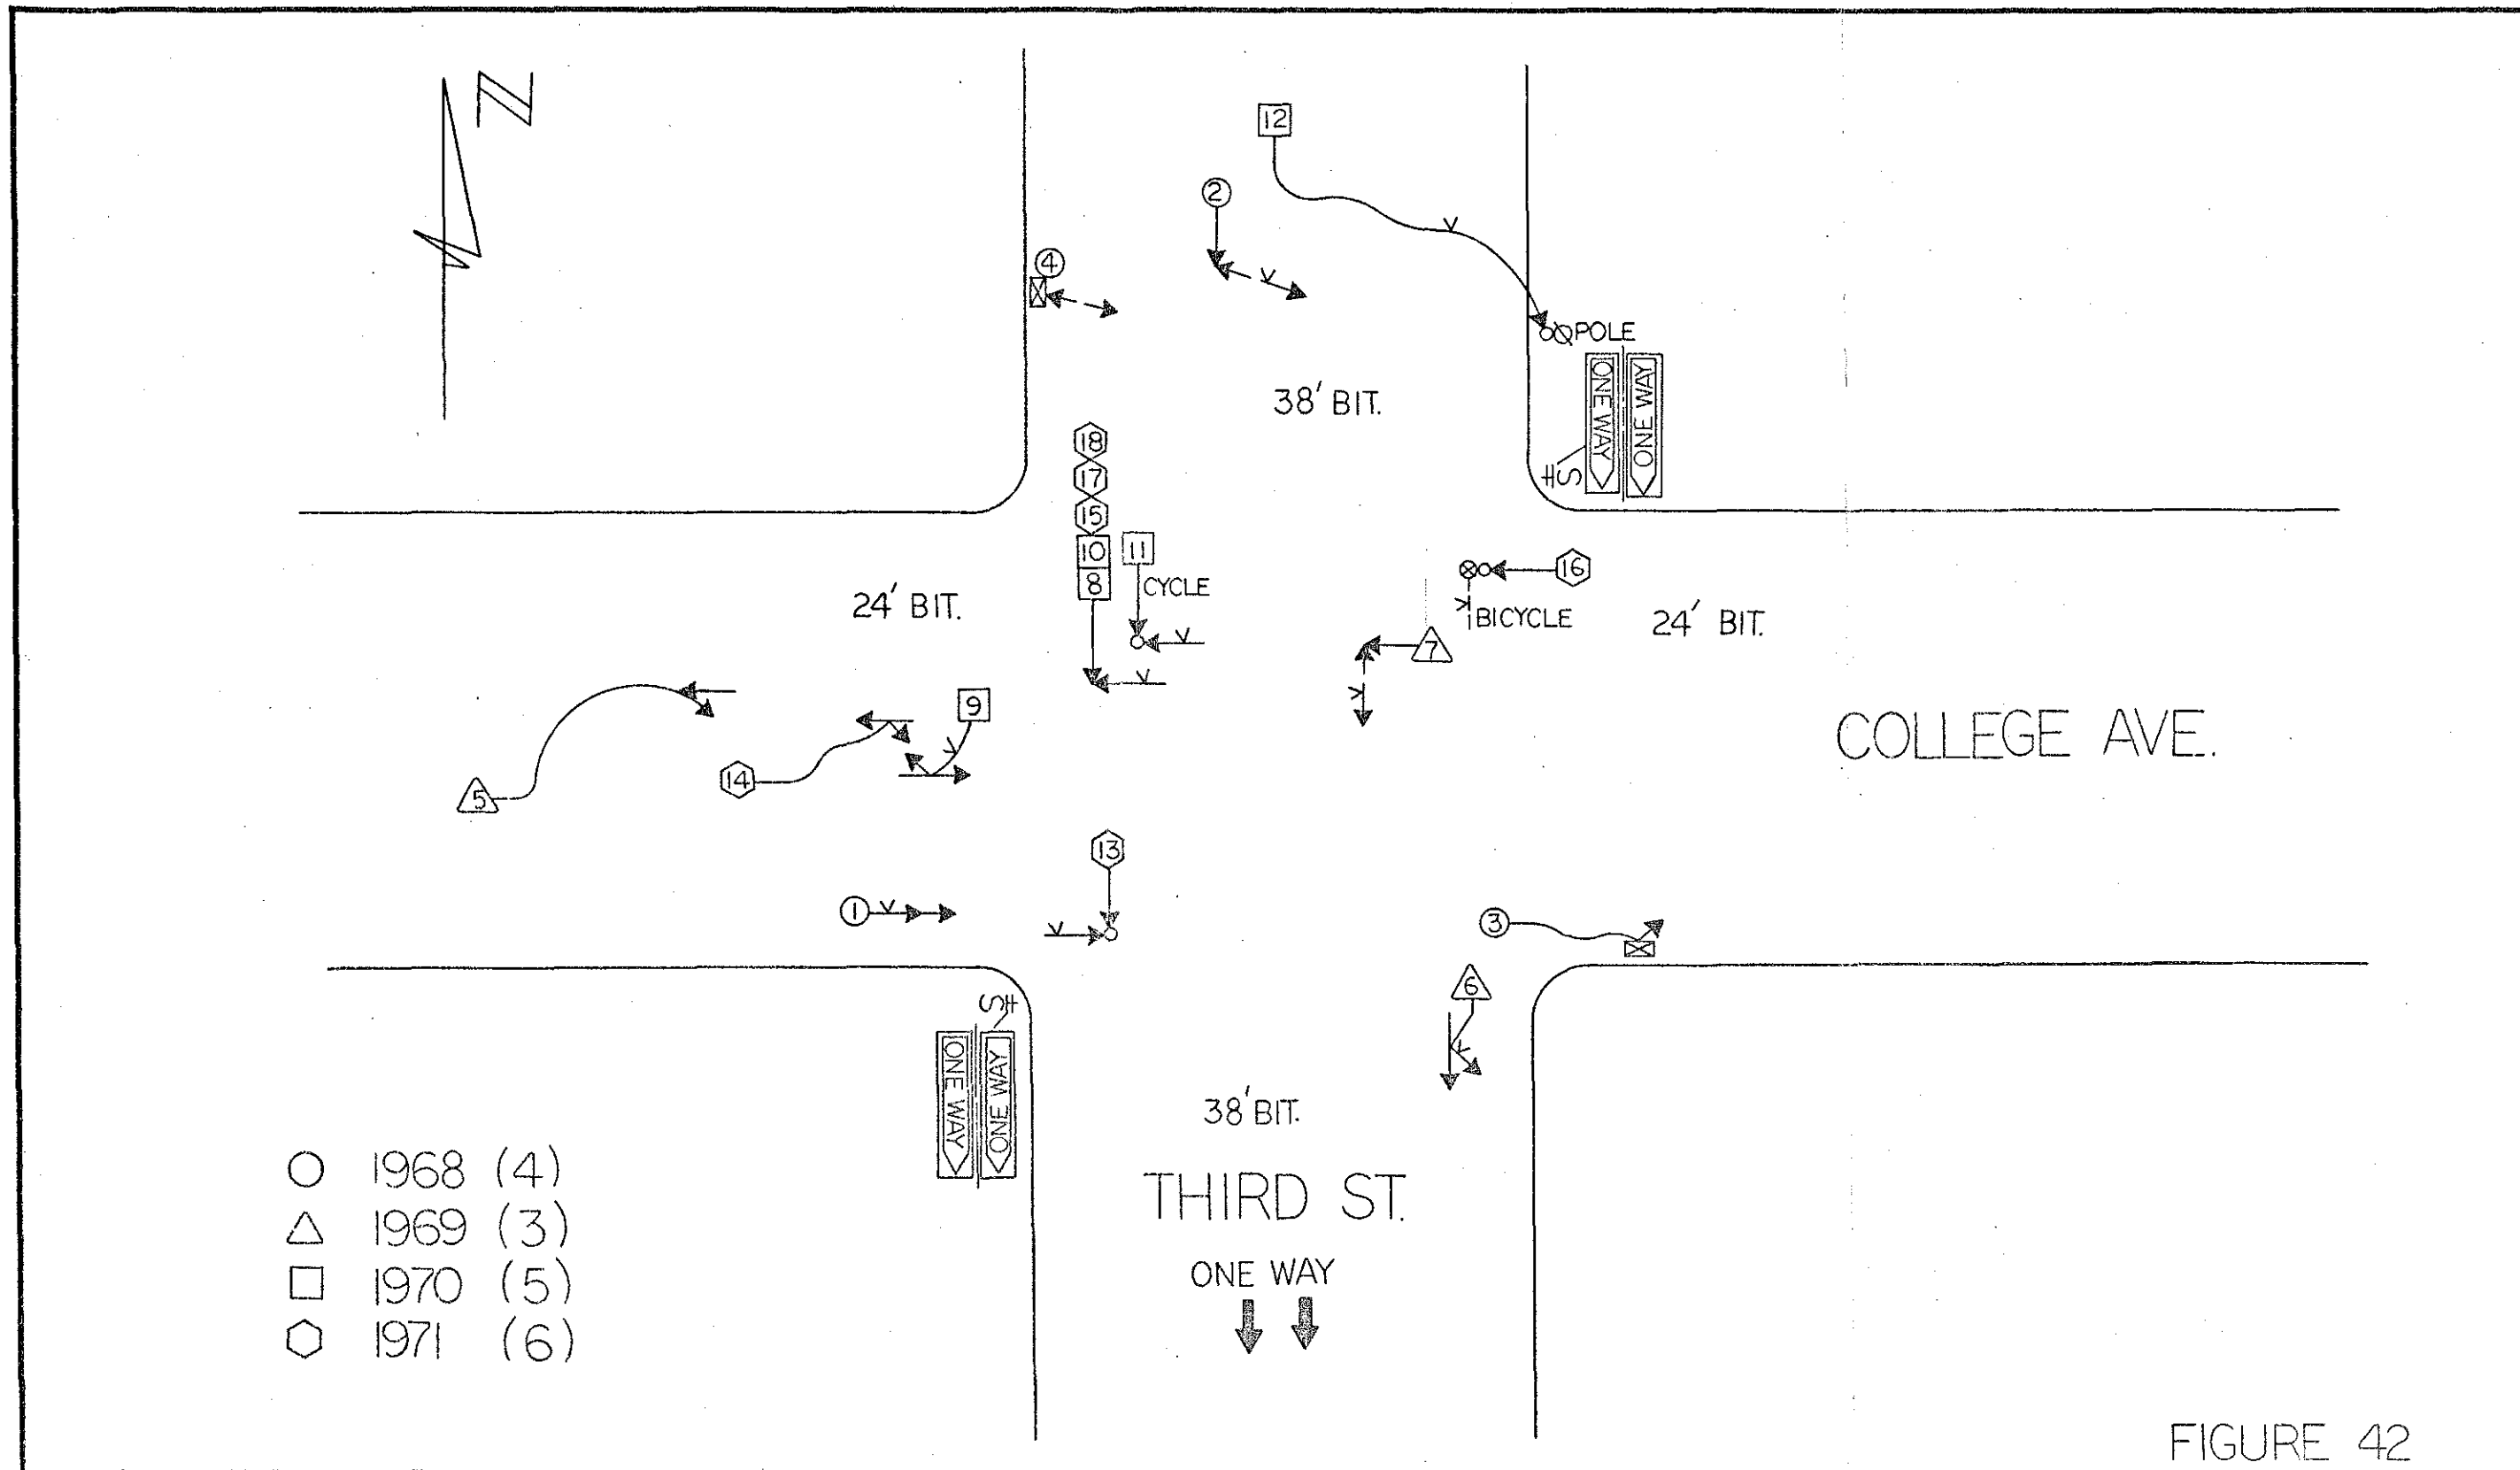
Four of the eight violators involved in the right-angle accidents indicated that they did not see any vehicles on Third Street. The sight distance from College Avenue is poor due to parked cars on Third Street. For this reason it is recommended that the parking on Third Street be removed a distance of 75 ft from the northeast and northwest corners.
