PCC PAVEMENT JOINT RESTORATION
AND REHABILITATION
(Federal Highway Administration NEEP Project 27)
Construction Report

J. E. Simonsen
F. J. Bashore
A. W. Price

Research Laboratory Section
Testing and Research Division
Research Project 79 F-159
Research Report No. R-1179

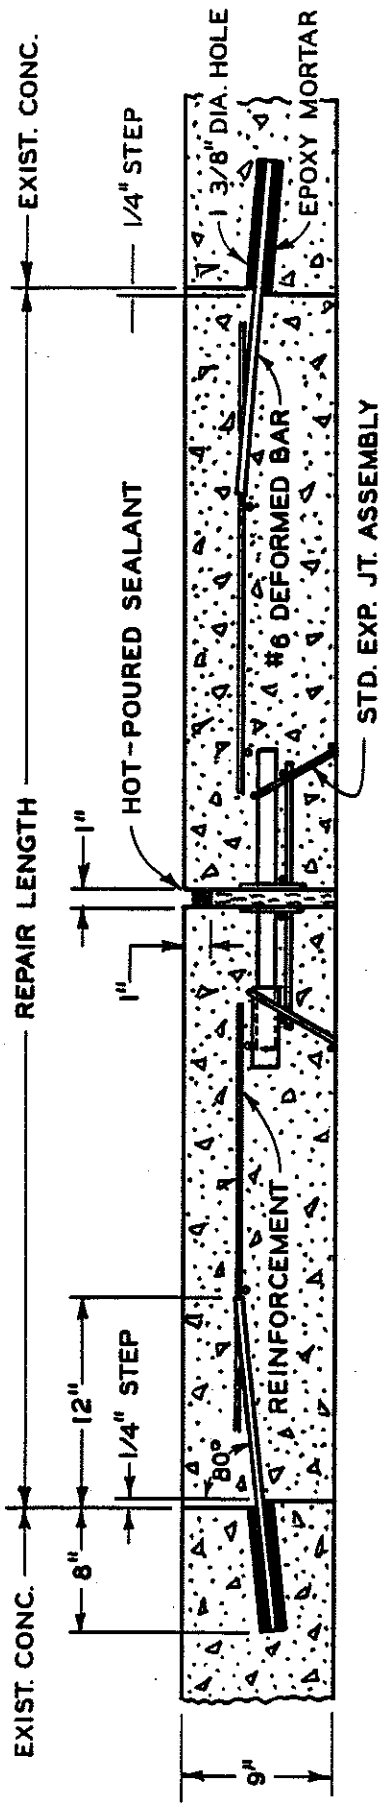
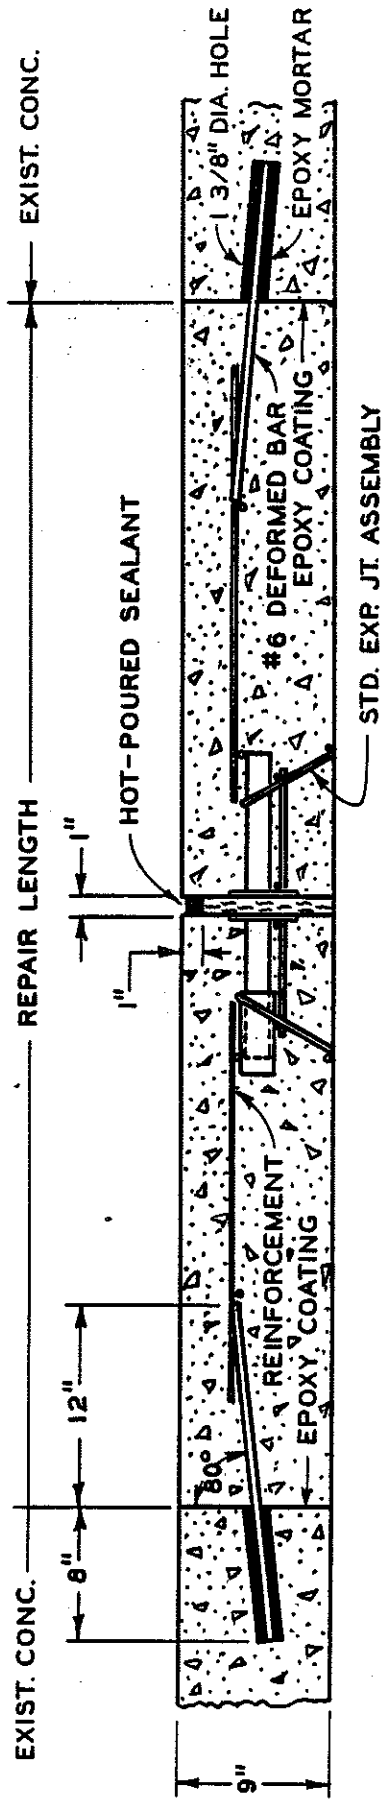
Figure 1. Experimental types of repairs.

a. Repair with step-cut end limits.

b. Repair with epoxy coated end limits.

On the basis of laboratory test results on different types of tied joints, two types were selected for field testing (Fig. 1). Both types utilize No. 6 deformed tie bars set in a 1-3/8 in. diameter by 8 in. deep hole with Type II epoxy mortar. This epoxy conformed to the low temperature grade in MDOT Standard Specifications, Section 8.16.05, and was used to obtain early strength.

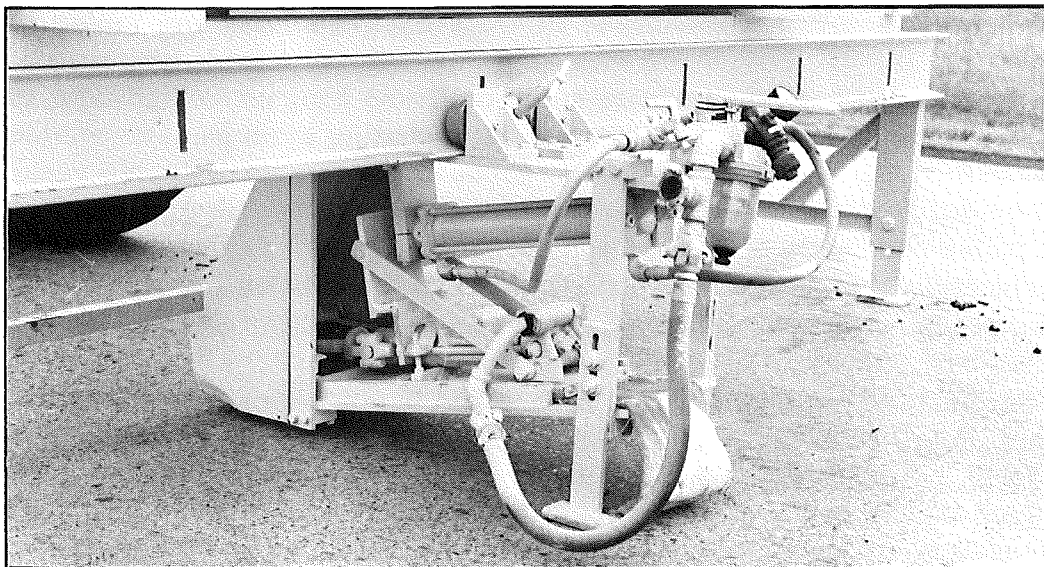
Figure 2. Machine for drilling holes in vertical end faces of concrete pavement. The drill is mounted on rollers on back-to-back channels to allow positioning of holes across the pavement width. An air cylinder provides pressure for forward and backward movement of the drill.

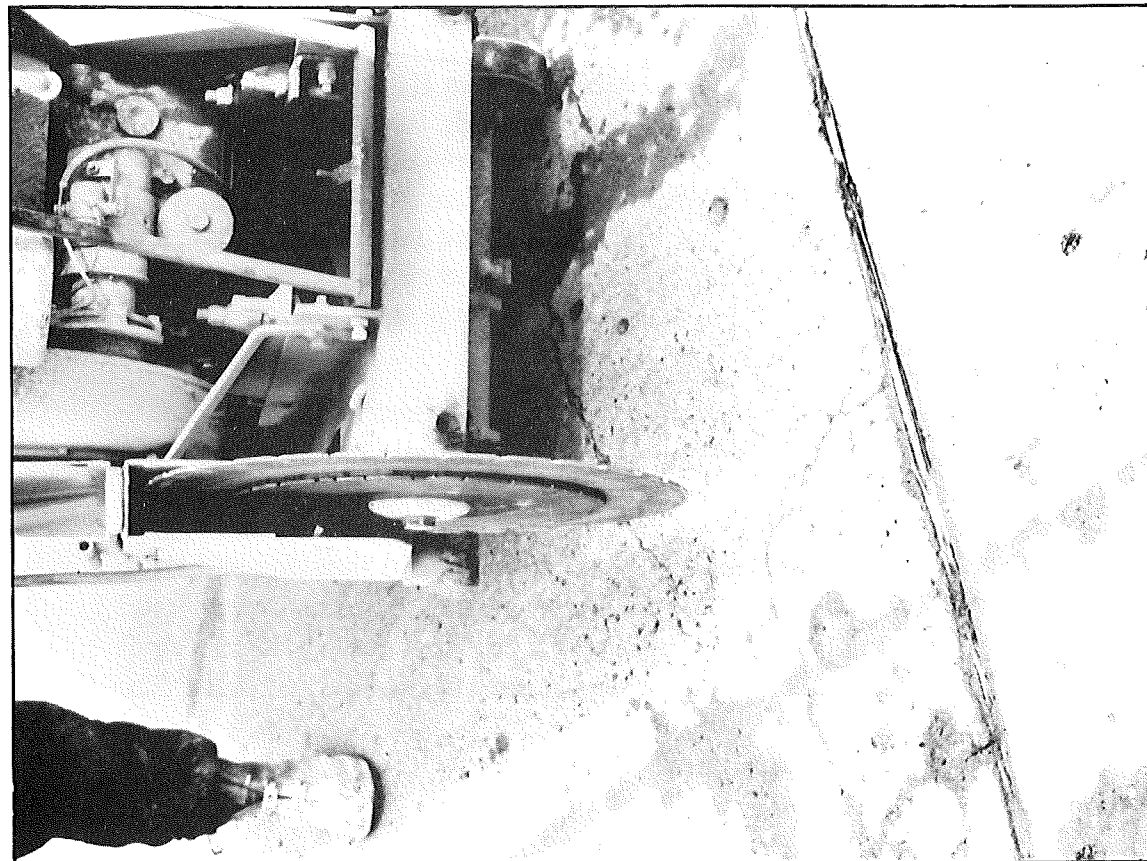
On the first step cut repair, one 18 in. blade with a spacer between it and the 26 in. blade was tried. However, the flexibility of the 18 in. blade outside the spacer support resulted in difficult sawing and a step of approximately 1/8 in. in width. Therefore, on the second repair, two 18 in. blades were mounted next to the larger blade. This set-up resulted in a step slightly over 1/4 in. wide and did not interfere appreciably with the normal operation of the saw. Figure 3 shows the blade mounting arrangement used for the second repair and Figure 4 shows the step after concrete removal.

Figure 3. Saw blade mounting arrangement to make step saw cut--one 26-in. blade with two 18-in. blades next to it.

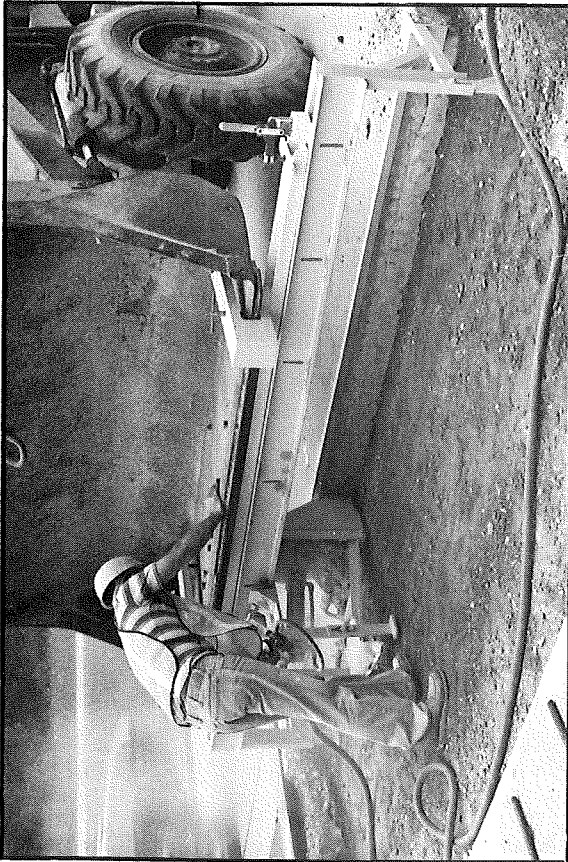
Figure 5. Drilling holes for tie bar installation. Dark lines on support channel indicate hole locations.

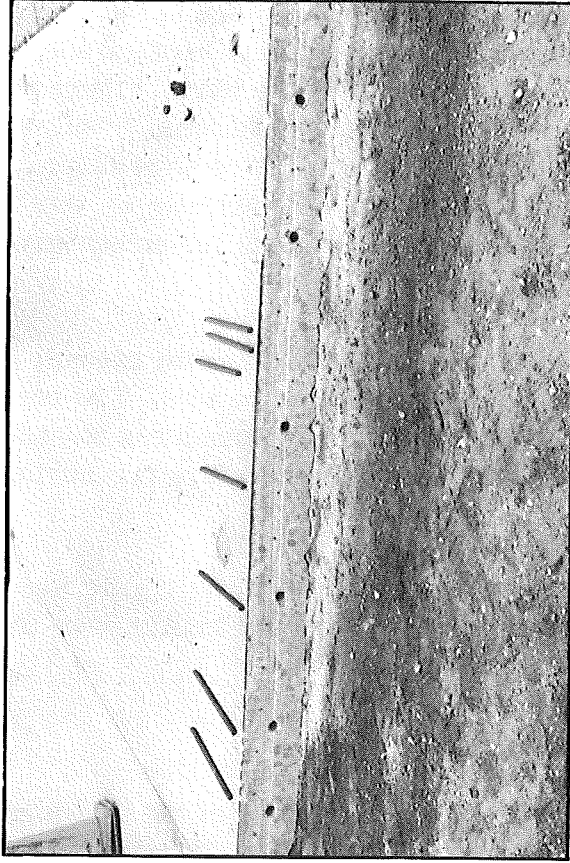
Seven tie bars were installed in each end face of a repair at the following spacing: 12-18-18-24-24-18-18-12 in. (that is, the first and last bars are 12 in. from a lane edge). The number of tie bars at each repair end was selected on the basis of laboratory test results which showed that seven bars used in conjunction with either a step cut or an epoxy coat should develop close to the same shear strength as a tied construction joint used in new pavement construction.

Figure 6. End face of repair showing part of the transverse 12-18-18-24-24-18-18-12-12 in. spacing of tie bars. Vertically, the holes are at mid-slab depth.

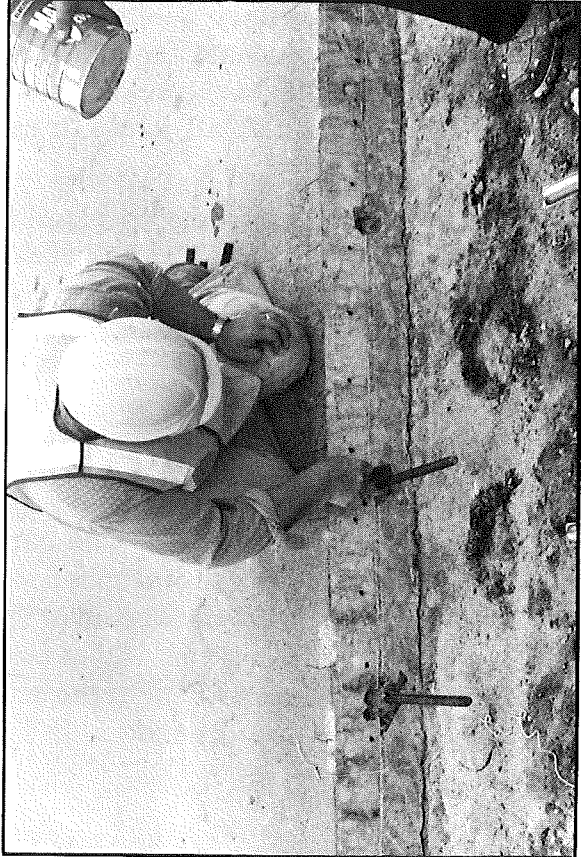
Figure 7. Hand placing of tie bars in end face of pavement slab.

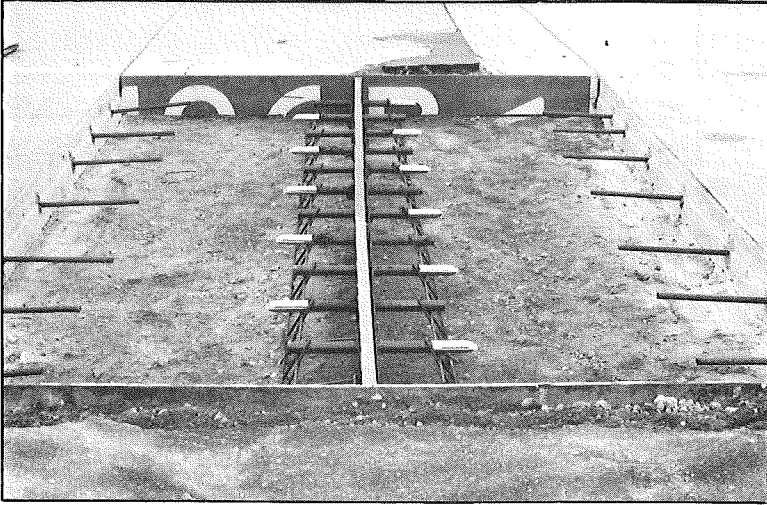
Figure 8. Repair area with tie bars, forms, and expansion joint assembly in place.
