THE RELATIONSHIP OF AGGREGATE  
DURABILITY TO CONCRETE PAVEMENT  
PERFORMANCE, AND THE ASSOCIATED  
EFFECTS OF BASE DRAINABILITY

C. J. Arnold

Research Laboratory Section  
Testing and Research Division  
Research Project 73 F-136  
Research Report No. R-1158

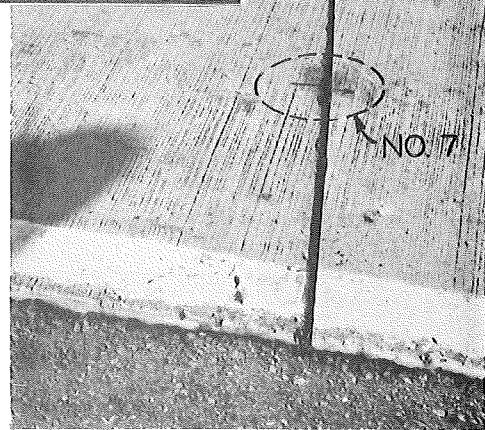
Figure 5. Cores cut from the faulted section to determine condition of the bottom of the slab at locations away from joints. Core No. 11 was cut 9-ft from transverse joint, Core No. 12 at 5-ft, and Core No. 13 at 1-ft.

severe deterioration of the bottom and joint face surfaces. Again, the bituminous base was intact. Here we have the reason for faulting; concrete debris from the deteriorated faces and bottom of the slab, being pumped by truck traffic, because of the captive water between the pavement and base. Figure 5 shows cores removed 1, 5, and 9-ft away from the transverse joint, showing the slab to be bonded to the base only at the 9-ft distance. Figure 6 shows typical pavement surface, concrete and base cores from the ATPM base sections. These sections do not show the concrete deterioration or faulting that was so evident on the non-draining bituminous base.

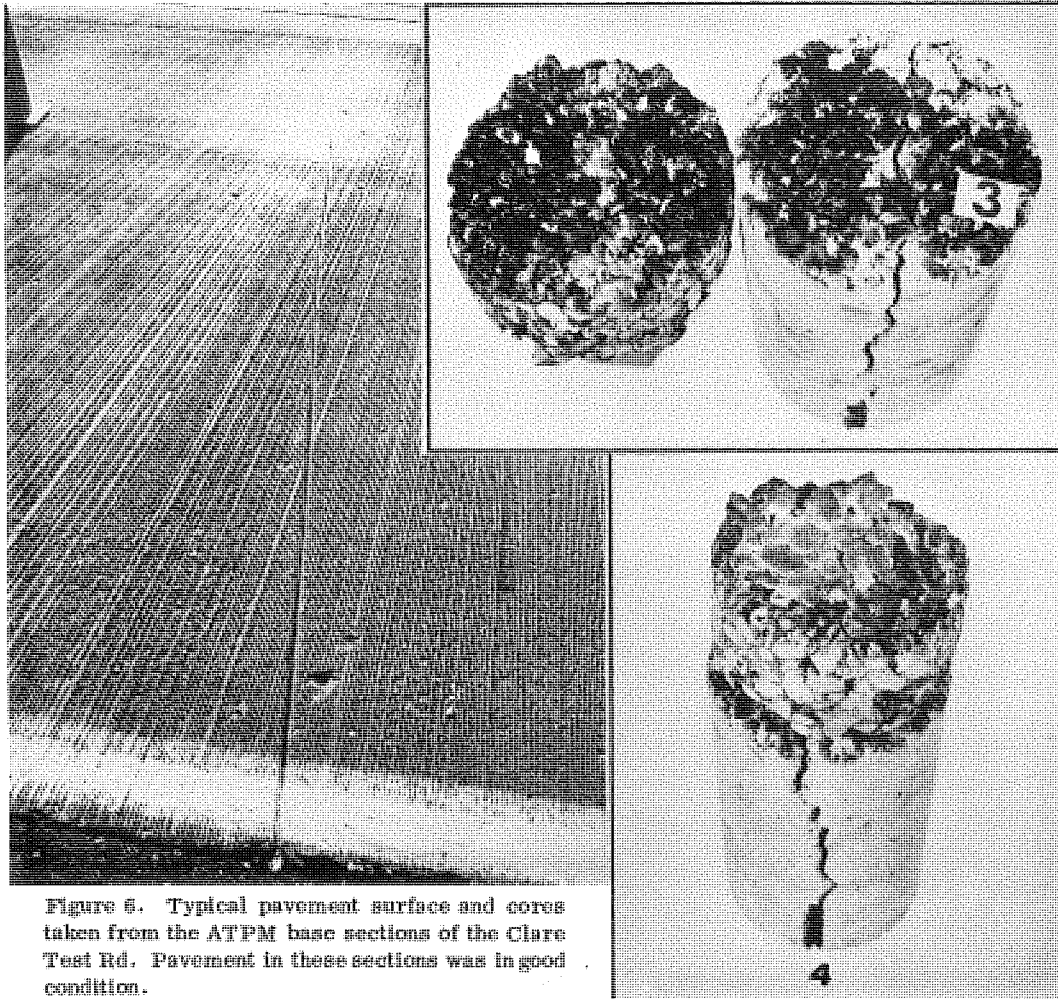
The concrete loss from the cores appears to be typical of heavy scaling, such as often occurs with non-air-entrained concretes. Project records show air checks near this location to be within specified limits, but toward the lower side of tolerance. Preliminary testing of the cores removed from the job indicate an air content below that required to prevent
