**CRASH TESTING OF MICHIGAN'S
TYPE B (W-BEAM) GUARDRAIL
SYSTEM – PHASE II**

MwRSF Research Report No. TRP-03-104-00

December 13, 2000

TESTING AND RESEARCH SECTION
CONSTRUCTION AND TECHNOLOGY DIVISION
RESEARCH PROJECT NO. RC-1398B

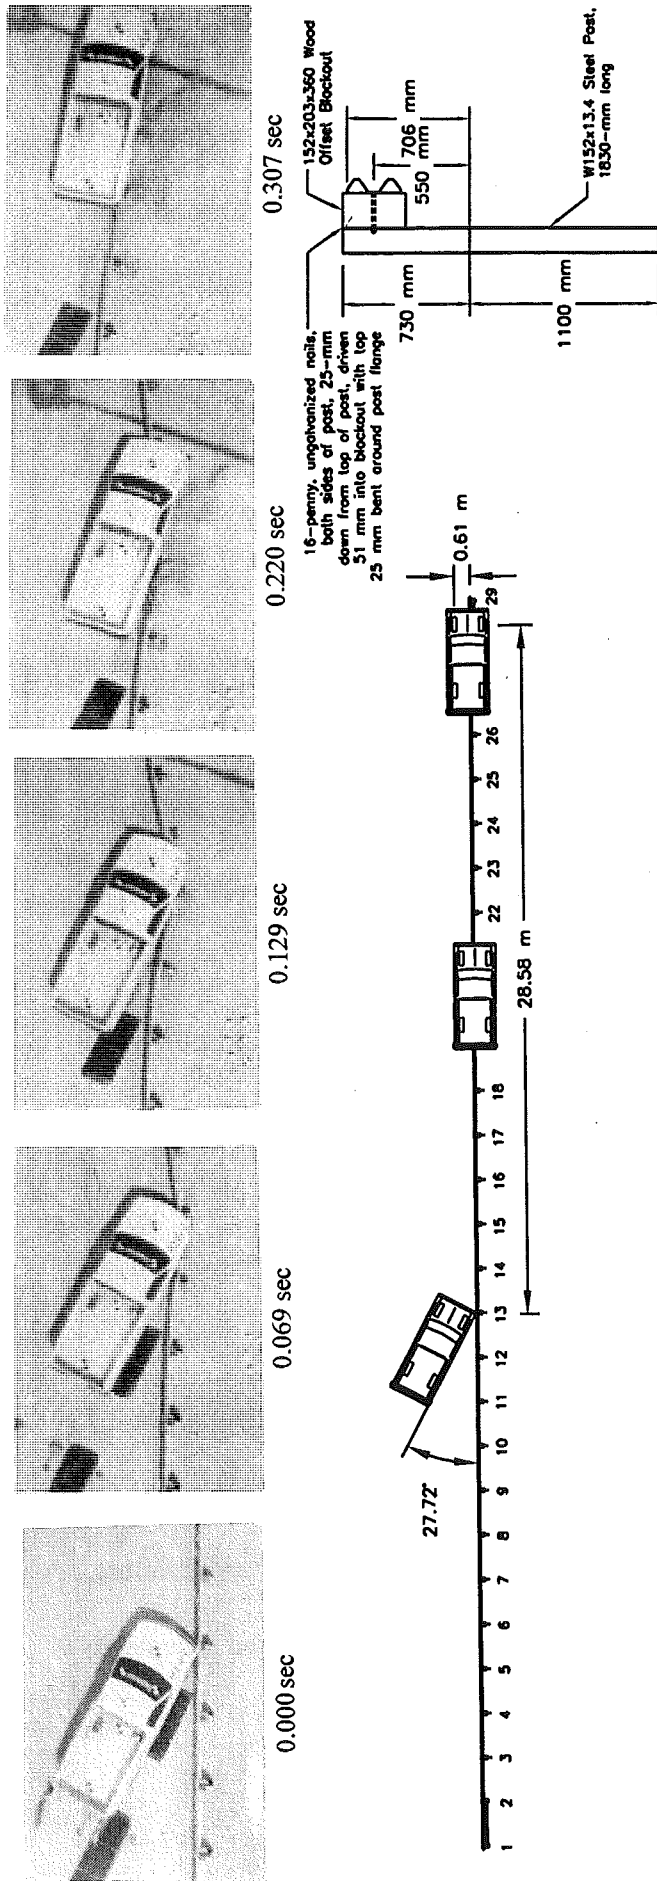
● Test Number	MIW-2	● Vehicle Angle	27.7 degrees
● Date	5/12/00	● Impact	NA
● Appurtenance	Michigan's Type B (W-beam) guardrail system	● Exit	NA
● Total Length	53.34 m	● Vehicle Snagging	Minor wheel snag on post no. 14
● Steel W-Beam (Nested)		● Vehicle Pocketing	None
Thickness	2.66 mm	● Vehicle Stability	Satisfactory
Top Mounting Height	706 mm	● Occupant Ridedown Deceleration (10 msec avg.)	9.04 < 20 G's
● Steel Posts		Longitudinal	9.94
Post Nos. 3 - 27	W152x13.4 by 1,830-mm long	Lateral (not required)	7.35 < 12 m/s
● Wood Spacer Blocks		● Occupant Impact Velocity	3.89
Post Nos. 3 - 27	152 mm x 203 mm by 360-mm long	Longitudinal	Moderate
● Soil Type	Grading B - AASHTO M 147-65 (1990)	Lateral (not required)	1-RFQ-4
● Vehicle Model	1994 GMC 2500 2WD	● Vehicle Damage	1-RFE3
Curb	2,0281 kg	● TAD ¹²	28.58 m downstream
Test Inertial	2,034 kg	● SAE ¹³	0.61 m traffic-side face
Gross Static	2,034 kg	● Vehicle Stopping Distance	Moderate

● Vehicle Speed	99.8 km/hr	● Barrier Damage	Moderate
Impact	NA	● Maximum Deflections	
Exit	NA	Dynamic - Post	772 mm
		Dynamic - Rail	1,084 mm

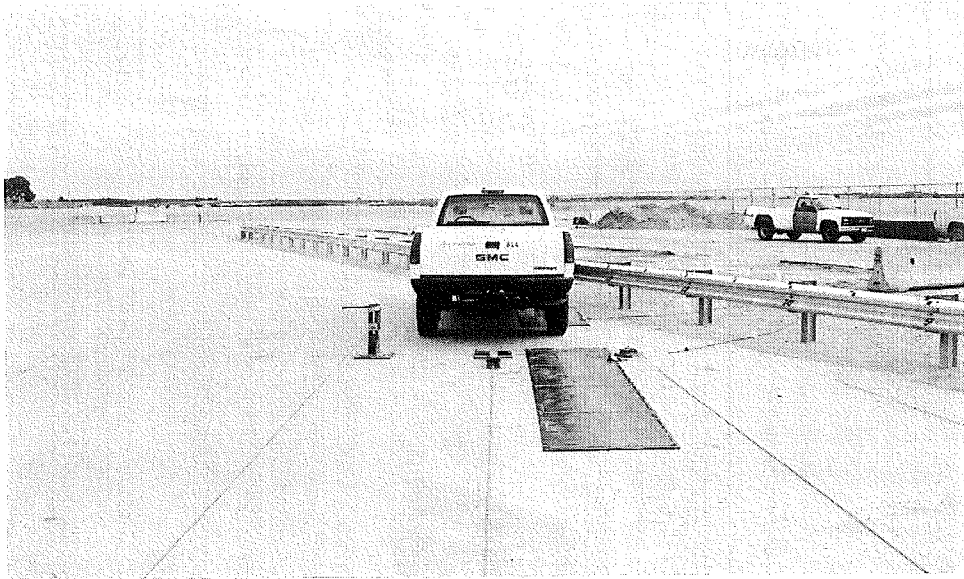
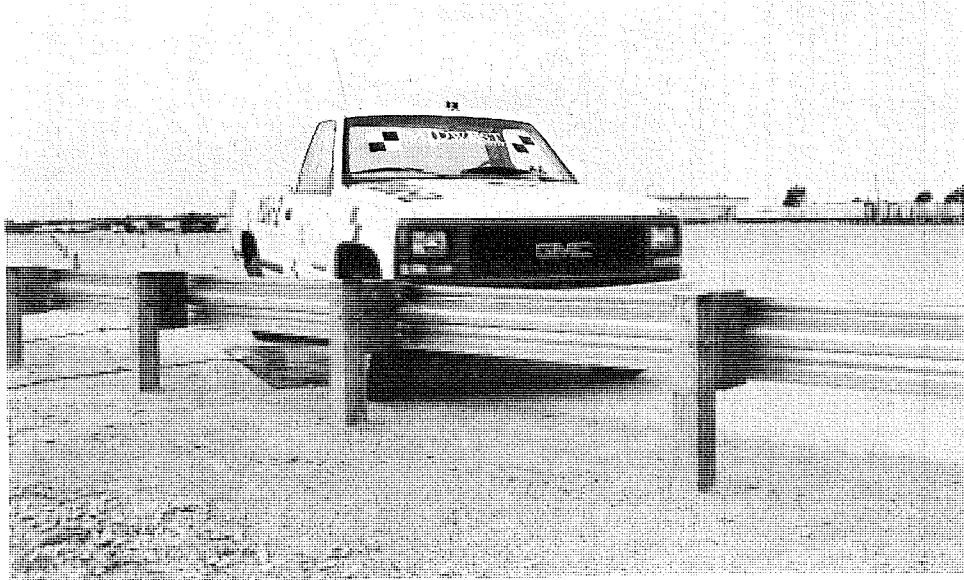
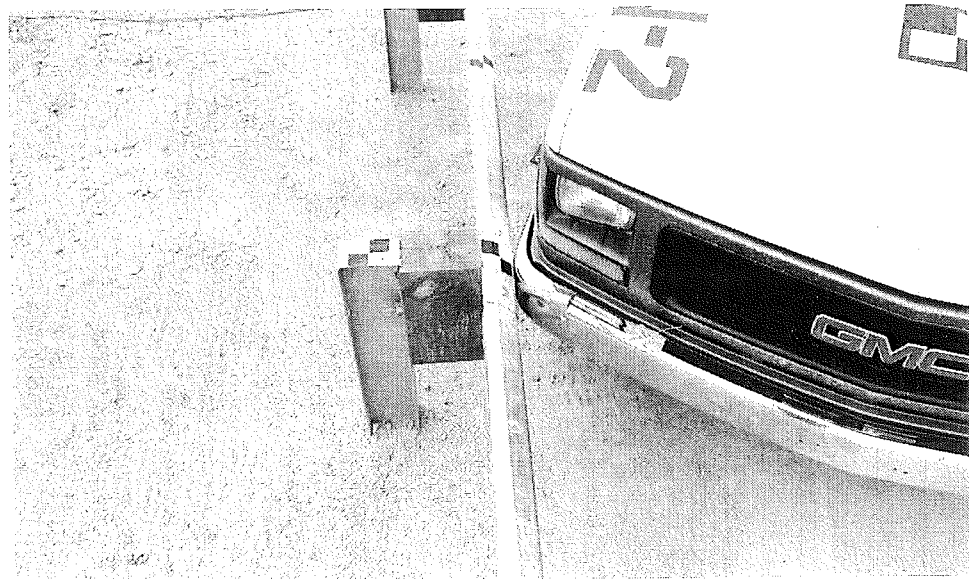
Figure 15. Impact Location, Test MIW-2

Initial impact occurred at the center of post no. 13, as shown in Figure 15. Upon impact with the guardrail, post no. 13 rotated backward. At 0.046 sec after impact, the right-front corner of the vehicle, which was at the midspan between post nos. 13 and 14, crushed inward. At 0.059 sec, post no. 14 quickly rotated backward. At 0.069 sec, the right-front corner of the vehicle continued to crush inward as post no. 13 had rotated backward to its maximum deflection. At 0.083 sec, the right-front corner of the vehicle was at post no. 14, and post no. 15 began to show movement. At 0.129 sec, the right-front corner of the vehicle was at the midspan between post nos. 14 and 15. At this same time, post no. 14 reached its maximum deflection as the truck began to redirect. At 0.134 sec, the guardrail released from post no. 14. At 0.158 sec, the front bumper rose above the top of the rail. At 0.192 sec, the right-front tire impacted post no. 15 and was deflated. At this same time, the front end of the vehicle began to pitch upward and the left-front tire was airborne. At 0.220 sec, the front of the vehicle was at post no. 16. At 0.307 sec, the front of the vehicle was at post no. 17, and the rear bumper contacted the rail. At 0.383 sec, the right-rear tire impacted post no. 15 and was deflated. At 0.432 sec, the right-rear tire, which had been riding along the traffic-side face of the rail, lost contact and was located on the back side of the rail. At 0.44 sec, the vehicle reached its
