Improved Performance of JPCP Overlays

Final Report

July 2013

A joint UM-MDOT forensic investigation was initiated in 2009 with the major objective to determine the causes of poor performance of some of Michigan's concrete overlays. The major areas of concern included longitudinal cracking starting year one (I-75, West Branch), in the undoweled test sections, and rapid distress development in some recent projects. To accomplish the objectives from a forensic investigation, eight projects were selected based on age and varying performance levels (good to poor). Finite element modeling was used to understand the longitudinal cracking phenomenon found in the I-75 NB, West Branch project, and hot weather construction related early cracking that developed in another project (US-131, Kalamazoo). Laboratory testing was undertaken to assess the frost durability resistance in one project (US-131, Rockford), which had

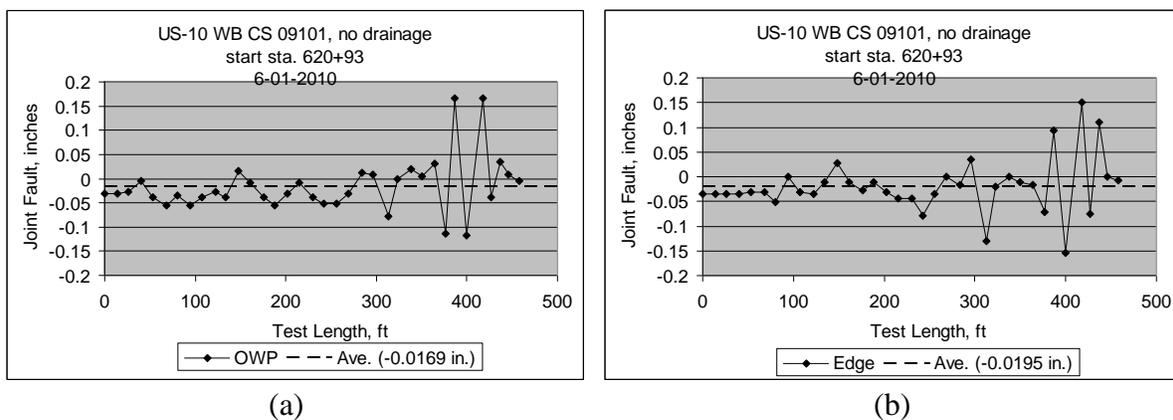
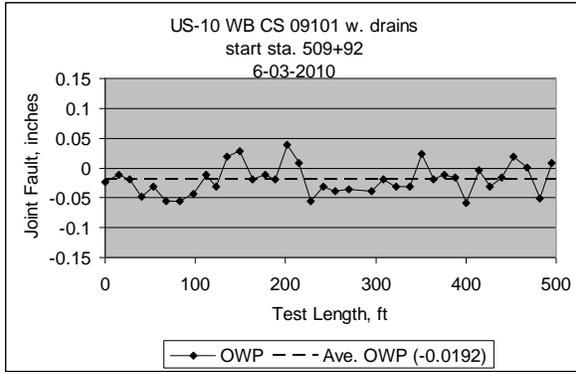
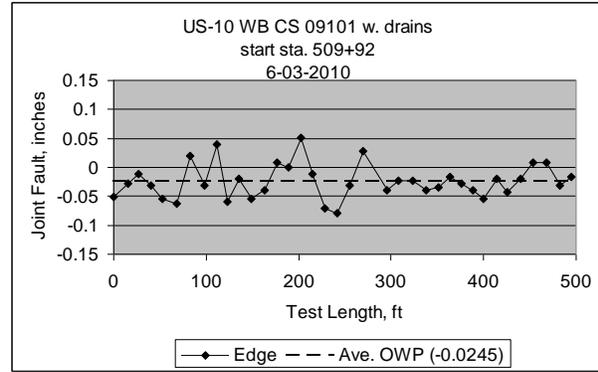
The main purpose of field work on WB US-10 was to evaluate whether any differences in distress (joint faulting and slab cracking) had developed between test sections with and without a drainage system. No major differences could be determined since both test sections have developed extensive pumping related cracking and similar joint faulting values (Figure 3.6). These results are consistent with field coring showing erosion of HMA separator layer, and the examination of drain outlets, which showed that they were clogged and ineffective.

Figure 3.6 (a-d). Joint fault values for US-10 WB test sections with and without drainage systems.

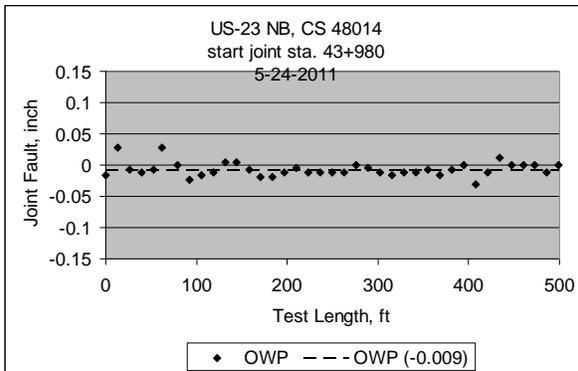
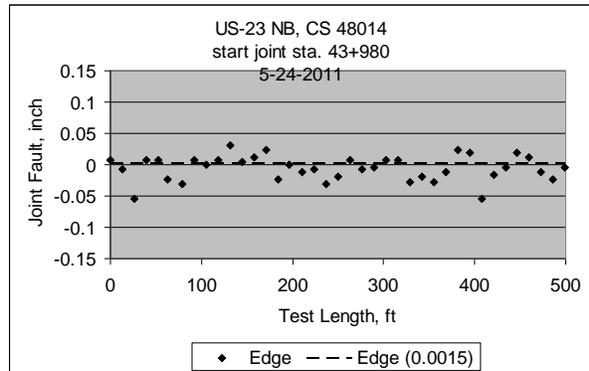
It is significant that one of the older projects from 1999 (US-23 NB, Northern Livingston Co.) has developed no slab cracking at the time of the field investigation (May, 2011) in the entire NB direction. Average joint faulting for the 500 ft test section was found to be insignificant (Figure 3.7) in both the outer wheel-path (OWP) and transverse joint edge. Thus, it is concluded that pumping is insignificant even though the drainage system was found to be capped (Figure 3.1).

Figure 3.7 (a-b). US-23 NB, Northern Livingston Co., joint fault results.

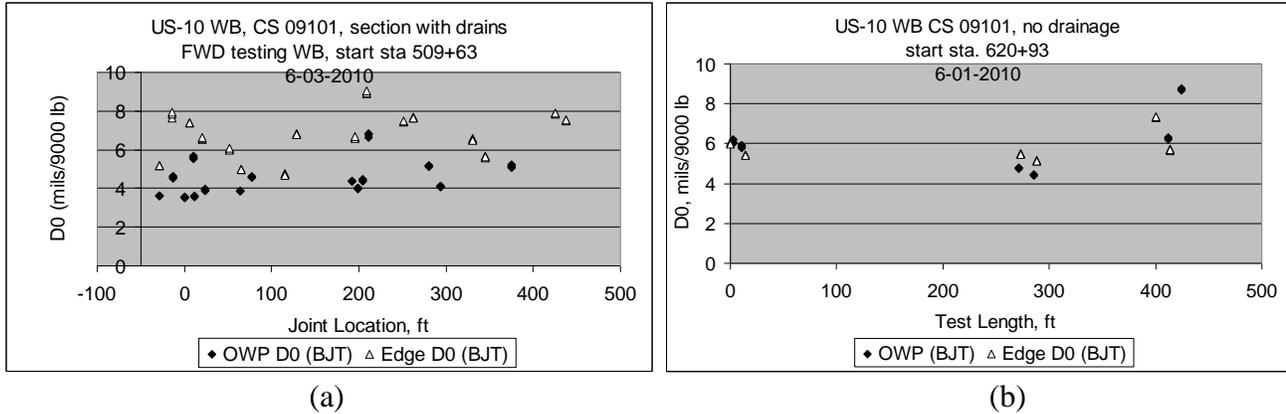
Due to pumping effects in the WB US-10 joint edge deflections from FWD testing (Table 3.1) are higher as compared to a project where pumping is not a factor (e.g. NB US-23 project). (Figures 3.8 and 3.9, and Table 3.1).

Figure 3.8 (a-b). Falling Weight Deflectometer (FWD) joint deflection values for the WB US-10 overlay.

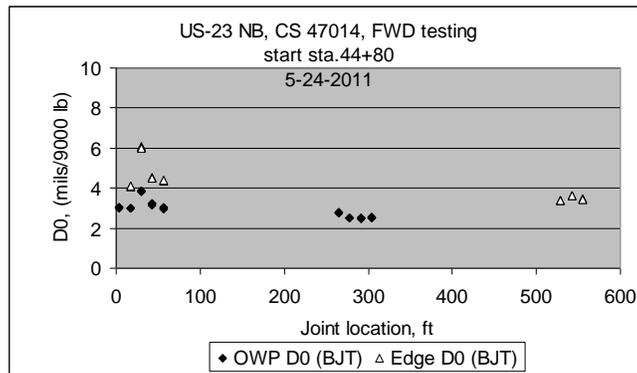
Figure 3.9. FWD joint deflection for the US-23 NB overlay.

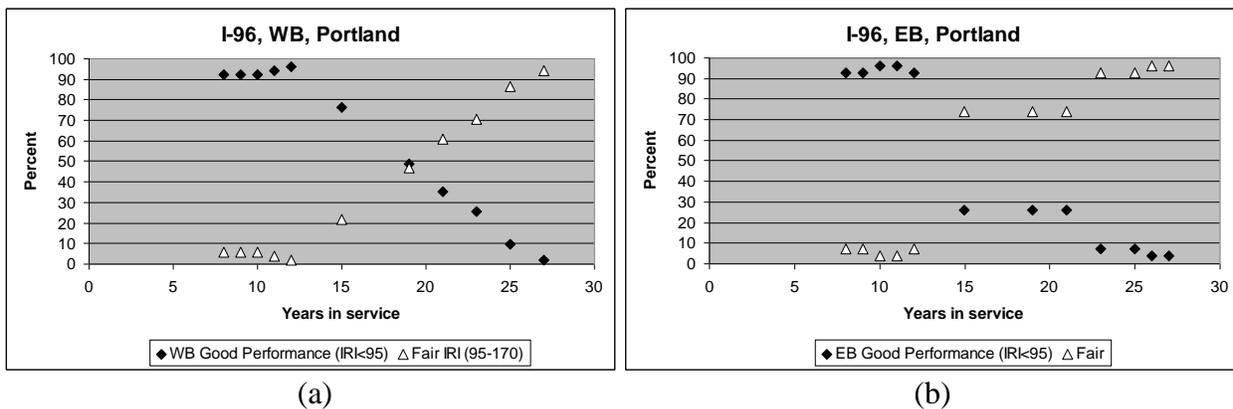
The percentage of IRI values for each traffic direction rated good is decreasing over time once structural level distresses develop, while the percentage of IRI values rated fair is increasing. This is illustrated for the oldest in-service overlay project (I-96, Portland) in Figure 3.14. Initially, pumping is localized and no structural level distress is developing. At some point, in this case after about 12 years, structural level distress is developing which can be seen from a decrease in percent of good IRI 0.1 mile segments at the expense of a rise in percent fair IRI values. For this project, preventive maintenance, PM, occurred in 2005 (i.e. year 21) and again in 2012 (year 28).

Figure 3.14 (a-b). Development of percent IRI of total project IRI in the Good and Fair ranges over time for the I-96, Portland JRCP overlay.

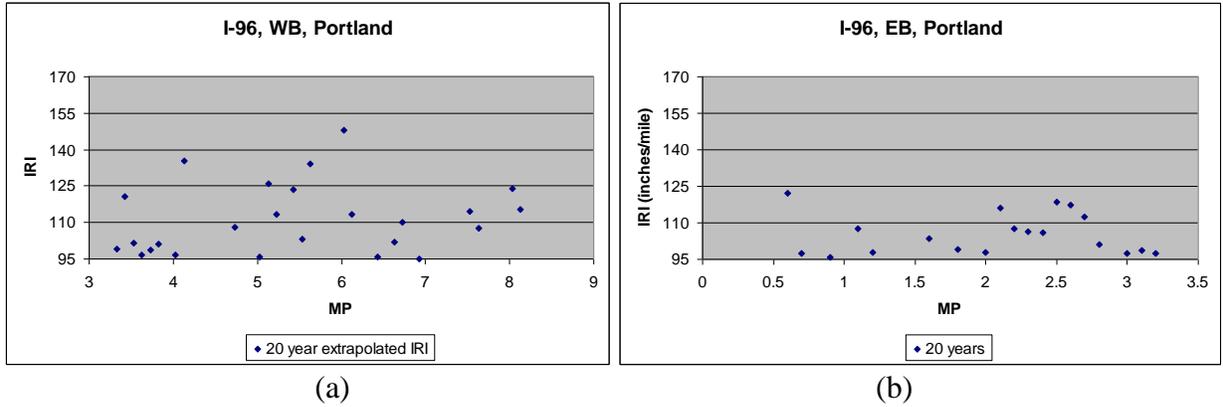
Individual IRI results (/0.1 mile) versus milepoint (MP) further show that distress development is location specific, likely the result of varying localized drainage quality. Figure 3.15 illustrates only IRI values in the fair category for WB and EB directions. These results identify “hot spots” (i.e. locations by MP where PM is most needed) with localized high IRI values. After 20-years (i.e. design life), about 50% of IRI values are now in the fair category. Again, in year 28 (2012) joint repairs were undertaken (Figure 3.16).

Figure 3.15 (a-b). Localized distress “hot spots” (IRI>110) in WB (a) and EB (b) directions.

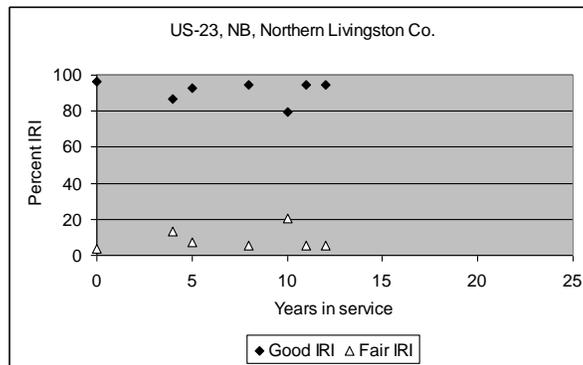
The US-23, NB, project has not developed any pavement distress by year 12 (2011) consistent with IRI plot in Figure 3.17.

Figure 3.17. Good performance is found for US-23, NB, Northern Livingston Co. overlay project in year 12 (2011).

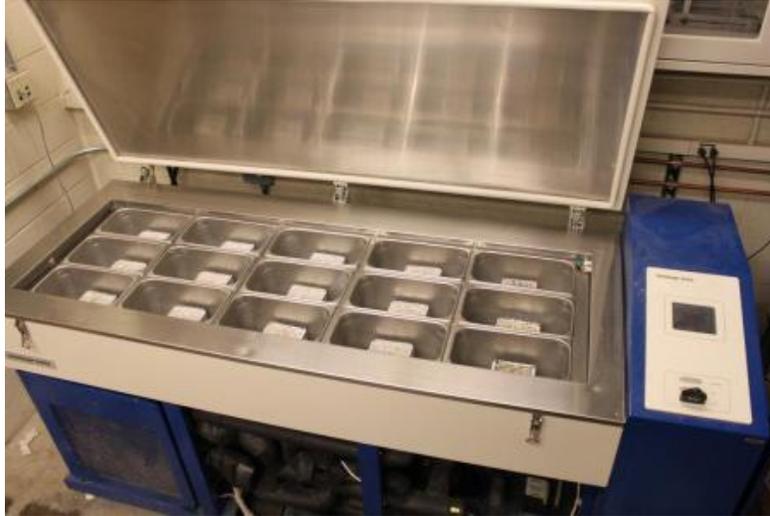
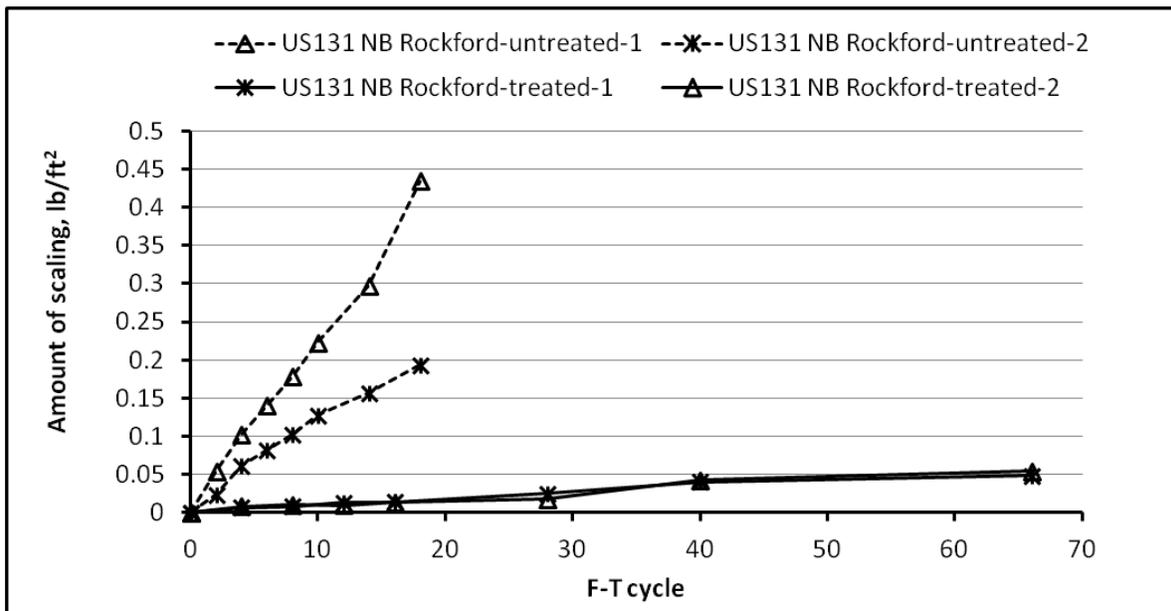
Laboratory salt scaling test results verified poor resistance to a 3% NaCl solution (Figure 3.18 a and b) for the US-131, Rockford, concrete. Mitigation by means of a surface treatment with a silane liquid was investigated for this concrete. The surface of two cut field samples were pre-dried followed by re-saturation to a saturated surface dry condition and air-dried at room temperature for about 3 hours before surface treatment. The silane treated specimens were cured for one week at room temperature and then subjected to freeze-thaw testing using German test procedure (RILEM TC-117). This test consisted of exposing the silane treated surface to a 3% salt solution during a freeze-thaw cycle. The surface scaling was reduced substantially (Figure 3.18 b). A comparison of the untreated surface before and after 22 freeze-thaw cycles illustrates that salt scaling deterioration is occurring within the paste (Figure 3.19 a and b), and that a silane surface treatment is effective (Figure 3.19 c) in reducing salt scaling of concrete with low air content for at least 66 freeze-thaw cycles in the laboratory.

Figure 3.18 (a- b). Salt scaling test equipment (a) and results (b).

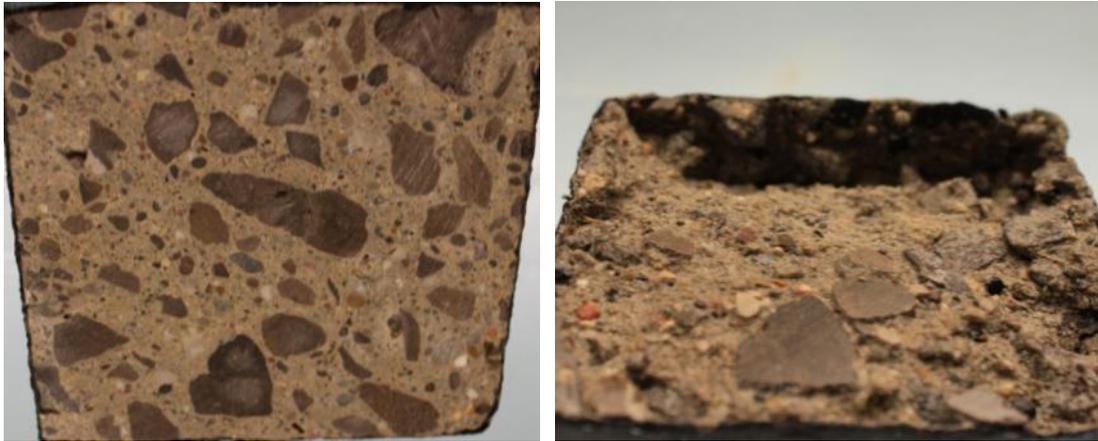
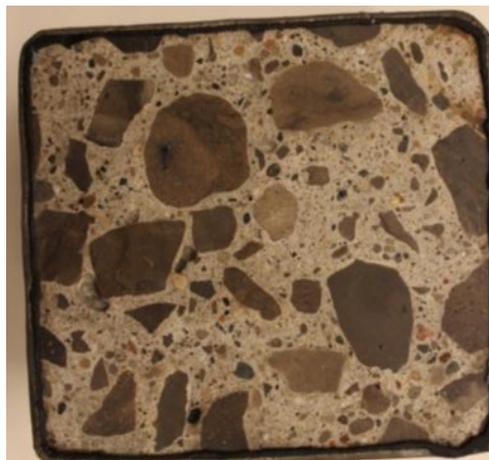
Figure 3.19 (a-c). Specimen surface before test (a) following 22 freeze-thaw cycles of untreated surface (b) and after 28 freeze-thaw cycles of treated surface (c).

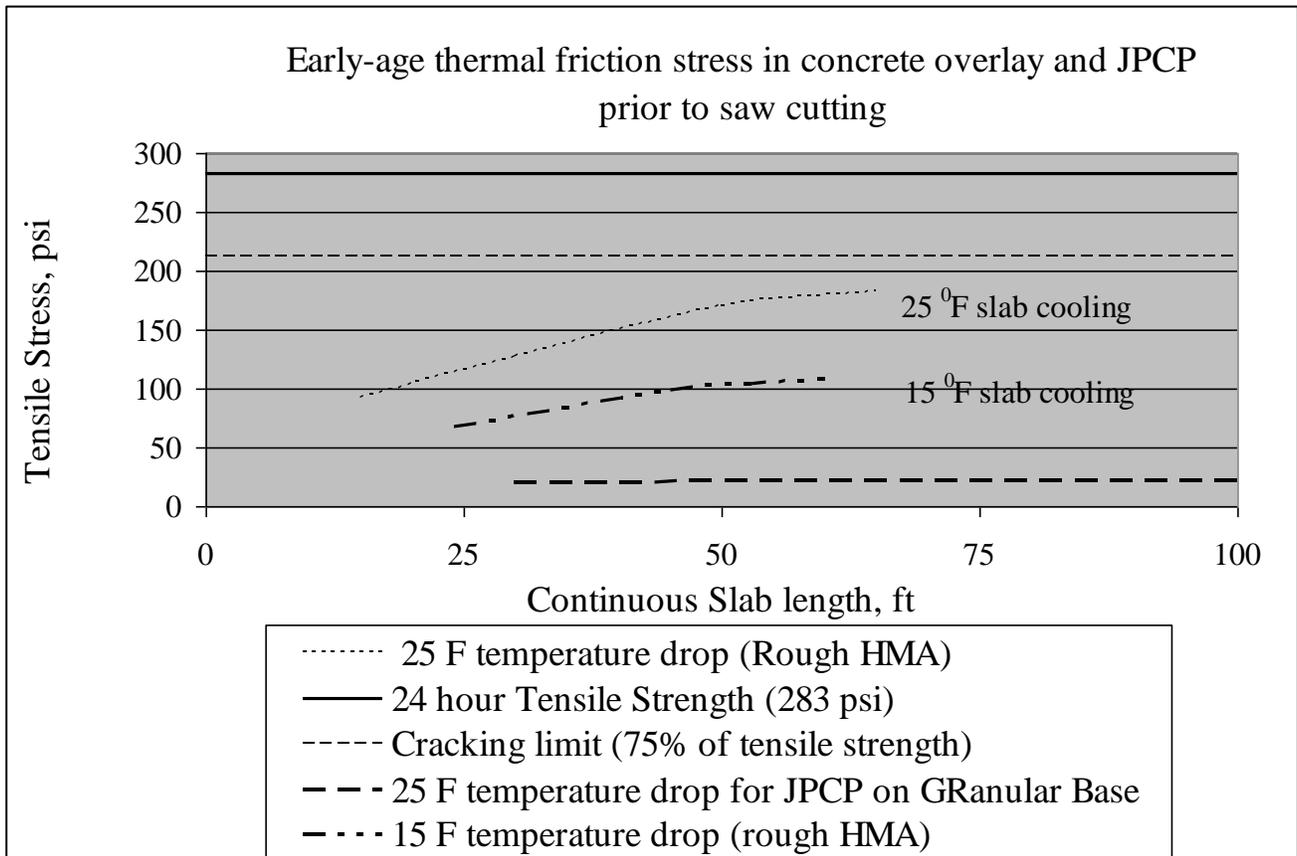
slip for the elastic range. The critical slip value of 0.0098 inches marks the transition from elastic behavior to a fully plastic behavior (i.e. sliding friction). During cooling the slab-base stress was analyzed for a temperature drop of 15 °F and 25 °F for increasing continuous slab length in order to simulate a pre-saw cut condition. A rough HMA interface produces significant tensile stress at the slab bottom as seen from the simulations in Figure 3.20.

Figure 3.20. EverFE tensile stress predictions at bottom of overlay concrete for increasing continuous slab length due to friction forces between the concrete and the HMA interlayer.

A 24-hour tensile strength of 283 psi was calculated from compression tests on laboratory concrete containing same mix proportion as the US-131, Kalamazoo, concrete. These simulations support practical observations that joint sawing in unbonded concrete overlays should be undertaken as soon as possible due to the stiffer base condition (Harrington et al., 2008). The same simulations were run for a JPCP over a granular base with recommended shear-slip constants ($k=0.099\text{ksi/inch}$; slip limit=0.02 inches). Friction-based slab stresses were small for this case.

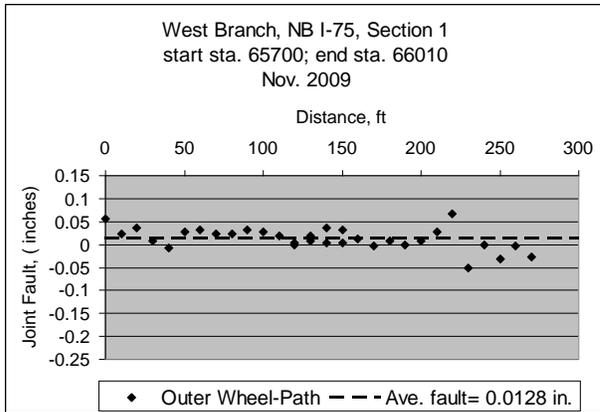
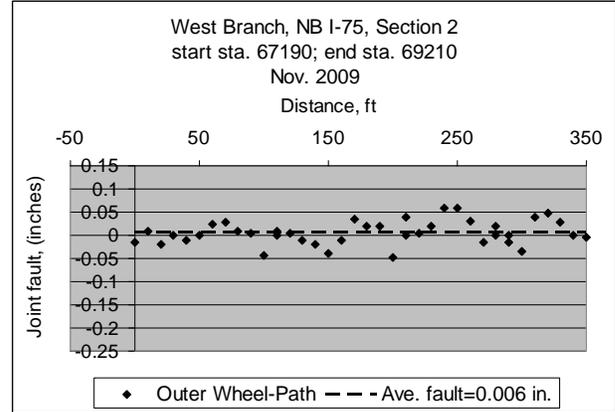
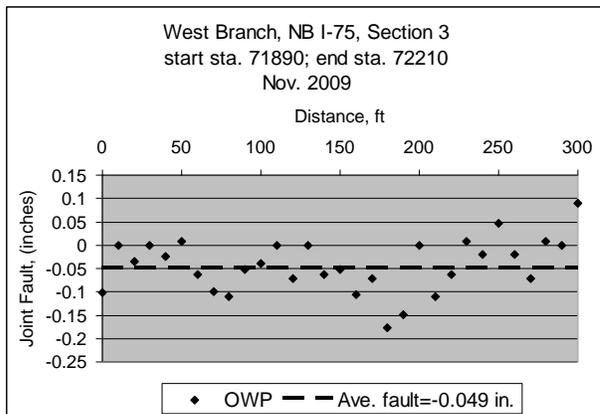
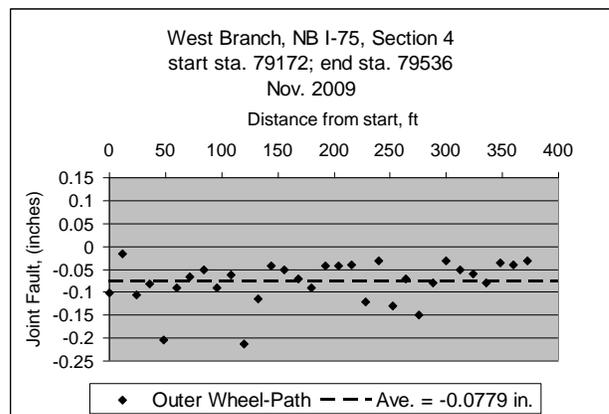
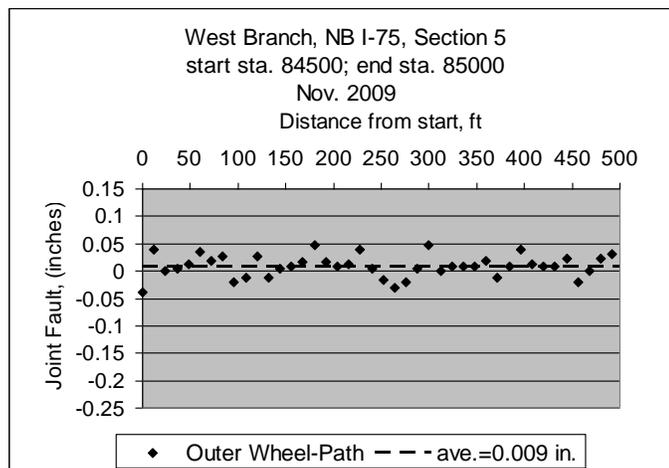
Figure A7 (a-e). Joint fault results in the outer wheel-path for Sections 1-5 in Year 6 (November 2009).

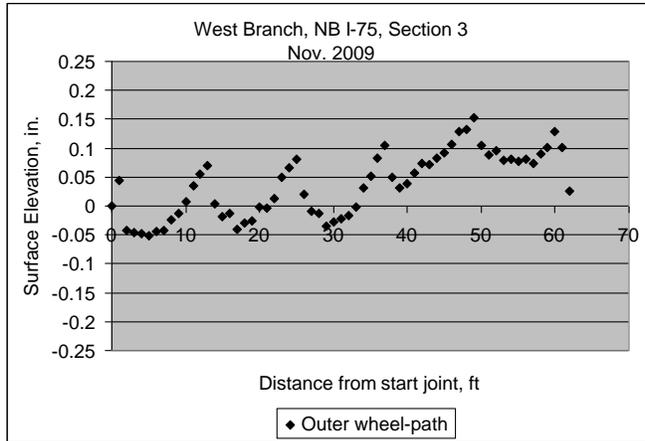
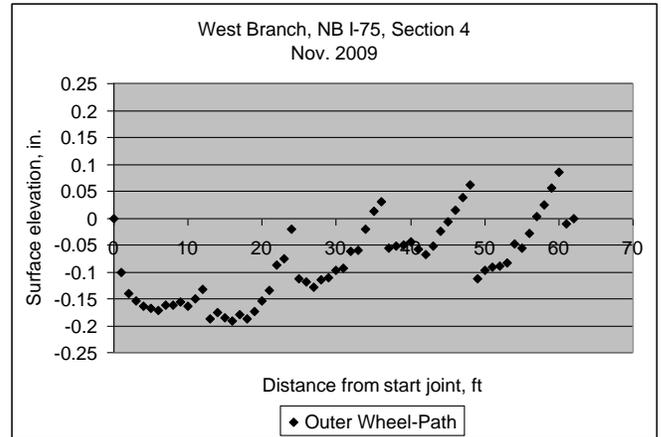
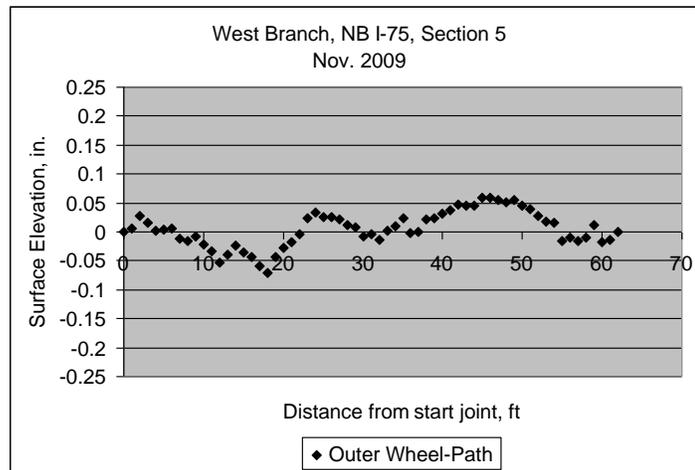
questionable, and therefore, joint-load transfer calculations are not realistic. Therefore, the average deflection values (mils/9,000 lbf) are presented in Table 3.1 (Chapter 3) for the D0 values, deflection underneath the load-plate, for loading before the joint (BJT) and after the joint (AJT). These tests were conducted on three slabs within each test section that had no visible cracking. The outer corner D0 values BJT and AJT are slightly larger in sections 3, 4 and 5 as compared to sections 1 and 2, where moisture entrapment along outer corners is less. This suggests that erosion is happening. Surface elevation profiles for 5 consecutive slabs illustrate that slab joint faulting and slab rotation from pumping is reduced in the doweled section (Figure A9 (a-c)).

Figure A9 (a-c). Dipstick surface profiles for 5 consecutive slabs in November 2009.

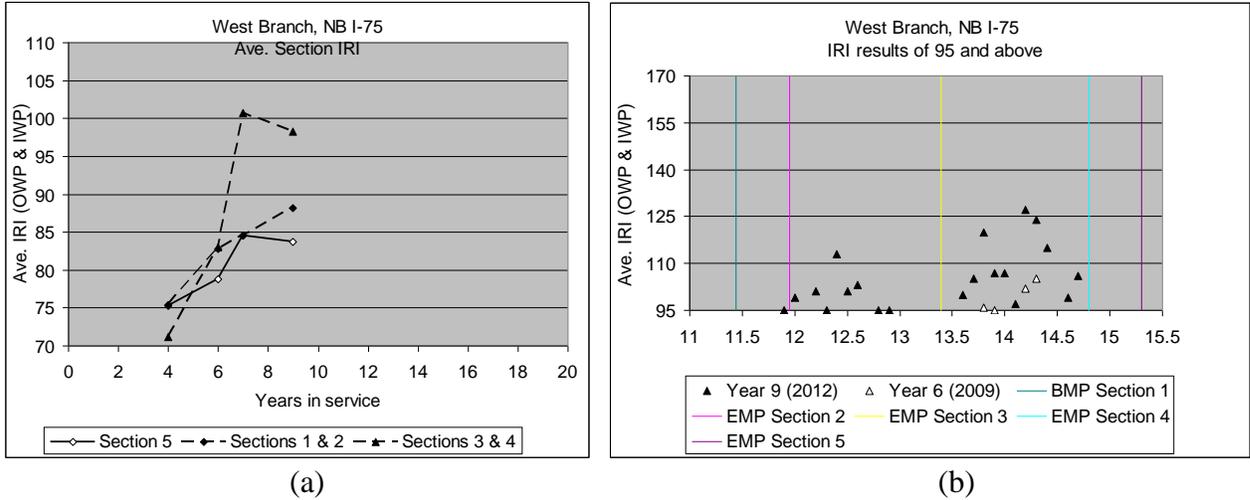
Pavement roughness increase over time, as measured by the International Roughness Index, IRI, has been correlated empirically to pumping related distress in JPCP pavements (NCHRP 1-37a). Thus, IRI increase over time was found to be a good measure of distress development. MDOT's Pavement Management System, PMS, database provides IRI values for every tenth mile along the outer and inner wheel-paths. The results in figure A10a show a rapid increase in yearly average section IRI for sections 3 and 4, while increase in pavement roughness is lower for the sections with less pumping. Individual IRI results in the fair range (95-170) are good indicators of locations where pumping is most severe (Figure A10b).

Figure A10 (a-b). IRI results for West Branch, NB I-75.

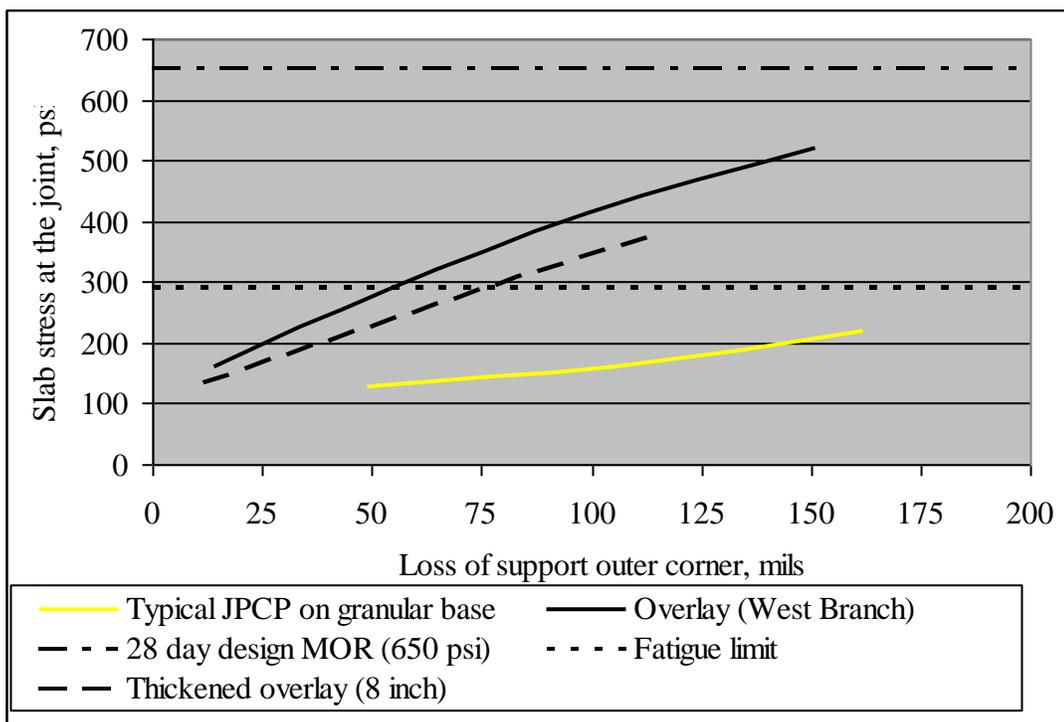
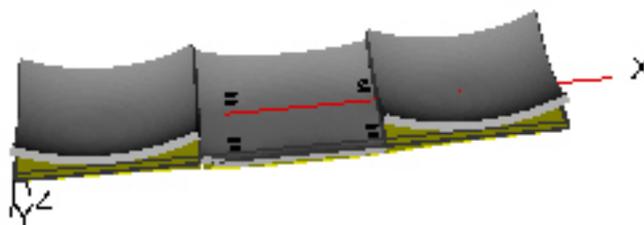
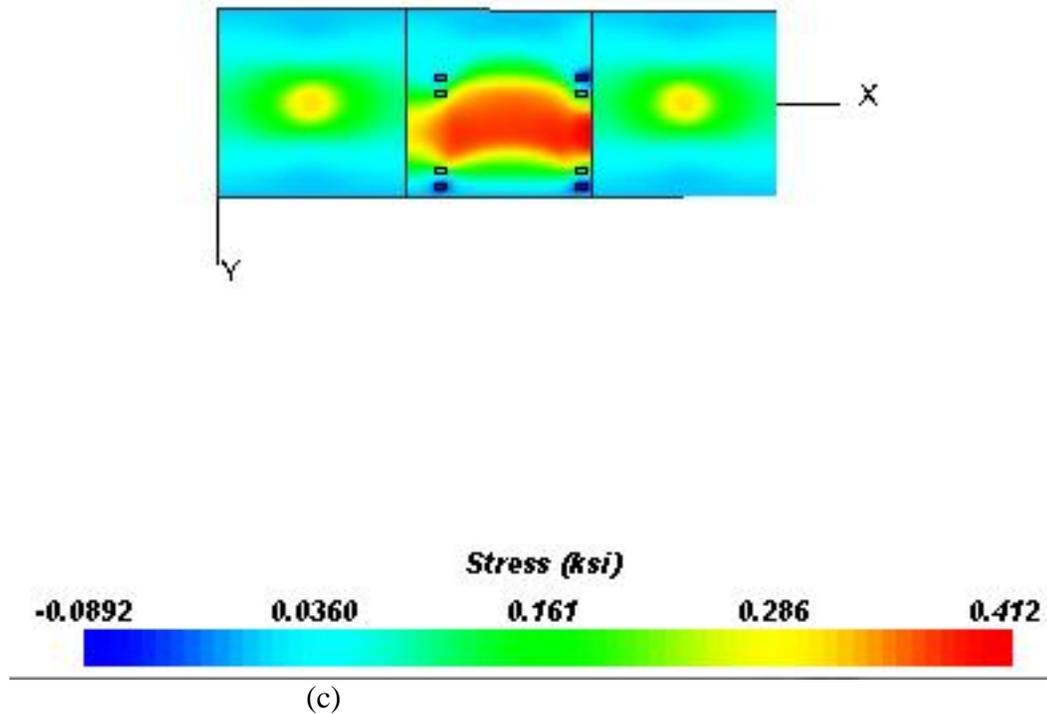
Longitudinal slab stresses at the transverse joint are much more sensitive to loss of joint support in an overlay than in a JPCP on OGDC as seen from stress simulations (figure A13a) as they quickly reach the fatigue region (above 300 psi in flexure stress) for a typical 28-day design strength (650 psi). Slab stresses at the joint are maximum at the slab top surface. A typical stress contour plot (figure A13c) illustrates that slab stresses are maximum at the joint between the two axle-wheels in the y-direction (i.e. parallel to the transverse joint). Increasing slab thickness from the current 6 inches to 8 inches has only minor effect. It is not practical to counteract loss of slab support by increasing slab thickness.

Figure A13 (a-c). EverFE slab stress predictions for top surface at transverse joints versus increasing loss of joint support at outer corners (a); slab deflections (b) and contour plot (c) for the 6 inch un-bonded overlay for a joint corner gap of 100 mils prior to loading.
