PERFORMANCE EVALUATION OF AN
EXPERIMENTAL SLURRY SEAL EMULSION AS FILLER
OF DETERIORATED LONGITUDINAL JOINTS IN
CONCRETE PAVEMENT BEING PREPARED
FOR ASPHALTIC CONCRETE RESURFACING

Research Laboratory Section
Testing and Research Division
Research Project 78 TI-467
Research Report No. R-1237

Michigan Transportation Commission
William C. Marshall, Chairman;
Lawrence C. Patrick, Jr., Vice-Chairman;
Hannes Meyers, Jr., Carl V. Pellonpaa,
Weston E. Vivian, Rodger D. Young
James P. Pitz, Director
Lansing, October 1983

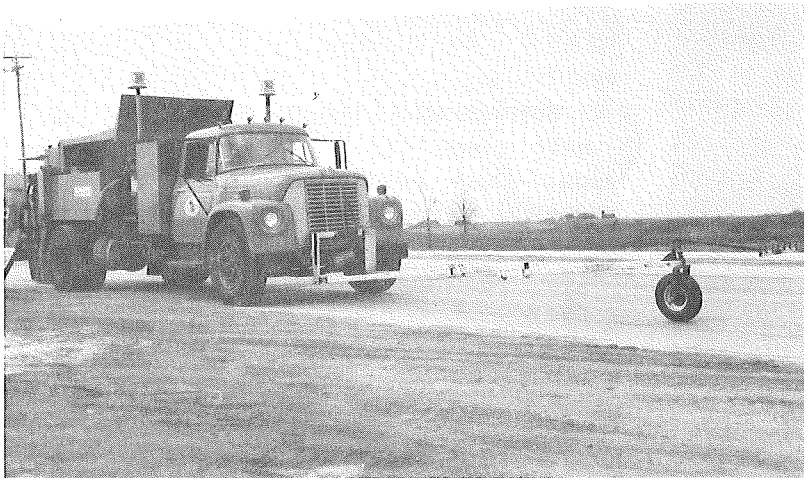
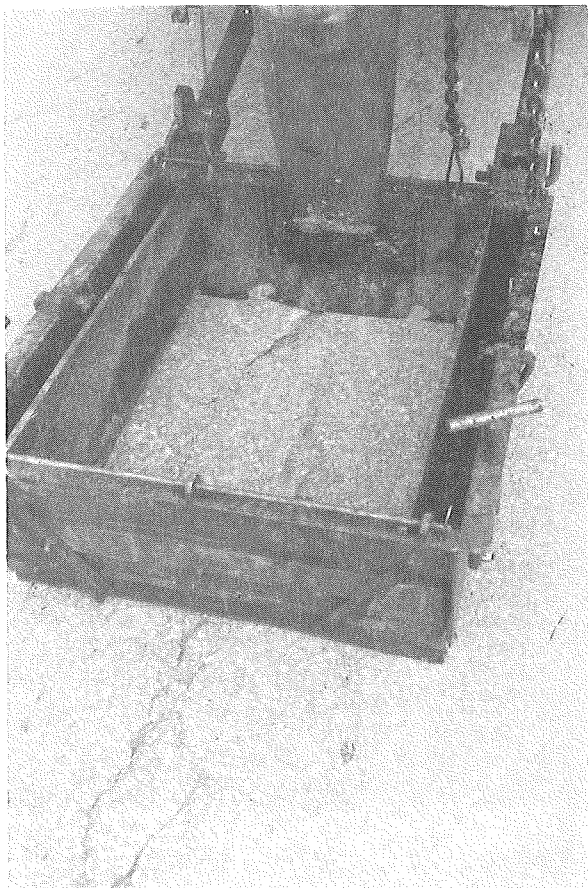
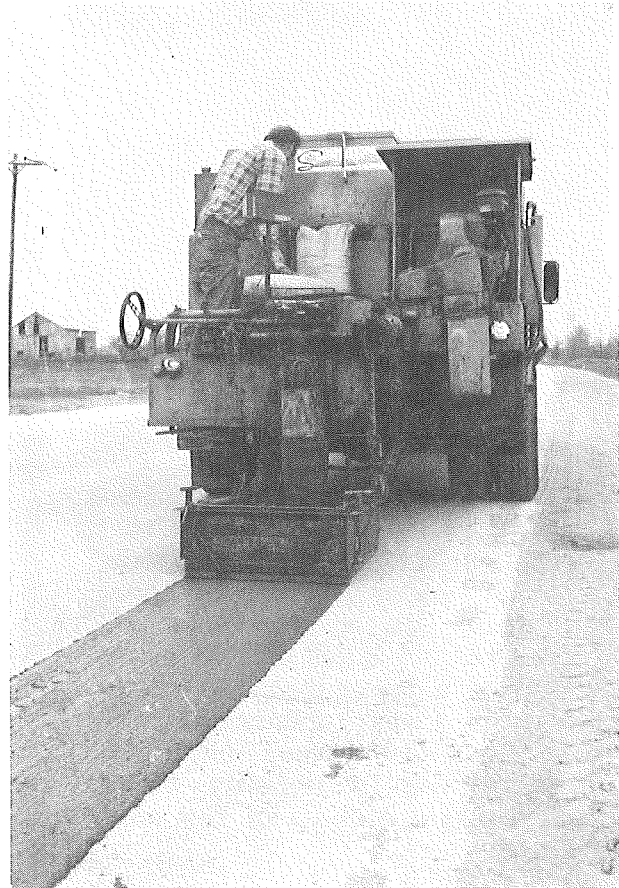
Figure 6. Truck-mounted slurry seal equipment applying sealant to a longitudinal joint under study.

◀ The slurry seal equipment mounted on a truck included materials storage, a mixer, and a spreader section. For better control of lateral spreading operation a bogie wheel was attached to the truck front.

Spreading cold slurry seal over a longitudinal joint. The machine moving at 2 miles/hr deposited a slurry strip, 32-in. wide and 1/2-in. thick. ▶

◀ The spreader box and a squeegee deposited the slurry seal in controlled amounts.

Before the slurry seal was applied, the test strip area was cleaned out with compressed air, blowing out dust, dirt, and loose aggregate from deteriorated joints and cracks. The slurry seal equipment used in the project was a travel blending unit, truck mounted, with a towed spreader-box attached (Fig. 6). All the slurry ingredients were proportioned, mixed while the truck is running and applied without heat, to longitudinal joints and surface cracks within each test strip. A single bogie wheel extending from the truck front aided the slurry operator in keeping the spreader box in the desired lateral position during the filling operation. All the aggregate material and asphalt emulsion used in the slurry mixture were stored at an accessible location about two miles from the project site. The slurry machine carried enough mix material to last about an hour, after which it took about half an hour for the reloading round trip. Under sunny weather and air and pavement temperatures over 60 F, the slurry machine, in a single pass, covered three miles of test strips the same day at an application rate averaging 8 lb/sq yd. Figure 7 shows a typical 'before and after' slurry filling operation.
