EVALUATION OF THE LATERAL STABILITY OF  
POSTS FOR DEEP BEAM GUARD RAIL

Highway Research Project  
55 F-39

Research Laboratory  
Testing and Research Division  
Report No. 230  
June 23, 1955

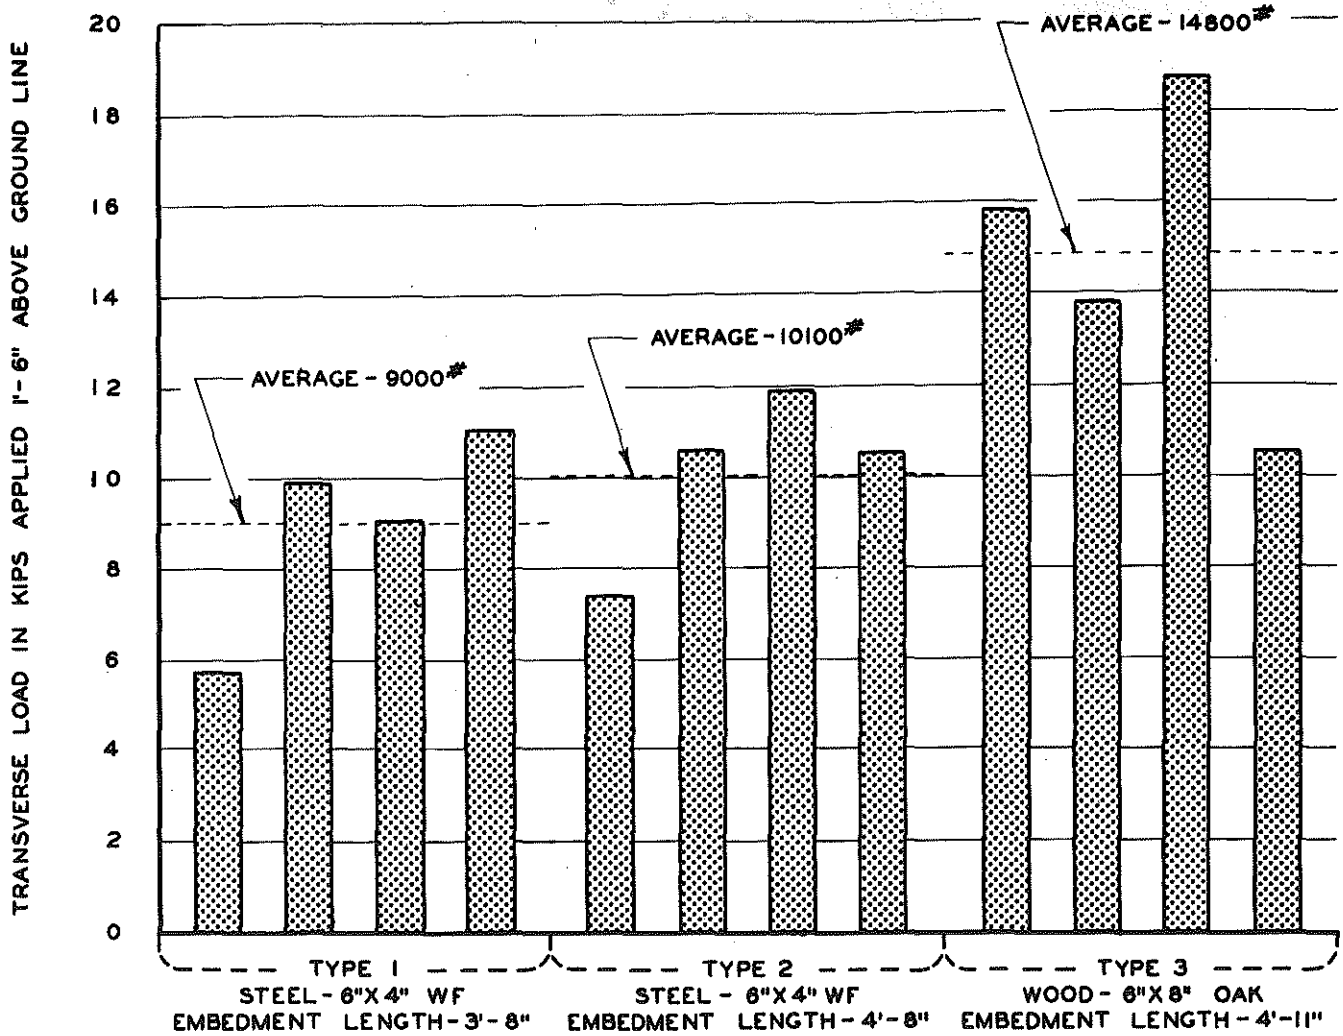
The results of the test indicate the average transverse load resistance of the oak sections to be 46 percent greater than that of the long steel sections, and 64 percent greater than that of the short steel sections. The average transverse load resistance of the long steel sections was 12 percent greater than that of the short steel sections. However, due to the heterogeneous nature of the soil at the test site, these figures are not to be construed as absolute values. They indicate only comparative results for the particular soil condition encountered.

▲ FIGURE 1  
 MAXIMUM TRANSVERSE LOADS FOR EACH OF THE THREE TYPES OF GUARD POSTS. (GRADUALLY APPLIED LOADS)

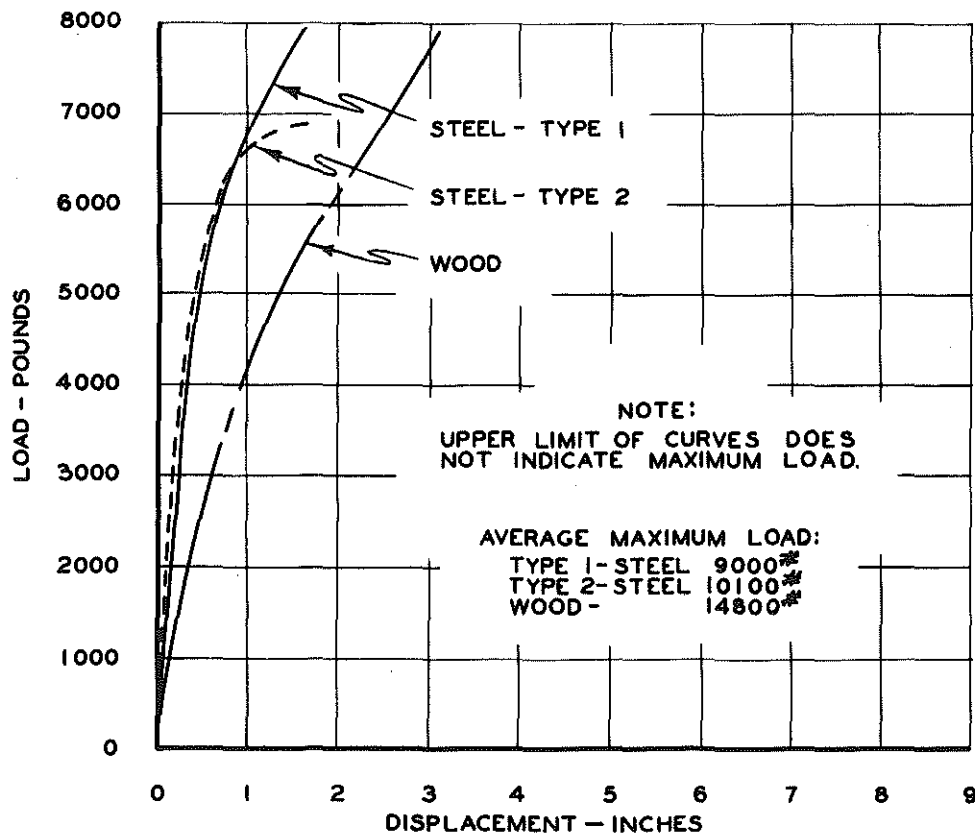
▲ FIGURE 2  
 AVERAGE DISPLACEMENT OF EACH OF THE THREE TYPES OF GUARD POST.
