MONITORING MOVEMENT OF THE ZILWAUKEE BRIDGE

JANUARY 1985

Research Laboratory Section
Testing and Research Division
Research Project No. 82 TI-849
Research Report No. R-1250

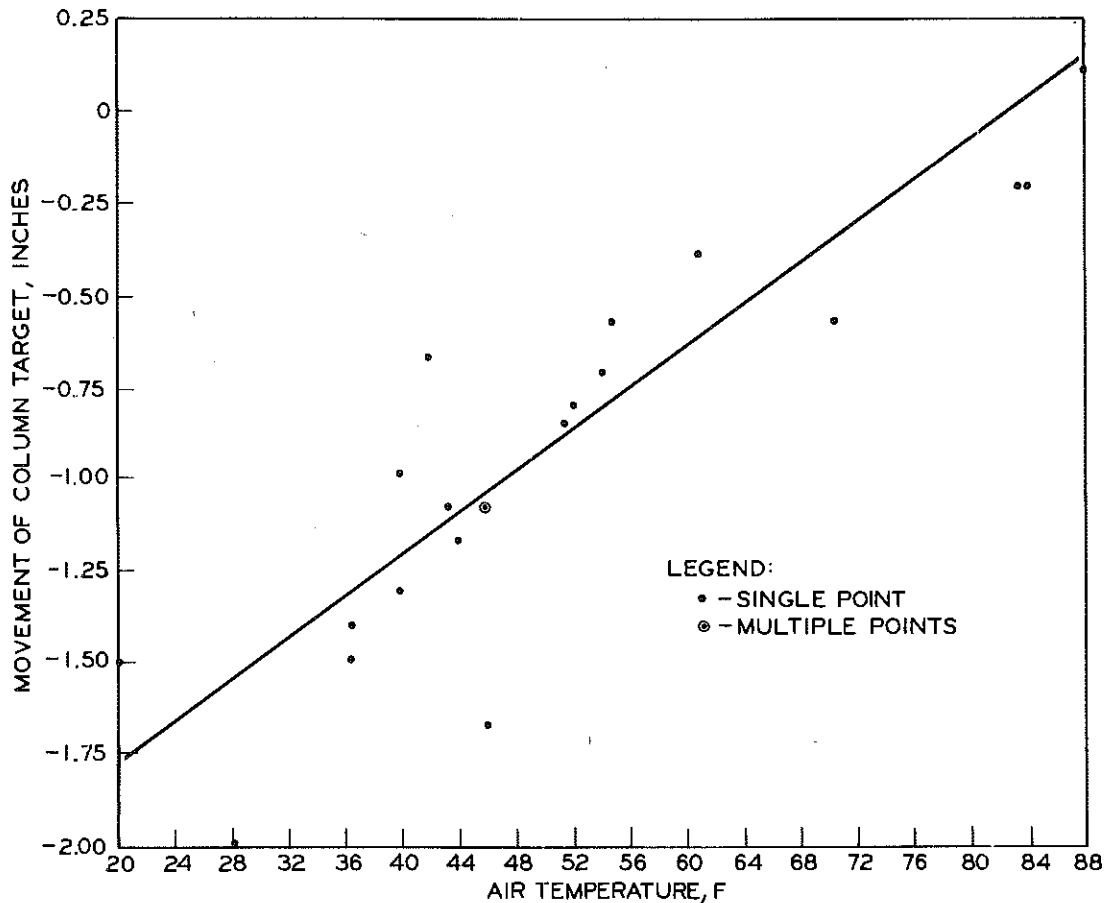
Reference points were set vertically at 10-ft intervals on the side of the column, so that displacement of those points could be read with the theodolite (see page 59 of Appendix B). Readings were taken at least daily--and usually more frequently--during the week of September 13, and approximately once a week for the remainder of Phase I. These measurements were among the most useful of all the readings taken on the structure. It was found that column movement varied directly with temperature of the superstructure. The top target movement ranged from -2.00 in. (toward the river) at 20 F to +0.22 in. (away from the river) at 87 F. Note that the column top was shifted approximately 8 in. towards the river when the instrumentation was installed. This meant the column moved toward the river during contraction of the superstructure, and away from the river as temperatures rose and the bridge expanded. The straight line relationship of temperature to target reading is shown in Figure 14.

Further, all of the remaining targets showed a movement with temperature in such fashion that the data points could be represented by a straight line, indicating that the column was not bending significantly as it moved. It also appeared that the effective point of rotation was located about 17 ft below the top of the damaged footing.

Figure 14. Linear relationship of column target readings to air temperature.

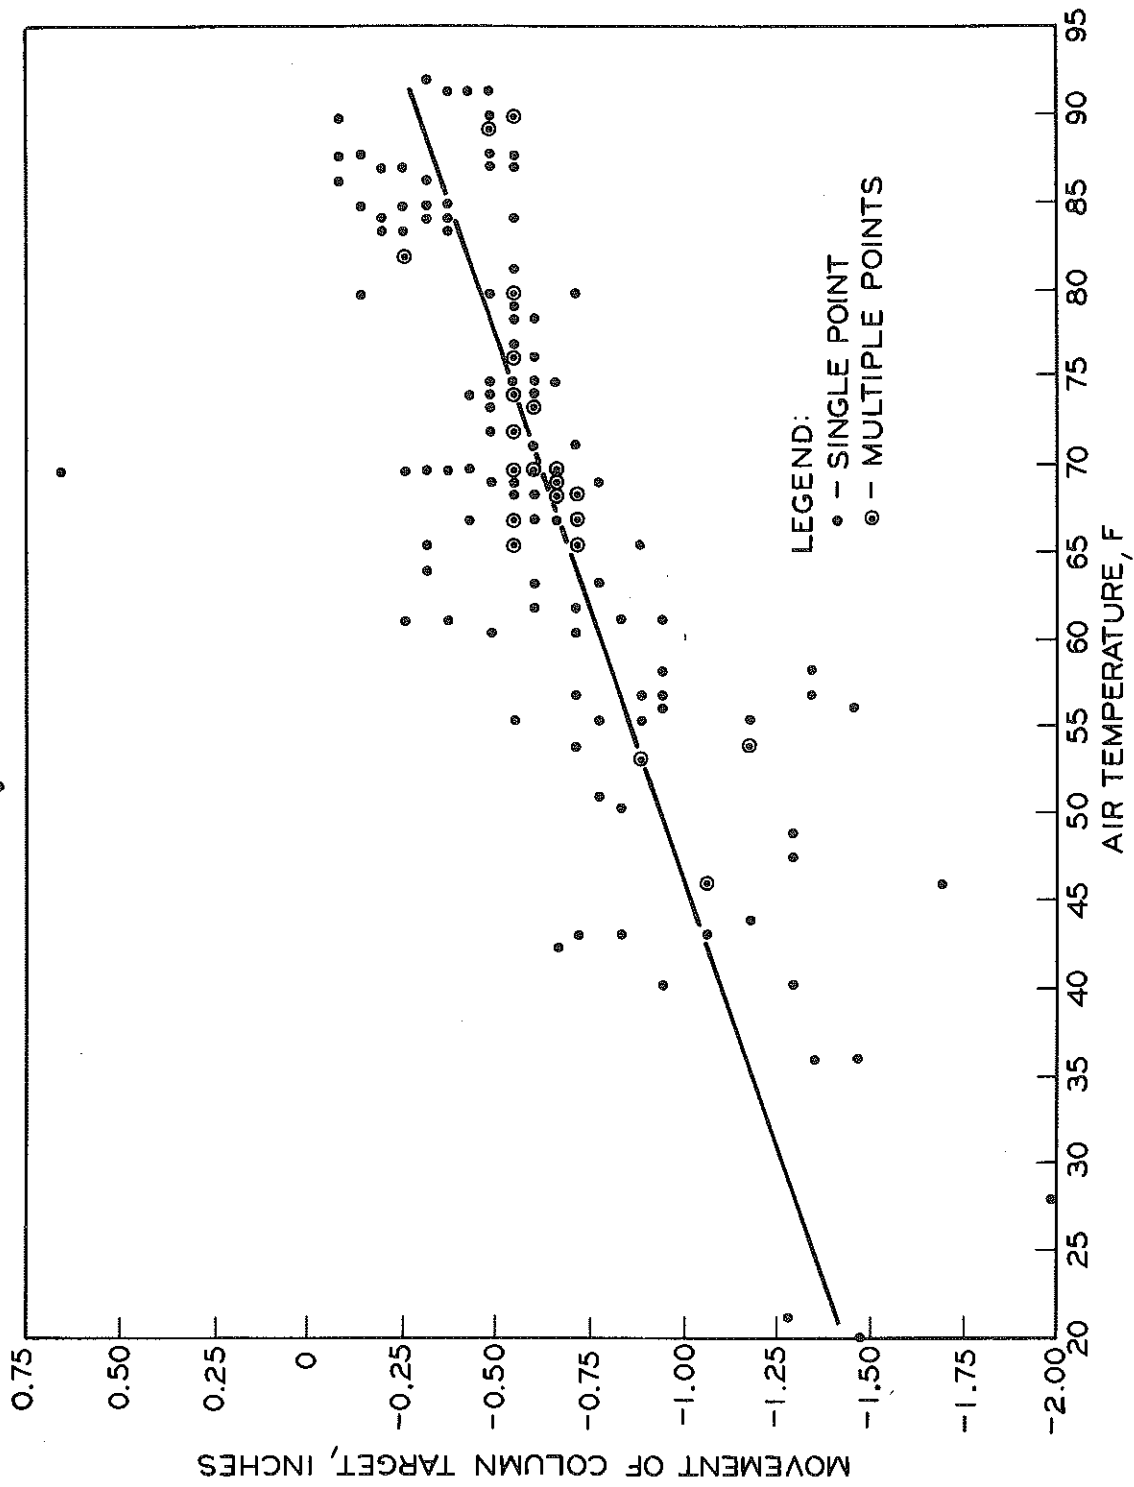
Figure 19 shows the linear relationship between column movement and temperature for Phase II. Phase I and II data are combined in Figure 20. Both figures show a strong linear relationship, indicating no significant change in the support condition during the monitoring period.

Figure 20. Linear relationship of target at top of column versus air temperature, Phases I and II.

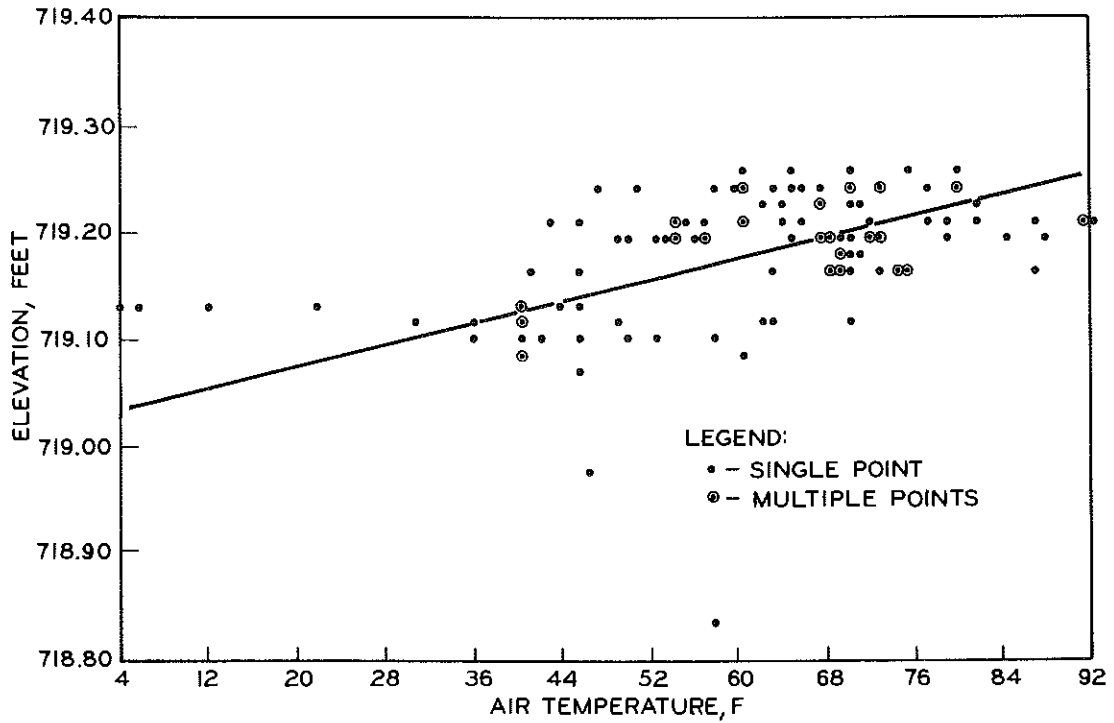
Measurements taken during Phase II showed a tendency for the south end of the cantilever to drop as temperature increased during the day. The point just south of the damaged expansion joint showed some movement, but did not vary directly with temperature and for the most part remained stable. When the data from Phases I and II were combined, the long-term trend was for the superstructure to act as a rigid body. As temperature increased during the day, the south end of the cantilever decreased in elevation and the expansion joint end increased in elevation. The opposite trend held true as temperature decreased. This long-term trend is shown by the linear regression analysis in Figures 21 and 22.

Figure 21. Linear relationship of the point just south of the expansion joint (No. 28) to temperature, Phases I and II.

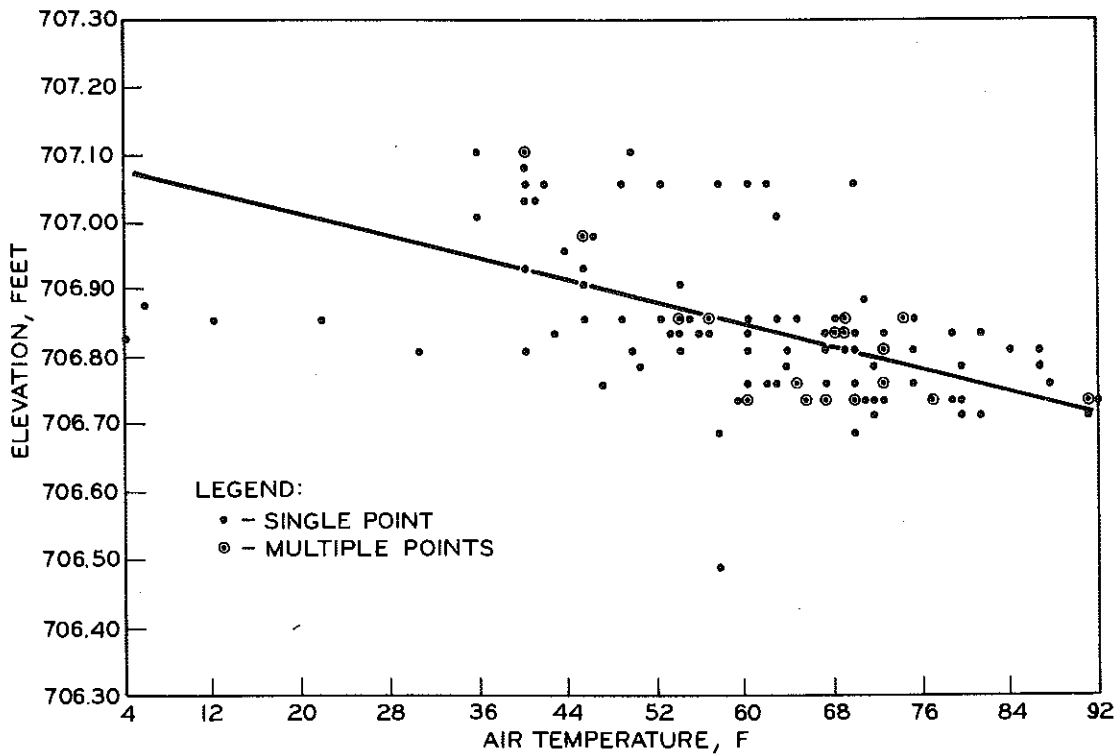
Figure 22. Linear relationship of the point at the end of the cantilever (No. 40) elevation to temperature, Phases I and II.

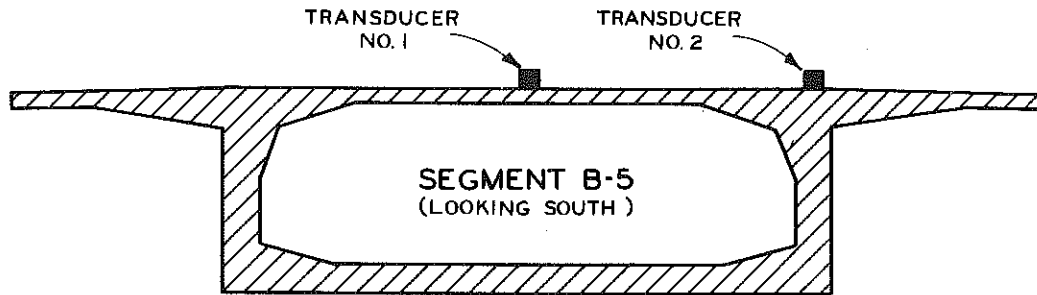
tilever deck; one in the middle of the segment and the other over the web (Fig. 23). During the removal and 'walking' down of the pier frame, vibrations reached maximum levels of 0.11 and 0.13 in. per second. This level is well into the perceptible range but still not excessive or indicative of any problem.

Figure 23. Location of transducers during pier frame removal.

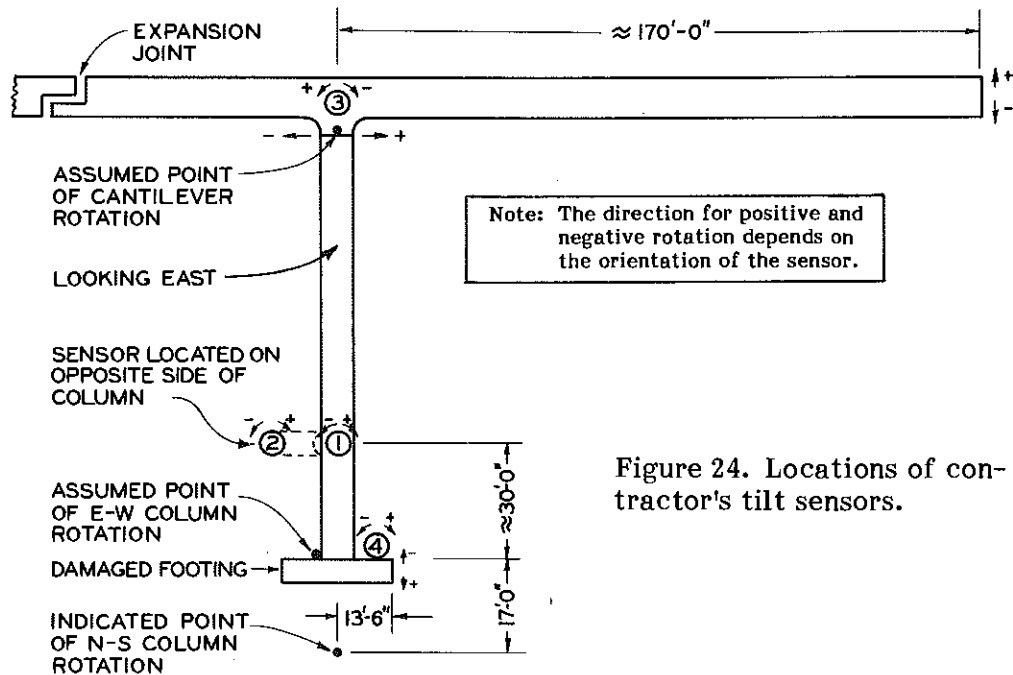
Extensometers were installed on the structure by the contractor at various locations at the start of repair work. These were attached to an alarm system which would warn workers to leave the area if any unusual movements took place. Primary sensors were installed on the footing's corners, referenced to anchors augered into the earth below. However, digging, filling, and insertion of freeze pipes in the area caused the soil to shift, giving faulty readings on the sensors. Since there was no suitable anchor point available for steady reference, the contractor was directed to put up a tilt sensing system that used the earth's gravity as a reference and, therefore, was independent of minor shifts in the surrounding soil. A Sperry tilt sensing system was obtained. Essentially the sensors consist of level bubbles with electrical wiring and electronic circuitry to detect rotation. Four sensors were installed: two were mounted on the west column about 30 ft above the damaged footing (one for measuring longitudinal movement and the other for measuring transverse movement), one on the footing, and one inside the superstructure on the floor of the segment just over the west column of pier 11N (Fig. 24). The tilt measuring system was connected with the major data logging system

Figure 24. Locations of contractor's tilt sensors.

At first there were problems with false alarms. After trying several different options such as interchanging tilt sensors and replacing the contractor's sensors with MDOT sensors, it was determined on August 31, 1983, that electromagnetic interference caused by a portable two-way radio entered the system through the unshielded cable running from the Sperry console to the Acurex Data Logger. This cable was replaced with a shielded one and there were no other false alarms, other than once when the footing sensor was bumped by a worker.

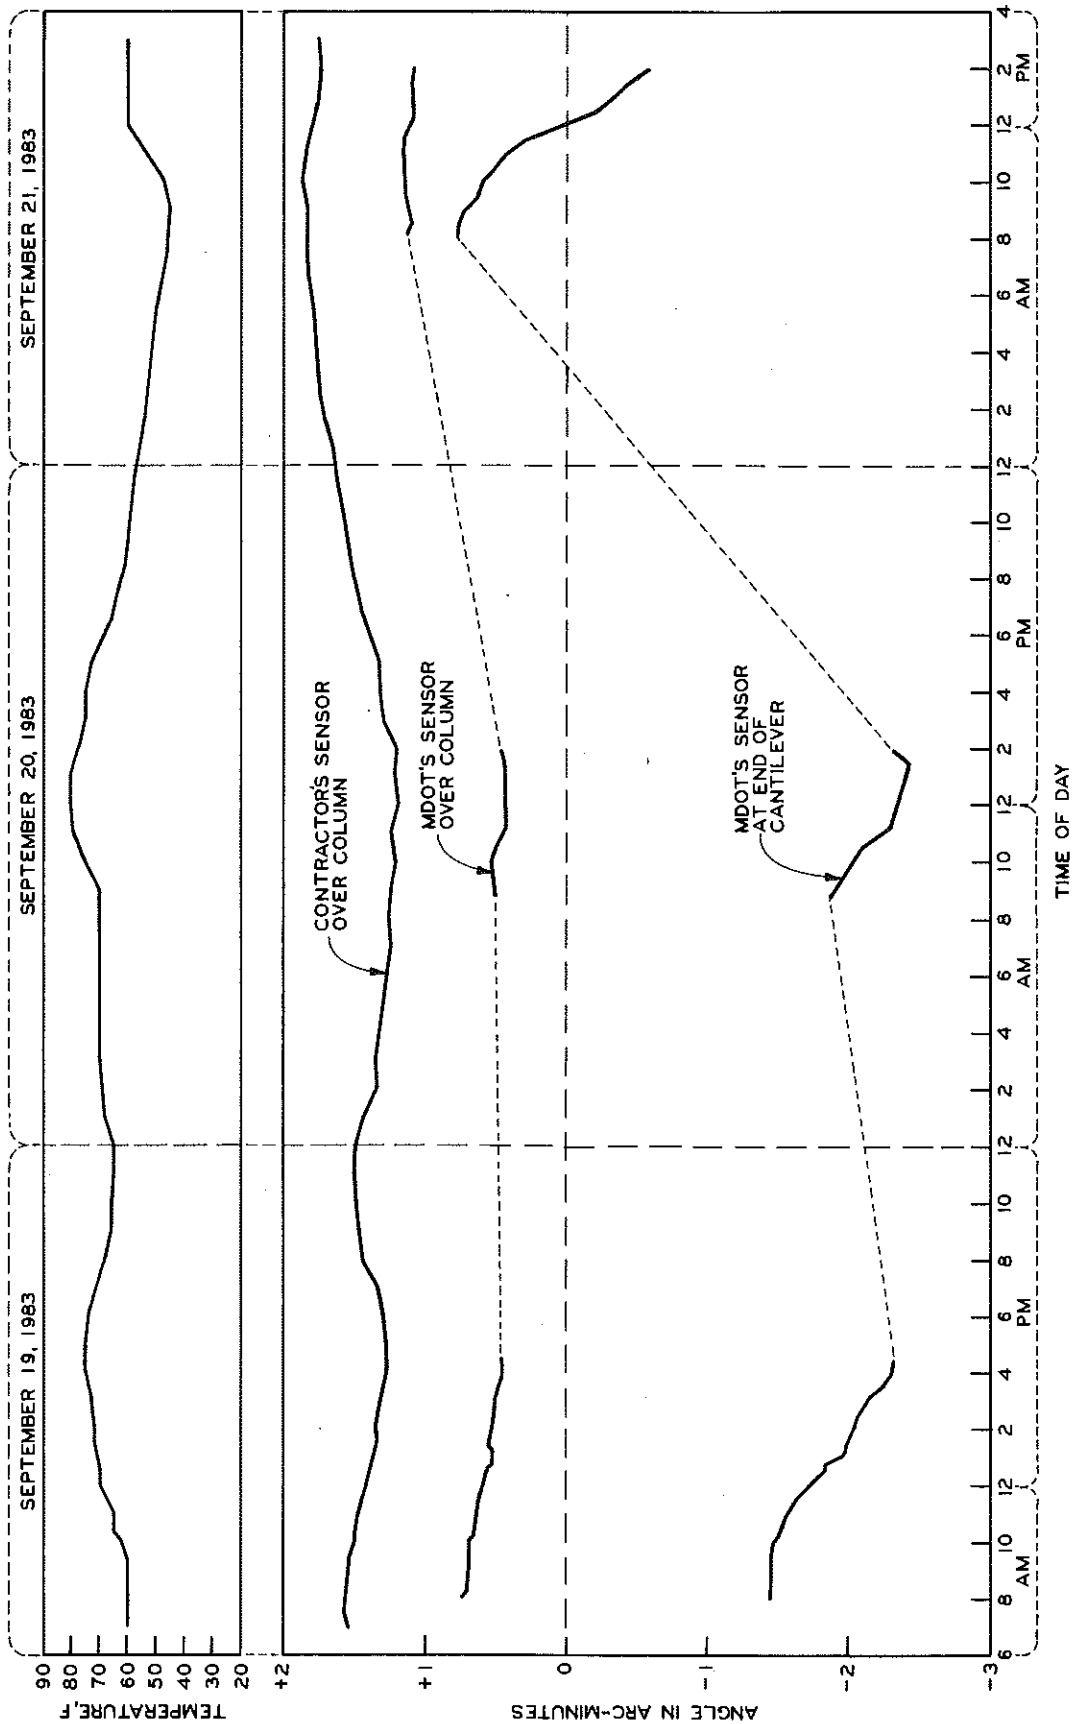
Figure 25. Tilt sensor movement during a sharp temperature drop.

On September 20, the most significant overnight drop in temperature occurred since monitoring began, and the tilt sensors reflected this change. From noon on September 20 to 9:00 the next morning, the temperature dropped 35 degrees. The tilt sensor at the south end of the cantilever showed a positive angle change of 3.16 arc-minutes, indicating a rise in the south end of the cantilever. The sensor over the column showed a positive angle increase of 0.65 arc-minutes. This sharp contrast is shown in Figure 25.

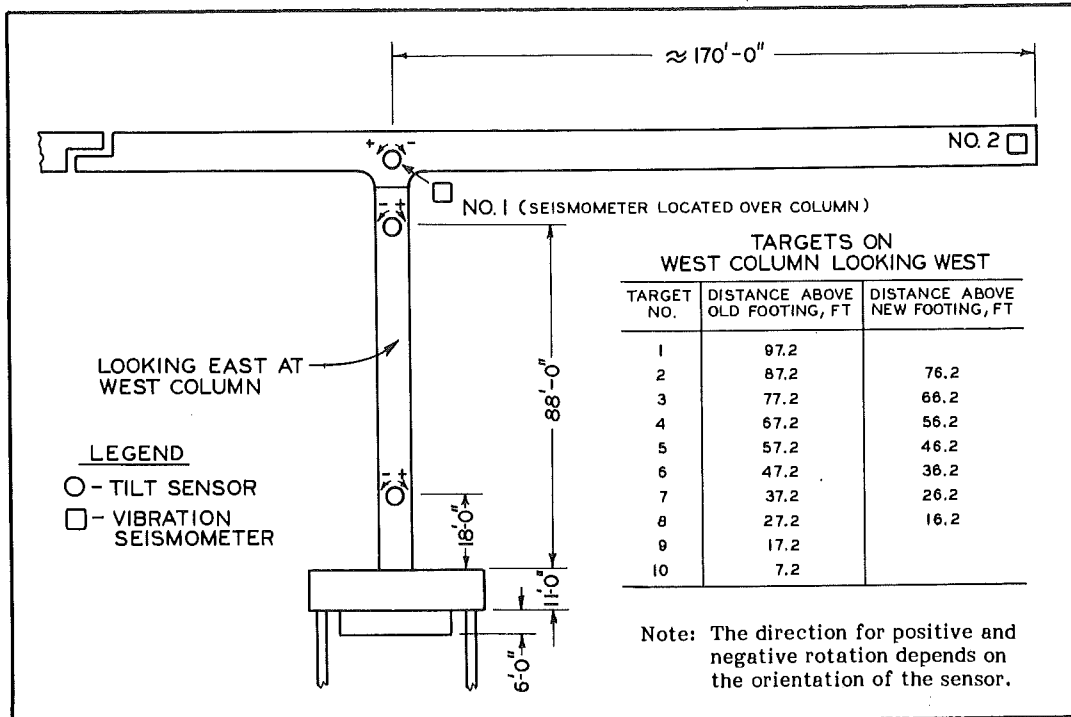
During this lift, extensometers, tilt sensors, and vibrations were monitored during jacking (Fig. 27). Elevation readings of the new footing and the columns were measured before and after jacking. Extensometers were placed on top of each column to measure relative movement of the deck to the pier. One extensometer was put on the east column and one on the west. Two vibration transducers were placed in the superstructure; one over pier 11N and one at the south end of the cantilever. One tilt sensor was placed in the superstructure directly over pier 11N. The other two were mounted on the west column to measure longitudinal movement; one on the lower portion of the column 18 ft above the new footing and the other near the top, 88 ft above the new footing.

It took about 10 minutes to equalize pressure in the jacks. During this time the extensometers showed very slight movement (0.010 in. each). Peak vibrations remained steady at 0.002 in. per second over the column and ranging from 0.001 to 0.008 in. per second at the end of the cantilever, neither of which were cause for concern.

During the jack pressurizing, the superstructure sensor showed an increase of 0.32 arc-minutes, indicating a fall of 0.15 in. at the expansion joint and a rise of 0.19 in. at the cantilever. The tilt sensor at the bottom of the column indicated a 0.06 arc-minute (0.04 in.) movement away from the river and the sensor on the top showed a 0.15 arc-minute (0.03 in.) movement toward the river. The targets on the east column appeared

Figure 27. Location of monitoring equipment during final lift.

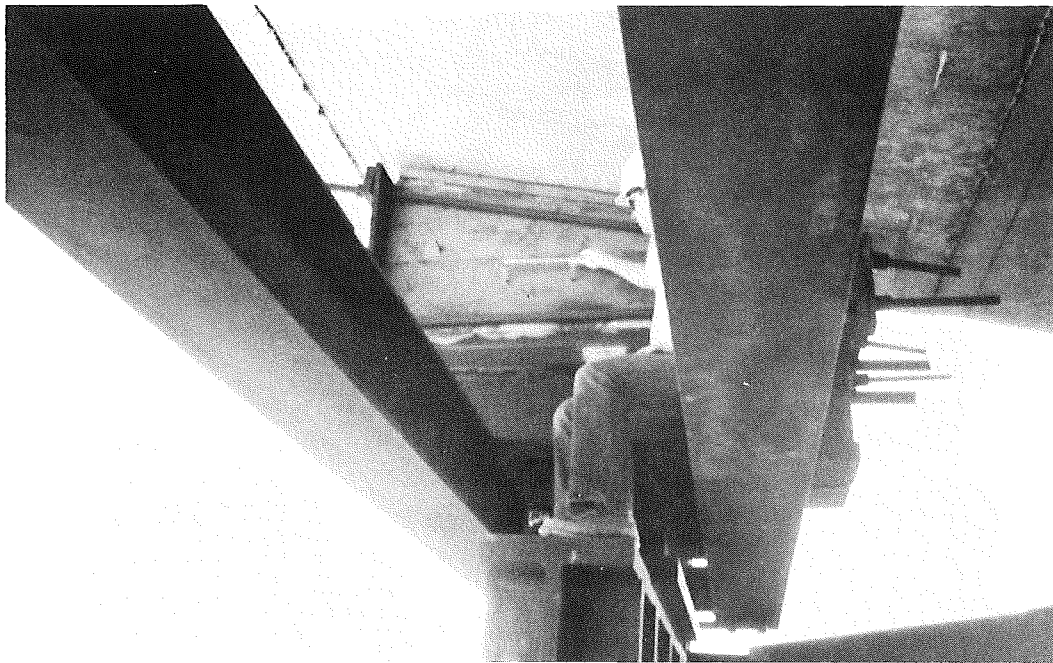
After the final jacking, it was discovered that the northeast bearing block was cracked (Fig. 28). Four of these epoxy blocks are located above the jacks (as shown in Fig. 26) and support the superstructure. Pins were

Figure 29. Calipers are used to monitor bearing block cracks.

Three sets of readings were taken on January 31, 1984. Two locations, both situated at the top of the block, showed the crack to be opening. A frame was subsequently constructed to hold the block together. Construction personnel monitored the cracks after this and found no further movement had occurred.

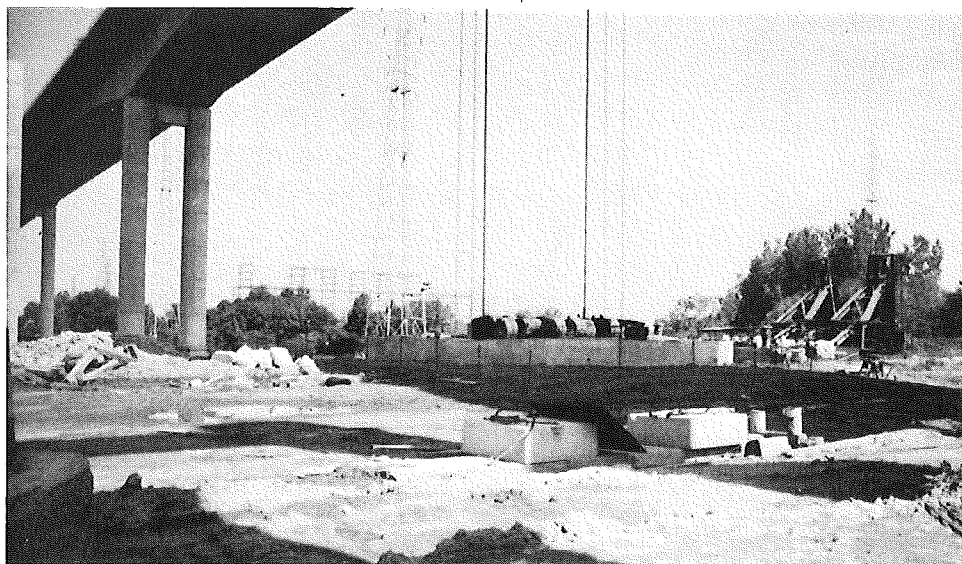
Figure 33. Weighted block with extra tie-down cable.

Final Rotations - Two extra cables were added between the tie-down block and the expansion joint and two extra hydraulic rams added. Additional weight was also added to the tie-down block (Fig. 33). This took an additional two weeks and on March 23, 1984 the final rotation step was ready to take place.

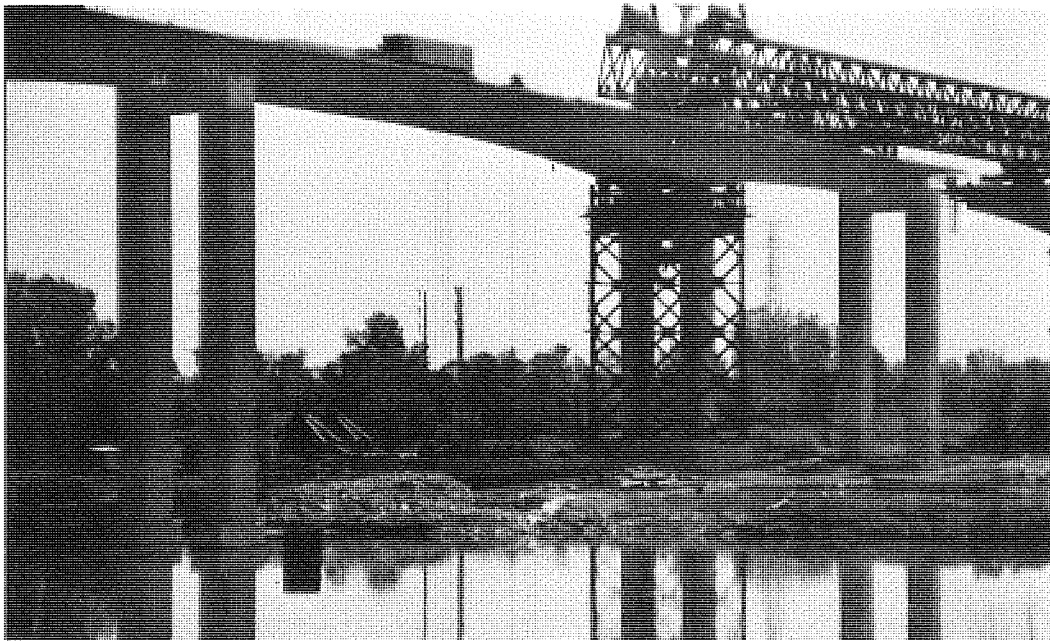
The superstructure moved a total of 27.67 arc-minutes during the two final rotations. This brought the south end up an additional 16.40 in. and the expansion joint end down 12.60 in. The superstructure was now back to its approximate original alignment (Fig. 34).

Figure 34. Zilwaukee bridge after completion of the realignment procedure.

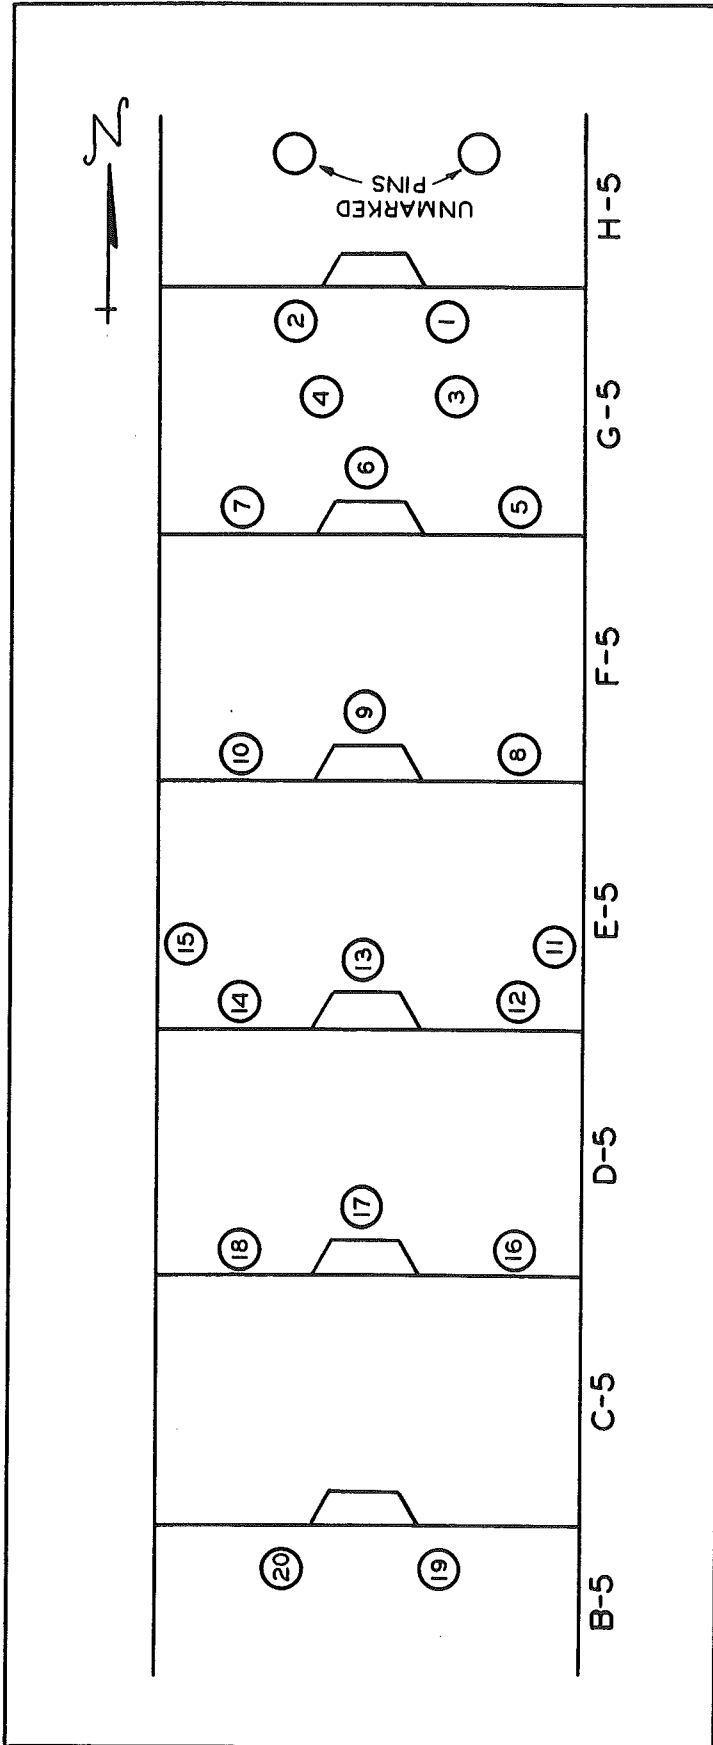
Figure B-14. Pin locations for monitoring segment cracks.

Pins were placed along segment joints and cracks inside the superstructure as shown in Figure B14. Pins 1 through 10, 12 through 14, and 16 through 18 were placed on cracks or joints in the floor and 11 and 15 on the walls. The original surface crack width was measured to the nearest 0.001 in. with the calibrated eyepiece in the small microscope shown in Figure B15. A vernier caliper was used from then on to measure relative change in these cracks to the nearest 0.001 in. (Fig. B16).

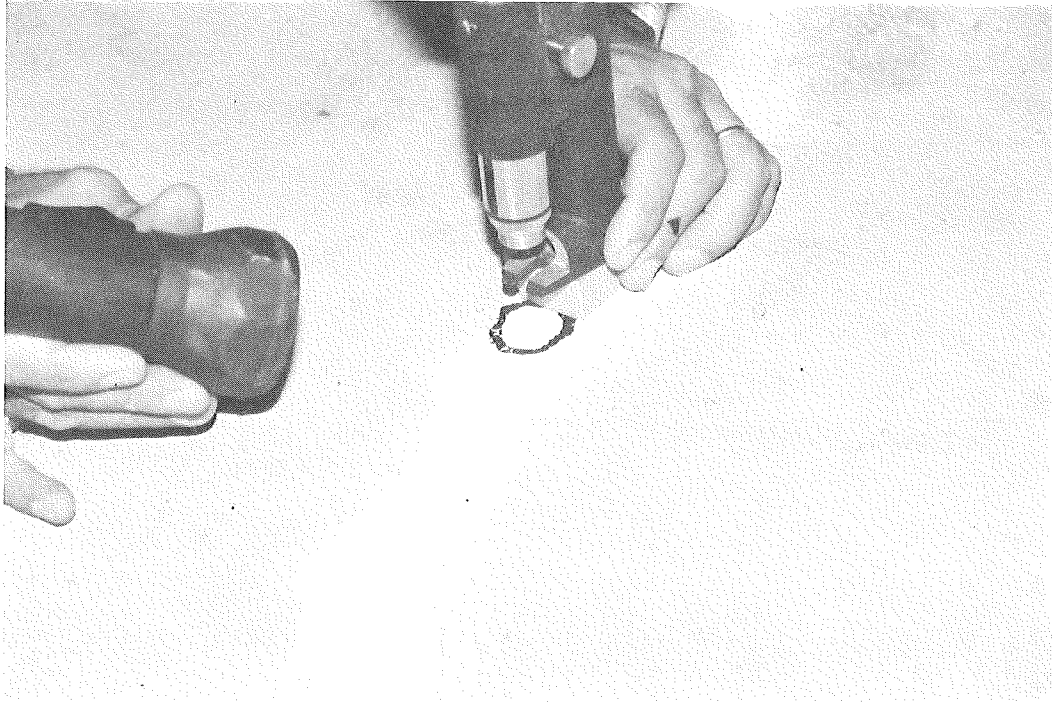
Figure B-15. Crack widths inside superstructure were measured with a calibrated eyepiece.

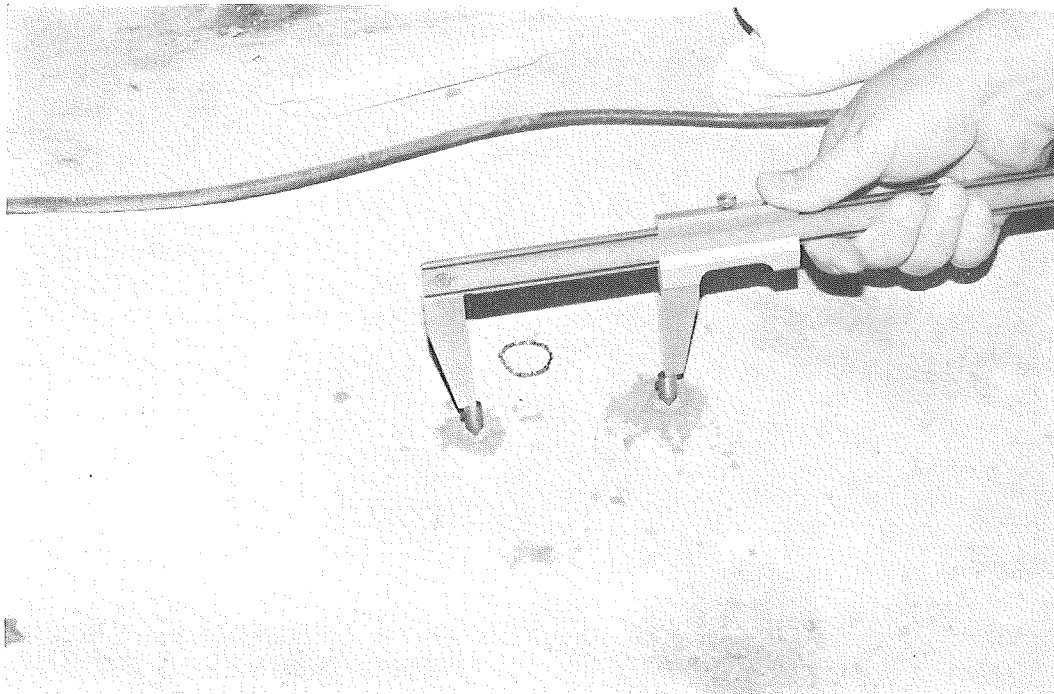
Figure B-16. Measuring segment crack widths with a caliper.

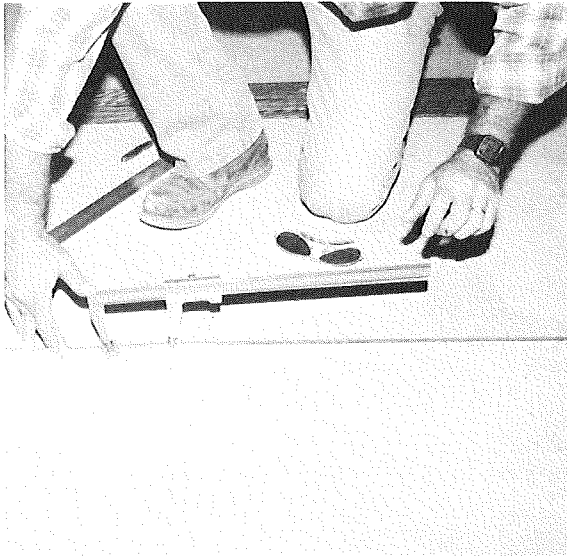
Figure B-17. Total length of cracked sections of segment bottoms were measured with a caliper and an invar tape.

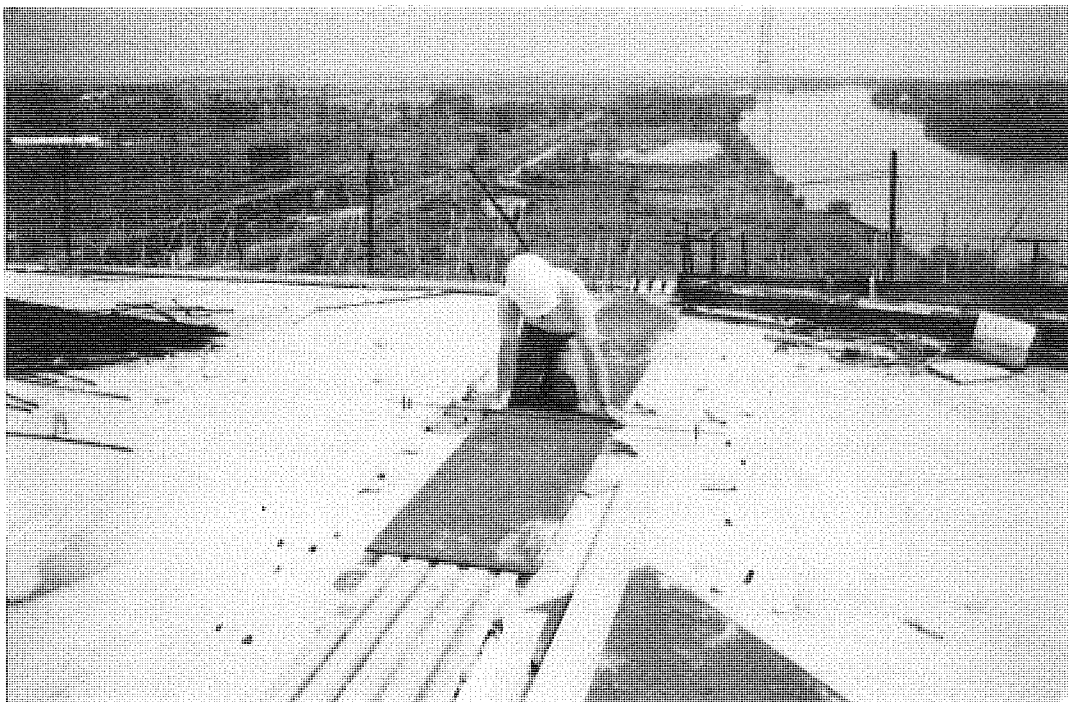
Two sets of pins were placed on each of three expansion joints; the damaged expansion joint and the next two immediately to the north. For each joint, a set of pins was placed near the east shoulder and the other near the west shoulder. A set of trammel points was used to monitor movement to the nearest 1/64 in. immediately before and after each rotation step (Fig. B22).

Figure B-22. Measuring expansion joint with trammel points.

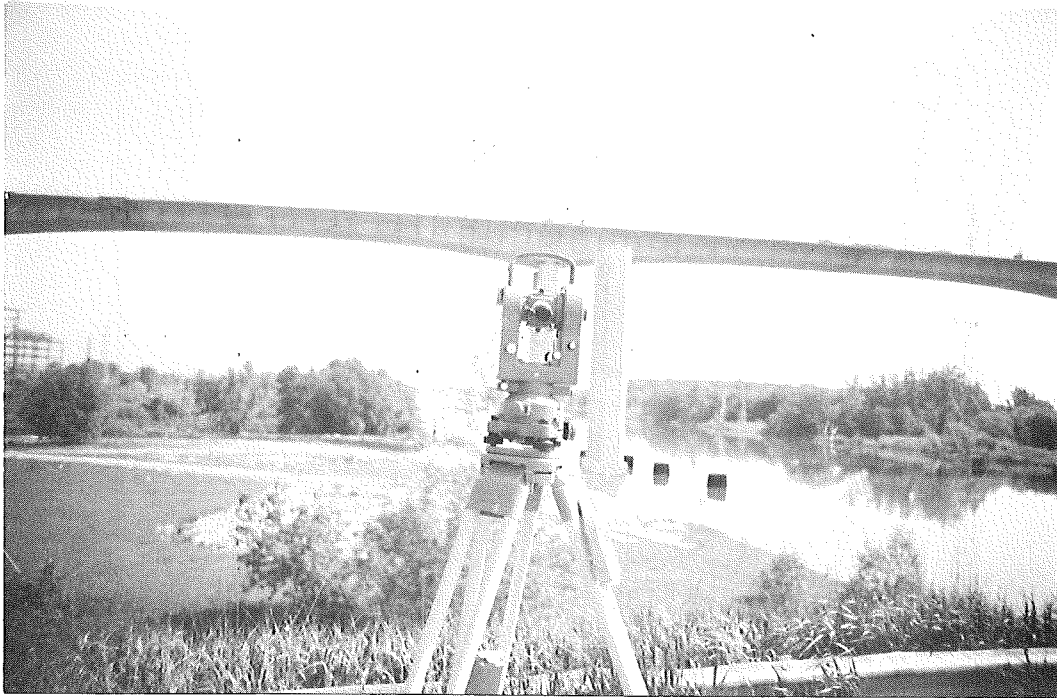
During each of the six rotation steps, the movement of the superstructure north of the damaged expansion joint was a concern. The theodolite was placed over a monument set in the shoulder along I 75 in a location where the superstructure could be seen between piers 13N and 14N (Fig. B23). A nail with inscribed cross hairs in the I 75 median curb was used for a backsight target. A tape for a Philadelphia level rod was mounted on the fascia of the superstructure (Fig. B24). This allowed monitoring to the nearest 0.01 ft. A site diagram is shown in Figure B25.

Figure B-23. A theodolite was used to monitor superstructure movement between piers.
