MICHIGAN
STATE HIGHWAY DEPARTMENT
JOHN C. MACKIE, COMMISSIONER

349
November 1, 1960

Subject: Performance of Non-Metallic Base Plates. Research Project 53 G-70.
Report No. 349.

Reported by L. T. Oehler and O. L. Lindy.

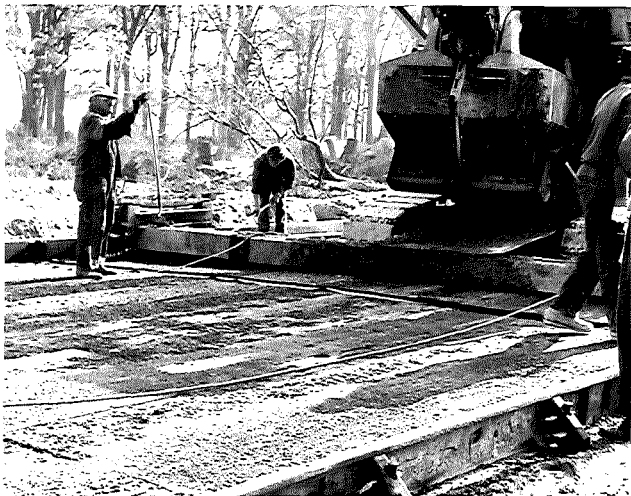
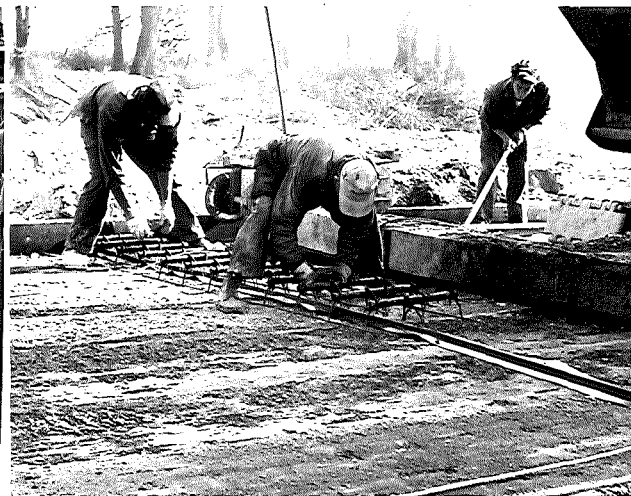
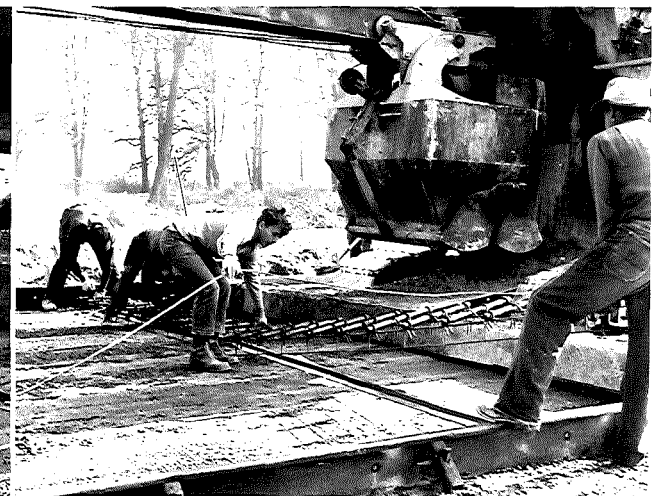
Figure 5. Views of the two ends of one wrinkled plate show poor contact with the base and paving forms (left and center). The same plate is shown at right as paving machine approaches.

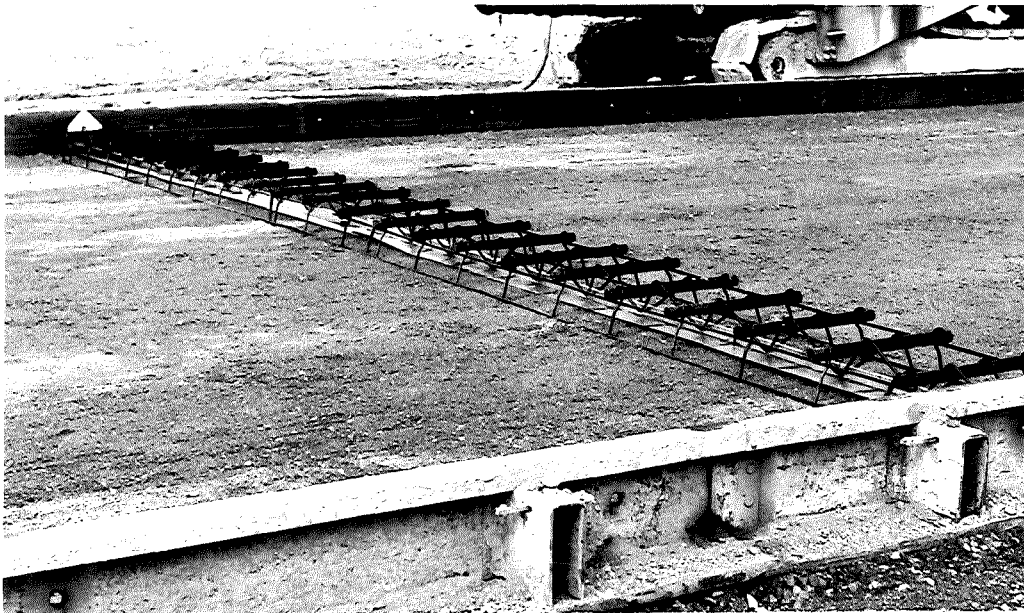
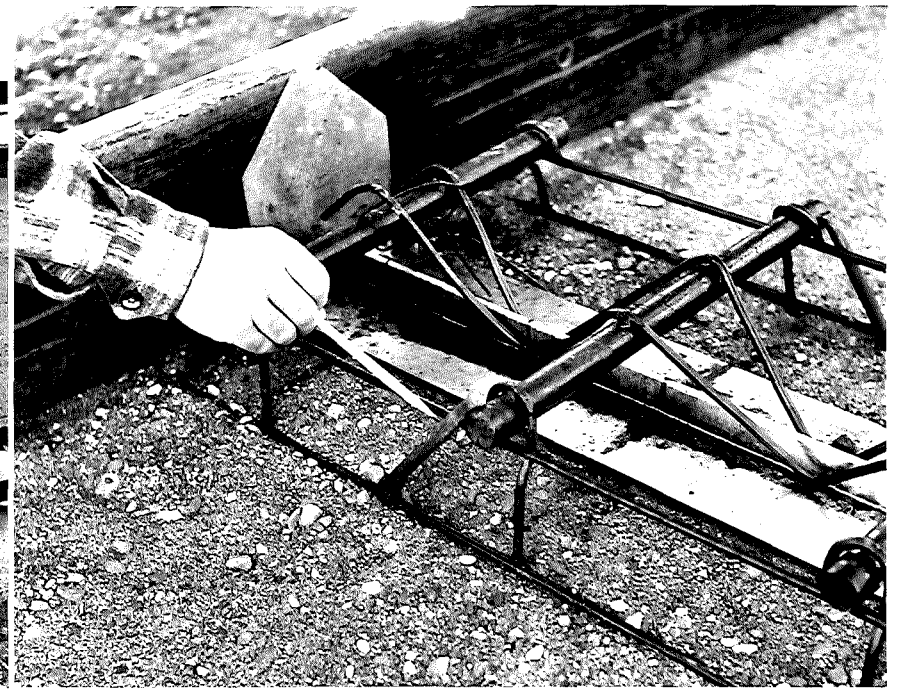
1. A large-radius curve of the base plate at the pavement edge, rather than a right-angle corner, results in a thinner slab at this most critical point and a possibility of a corner break (Fig. 7A).

2. A badly tilted end plate results from lack of stiffness of the material and from its wrinkled condition when uncoiled (Fig. 7B). The tilt prevents proper alignment with respect to the top joint groove.

3. A joint groove not properly placed with respect to the base plate and load transfer assembly, is a serious deficiency which, it has been noted repeatedly, may cause a broken joint on the side containing little or no dowel length (see letter from E. A. Finney to W. W. McLaughlin, 12-29-57). This trouble is not associated with the type of base plate material, but is caused by lack of care in placing the styrofoam strip above the joint (Fig. 7C).

Figure 7. The three most common types of incorrect placement for non-metallic base plates are formation of a curve rather than a right angle at the pavement edge (left); tilting of the plate during pouring operations (center); and misalignment of the top surface joint groove (right).

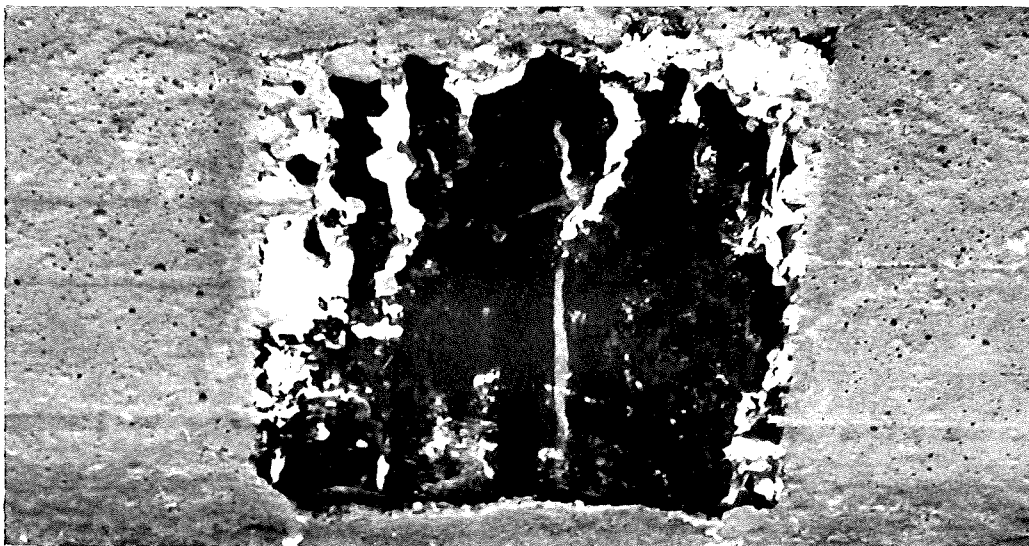
Figure 10. The non-metallic plate forms a correct right-angle end plate, is adhering well to the slab edge, and is properly centered with the top surface joint groove, which has not yet been opened.
