**JOINTED CONCRETE PAVEMENTS  
DESIGN, PERFORMANCE AND REPAIR**

**C. J. Arnold  
M. A. Chiunti  
K. S. Bancroft**

**Research Laboratory Section  
Testing and Research Division  
Research Projects 68 F-101, 70 F-113,  
70 F-116, 71 F-122, 73 F-136, and 74 F-140  
Research Report No. R-1169**

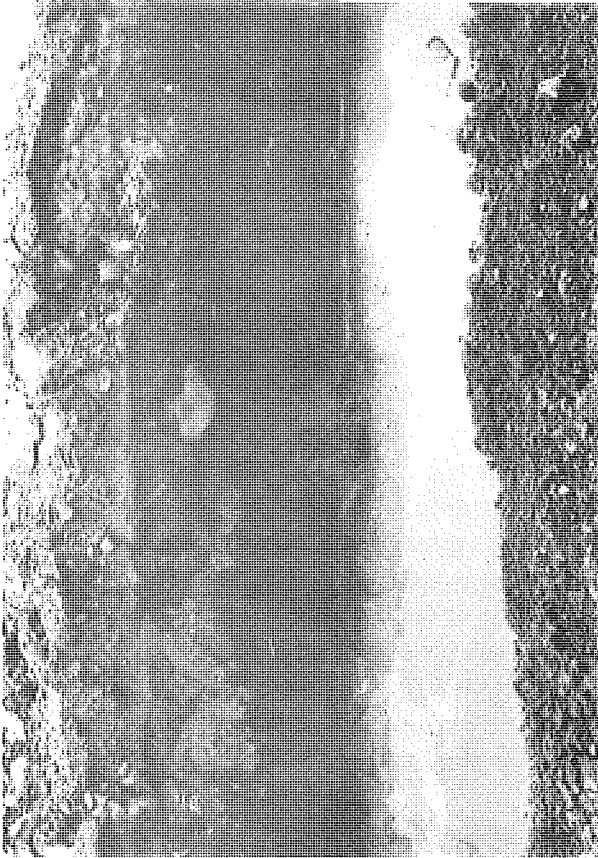
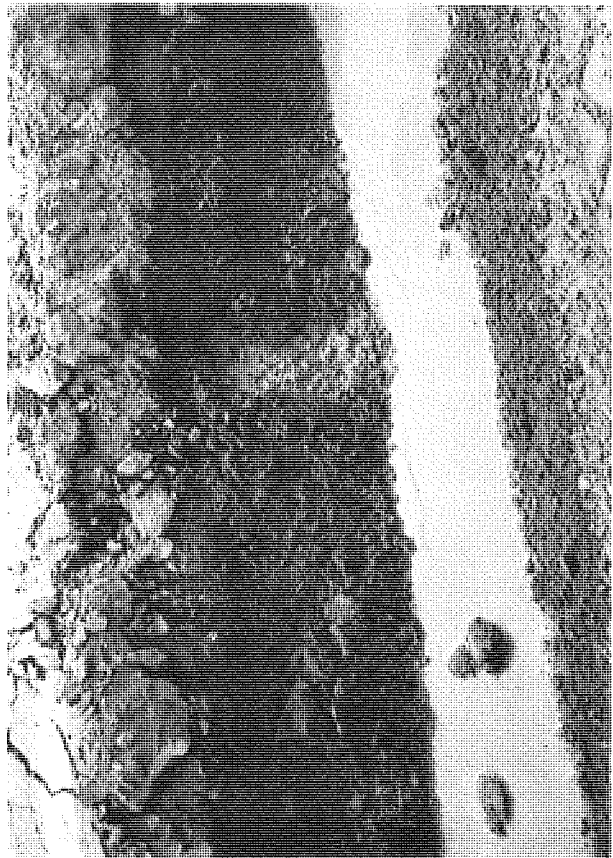
While some pavements in Michigan do not exhibit the traditional D-cracking symptoms shown by portions of this particular project, it does occur at many sites throughout the State. The time frame for crumbling seems to be in the 15 to 20 year range, with the discoloration phase beginning around the 10-year mark. It is apparent also, that the disintegration of the lower joint faces on many projects throughout the State results from a similar cause, even though the typical symptoms do not show up at the top surface of the pavement. The collection of water in transverse joints, especially those with poor seals and base plates, appears to be a major factor in the type of deterioration that exists.

As the bottom of the joints turn to rubble, the holding capacity for water increases. The dense-graded base course and shoulder material used in the State for many years form a barrier to the escape of water, with the result being a continually wet condition within the joint. Disintegration of the top of the joint face adds still more to the water gathering tendency of the joint. Figure 15 shows an edge view of an old pavement, taken on a pavement-removal project, after the shoulder had been bladed away. Three adjoining transverse joints were photographed. In the center of the picture in each case is the end of the transverse joint. Note the miniature mud slide that resulted from water running out of the joint.
