PERFORMANCE OF A 20-YEAR-OLD SECTION OF US 27
Marshall to the Eaton County Line (13072)

Research Laboratory Division
Office of Testing and Research
Report No. 306
Research Project 54 F-37

Michigan State Highway Department
John C. Mackie, Commissioner
Lansing, March 1959

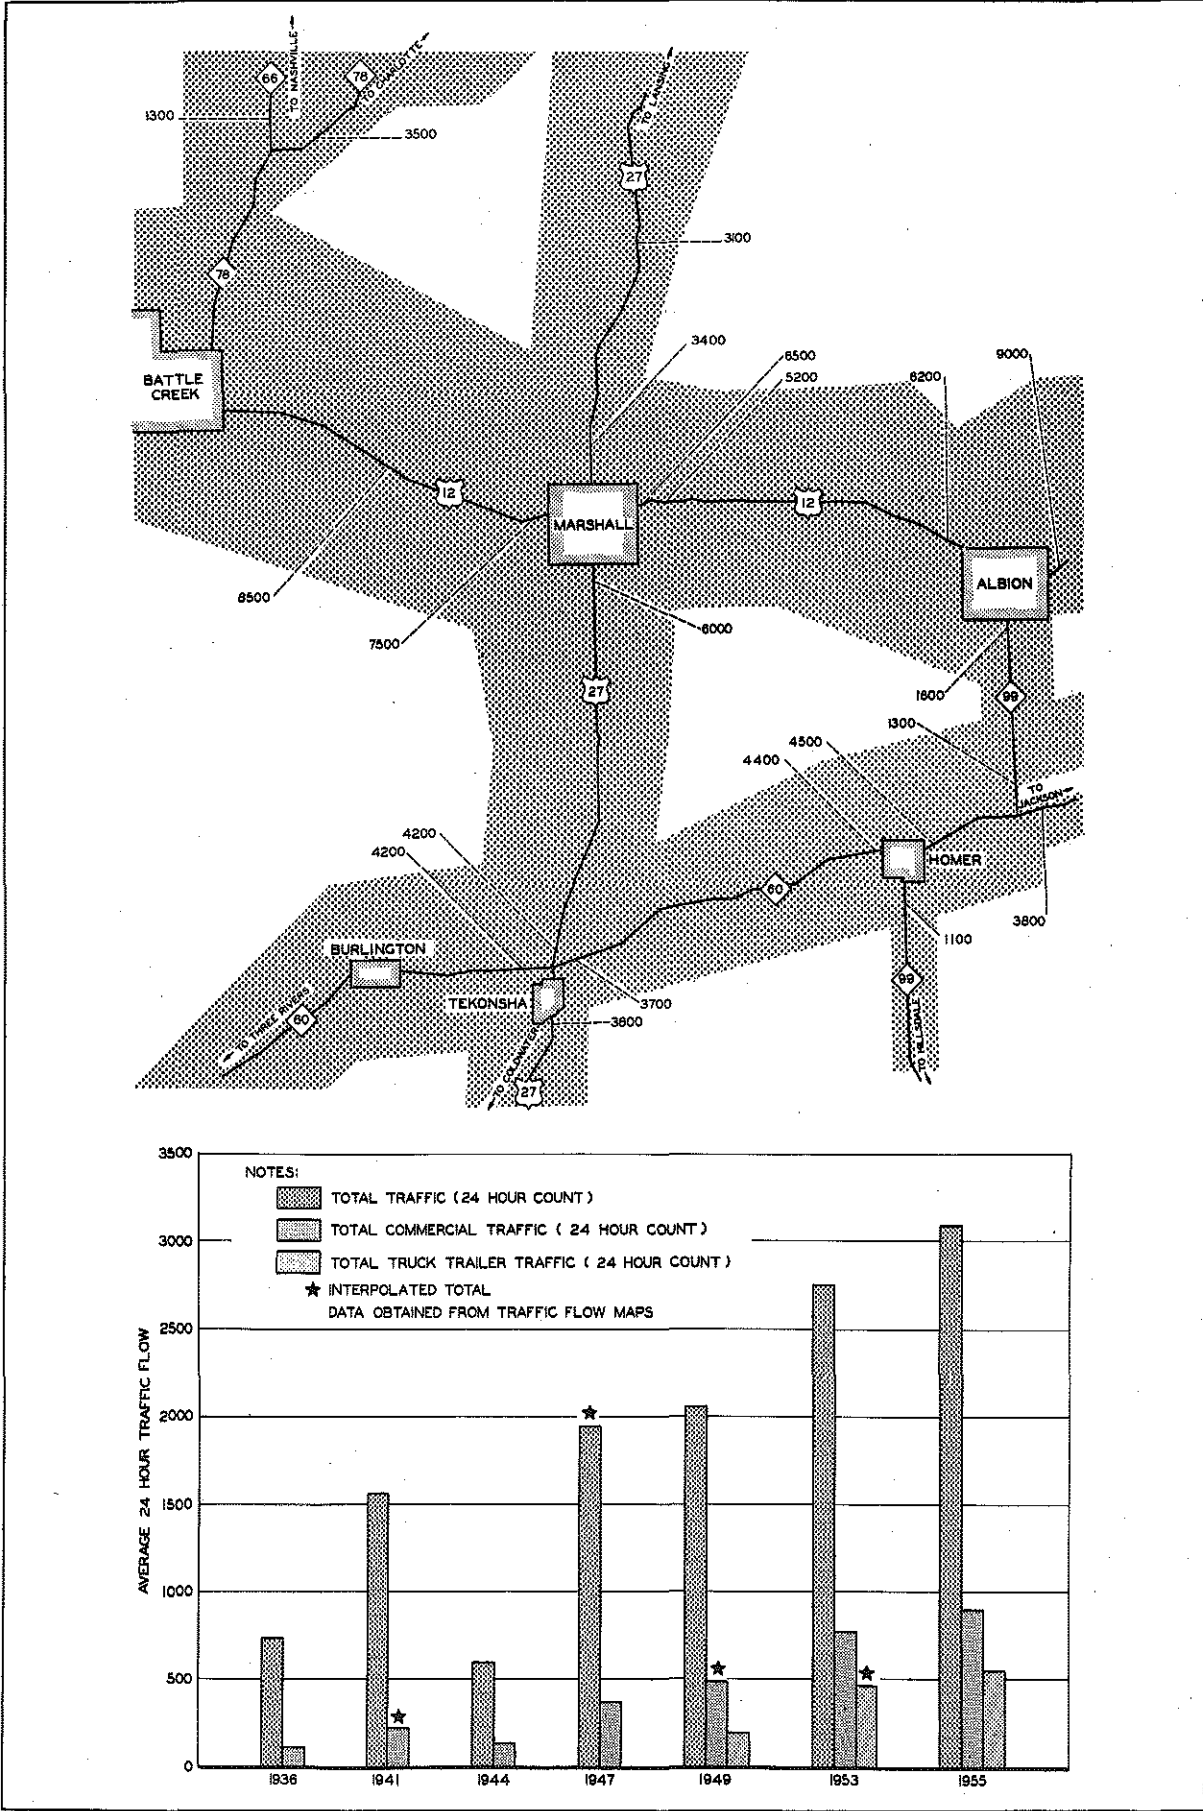
Figure 2. Traffic Volumes and Flow Pattern

Traffic volumes and the flow pattern for the project are shown in Figure 2. These data indicate that total traffic increased over 400 percent between 1936 and 1955, and that the contracts may be considered part of a heavily travelled highway system.

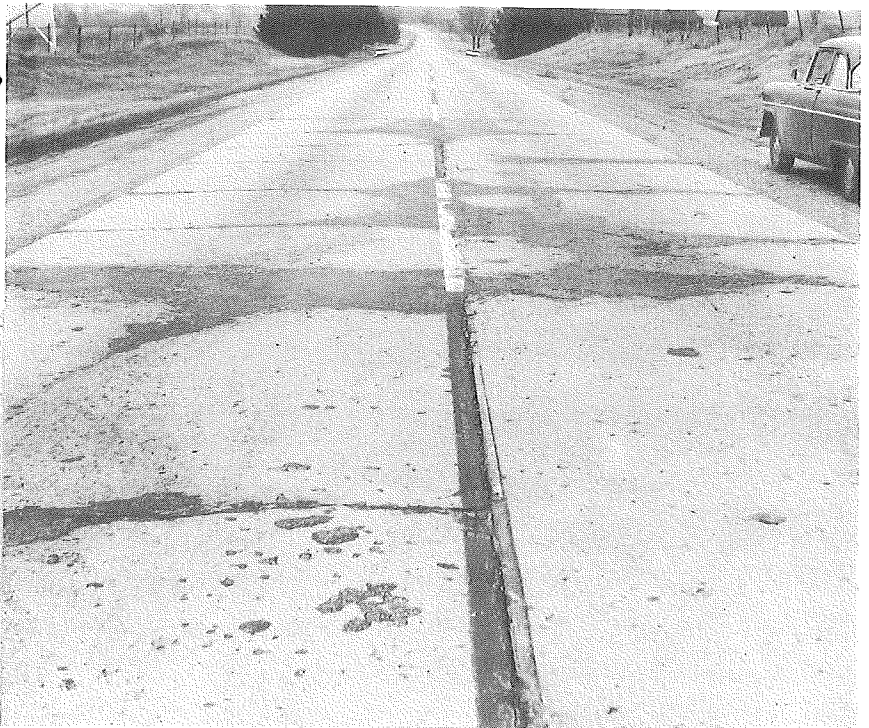
Figure 4. Surface Condition: Contract 3.

Station 89+49. The condition of this expansion joint was typical of those in Contract 3; note longitudinal cracking (top). occasionally found in this project.

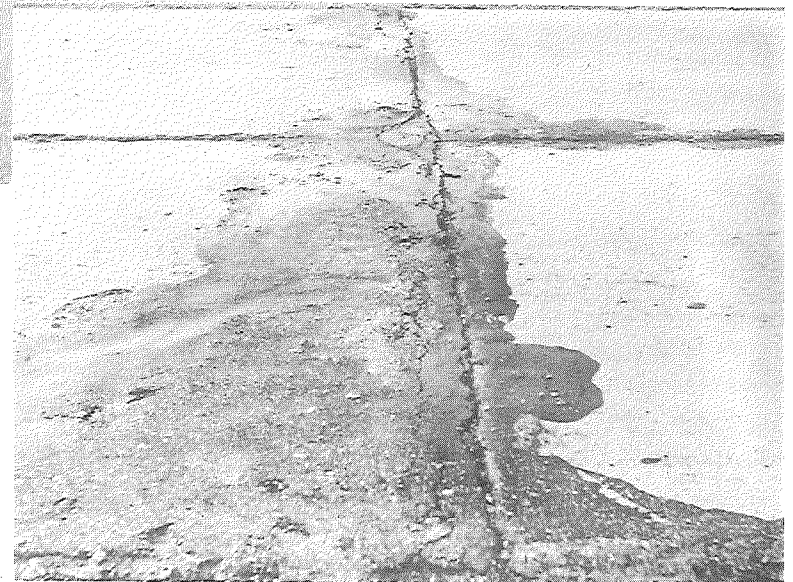
Figure 6. Surface Condition: Contract 5.

▲ Station 469. This joint subject to pumping, showed disintegration typical on Contract 5, with heavy spalling and corner breakage.

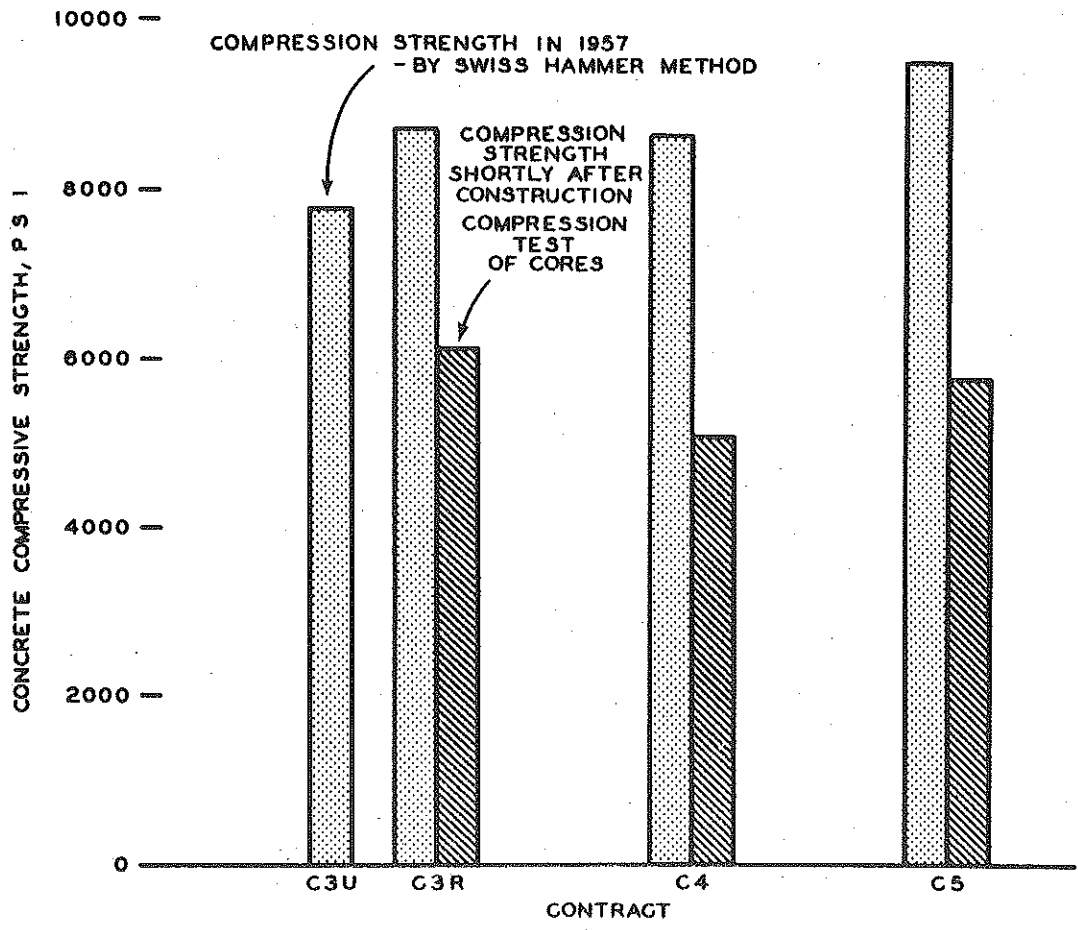
Figure 9. Compressive Strength of Concrete Pavement

To determine the quality of the concrete used in these projects, compressive strengths found for cores taken shortly after construction were compared with strengths obtained in 1957 using the Swiss Hammer method (Figure 9). In both cases, these were average values based on numerous tests made throughout the length of the different contracts. Concrete core data were not available for the urban section of Contract 3. The Swiss Hammer method is not a standard MSHD test procedure. It does not give absolute values of compressive strength, but is a non-destructive device suitable for obtaining relative values for concrete and other materials. Compressive strength in various portions of the test area was relatively constant.

A study of patching and cracking patterns showed that the pavement condition was not a function of concrete quality alone. Compressive strengths of the concrete, taken at various locations, did not indicate a correlation between concrete quality and pavement condition. This left only the supporting power of the subgrade or the concrete reinforcement to account for any unusual elements in pavement performance. From the data available for this study, neither the foundation nor reinforcing could be entirely eliminated from consideration, nor could either be selected as the principal cause of the pavement's performance.
