DESIGN, MAINTENANCE, AND PERFORMANCE OF RESURFACED PAVEMENTS

AT WILLOW RUN AIRFIELD

William S. Housel

January, 1962

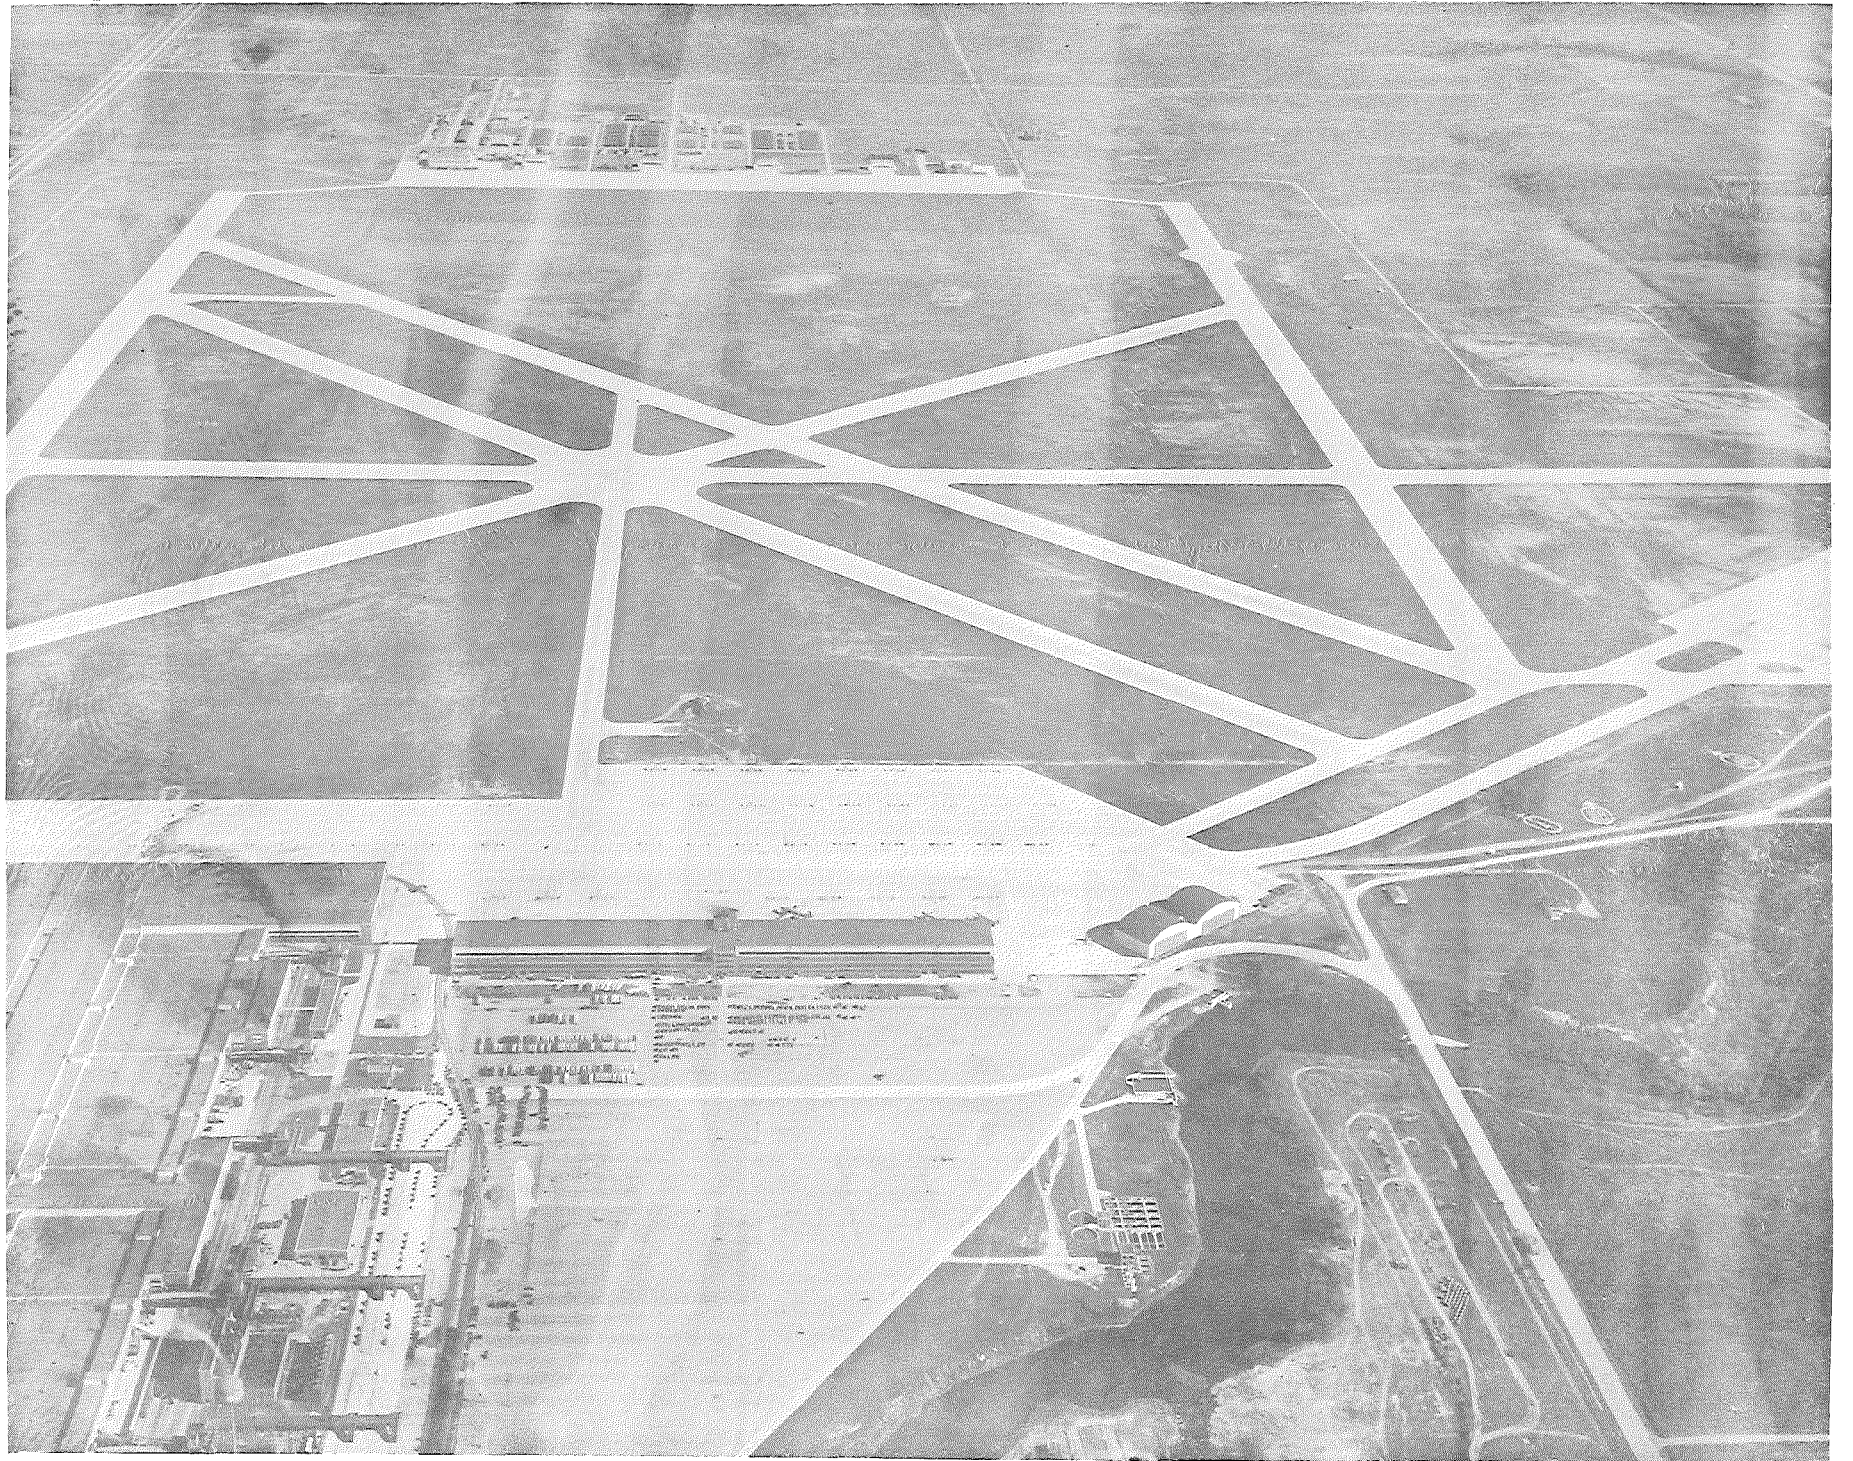
FIG. 1

Fig. 1 is an aerial photograph of Willow Run Airfield, with the manufacturing plant in the left foreground and the main west apron and hangar in the central foreground with the runways and taxiways extending beyond, to the training facility at the east end. There were approximately 1,500,000 square yards of concrete pavement, roughly equivalent to 115 miles of 22 foot highway pavement. As noted in the introduction, there were three stages of construction during the period from 1941 through 1943. All of the concrete pavement was unreinforced, with the main apron, runways, and taxiways built in 1941 with an 8-6-8 thickened edge section. The east apron and connecting taxiways, built in 1942, have been little used other than for training and experimental purposes and will not be discussed in detail in this report. Additions to the main west apron, in 1943, were

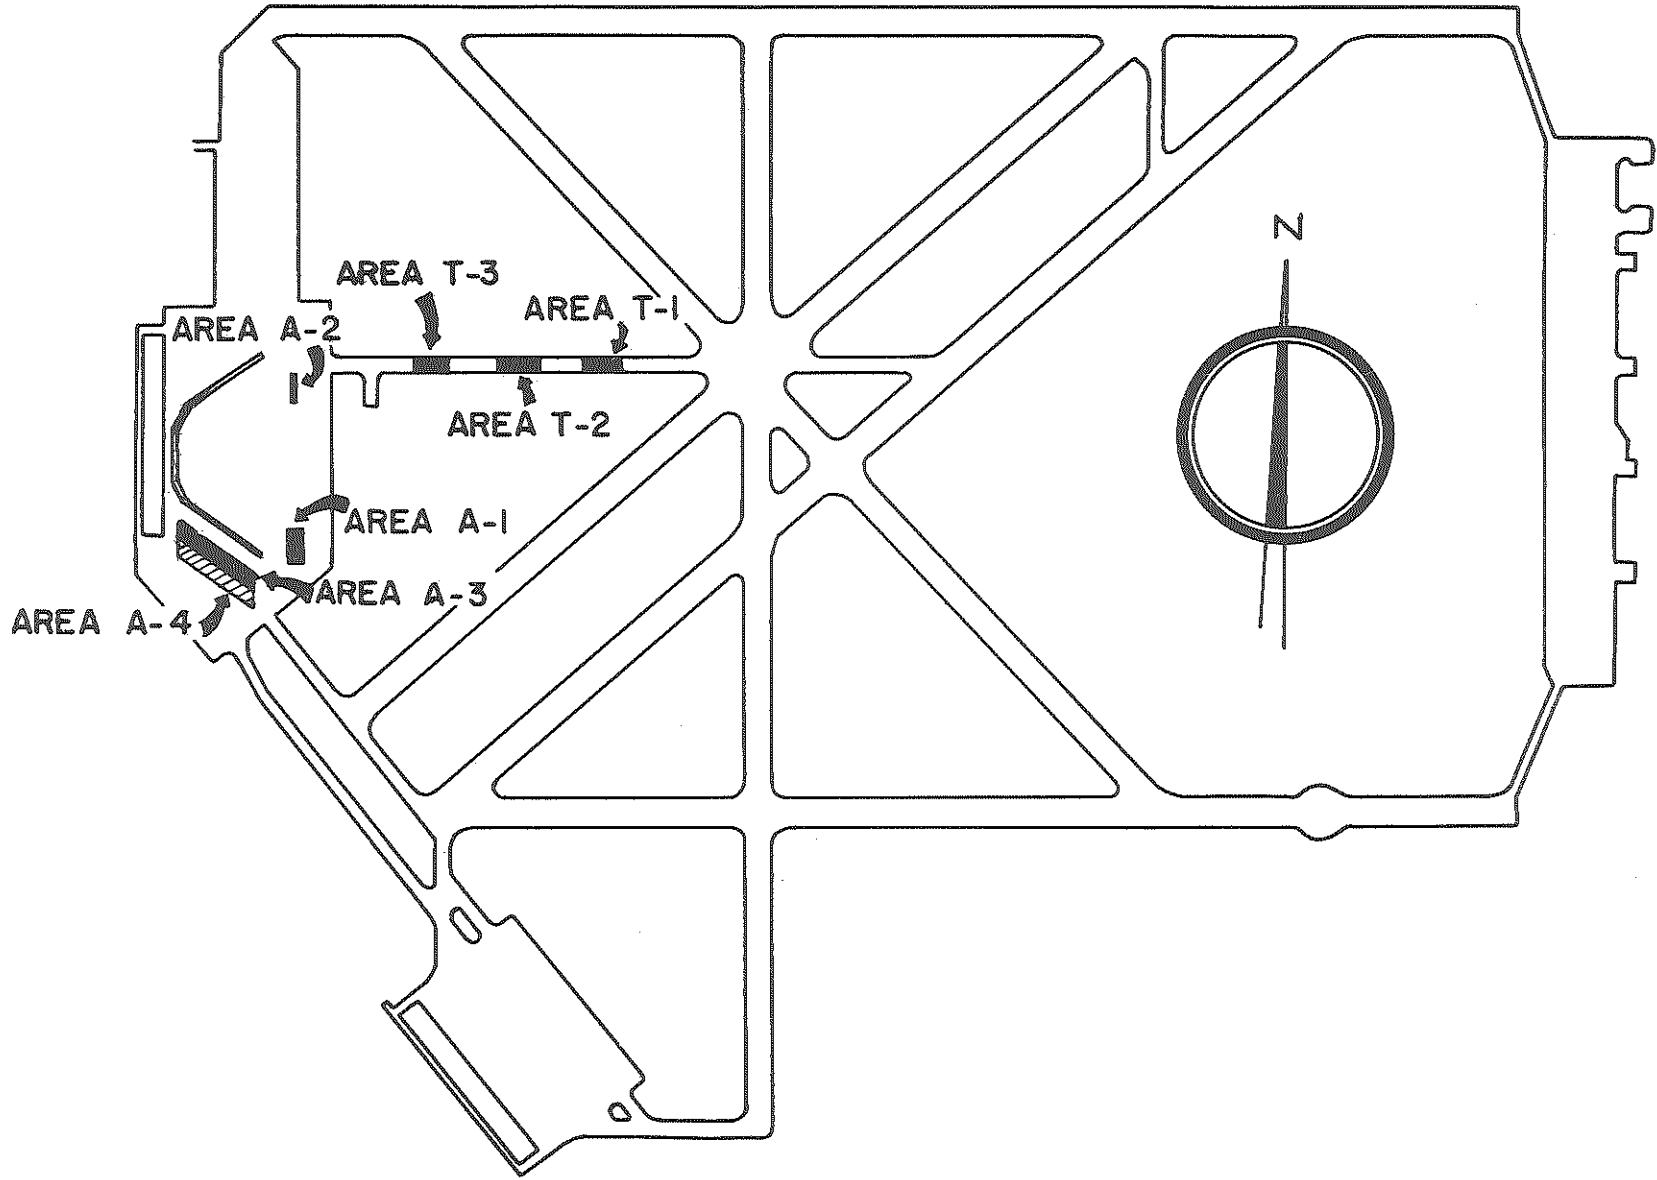
FIG. 6

Subsequent discussion in this paper will be devoted to a survey of reflected cracking in selected test areas and the general performance of the 1955 resurfacing, where several variations in construction details were undertaken on an experimental basis. These test areas have been designated in Fig. 6, with three areas, T-1, T-2, and T-3, on the center taxiway, and two areas, A-1 and A-2, on the 1943 apron. Areas A-3 and A-4, on the main apron, are of more recent origin and represent resurfacing carried out in 1960, in which one experimental area included a wearing course of Epon asphaltic concrete, laid primarily as a protection against spillage of gasoline and oil in the apron area. While it might be termed an unanticipated
