**INTERIM REPORT ON  
EFFECTS OF CORROSION ON BRIDGES OF UNPAINTED  
A588 STEEL AND PAINTED STEEL TYPES**

**J. D. Culp  
G. L. Tinklenberg**

**Research Laboratory Section  
Testing and Research Division  
Research Project 78 G-241  
Research Report No. R-1142**

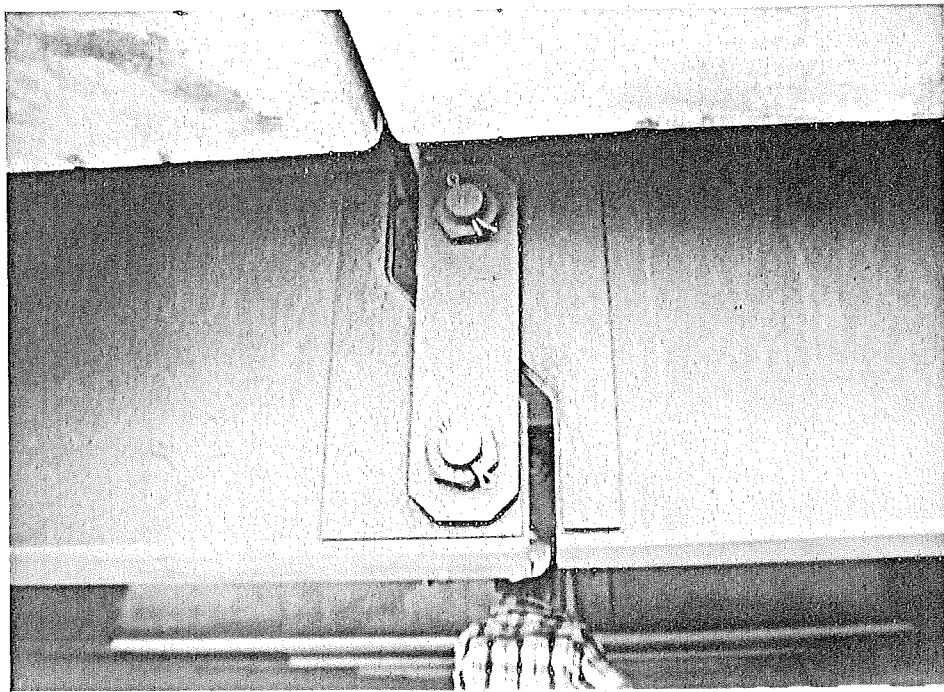
type of corrosion that occurs between two surfaces that are in close contact with each other in a corrosive environment. Its rate can be 10 to 100 times that of general corrosion. Galvanic corrosion is also an accelerated form of corrosion that occurs between two dissimilar metals placed in contact in a corrosive environment. Both of these situations occur behind the link plates on the cantilever expansion joint detail illustrated in Figure 10.

Figure 10. Cantilever expansion joint detail showing the link plate and link pin assembly.

The smooth ring outlined around the pin hole in Figure 13 occurred by galvanic corrosion action of the bronze washer that was used between the beam end and the link plates. Since bronze is cathodic (i.e., electrically positive) to steel when these two metals are placed in contact in a corrosive environment, the steel corrodes sacrificially to the bronze. This accounts for the sharp step that can be seen at the edge location of the bronze washer. Pit depths as much as 0.25 in. occurred in the beam end behind the link plates. The pin plates and pins were in such poor condition that we recommend that any maintenance work on this type of assembly include the replacement of link plates and pins, the coating of all joint surfaces with high performance coatings (such as zinc-rich epoxy with an epoxy topcoat) and the provision of some type of self-lubricating bushing between the link plate and pin. Some work has been done to evaluate the performance of the standard link plate and pin expansion detail on painted bridges. The two joints that have been disassembled show some of the same types of corrosion damage occurring. However, after about 20 years of service life the joints were not in as bad a condition as those of less than half that age in the unpainted condition. The detail is not a good one from a corrosion perspective, painted or unpainted, since it is impossible to maintain or lubricate it. We recommend the elimination of this detail whenever possible. The Department's Design Division is currently implementing this recommendation.

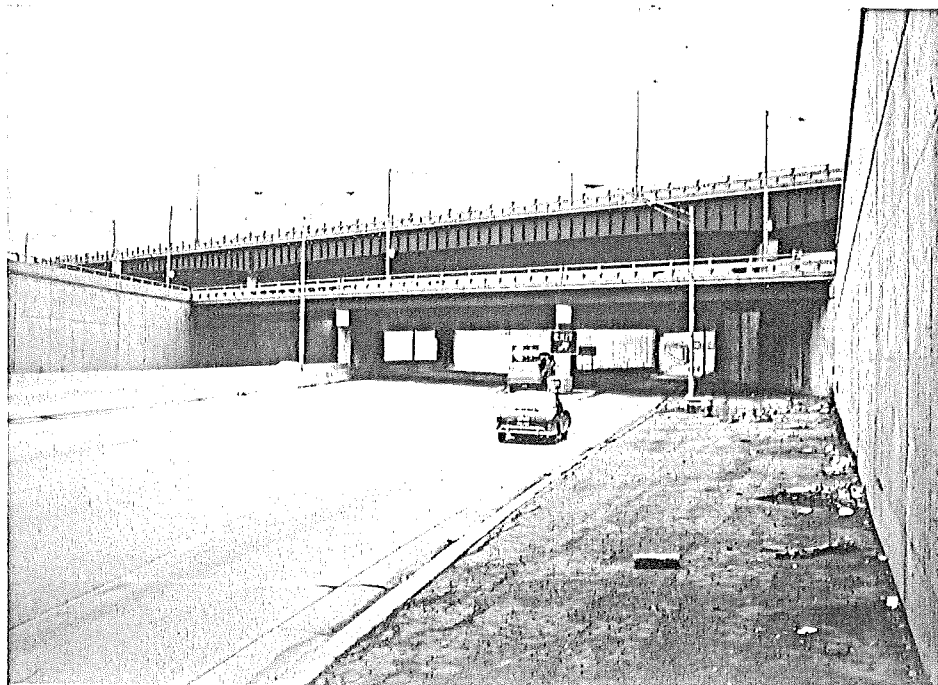
The effects of salt, sprayed and dusted on the bridge from highway traffic, are illustrated in Figures 14 and 15 for a bridge with 15 years of service life and Figures 16 and 17 for a bridge with 7 years of service life. This type of corrosion, where large sheets of rust build up and slough off, seems to have a periodic cycle that is related to the seasonal use of deicing salts. During the summer months a more normal rust layer may be observed in formation but the introduction of salt the next winter will penetrate this layer and again cause the sheet type failure. Any exposure of A588 steel that has previously developed a "tightly adherent patina" will not afford protection against corrosive contaminants since they can easily penetrate the rust layer and result in accelerated corrosion.

Figure 14. Geometry of bridge (lower structure) where salt spraying and dusting contaminates the unpainted steel.
