RESEALING OF OLD EXPANSION JOINTS WITH BITUMINOUS-  
RUBBER COMPOUND IN RELATION TO HIGHWAY MAINTENANCE

by  
Bryant W. Peacock  
and  
William Martin

Research Project 36 G-4 (3) F  
in conjunction with  
Research Project 36 G-4 (6)

Research Laboratory  
Testing and Research Division  
Report R-94  
March 14, 1947

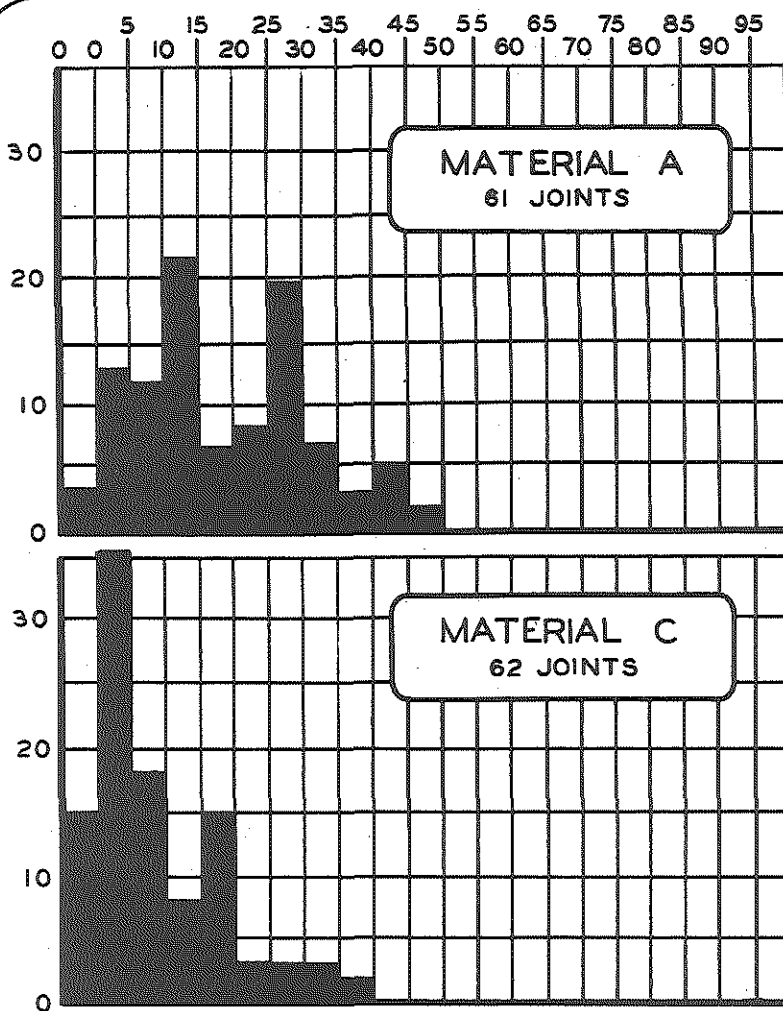
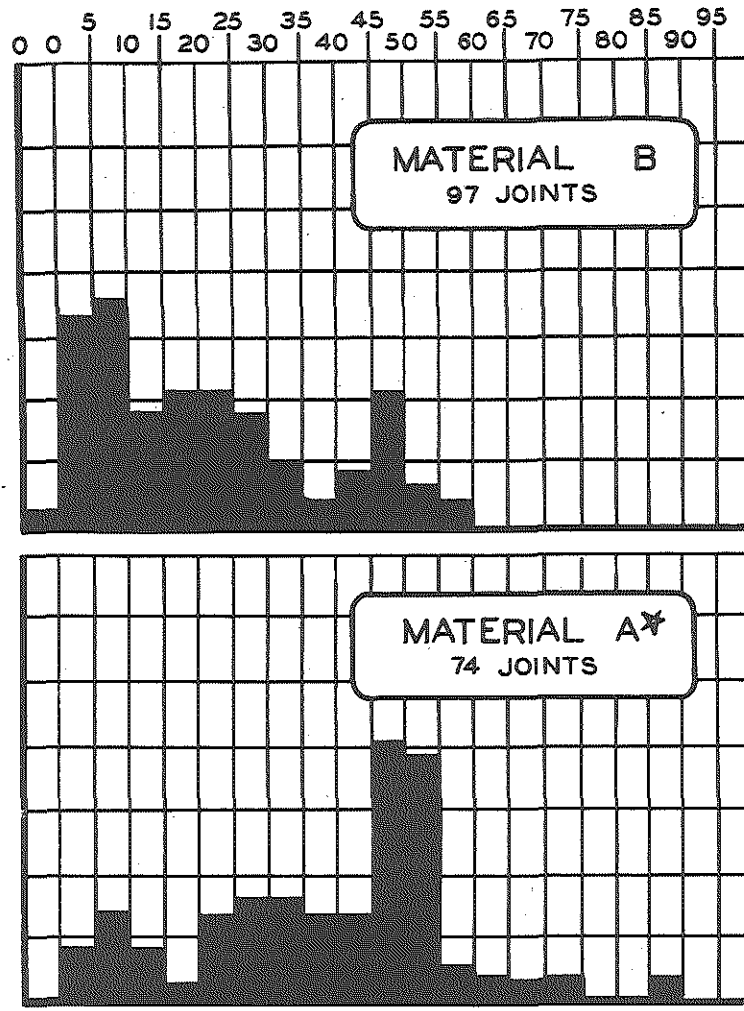
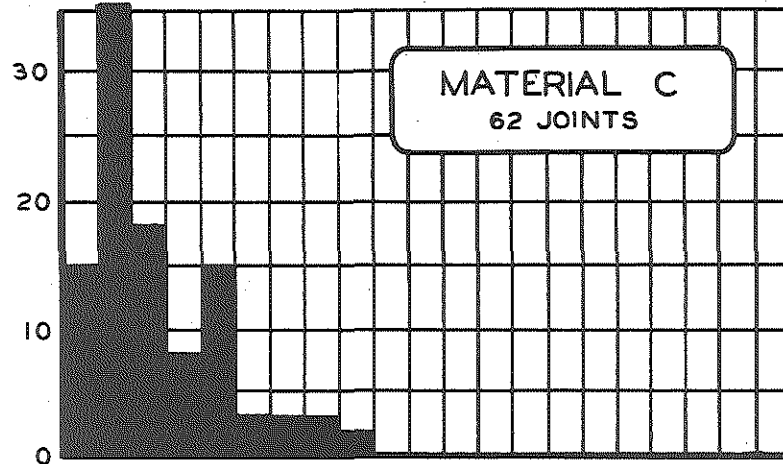
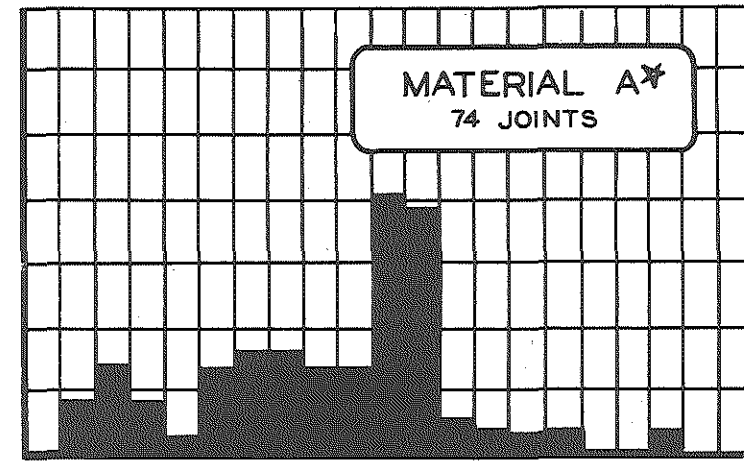
COMPARISON of ADHESION FAILURE in RELATION to FREQUENCY DISTRIBUTION of EACH MATERIAL

The chart in Figure 13 shows the frequency with which joints exhibited varying percentages of failure in adhesion. The ordinates are the numbers of joints within the failure brackets expressed as percentages of the total number of joints for each seal. Along the abscissae are plotted the failure brackets expressed as percentages of the total linear feet of joint face (40 feet). Here again, significant differences are seen among materials, material C showing up by far the best.
