R-319

1959 ROAD TEST ON 1,000 GALLONS OF  
3M CENTERLITE PREBEADED WHITE TRAFFIC PAINT

Research Laboratory Division  
Office of Testing and Research  
Report No. 319  
Research Project 47 G-36(12b)

Michigan State Highway Department  
John C. Mackie, Commissioner  
Lansing, December 1959

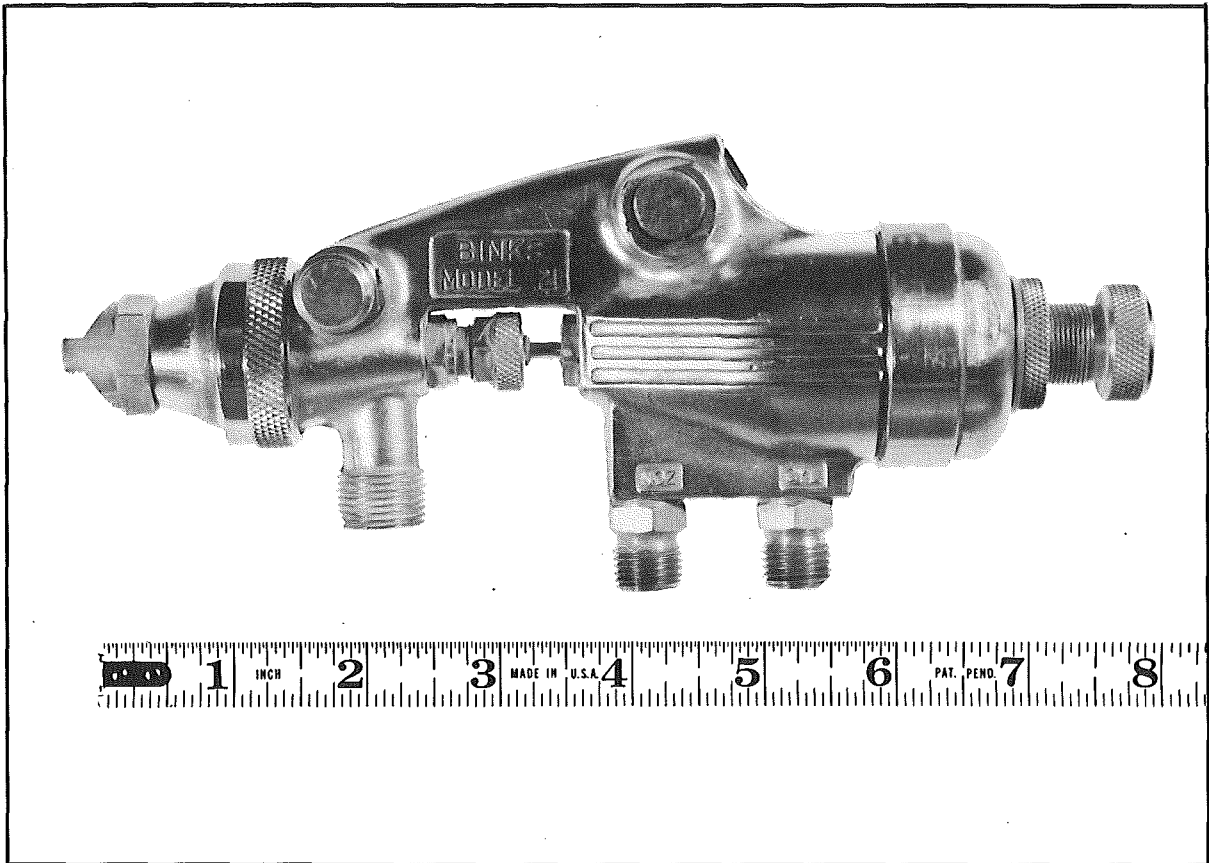
Figure 1. Assembled standard spray gun.

Fig. 1 shows an assembled spray gun, standard on roadway striping equipment and also the type used in the tests, and Fig. 2, the gun interior parts subject to wear and replacement.
