**MDOT RC-1617B**

**Evaluation of Bridge Decks Using  
Non-Destructive Evaluation (NDE)  
at Near Highway Speeds  
for Effective Asset Management  
– Pilot Project**

**FINAL REPORT**

Michigan Department of Transportation

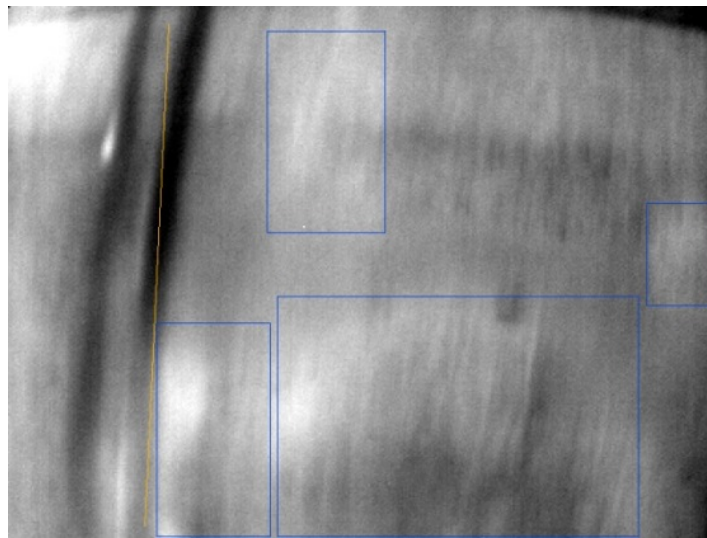
**Figure 4: Passive thermal imagery was processed and analyzed for the detection of potential delaminations (blue boxes).**

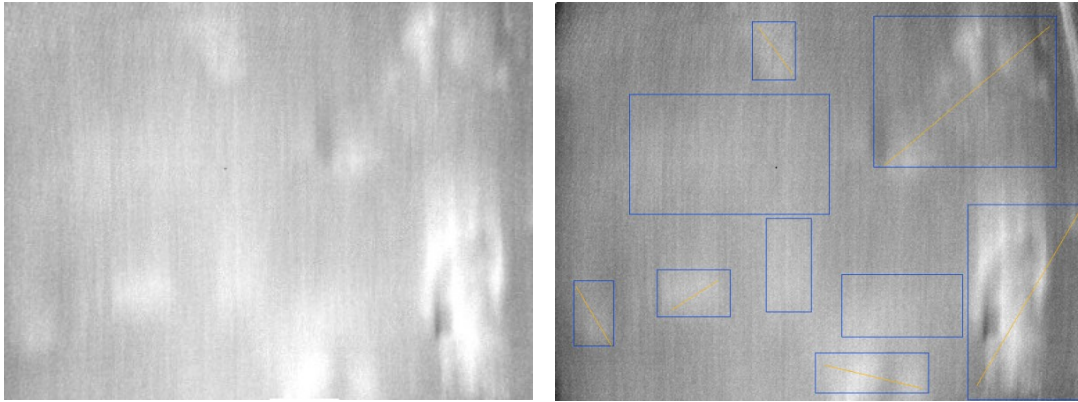
**Figure 7: Raw thermal imagery (left) and thermal imagery processed to highlight areas of potential delamination (right).**

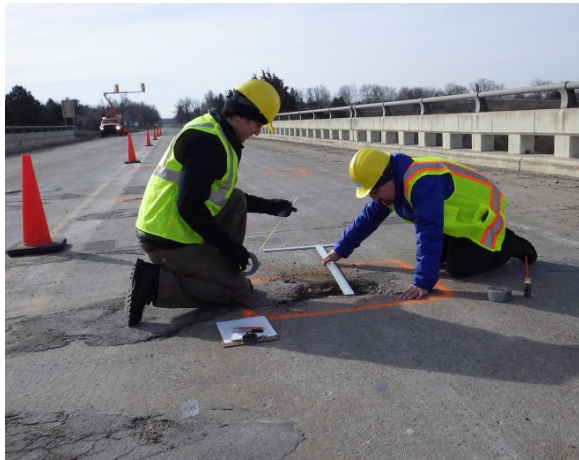
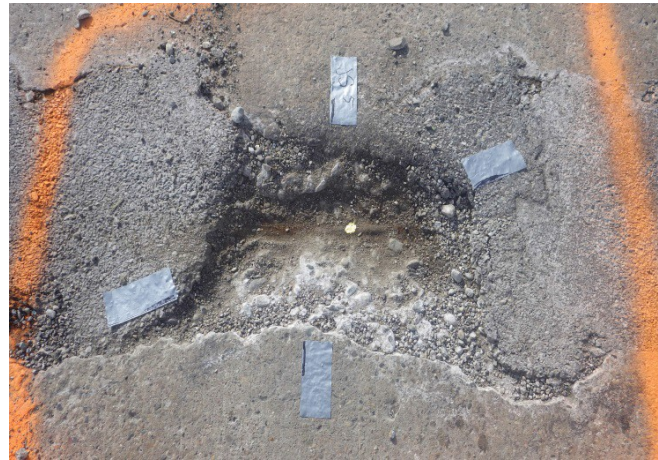
**Figure 12: Manual measurements the length, width, and depth of spall and patch features on the bridge deck.**

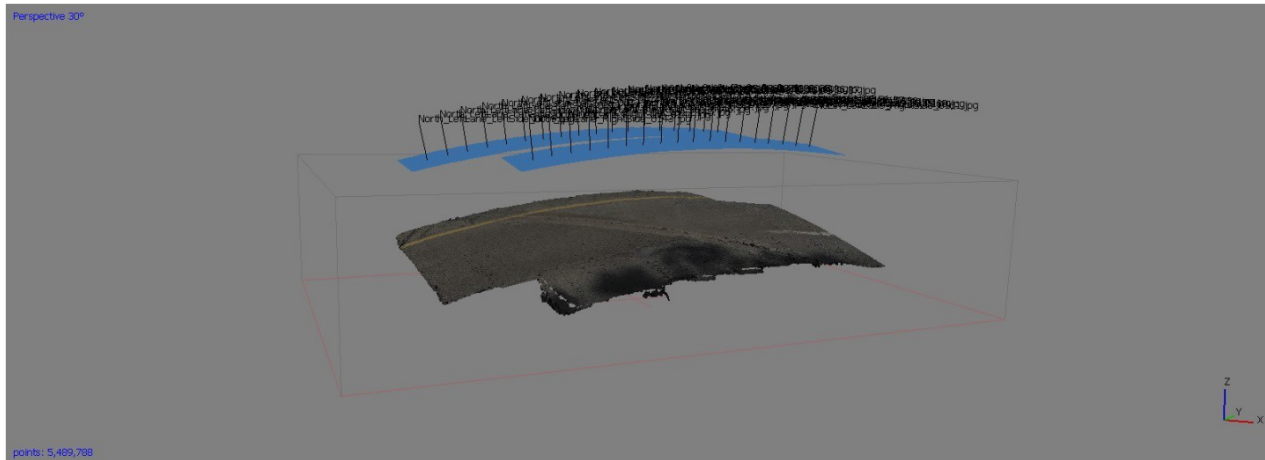
Despite having the extra overlap, the project team was unable to reconstruct 3D models of the bridge decks early in the project. As noted by the high deck surface rating of 8, the 8 Mile Rd bridge deck did not contain any spalling, I-696 and US-131 NB/SB had very few and small spalls, and I-75 NB/SB had more spalls and patching than the others, but was still a mostly flat surface

with few distresses. The resulting models would be severely distorted and not of sufficient quality to make reliable and accurate measurements (Figure 15). Because the RED Epic imagery was unable to be processed into an orthoimage and DEM, the imagery was mosaicked and georeferenced to the high-resolution base maps layer within ArcGIS. While this process is more time consuming, it provided a high-resolution base layer for manually georeferencing the thermal imagery and spalls.

**Figure 15: Example of I-75 point cloud demonstrating the reconstruction challenges encountered.**

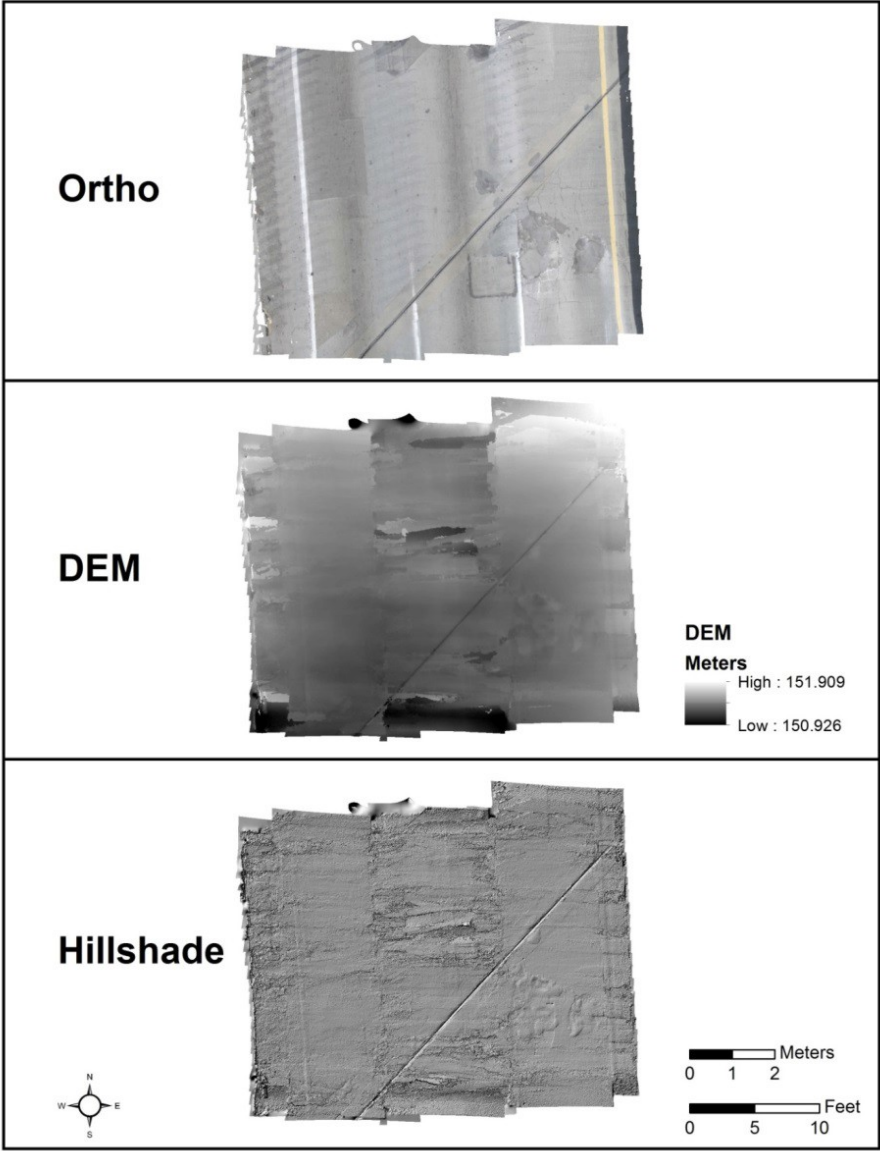
With the additional orientation defined, the north and southbound lanes of Lake Nepessing Rd were successfully reconstructed using only the geotagged RED frames. A 20 ft section of southbound I-75 using only the geotagged frames was processed as an example. Figure 16 shows the orthoimage, DEM, and Hillshade of this section. There are still parts of the 3D model, such as the edges and the center, where there is increased noise resulting in a jagged appearance in the DEM and Hillshade. This is a result of a flat road surface in the center of the model and reduced overlap at the edges. By comparison, the areas that contain the bridge joint and patching has less noise because there was more height variation.

**Figure 16: A roughly 20 ft section of I-75 SB processed through Agisoft using geotagged imagery and orientation parameters.**

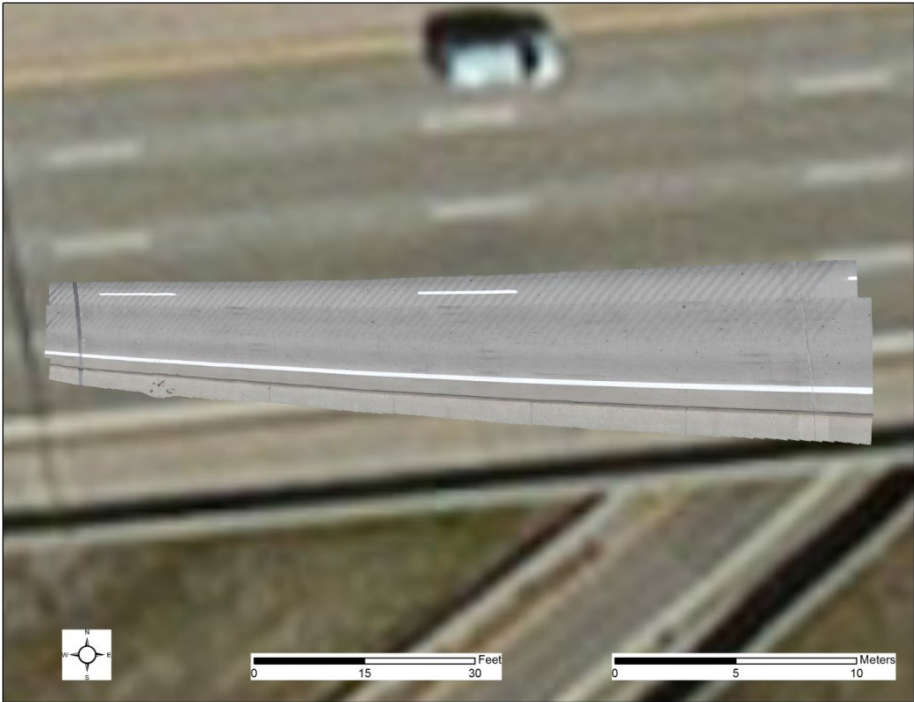
Including additional orientation information did not improve reconstruction modeling for all of the bridges in this study. However, I-696 and US-131 NB/SB, with deck surface ratings of 7 and 8/8, respectively, are very flat with very little spalling and patching, as compared to I-75 NB/SB. While adding camera orientation information was able to aid in the reconstruction of bridge decks with some height varying features, it was unable to correctly model those decks with no height variation. Figure 17 shows an example of a small section of the left lane of eastbound I-696, which was reconstructed using the additional orientation information. There is a 6 ft difference in lane width between the east and west side of the model and incorrect spatial position, showing that even with the additional information, excellent condition deck surfaces may not be accurately reconstructed.

**Figure 17: A section of I-696 modeled in Agisoft using geotagged RED imagery and camera orientation information.**

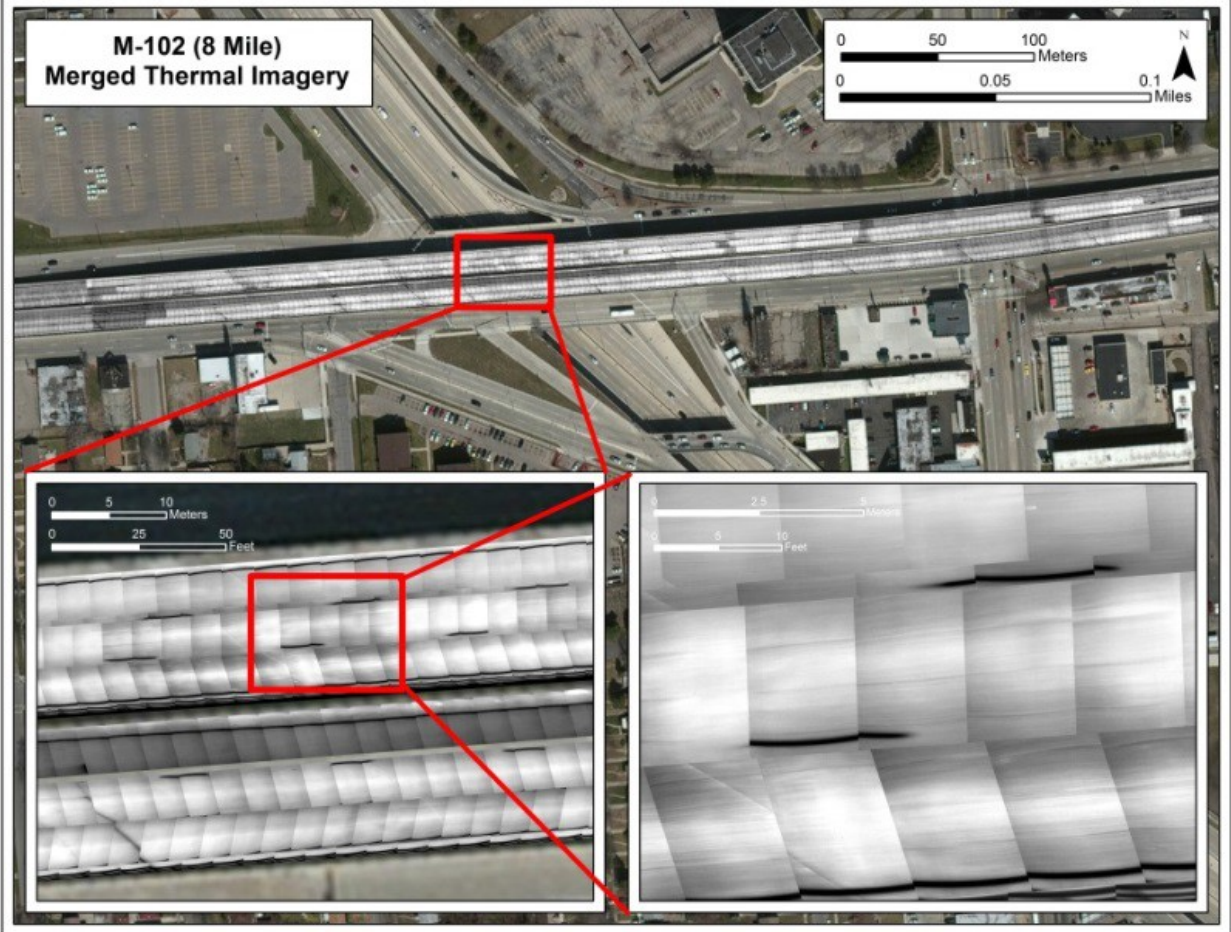
Similarly, the thermal imagery was also merged together through the same automated script. Individual frames were cropped and placed end-to-end, resulting in a single image for subsets of the bridge deck. The subsets were then merged together and georeferenced to ESRI base maps to create a single image per pass over the bridge (Figure 24). GS Infrastructure, Inc. inspected the thermal imagery and indicated any location that appeared to have a potential delamination. The merged optical and thermal images can then be placed on top of another and by using transparent layers in the GIS software; a better overview of where potential delaminations exist on the bridge deck can be seen (Figure 25). In total, 398 potential delaminations were identified by GS Infrastructure, Inc., totaling an area of 2,942 ft<sup>2</sup>, or approximately 1.73% of the entire bridge deck.

**Figure 24: Merged thermal imagery merged of M-102 (8 Mile) eastbound and westbound bridge decks.**

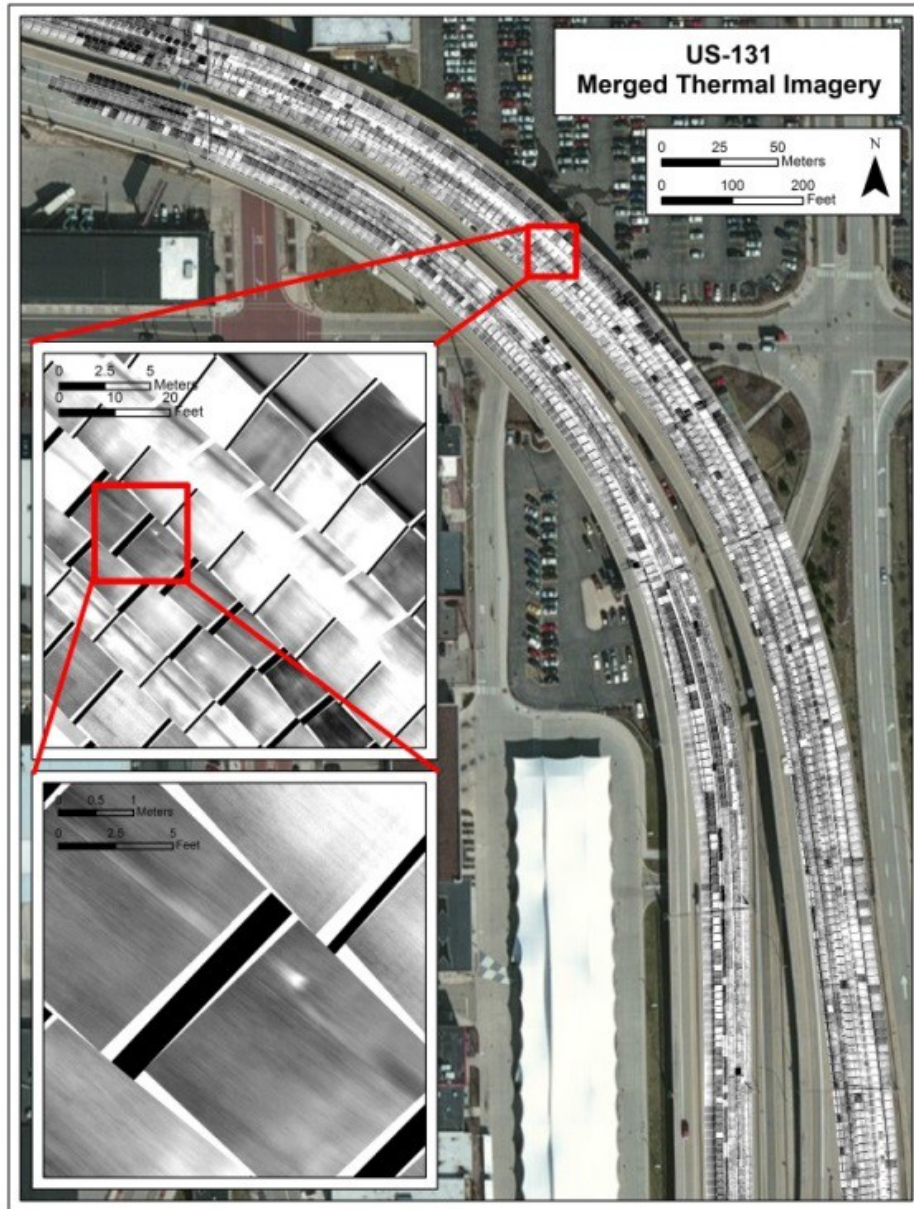
Figure 27: Merged thermal imagery of US-131 northbound and southbound bridge decks.

After merging the thermal imagery from US-131 through the use of the automated merging script, the merged output was georeferenced to ESRI base maps (Figure 27). GS Infrastructure, Inc. inspected the thermal imagery and indicated any location that appeared to have a potential delamination. The merged optical and thermal images were then placed on top of one another and through the use of transparent layers in the GIS software, an overview of potential delaminations and spalls appear on the bridge deck (Figure 28). In total, 133 potential delaminations (34 northbound and 90 southbound) were identified by GS Infrastructure, Inc. totaling an area of 532 ft<sup>2</sup>, or approximately 0.25% of both bridge decks combined. For the overall summary of each span's condition, please reference figures 41 and 42 and tables 9 and 10 in Section 4.3.6.

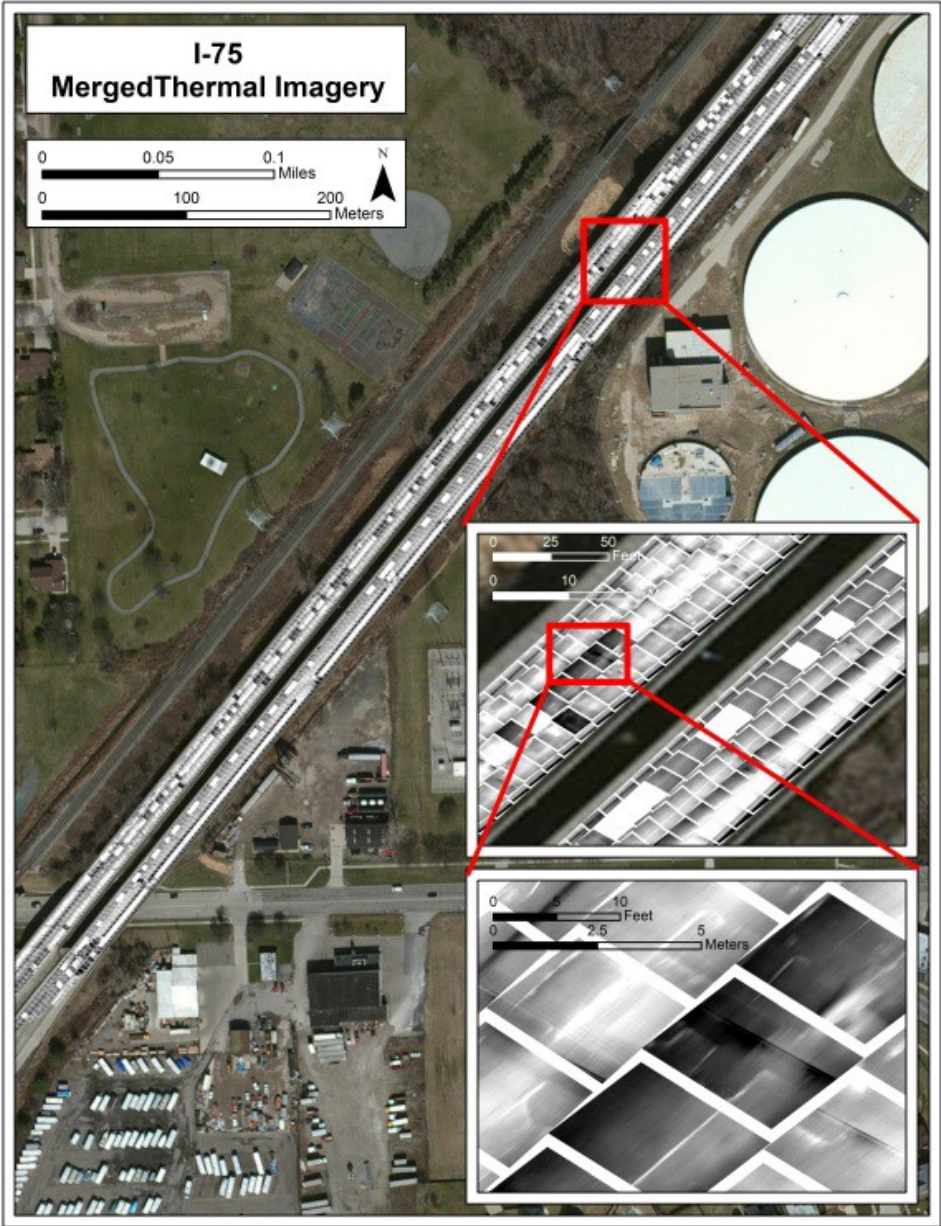
Figure 30: Merged thermal imagery of I-75 northbound and southbound bridge decks.

through the use of the automated merging script, the merged output was georeferenced to ESRI base maps (Figure 30). GS Infrastructure, Inc. inspected the thermal imagery and indicated any location that appeared to have a potential delamination. The merged optical and thermal images were then placed on top of one another and through the use of transparent layers in the GIS software, an overview of potential delamination locations and spalling appear on the bridge (Figure 31). In total, 1,877 potential delaminations (515 northbound and 1,362 southbound) were identified by GS Infrastructure, Inc. totaling an area of 16,328 ft<sup>2</sup>, or approximately 8.50% of both bridge decks combined. As previously noted, spalls and delaminations are color-coded by condition state as noted in AASHTO BEIM (2015). For the overall summary of each span's condition, please reference figures 43 and 44 and tables 11 and 12 in Section 4.3.6.

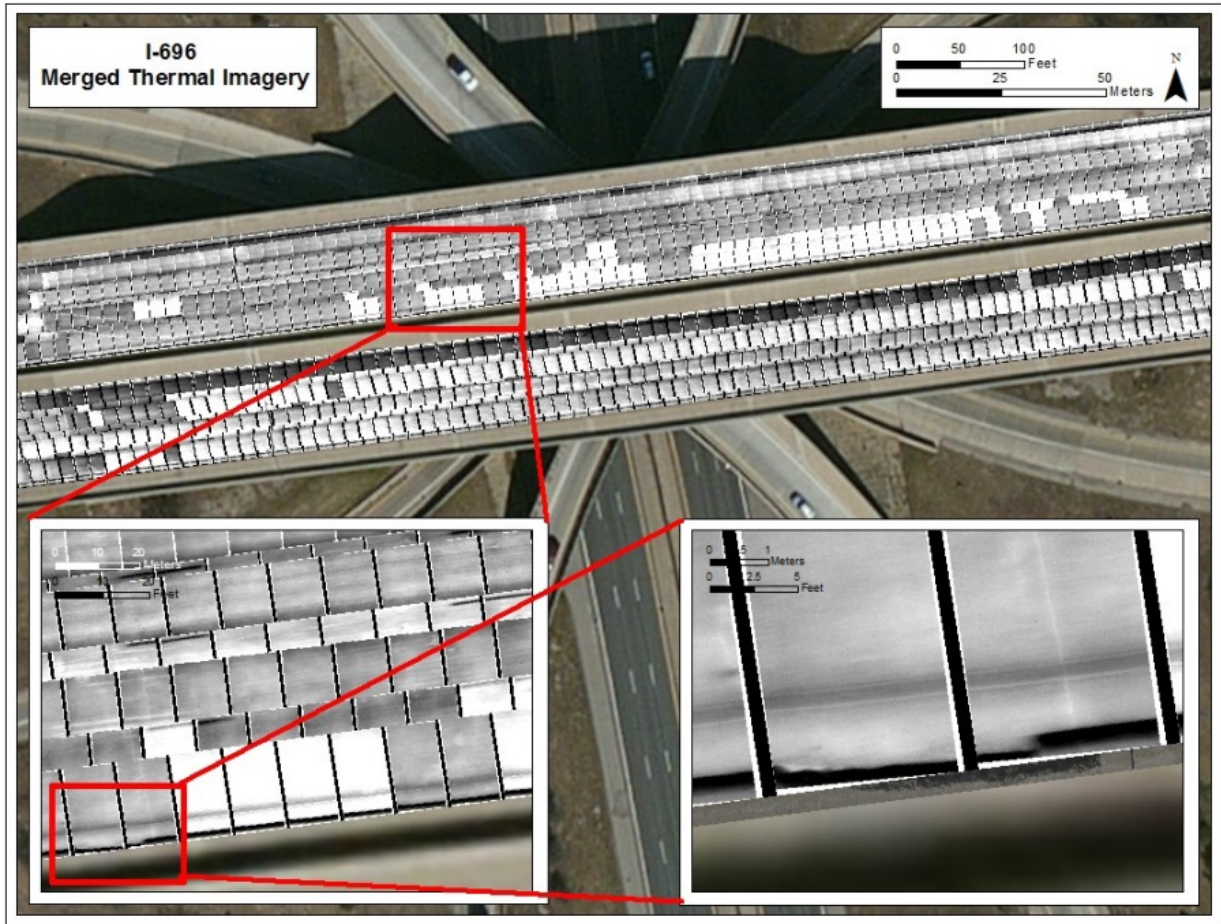
Figure 33: Merged thermal imagery of the I-696 bridge deck.

After merging the thermal imagery from I-696 through the use of the automated merging script, the merged output was georeferenced to ESRI base maps (Figure 33). GS Infrastructure inspected the thermal imagery and indicated any location that appeared to have a potential

delamination. The merged optical and thermal images were then placed on top of one another and through the use of transparent layers in the GIS software, a better overview of where potential delaminations exist and how it appears on the bridge deck can be seen (Figure 34). In total, 203 potential delaminations were identified by GS Infrastructure, Inc., totaling an area of 1,125 ft<sup>2</sup>, or approximately 1.10%. For the overall summary of each span's condition, please reference Figure 45 and Table 13 in Section 4.3.6.

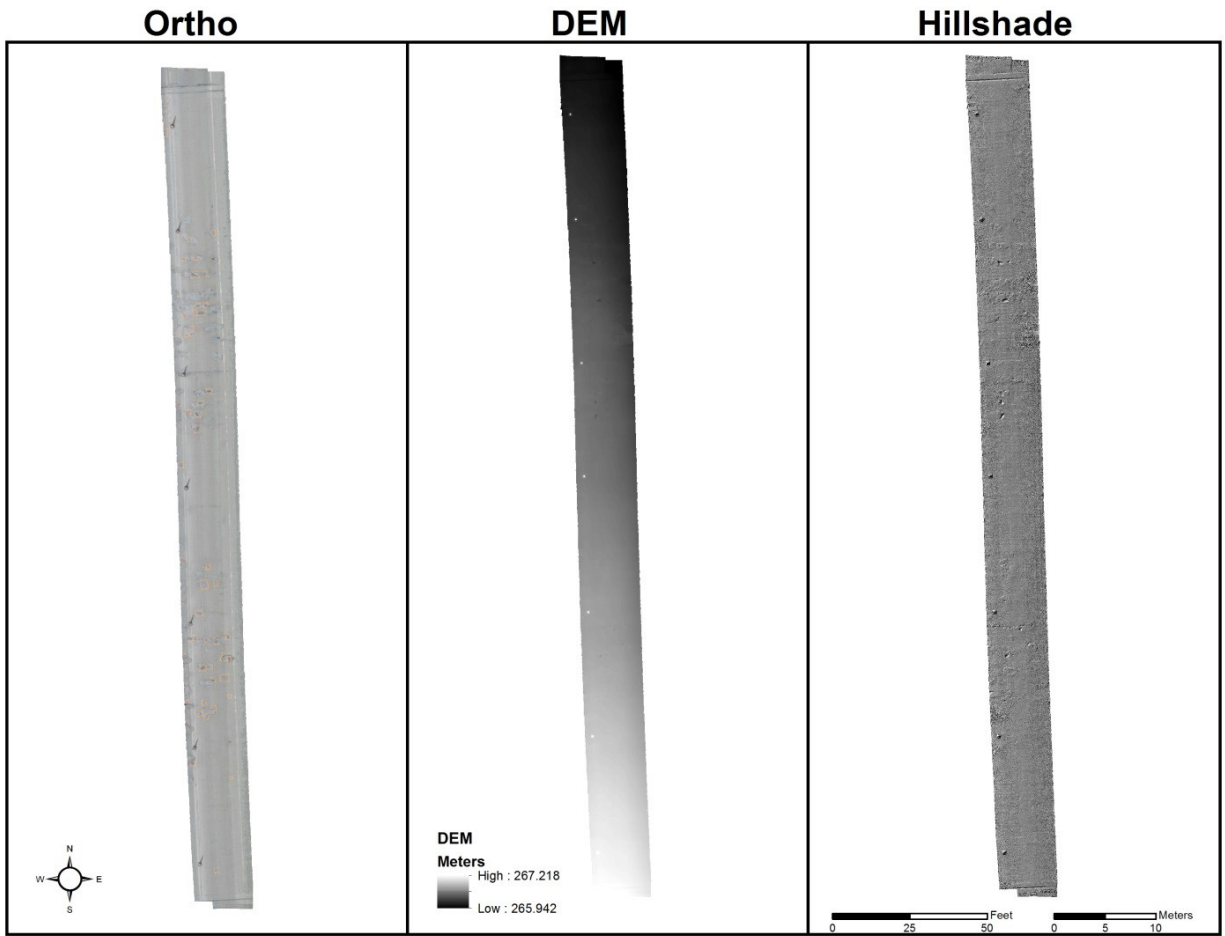
**Figure 35: Final products (Orthoimage, DEM and Hillshade) of the northbound lane of Lake Nepessing Rd. bridge deck.**

With the ability to process the RED Epic imagery through Agisoft PhotoScan, full models were created of each lane of the Lake Nepessing Rd. bridge deck (StrID: 5330) in Lapeer. Unlike the large deck bridges, the vehicle speed was limited to no more than 10 mph due to the space constraints of the required bridge lane closures. Both the north (Figure 35) and southbound (Figure 36) lanes were processed using the geotagged imagery. Each orthoimage has a resolution of 0.8 mm (~ 1/32 in.) and the DEM has a resolution of 3.2 mm (~1/8 in.). The orthoimage was used to calculate the length and width of each spall and patch while the DEM is used to calculate the depth of the spalls. Also shown in Figures 37 and 38 are hillshade views generated to produce a shadowed 3D image of the DEM through ArcGIS.

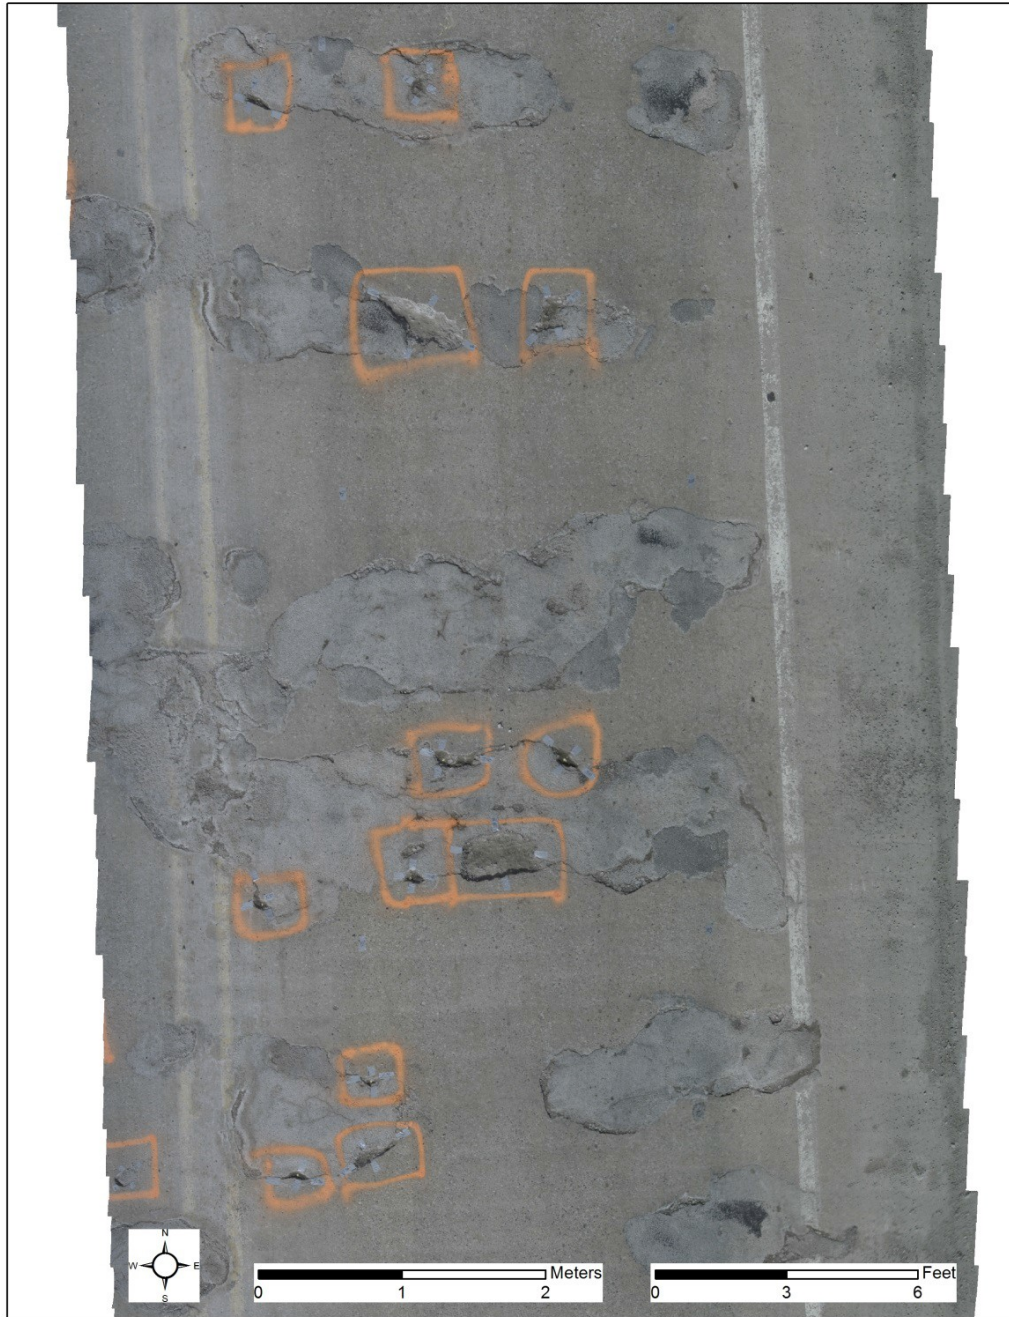
**Figure 37: Zoomed in portion of the Orthoimage of northbound Lake Nepessing Rd. bridge deck.**

Figure 37 shows a zoomed in section of the northbound lane of Lake Nepessing Rd. bridge deck. With a high-resolution orthoimage model, spalls and patches can be located and measured to compare to the in situ measurements. The hillshade of the DEM was reconstructed to show the detail of the patches and spalls (Figure 38). The increased noise on the right and left sides of the hillshade is a result of those areas being mostly flat and with less imagery overlap. There is less overlap on the sides than the center of the model. The edges were reconstructed from a single pass resulting in a point on the ground being represented in five frames. The center of the model was reconstructed from the overlap of both passes of the data collection resulting in a point on the ground being represented in at least 10 frames. The noise in the z-axis, or the amount of random error in the model reconstruction, in the center of the model is 0.16 in. (4.2mm) while on the sides of the model is up to 1.79 in. (4.5cm). Features such as spalls cannot be distinguished if they are less than this error.
