STATE HIGHWAY DEPARTMENT

December 20, 1962

Subject: Trenching for Expansion Joints. Research Project R-39 F-7(14). Report No. R-407.

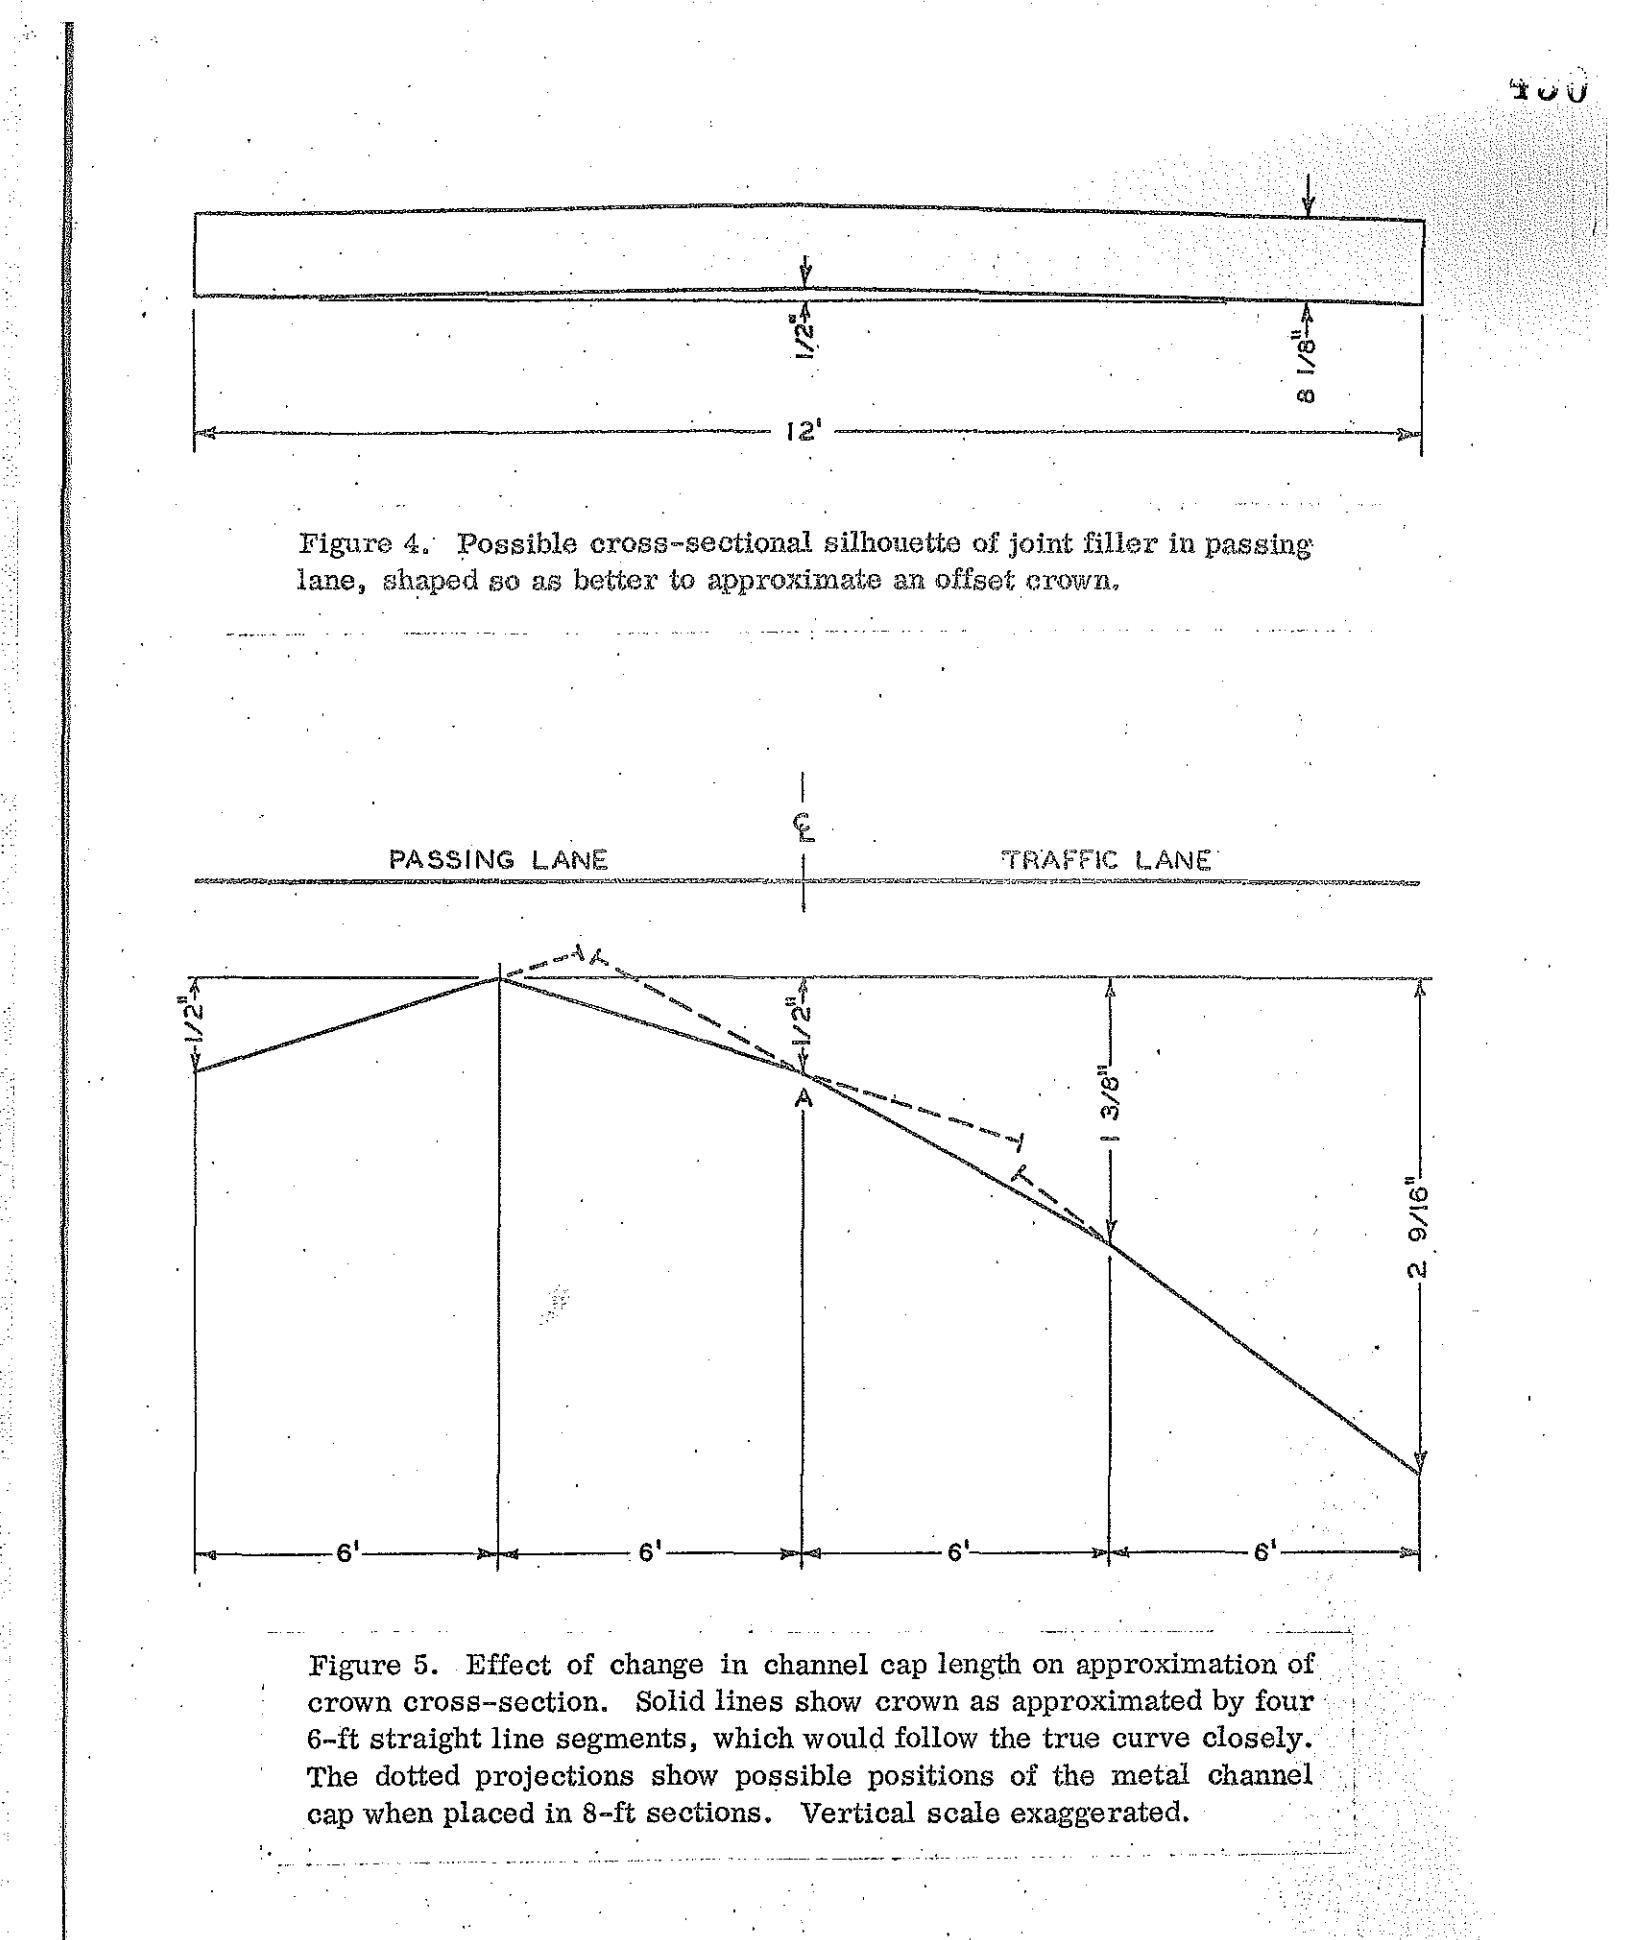
Another problem is that the metal channel cap, which is straight, cannot possibly conform to a curved or segmented filler. The channel rocks on high spots and is offset so as to form faults where channels end, as shown in Figs. 2 and 3. These metal protrusions increase the overall height of the assembly, and permit possible interference with the spreader and finishers.

Figure 3 (left). Another fault at junction of channels.
