PERFORMANCE OF HOT-POURED RUBBER-ASPHALT JOINT SEALING COMPOUNDS

Highway Research Project 53 G-71

Research Laboratory
Testing and Research Division
Report No. 220
May 19, 1955

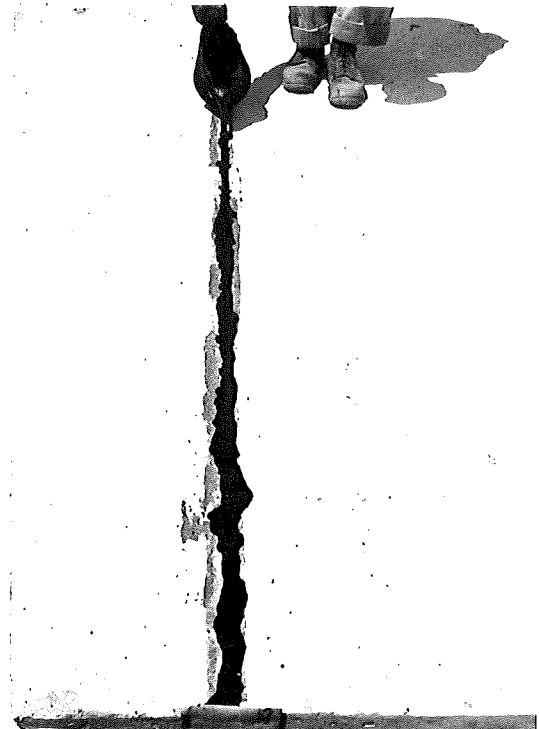
Examination of the joints just prior to sealing showed them to be free of all extraneous matter except for a very fine dust on the joint faces. This dust, observable only by wiping the finger tips across the joint faces, apparently results from cement laitance. Examination of a joint sealed the previous day indicated that adhesion was fair but not perfect. This lack of perfect adhesion, as seen in Figure 16, appeared to result from the fine laitance dust just described.

FIGURE 16. JOINT SEALED BY SARGENT CONSTRUCTION COMPANY. ADHESION GOOD BUT NOT PERFECT.
