**MICHIGAN DEPARTMENT OF TRANSPORTATION
MDOT**

THREE YEAR EVALUATION OF WHITETOPPING PROJECT ON M-46

Testing and Research Section
Construction and Technology Support Area
Research Project 98 G-0322
Research Report R-1417

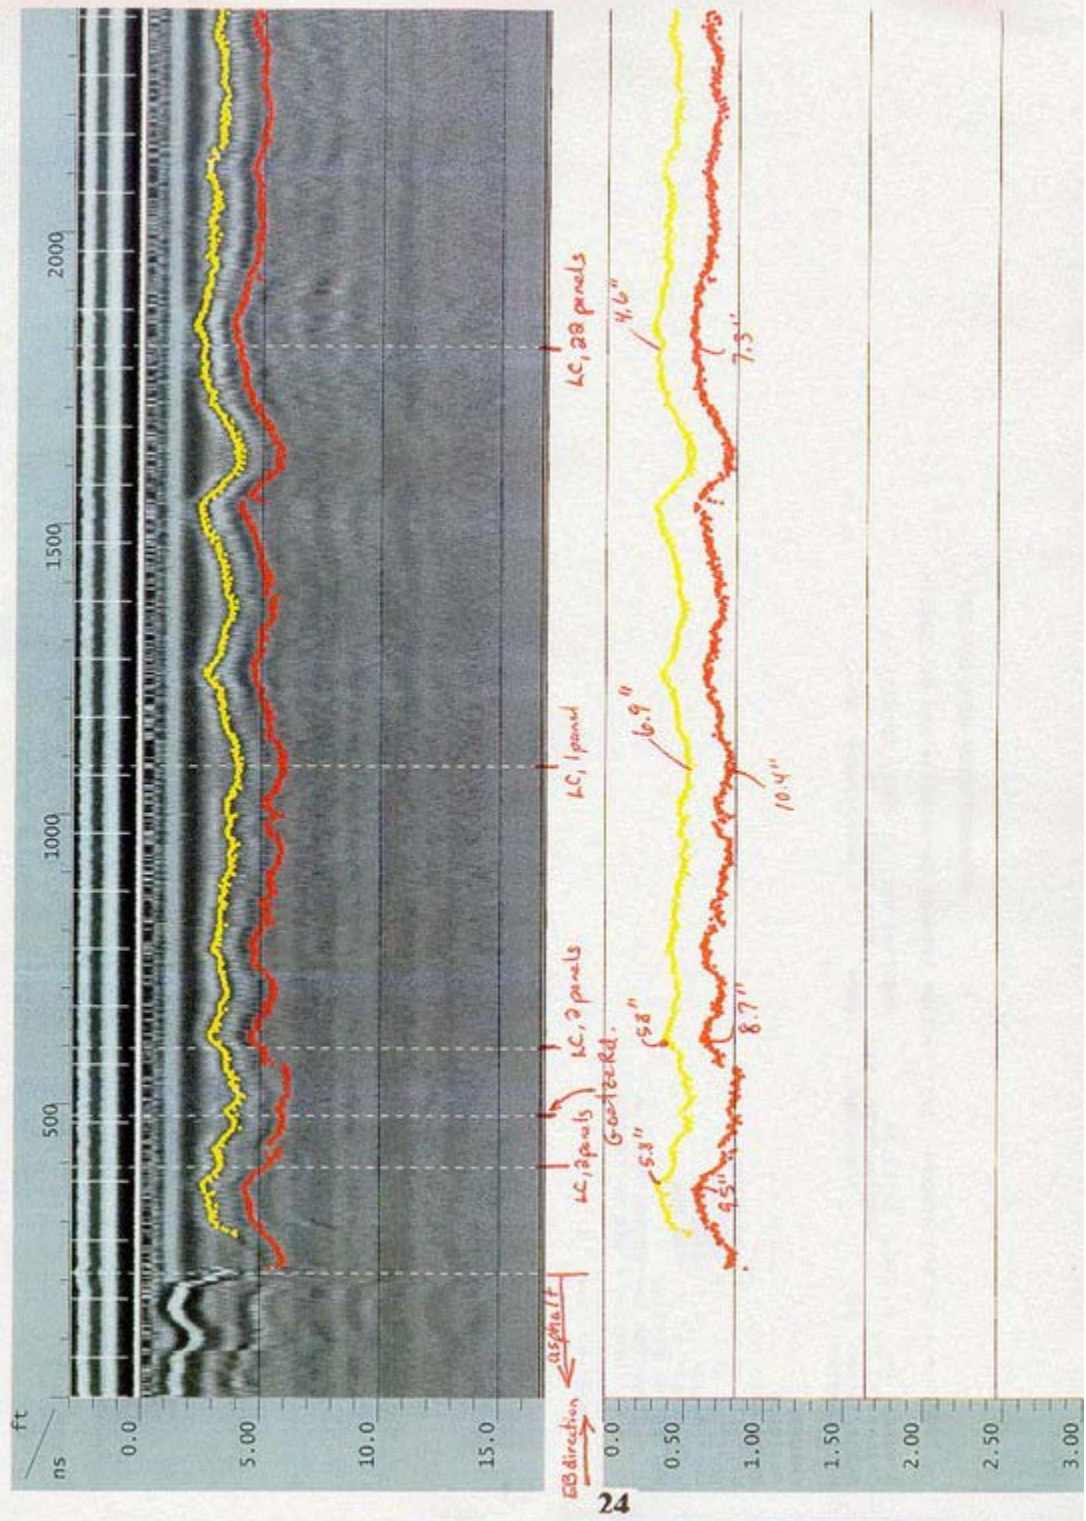
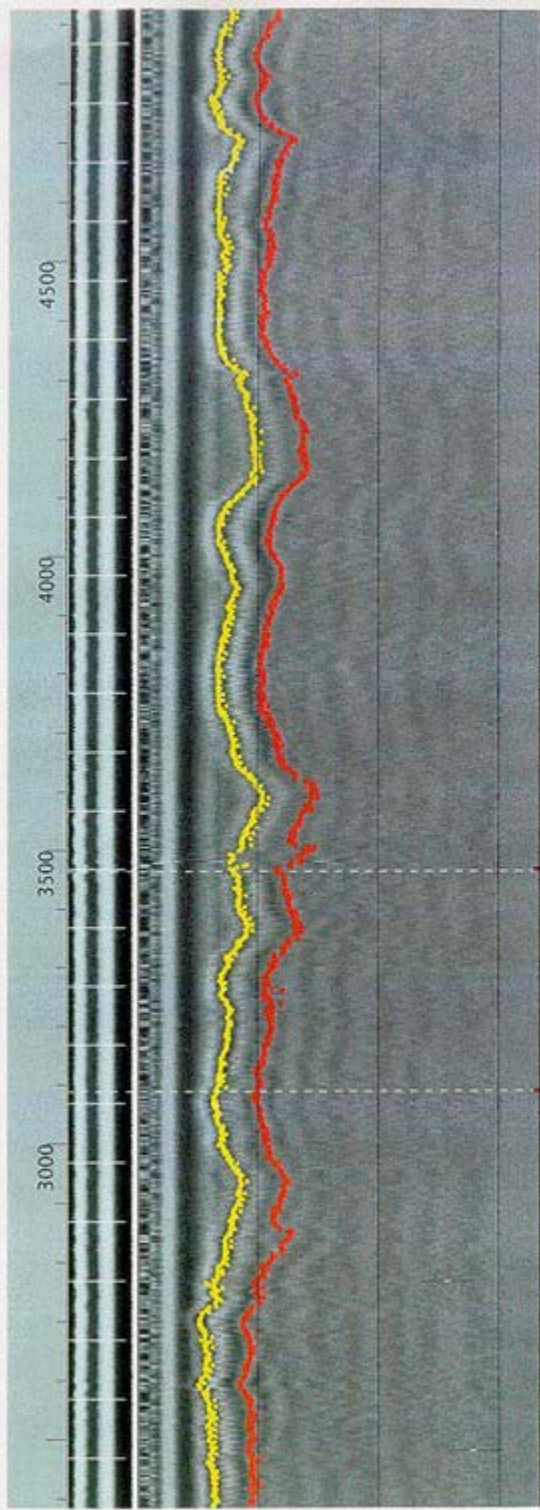
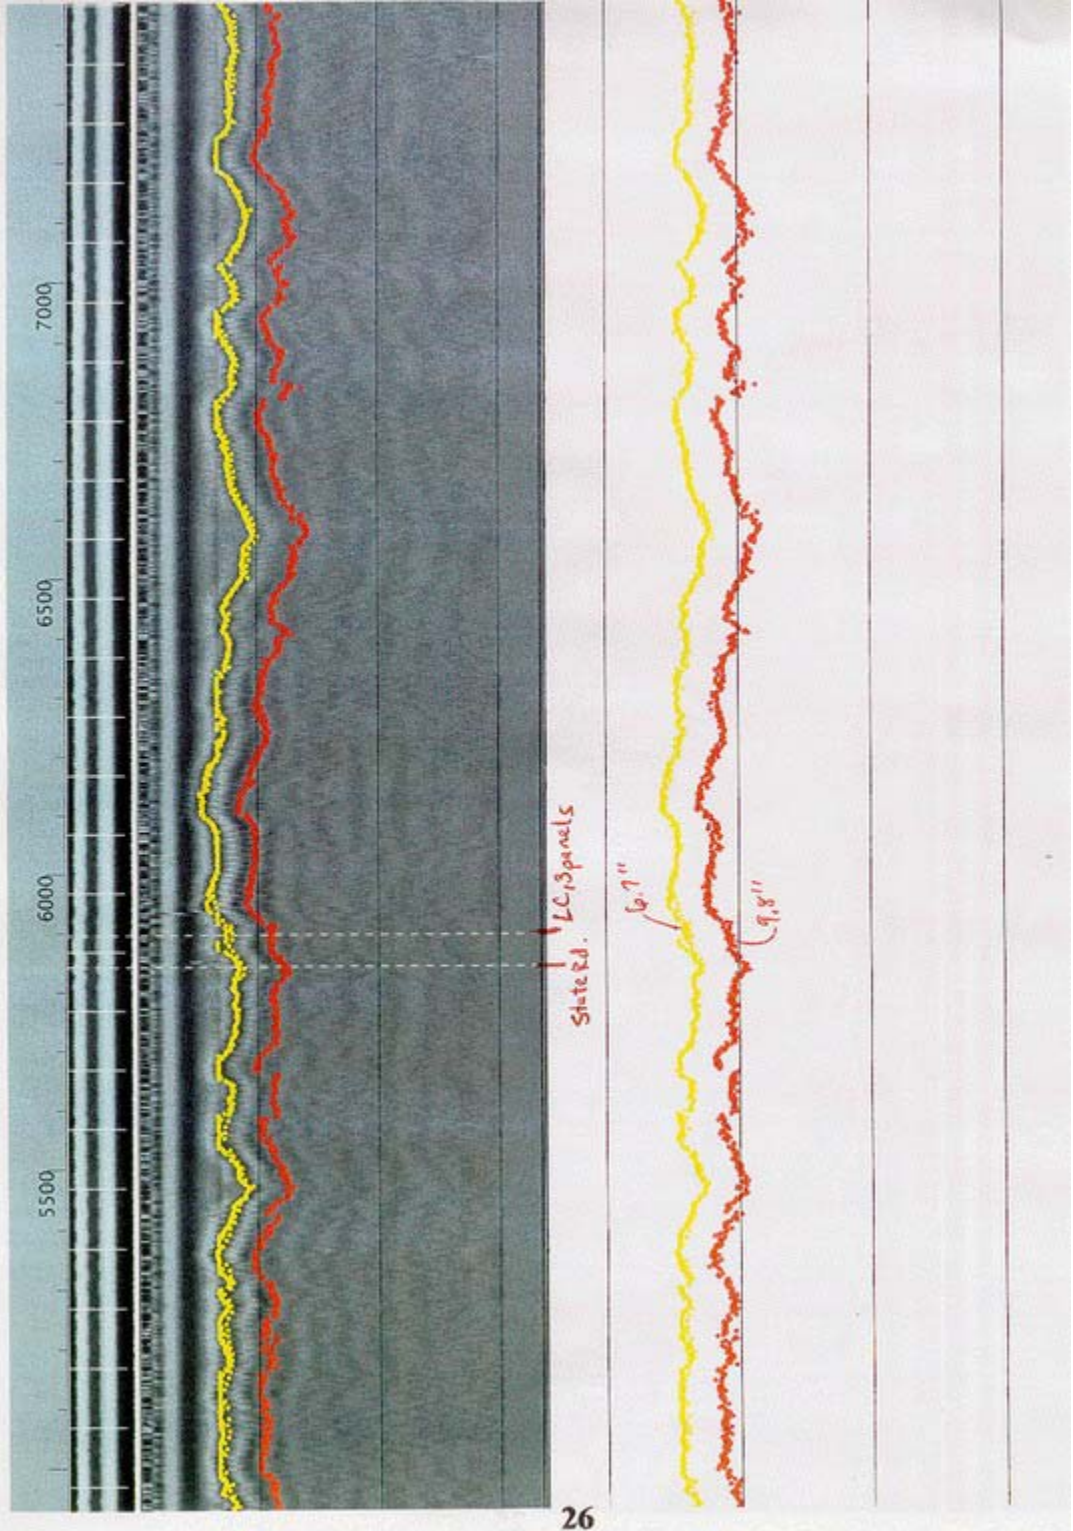
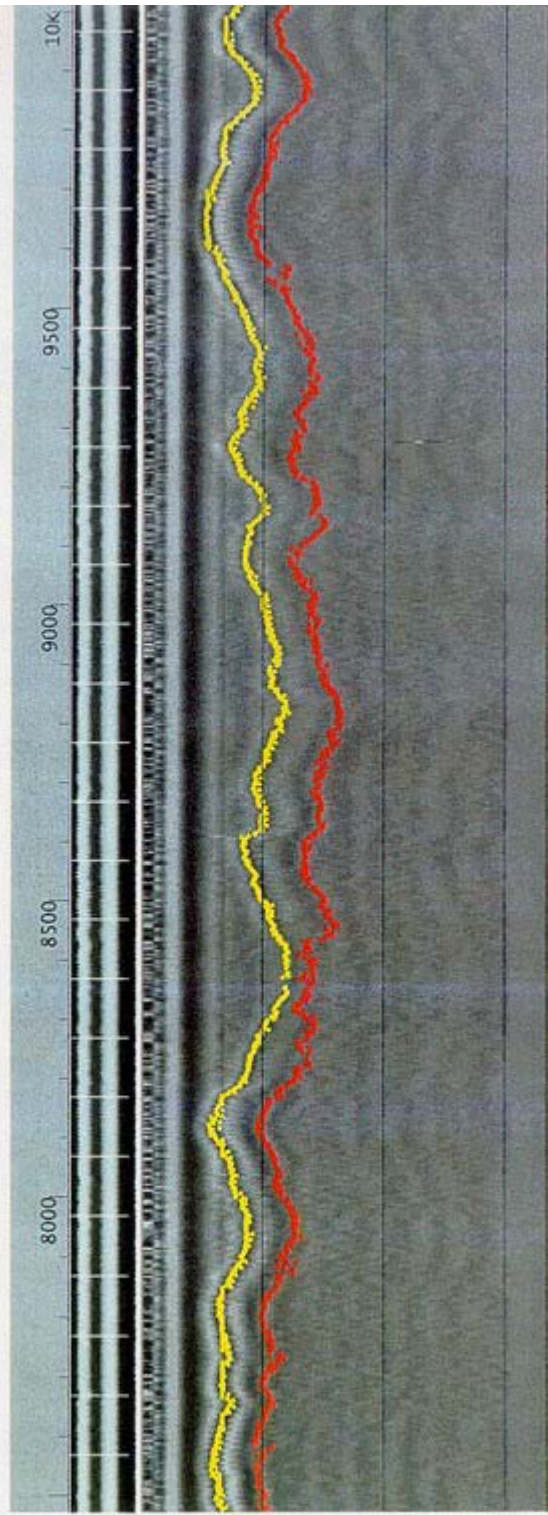
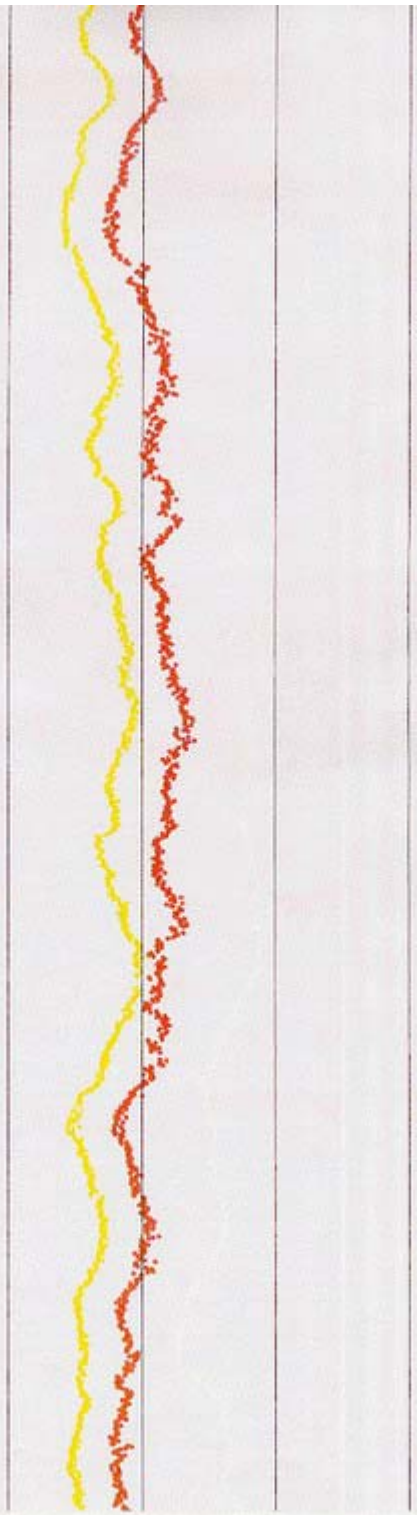
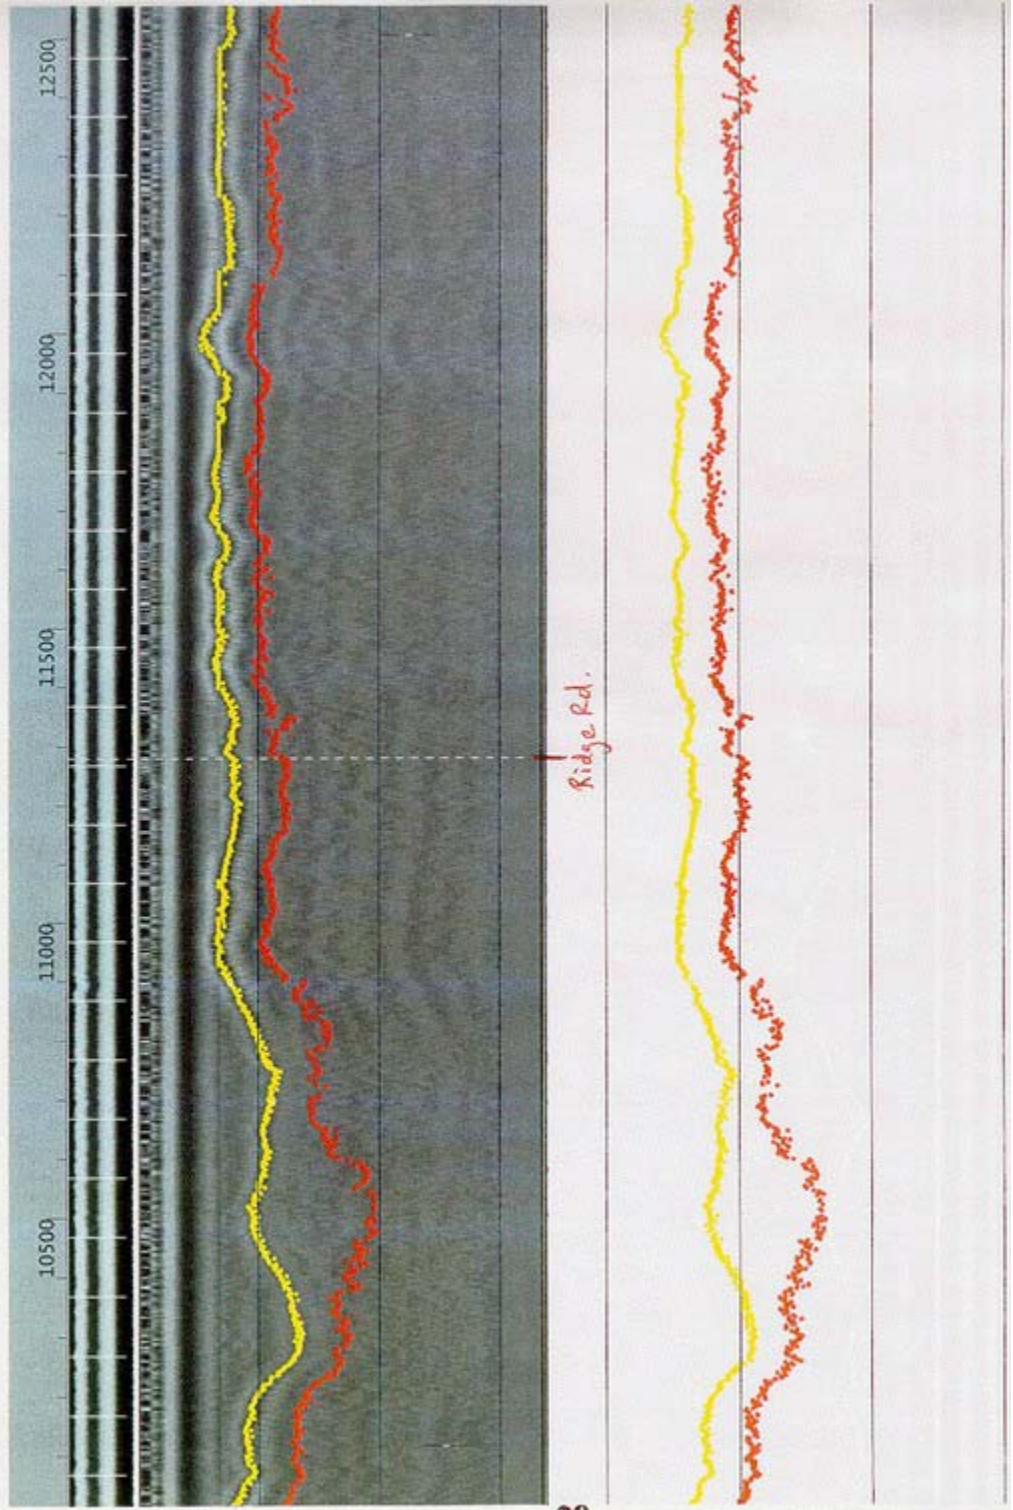
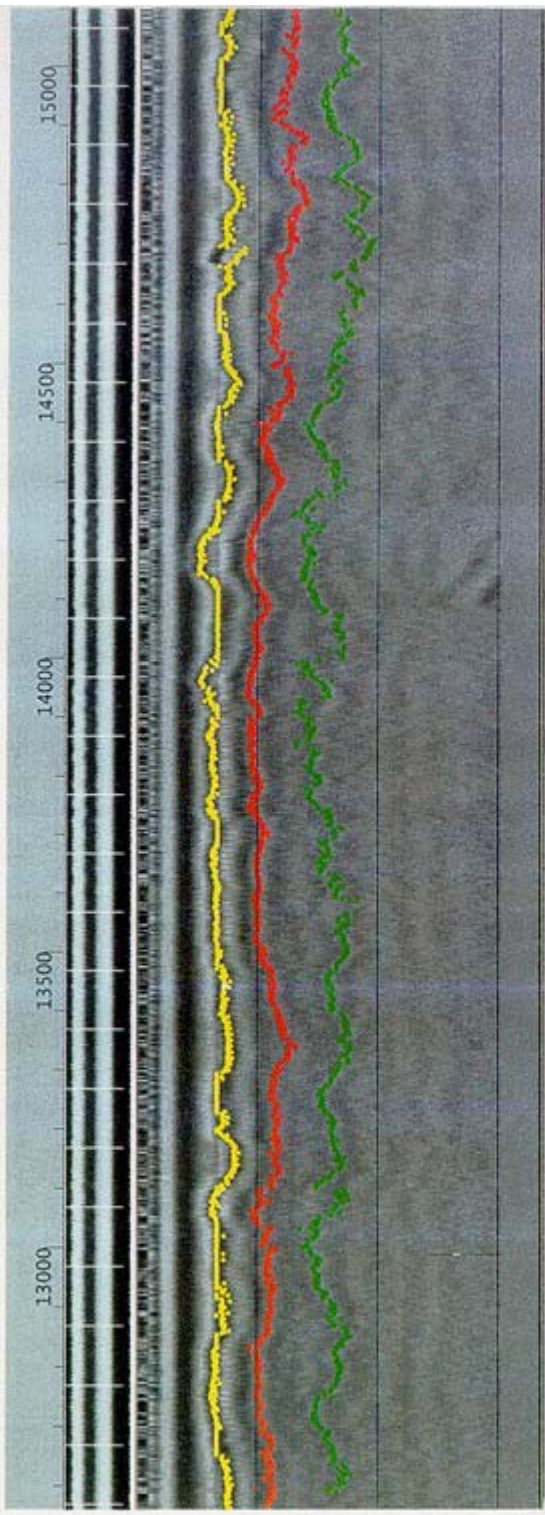
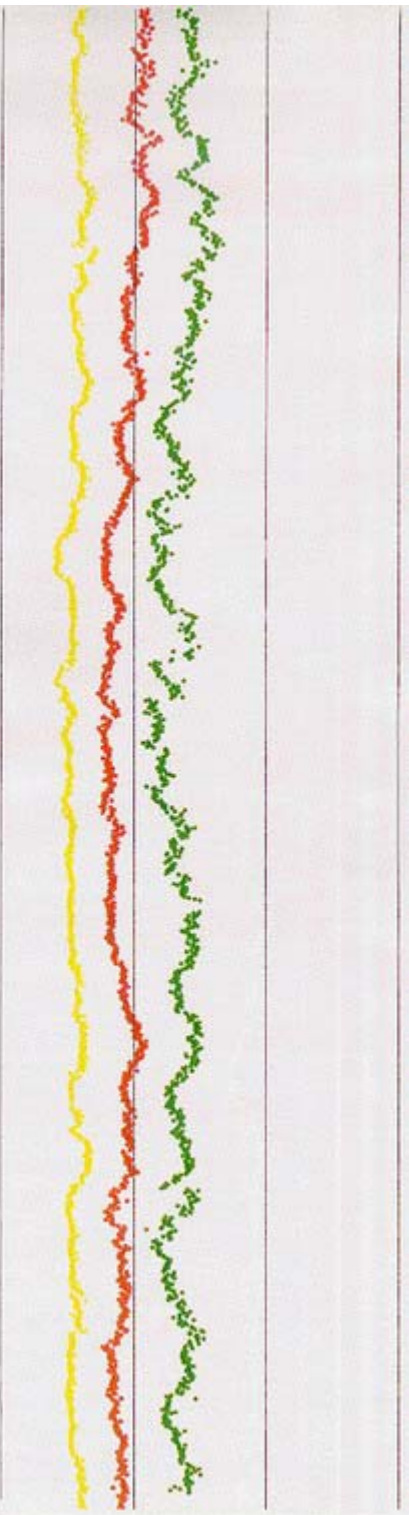
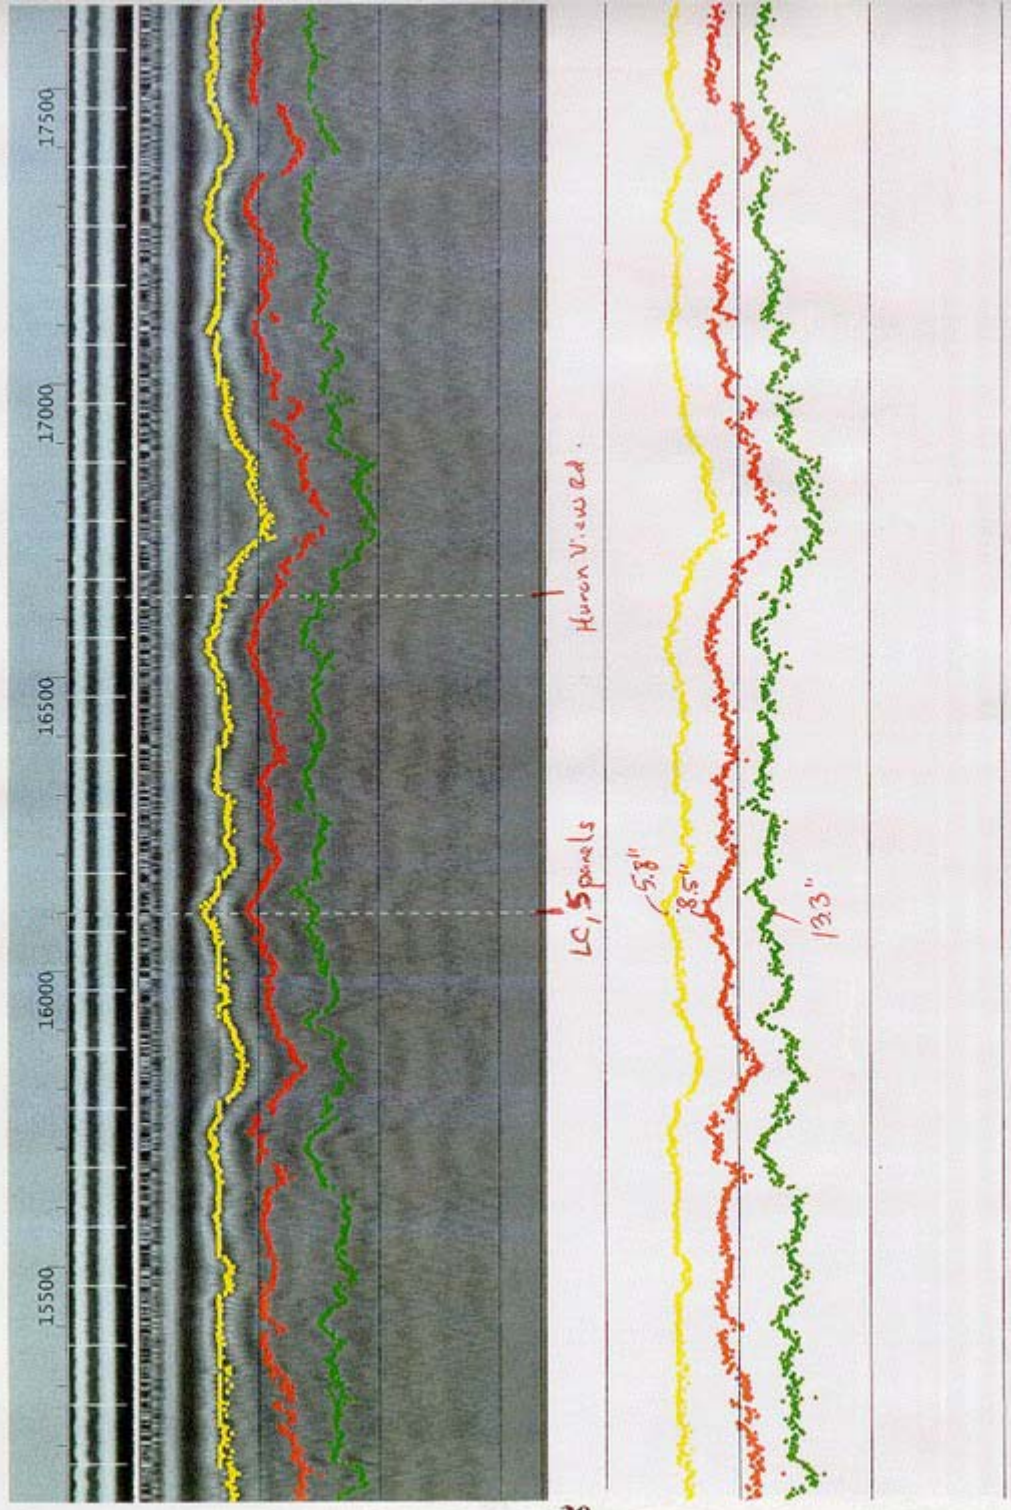
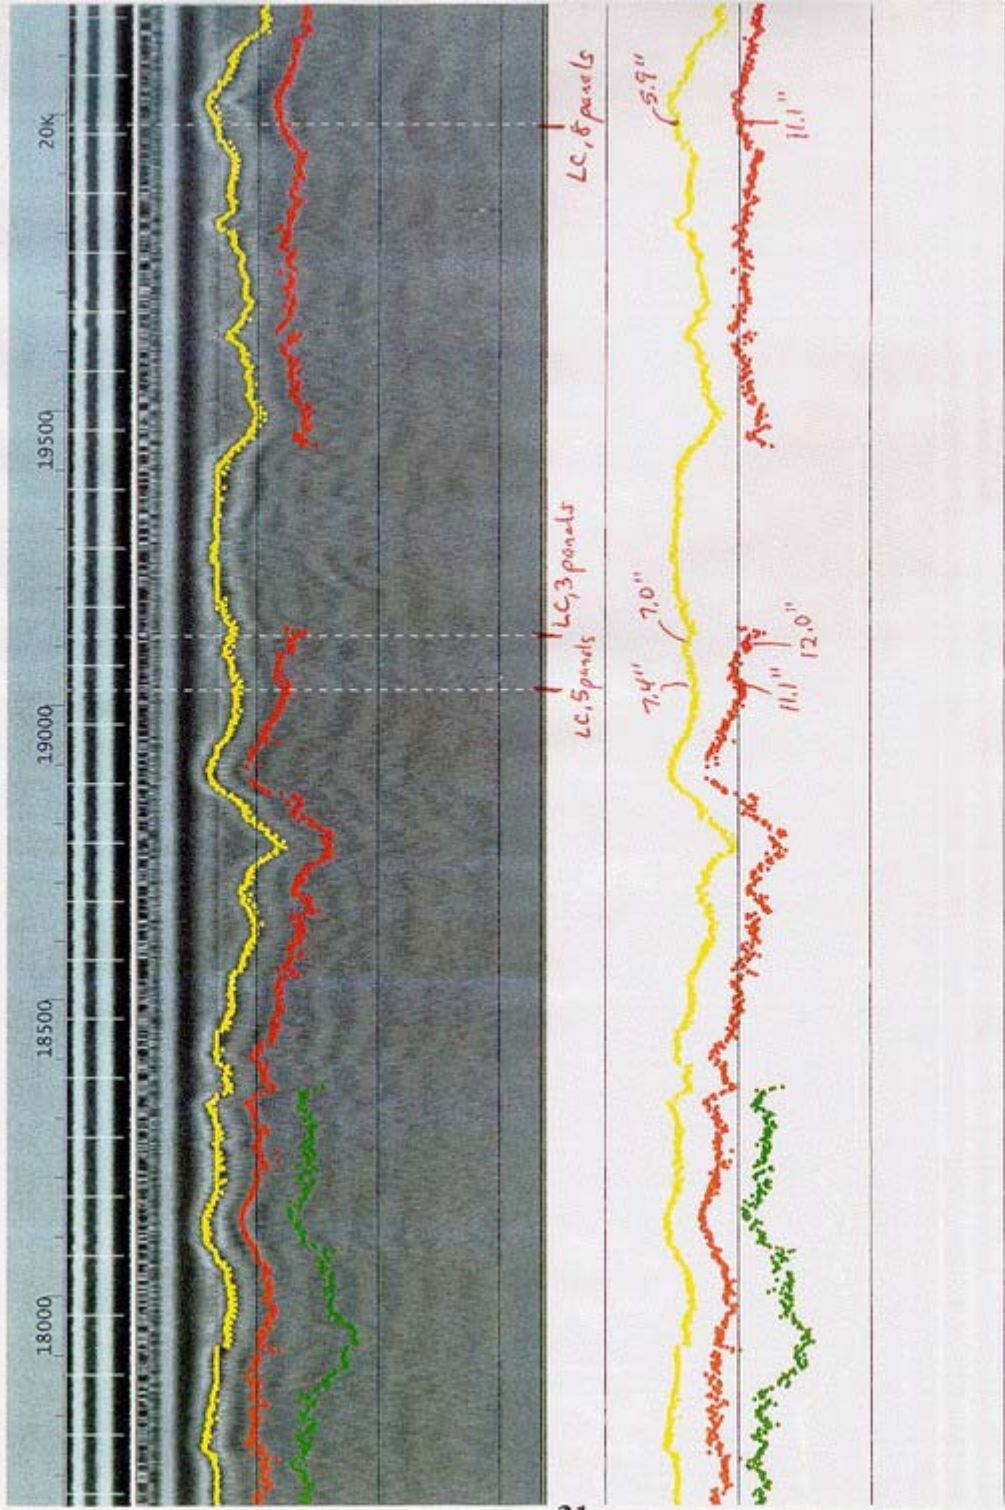
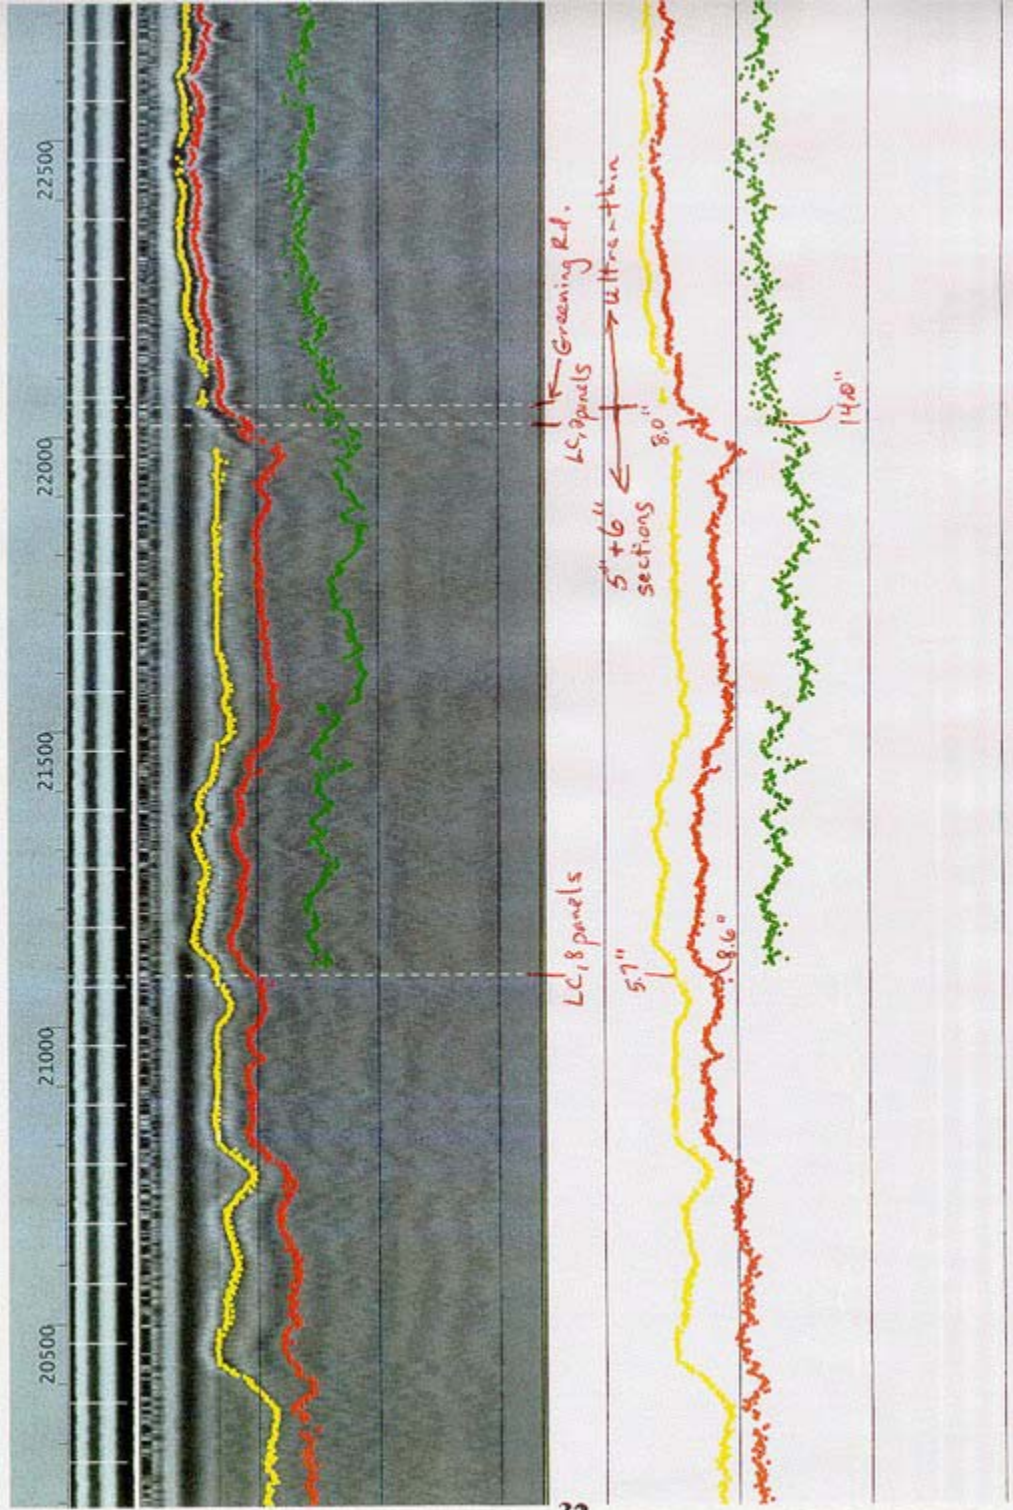
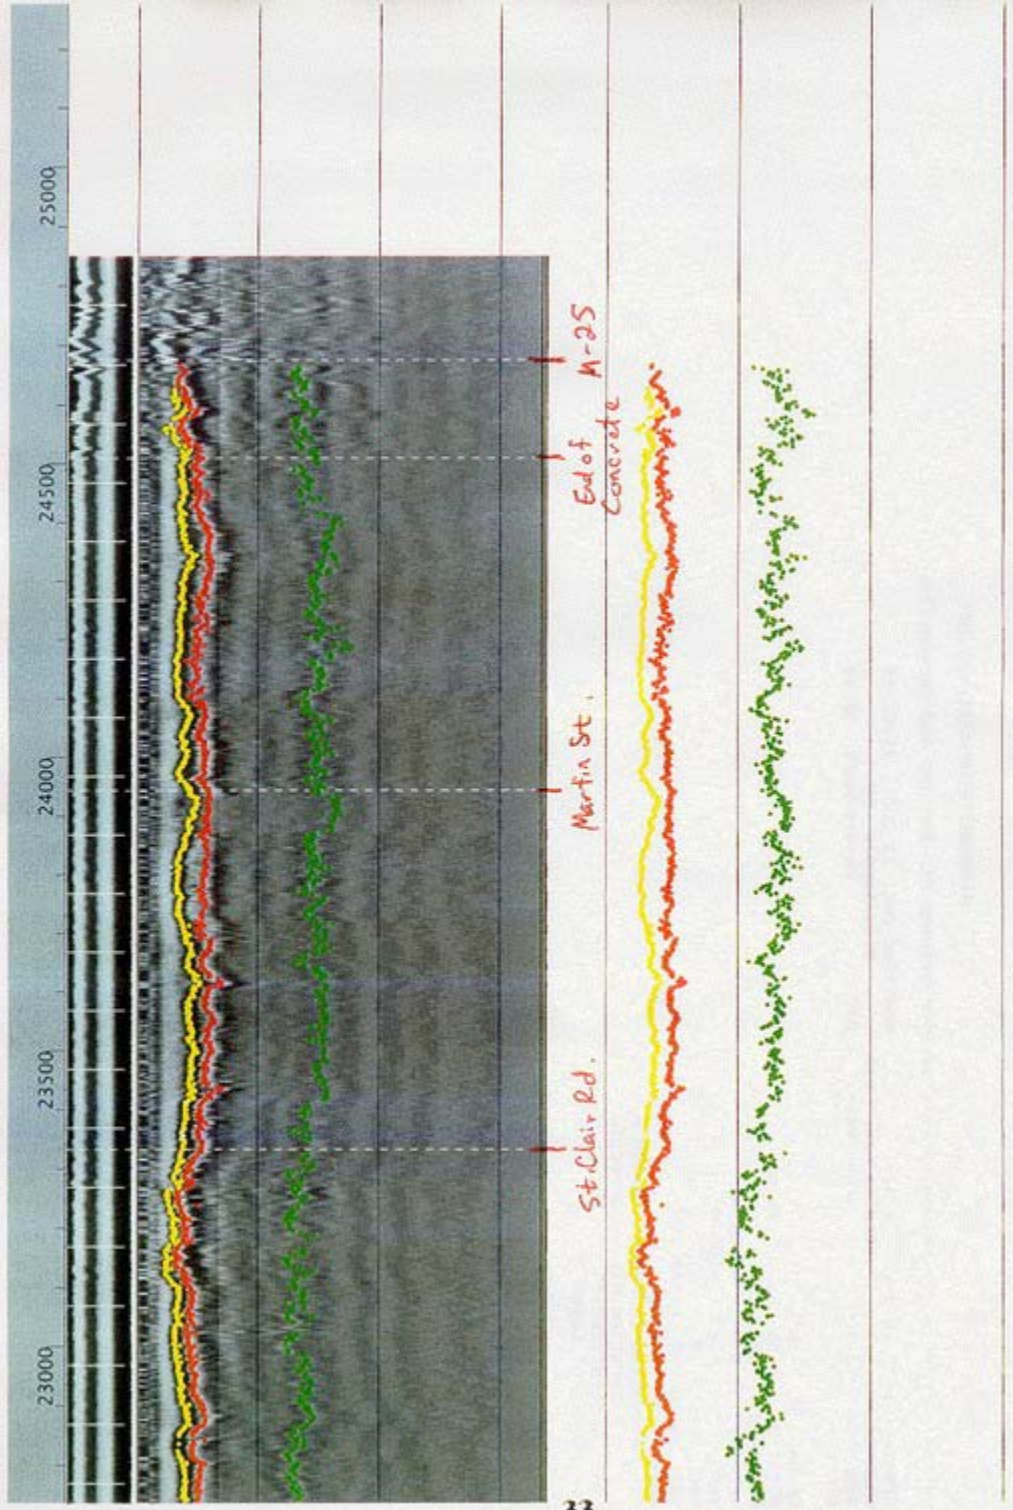
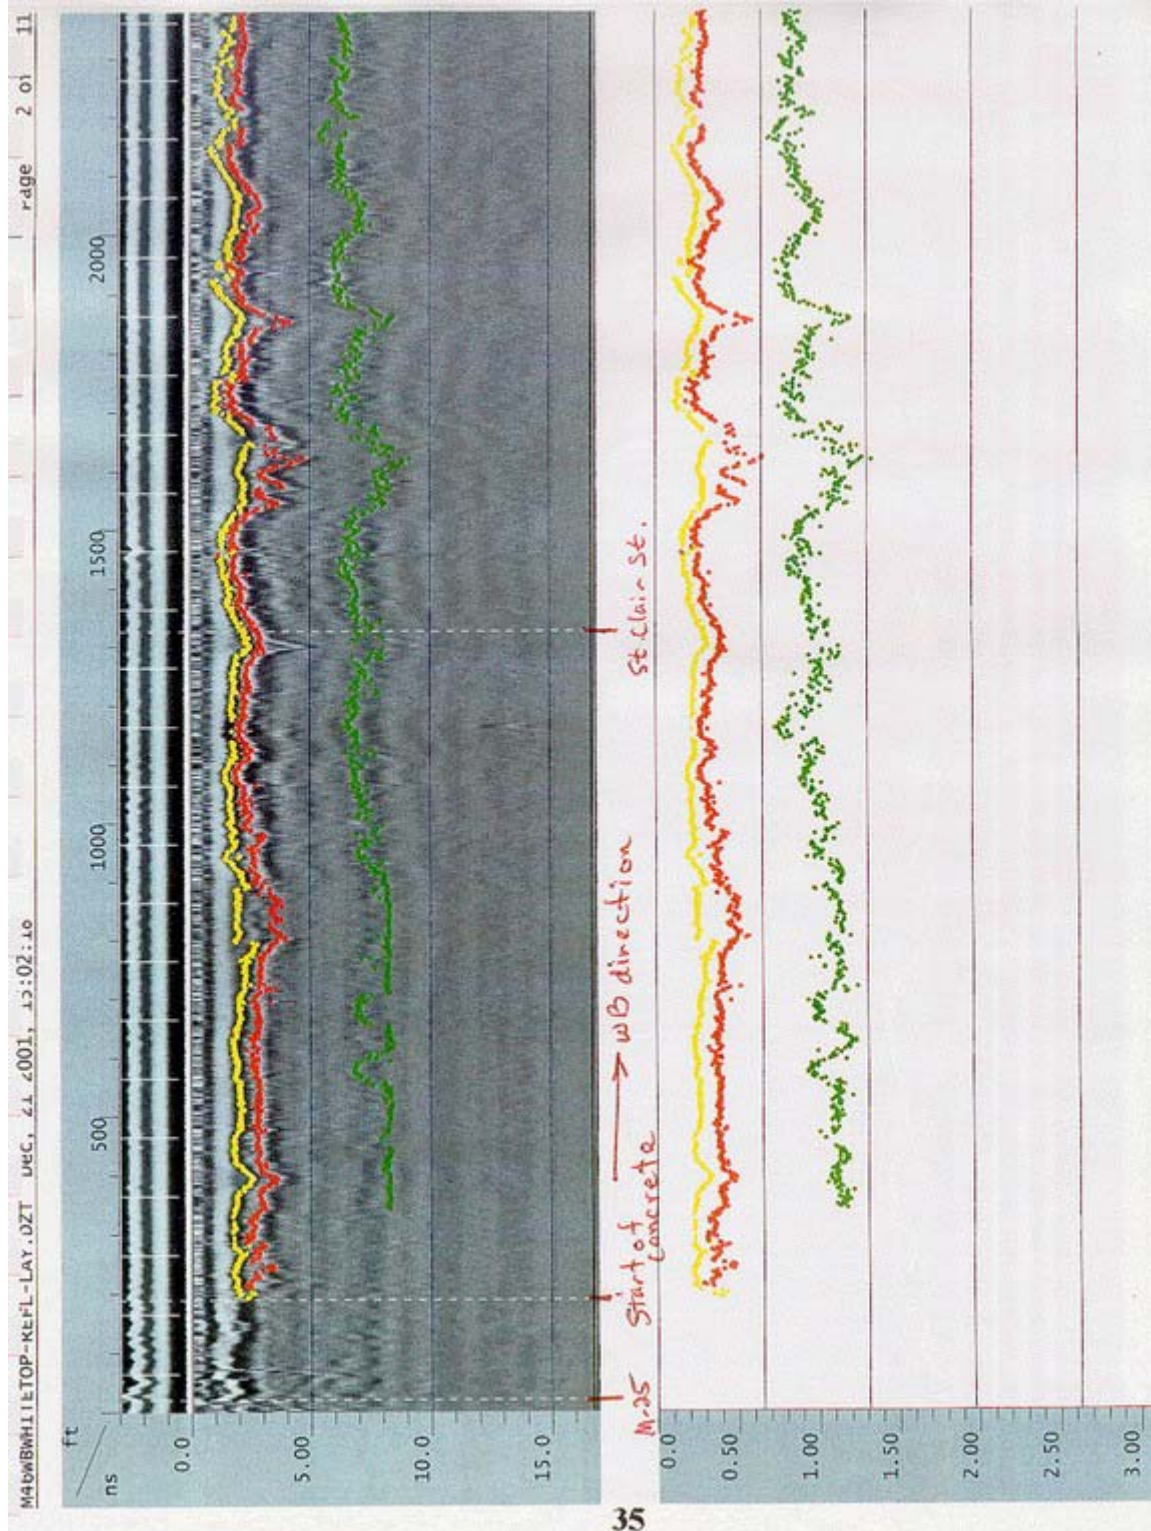
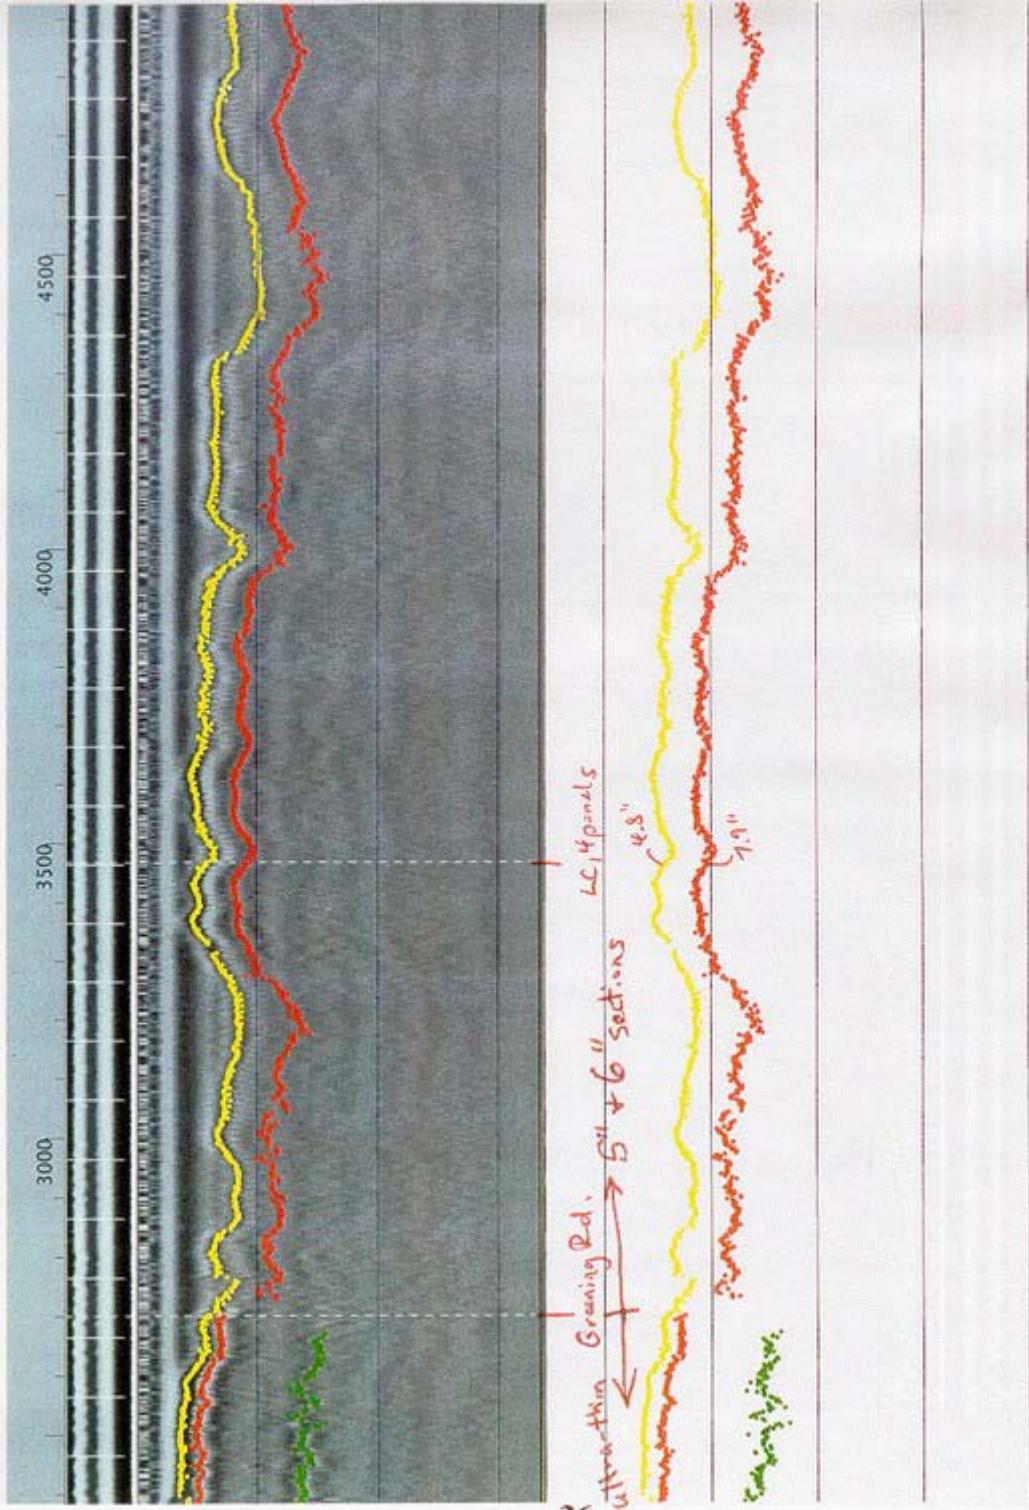
The GPR results can be found in the Appendix. The bottom of the concrete is marked with the top row dots, the bottom of the asphalt is marked with the mid depth dots, and the bottom of the base (when it could be located) is marked with the lower most dots. Concrete thickness does not appear to be a factor, since it varies from 4.8 to 8.3 inches at the longitudinal cracks. The asphalt thickness at the cracks averages 3.5 inches for the eastbound and 3.0 inches for the westbound. Fifteen random cores taken from the project immediately after construction showed the asphalt thickness averaged 4.0 inches in the eastbound lane, and 3.2 inches in the westbound lane. The cracks also did not appear to be located over areas where the asphalt and base layers dipped down, which would have been an indicator of support problems.

--Measurements written on the bottom graph are depths to the bottom of the pavement layers at the mark (dashed line). These are my interpretations of the radar output as to where the bottoms of the concrete and asphalt layers are. The scale is a little distorted in the printout. These numbers were picked off of the computer screen.

--Yellow represents bottom of concrete, red = bottom of asphalt, green = bottom of base
