A FIELD STUDY OF JOINT AND CRACK RESEALING  
METHODS AND MATERIALS

Highway Research Project 53 G-68

Research Laboratory  
Testing and Research Division  
Report No. 268  
November 1, 1956

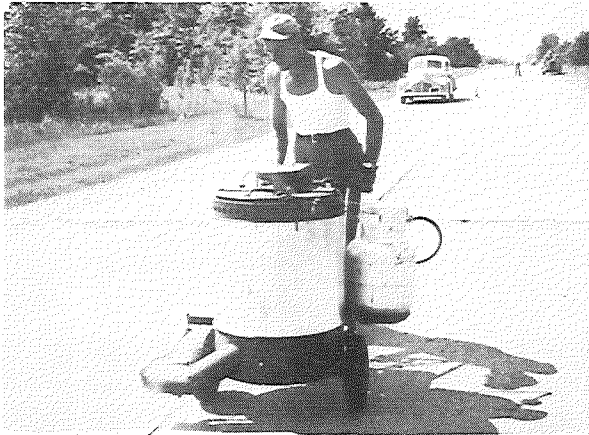
The sealing materials were poured from a mechanical pour pot, also of the double boiler type (Figure 2) using oil as the heat transfer medium, with thermostatically controlled gas heat and a thermometer to indicate the oil temperature. The pour pot was mounted on rubber tired wheels and was

FIGURE 2. SEALING LONGITUDINAL JOINT WITH MECHANICAL POURPOT.

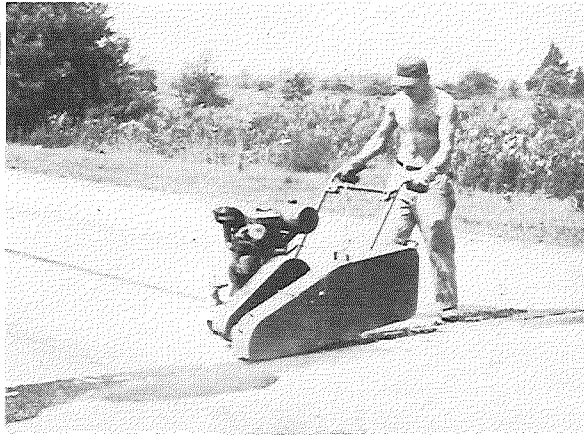
FIGURE 3. CONTRACTOR'S JOINT - CLEANING MACHINE IN OPERATION.

Two types of mechanical joint cleaning equipment were used for cleaning joints—one, a machine furnished by the contractor, Figures 3 and 4, and the other, a commercial joint cleaning machine owned by the Michigan State Highway Department, Figure 5.

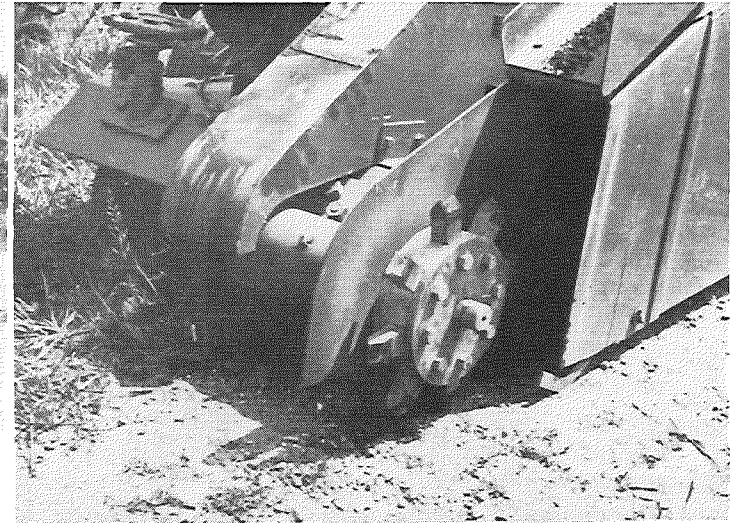
FIGURE 4. CUTTING HEAD OF CONTRACTOR'S JOINT - CLEANING MACHINE.

The first experiments in cleaning old materials from joints involved the use of both the Highway Department's (MSHD) and the contractor's joint cleaning machines. In cleaning transverse joints, old sealer and filler were first removed with the contractor's new machine and then the pavement surface at each side of the joint was freed from the old sealer and other materials, using the MSHD machine equipped with a surface scarifying head. Adjustments of various depths and cutters of various widths were tried with the contractor's machine, and a satisfactory cut was finally obtained with cutters 1 in. wide set to clean the sides of the joint to a 1-in. depth. The head of this machine equipped with 1-in. cutters is shown in Figure 4.

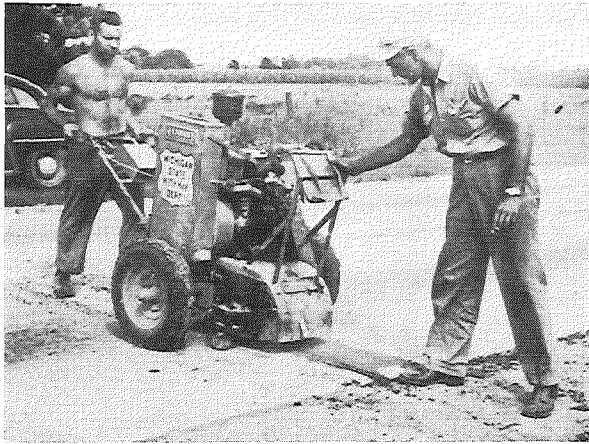
FIGURE 5. MSHD JOINT CLEANING MACHINE IN OPERATION.

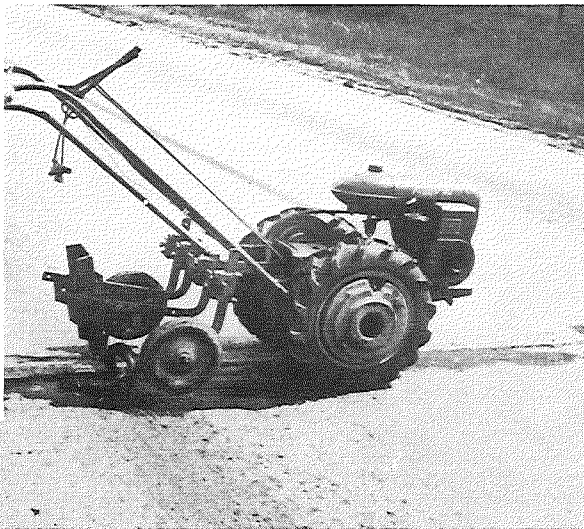
FIGURE 6. GARDEN TRACTOR WITH PLOW ATTACHMENT REMOVING OLD JOINT SEALER.

A small garden tractor with a plow attachment was used to remove the bulk of old materials from joints, Figure 6. Plow blades of various shapes are shown in Figure 7.

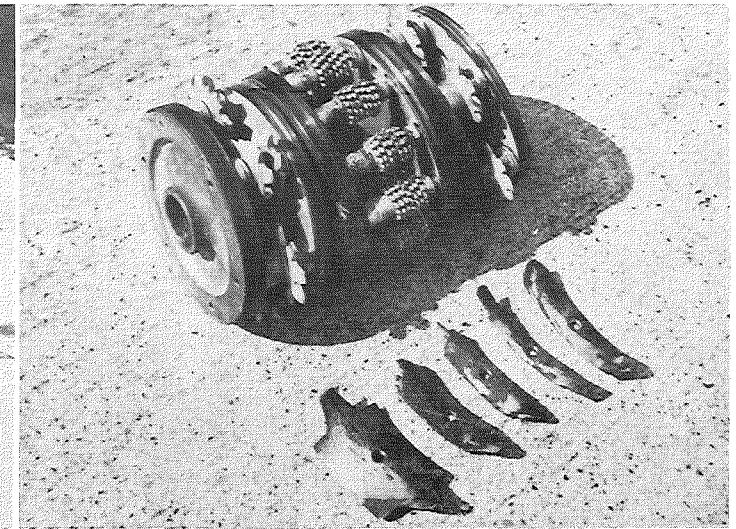
FIGURE 7. MSHD CUTTER HEADS AND TRACTOR PLOW BLADES USED FOR CLEANING JOINTS.

Because the transverse joints were faulted, scarifying operations with the MSHD machine required a pass on each side of each joint. In Figure 7, the center head is the type used for scarifying operations. The MSHD machine with a single row of 4-in. cutters (Figure 7, upper right), was tried for routing old material from the transverse joints but failed to perform as well as the contractor's machine.

The MSHD machine was again tried for removing old material from the transverse joints, but this time single and double cutters were alternated around the head (Figure 7, upper left). Since this operation left a cleaner joint than routing with the contractor's machine, the MSHD machine was adopted for this purpose.

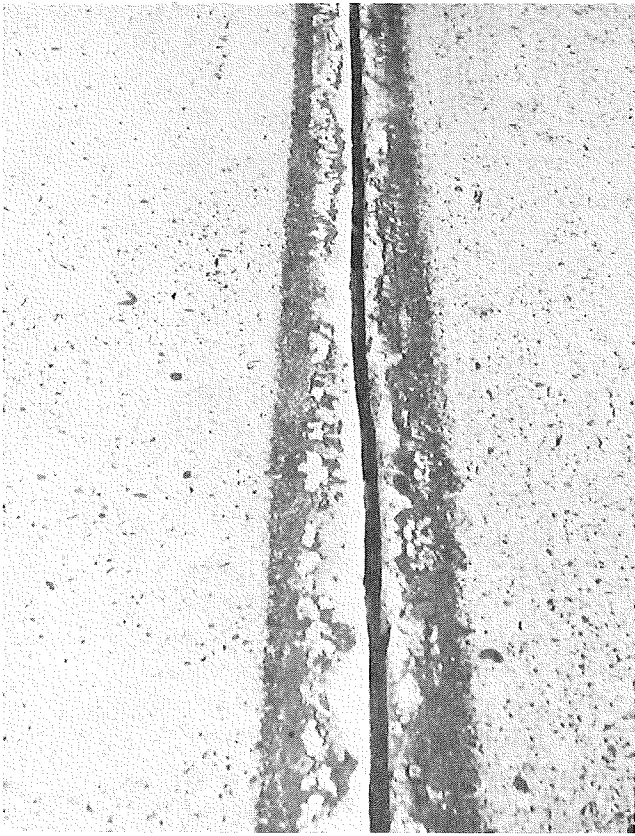
▲ FIGURE 8. LONGITUDINAL JOINT CLEANED AND READY FOR SEALING.

1. Plow out old filler to a depth of 3/4 to 1 in., preferably making one pass each way.
2. Make one pass with MSHD machine, using a single row of 4-in. cutters in the head to clean the vertical faces of the joint and to further remove the filler.
3. Sandblast vertical faces of the pavement surface to a distance of about 1 in. each side of the joint to remove traffic paint. If necessary, use hand tools to remove any filler left in the top inch of the joint.

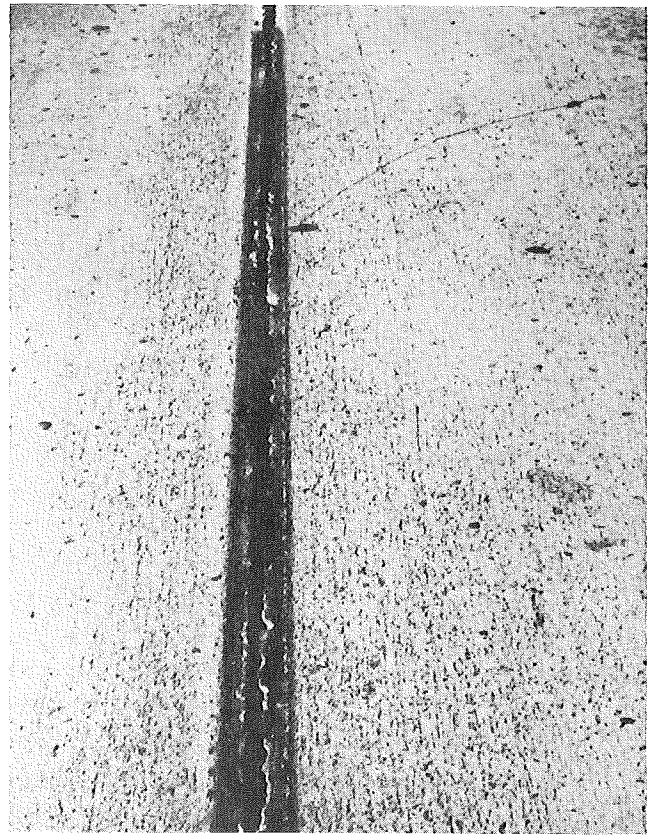
▲ FIGURE 9. LONGITUDINAL JOINT AFTER SEALING.

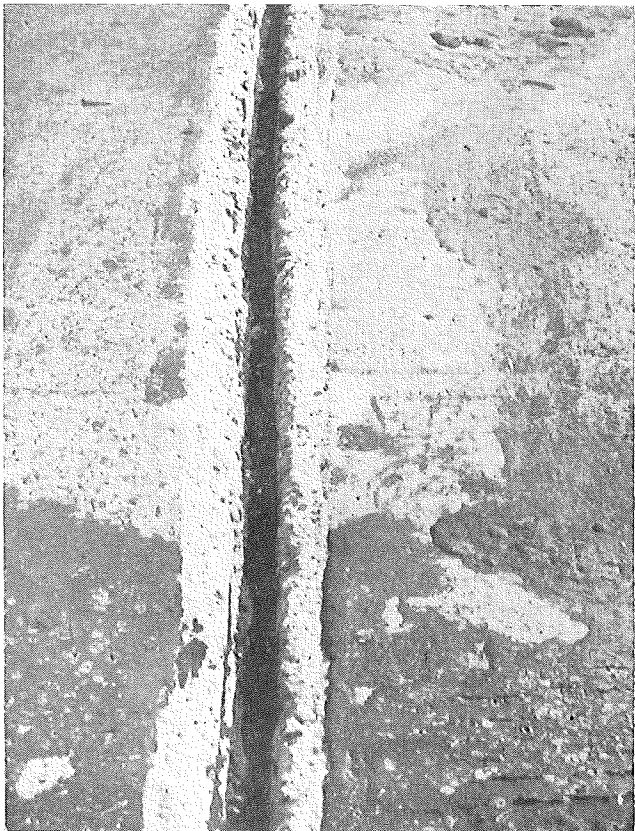
▲ FIGURE 10. EXPANSION JOINT IMMEDIATELY BEFORE SEALING.

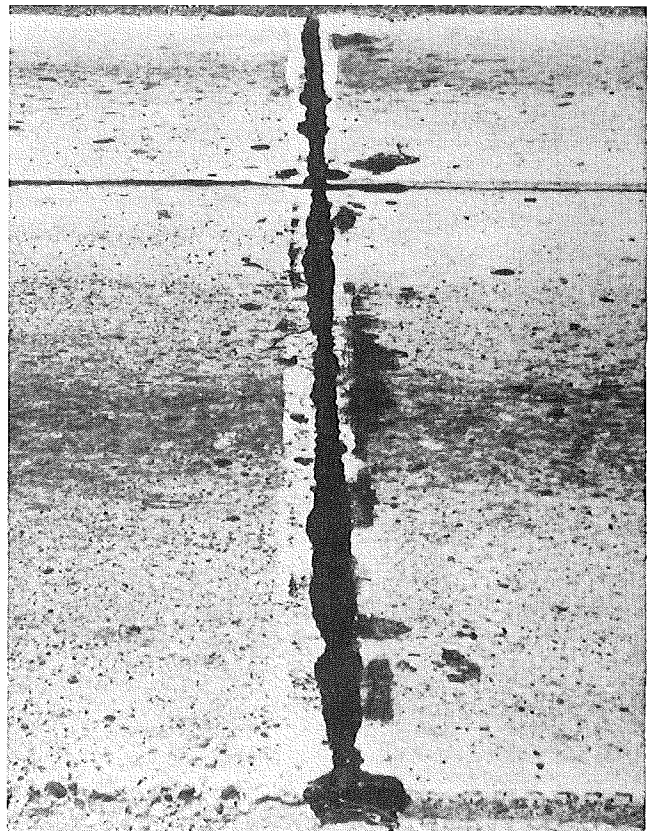
▲ FIGURE 11. EXPANSION JOINT AFTER SEALING.
