CRACKING OF CONCRETE PATCHES ON
PROJECT 49,7,C1, US 2, NORTH OF ST. IGNACE

E. A. Finney

Highway Research Project 44 G-27 (2)

Research Laboratory
Testing and Research Division
Report No. 105
December 15, 1947

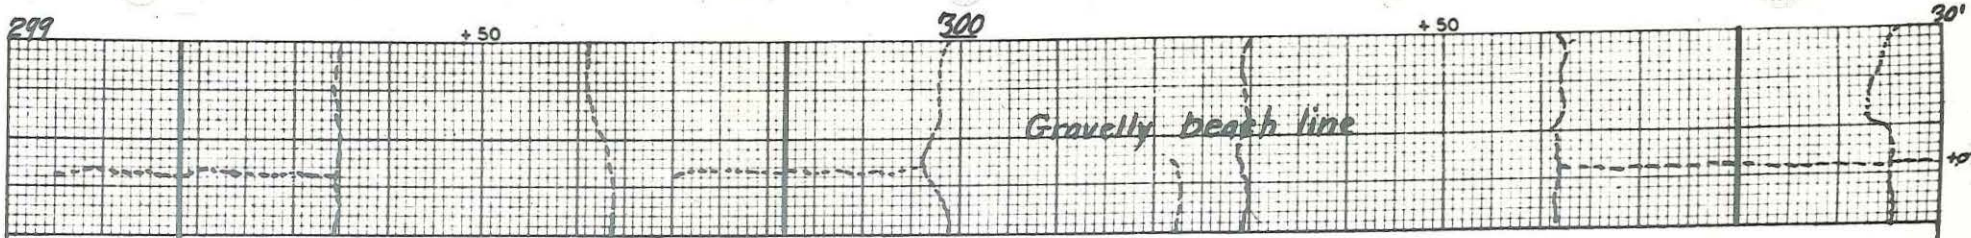
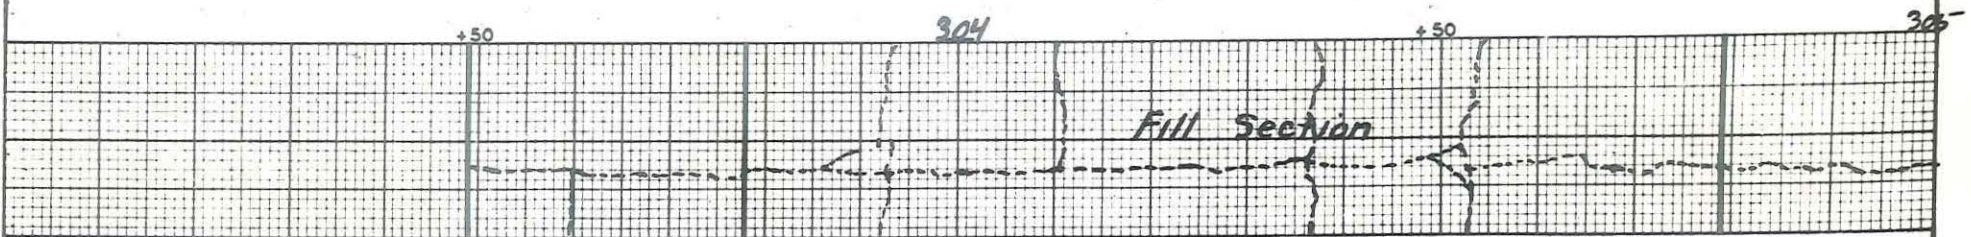
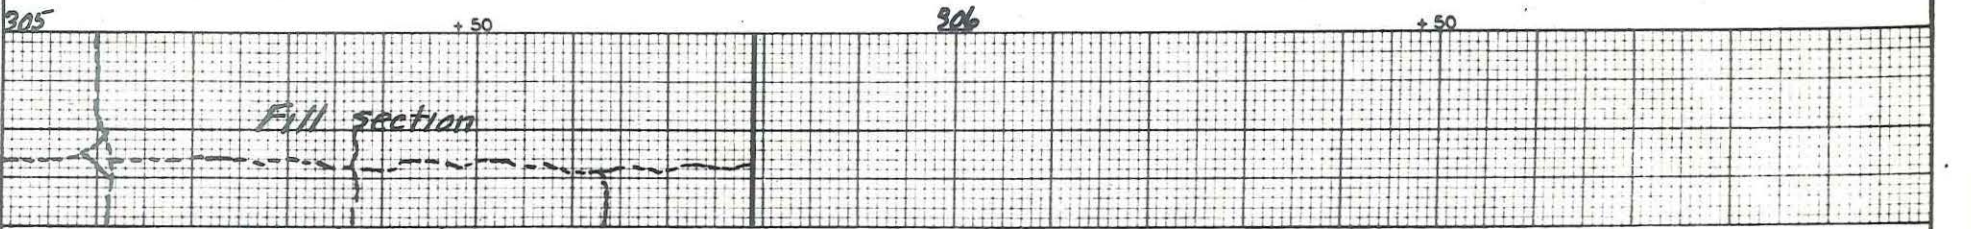
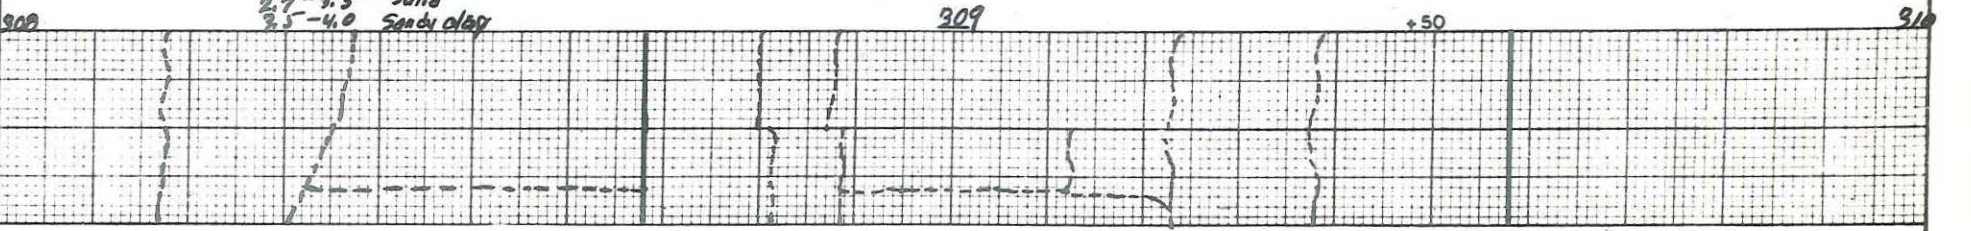
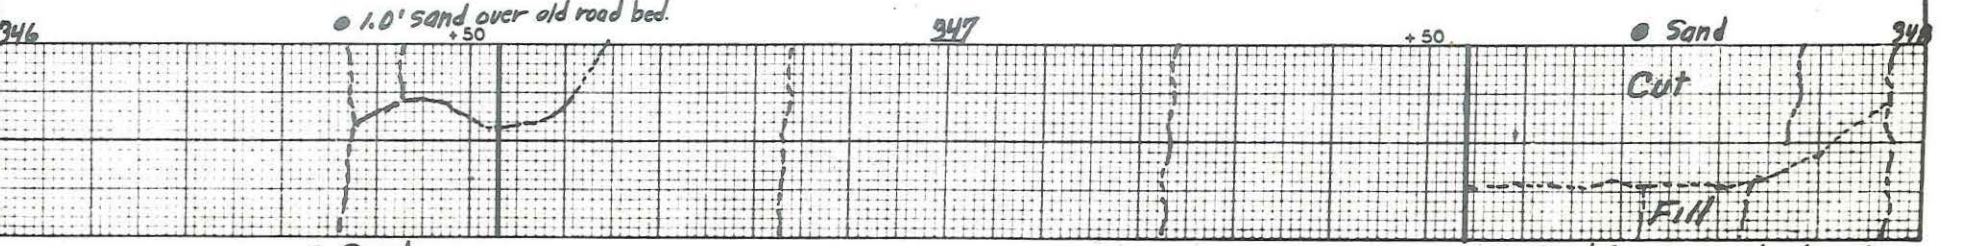
Figure 6

The cracking phenomena, described above, has all the manifestations of that caused by excessive subgrade volume change. Such volume change may be directly or indirectly attributed to: first, the presence of frost heave material in the subgrade, including silt, clay and peat suggested by a high water table; second, by the presence of different kinds of fill material in the same cross section; third, location of pavement over longitudinal cut and fill sections; and, finally, lack of uniform consolidation. All of these factors are known to exist on this project as disclosed by soil borings taken during the original survey in 1944 and observed from a study of construction plans and specifications as previously reported. Foundation soil conditions are shown on original condition survey graphs.
