EVALUATION OF GLARE SCREEN

**EVALUATION OF GLARE SCREEN**

**Research Laboratory Section  
Testing and Research Division  
Research Project 73 F-135  
Research Report No. R-1249**

**Michigan Transportation Commission  
William C. Marshall, Chairman;  
Lawrence C. Patrick, Jr., Vice-Chairman;  
Hannes Meyers, Jr., Carl V. Pellonpaa,  
Weston E. Vivian, Rodger D. Young  
James P. Pitz, Director  
Lansing, August 1984**

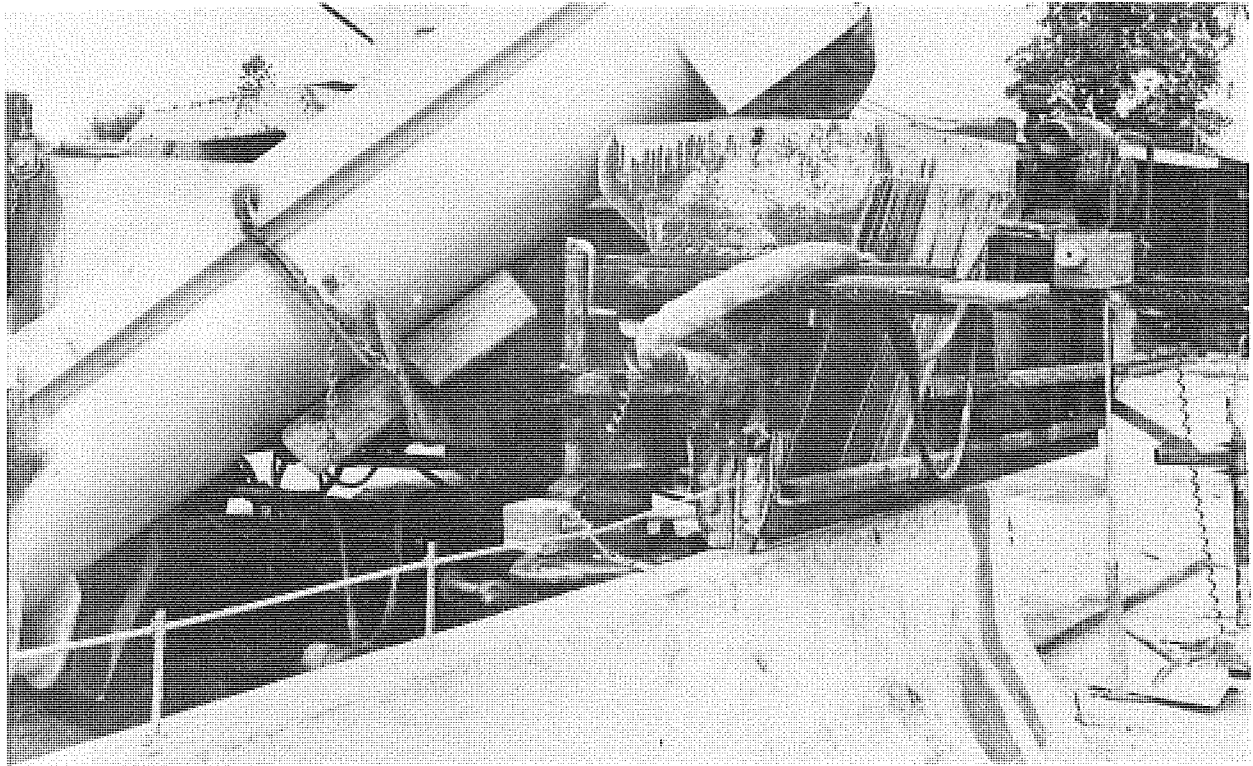
As a means of alleviating the problems that had been encountered with mesh glare screen, Champagne-Webber Inc., a Michigan contractor, proposed in the spring of 1978, the concept of slip-forming a concrete glare screen on top of an existing concrete median barrier. Vertical tie-bars were used to secure the screen to the barrier and longitudinal reinforcement was added to reduce flying pieces of concrete in case of vehicle impact (Fig. 2).

Figure 2. Slip-forming concrete glare screen on top of an existing median barrier. Note vertical tie-bars and longitudinal reinforcing steel.

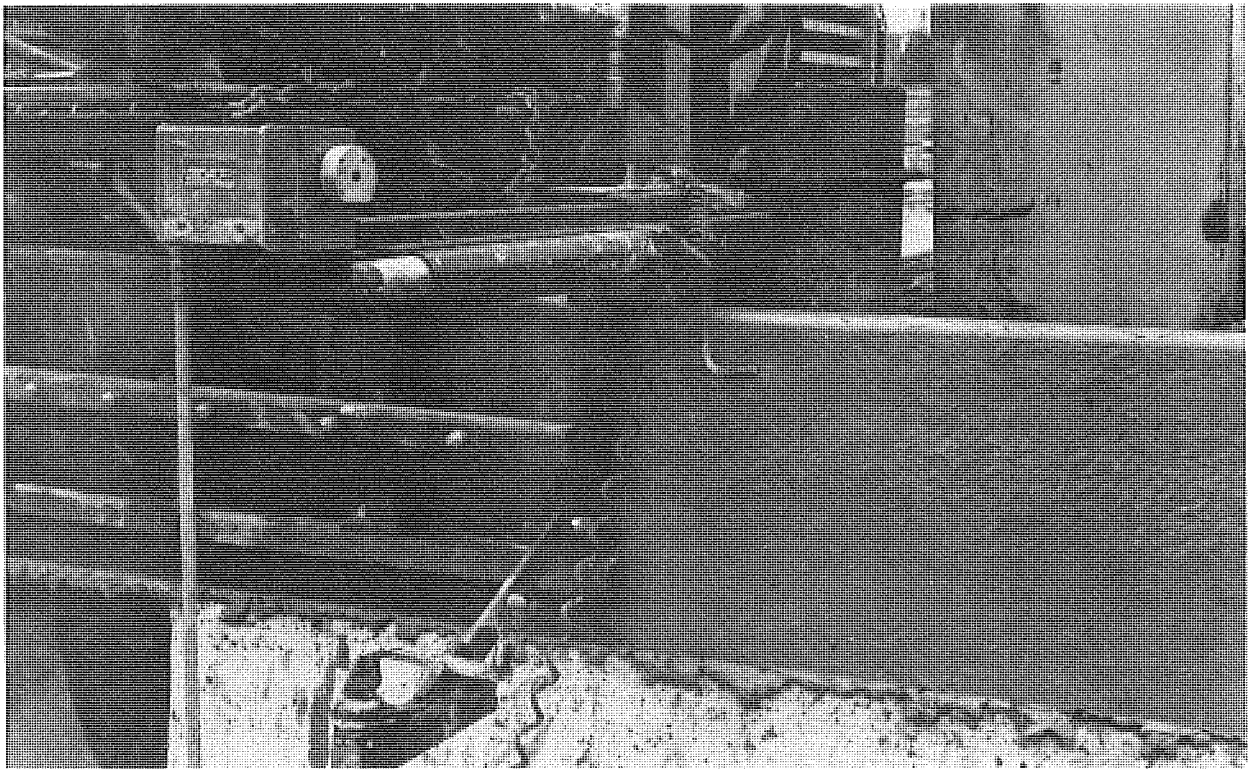
Figure 3. Concrete glare screen being constructed in the contractor's yard.

A section of experimental concrete glare screen, approximately 60 ft long, was cast at the contractor's yard. The concrete glare screen was slip-formed on an existing concrete median barrier as shown in Figure 3. Initially, there were some operational problems, but once the mix was properly adjusted to an approximate 2-in. slump, the glare screen was slip-formed quite readily. A portion of the glare screen contained no longitudinal steel so a comparative evaluation of screens with and without longitudinal reinforcement could be made. The mix used for the glare screen contained 17A aggregate and water reducer-retarder. High-early-strength concrete was used so destructive testing could be done sooner.
