**Pavement Demonstration Program Project Finalization
Low Volume (Thin) Concrete Reconstruction Projects –
M-13 & M-99
(MDOT Job Numbers 53356 & 75184)**

Final Technical Report

Report No. OR23-304, B

April 2024

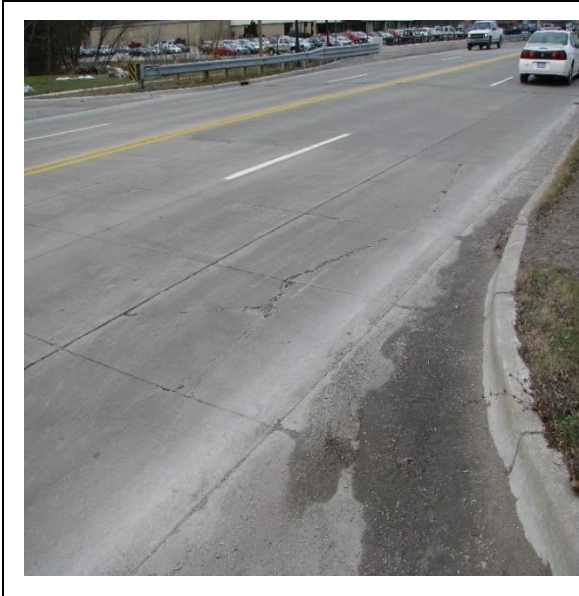
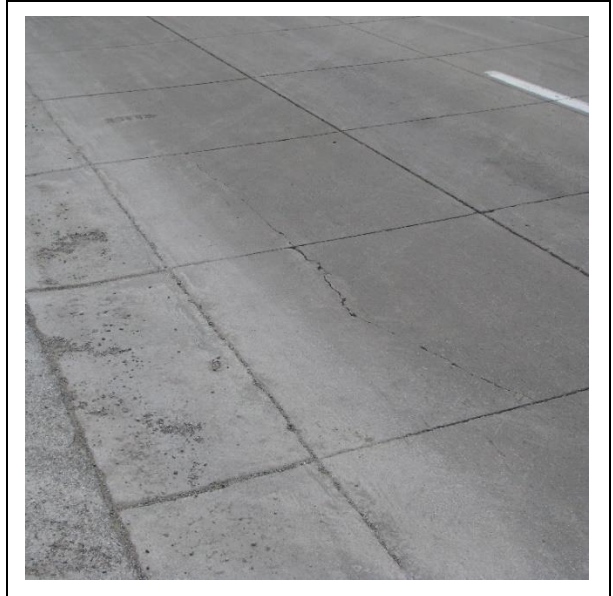
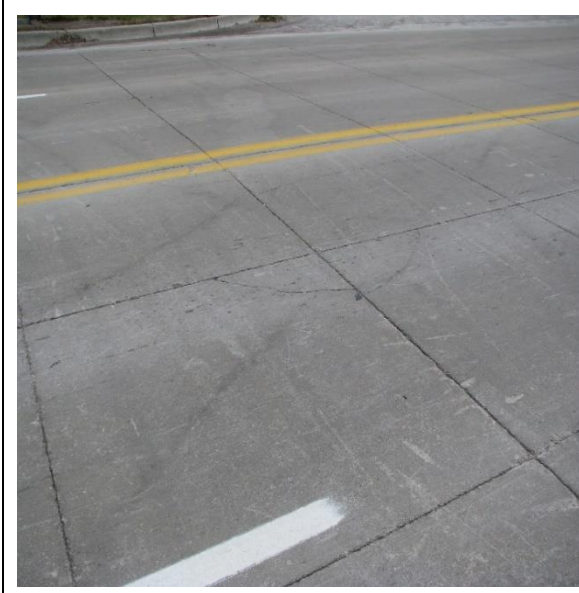
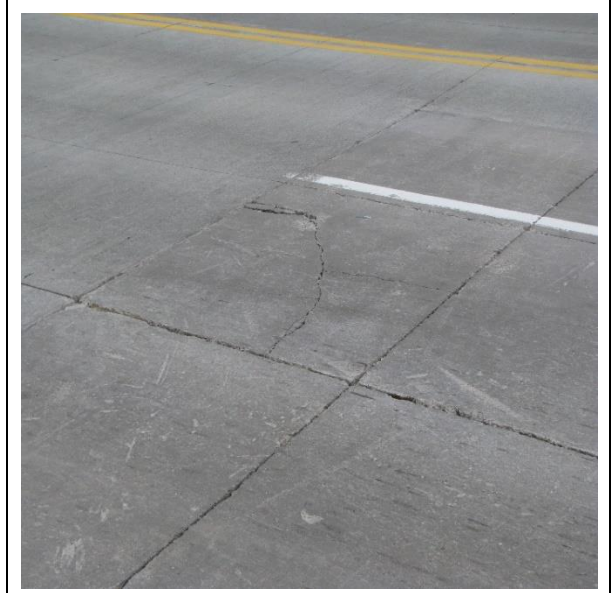
Figure 6. Distress Slabs South of Pinconning Bridge on M-13

Annual surveys noted that within the first 5 years of service, the M-13 project experienced minimal overall distress. Still, field surveys observed 9 cracked panels, some faulting along the longitudinal middle joint of the northbound outside lane, and minor intermittent joint spalling/raveling (less than 1" wide and 12" long). Notably, some of the cracked panels were at or near drainage structures. Additionally, the Pinconning Bridge had construction work conducted in 2010, for which heavy equipment (large crane, etc.) was parked on the travel lanes approximately 100 feet south of the bridge. Accordingly, the following year, 16 slabs were found to be cracked in all lanes and both directions of that area. As previously noted, the slab thickness decreases below the design thickness within 200-feet of the bridge. This may have also been a contributing factor along with the construction equipment. Examples of the observed pavement distresses are shown in Figures 5 and 6.

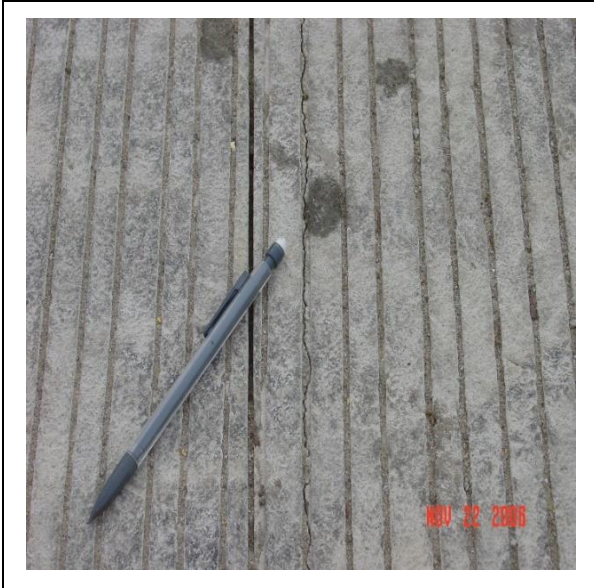
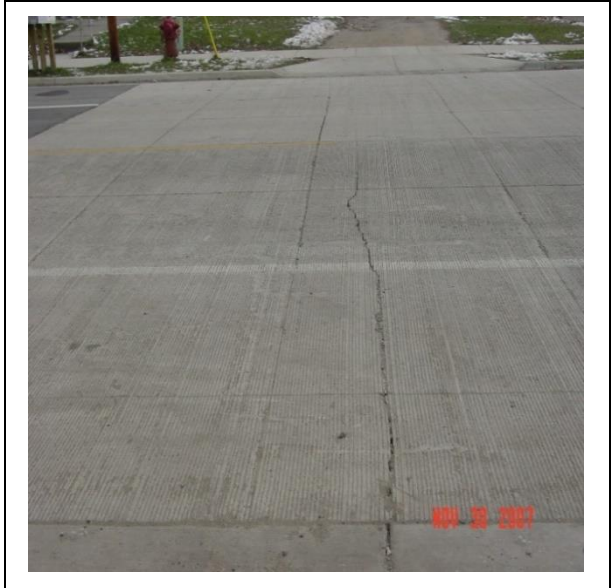
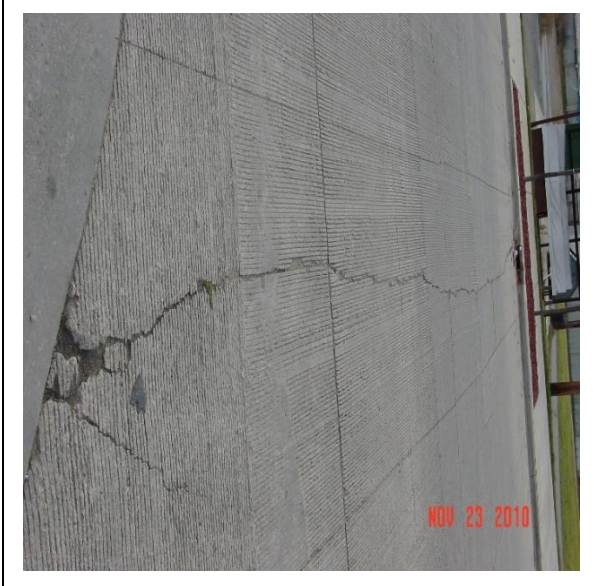
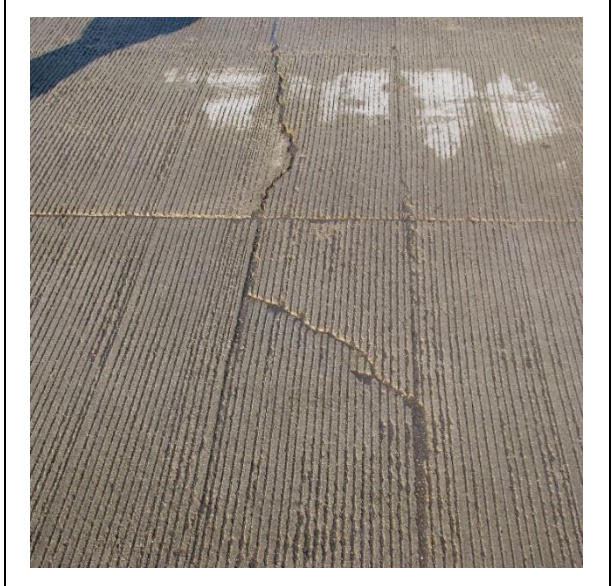
Figure 7. Field Survey Pictures of M-99

For M-99, several cracks were immediately observed within a few weeks of construction. Accordingly, since early cracking was observed and was within the five-year warranty period, two distress surveys were conducted to evaluate the warranty performance; one was in 2009 (3 years after construction), and the other was in 2011 (5 years after construction). See Appendix Figures B1 and B2 for the distress survey reports, *Warranty Inspection Report SWAD 2870* [1,2]. The concrete pavement was evaluated based on eight distresses: transverse cracking, longitudinal cracking, map cracking, spalling, scaling, corner cracking, joint seal failure, and shattered slabs. All distress types were observed in both surveys, except for map cracking and shattered slabs. Example images of the observed pavement distresses as documented in the warranty reports are shown in Figures 7, 8 and 9. Since the distress exceeded the allowable amount as defined by the

five-year warranty, approximately 3 slabs were replaced, and the remaining cracks and spalls were repaired with crack-sealing techniques.

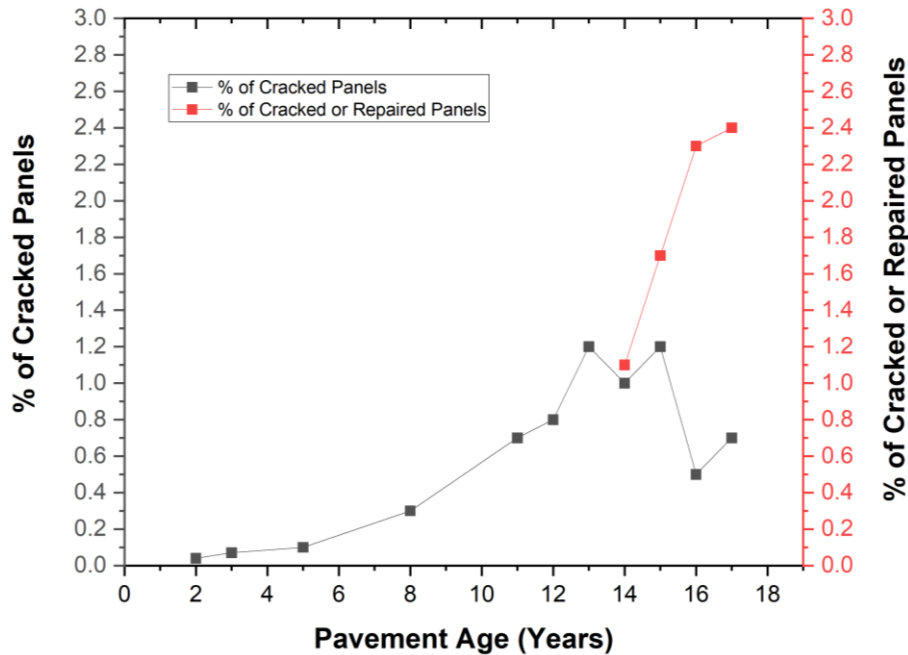
Figure 10. Percentage of Cracked and Repaired Panels for M-13

According to the April 2022 field survey of M-13, after 17 years of service, approximately 2.4 percent of all concrete panels are cracked or repaired. This percentage is relatively minimal over this timespan. Excluding the cracked and repaired slabs at the south side of the Pinconning River Bridge, this percentage decreases to 1.9 percent. Figure 10 shows the overall trend of crack and repair through the pavement's design life. Otherwise, some intermittent scaling and joint spalling

were observed. This primarily occurred within the first 550 feet of the project's south end within the northbound lanes. To address this, these have been filled with a spray-on asphalt emulsion patching material (commonly referred to by its commercial name AMZ). This joint deterioration is commonly related to the timing of the sawing operation. In both directions, the mid-lane longitudinal joint of the rightmost lane is exhibiting some widening and low levels of faulting at various locations. Accordingly, the field survey described the pavement's overall performance as good*. The April 2022 field survey notes are shown in Appendix Figure A34. Pictures of the current pavement condition on M-13 are shown in Appendix Figure A35.

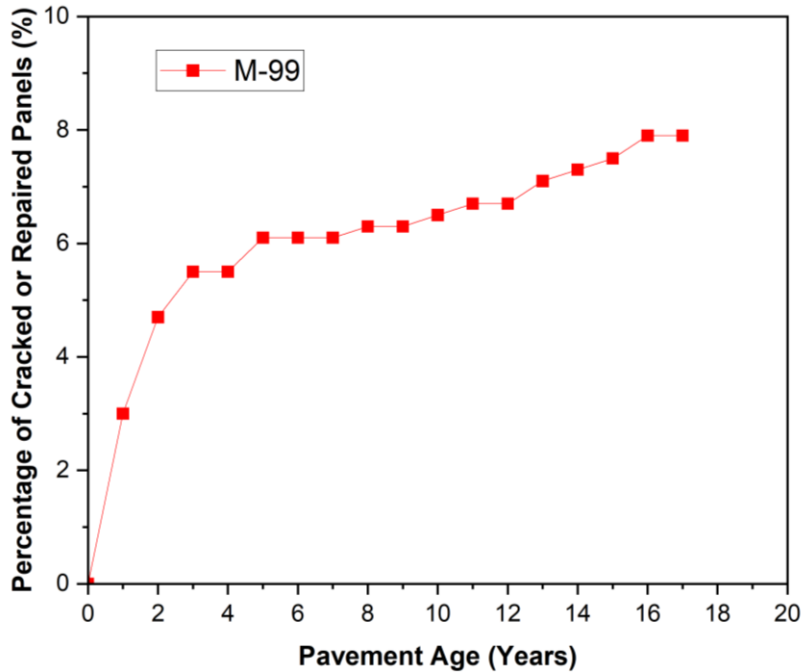
Figure 11. Percentage of cracked and repaired slabs for M-99

According to the April 2022 field survey of M-99, after 16 years of service, approximately 7.9 percent of all concrete panels are either cracked or repaired. While this percentage is higher than that of M-13, construction-related issues are at least partly contributing to this, including construction warranty repairs and initial spalling due to late sawing of the joints. This spalling is consistent with observations of the early annual reviews, where cracking was observed within inches of the joint. There are some faults, but they are isolated and minimal. As shown in Figure 11, like M-13, the progression of distress is steady. Accordingly, the field survey described the pavement's overall performance as fair*. The April 2022 field survey notes are shown in the Appendix, Figures A32 and A33. Pictures of the current pavement condition on M-99 are shown in Appendix Figure A36.
