EFFECTIVENESS OF SAWED-SEALED LONGITUDINAL JOINTS  
BETWEEN BITUMINOUS SHOULDERS AND RIGID PAVEMENT  
IN REDUCING LONGITUDINAL SHOULDER CRACKING  
First Progress Report

Research Laboratory Division  
Office of Testing and Research  
Research Project 66 E-37  
Research Report No. R-637

State of Michigan  
Department of State Highways  
Lansing, May 1967

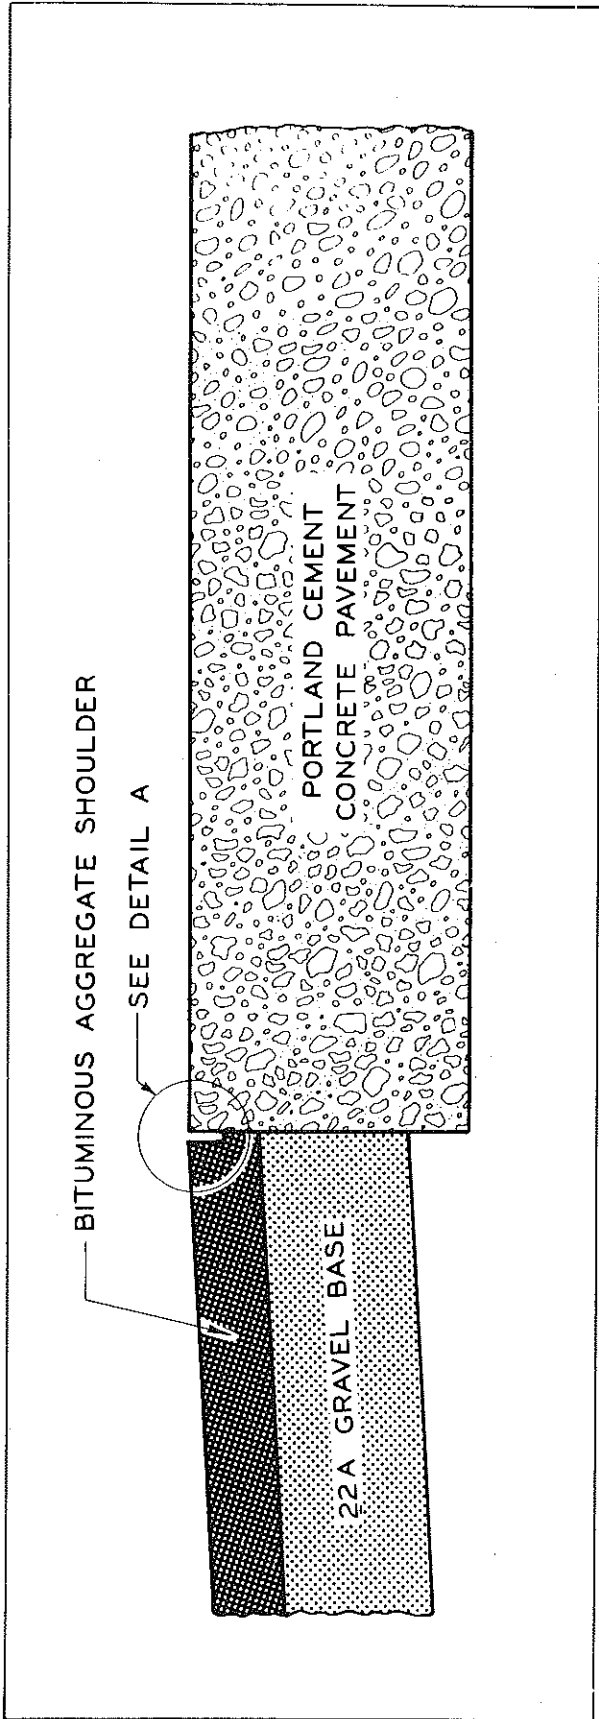
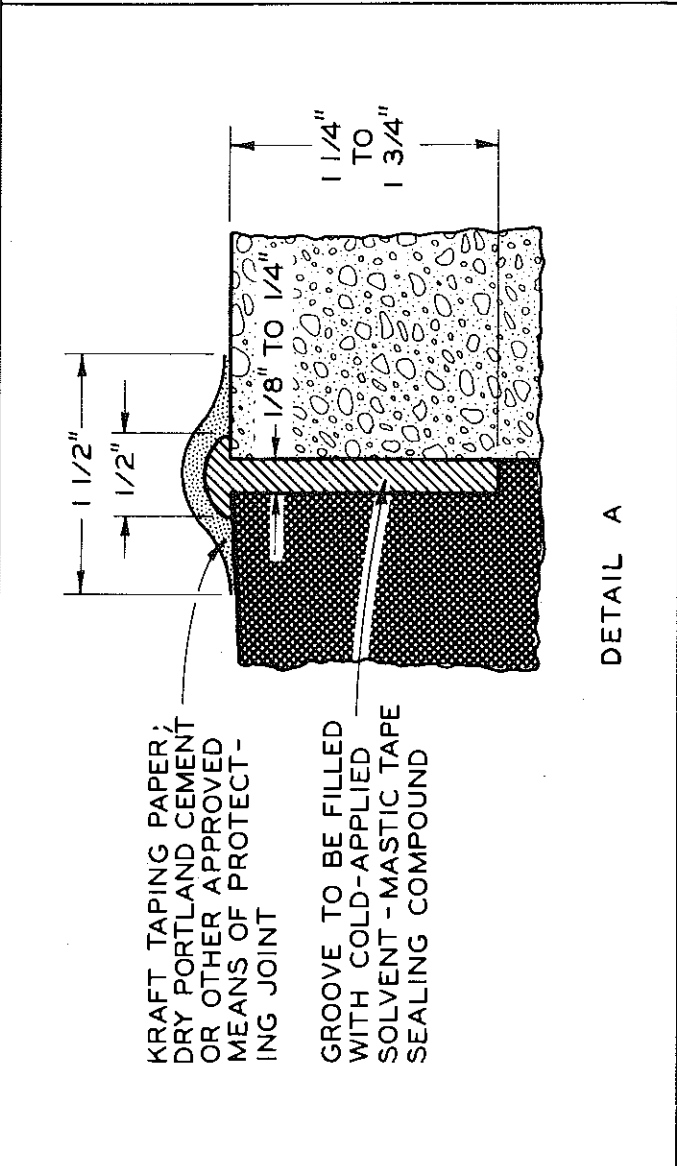
Characteristics of the experimental joint tested in these projects are shown in Figure 1. Joints as constructed were not less than 1/8-in. nor more than 1/4-in. wide and 1-1/4- to 1-3/4-in. deep. Joint grooves were filled with cold-applied sealer of the solvent-mastic type.

Figure 1. Sealed joint between bituminous aggregate shoulder and portland cement concrete pavement.

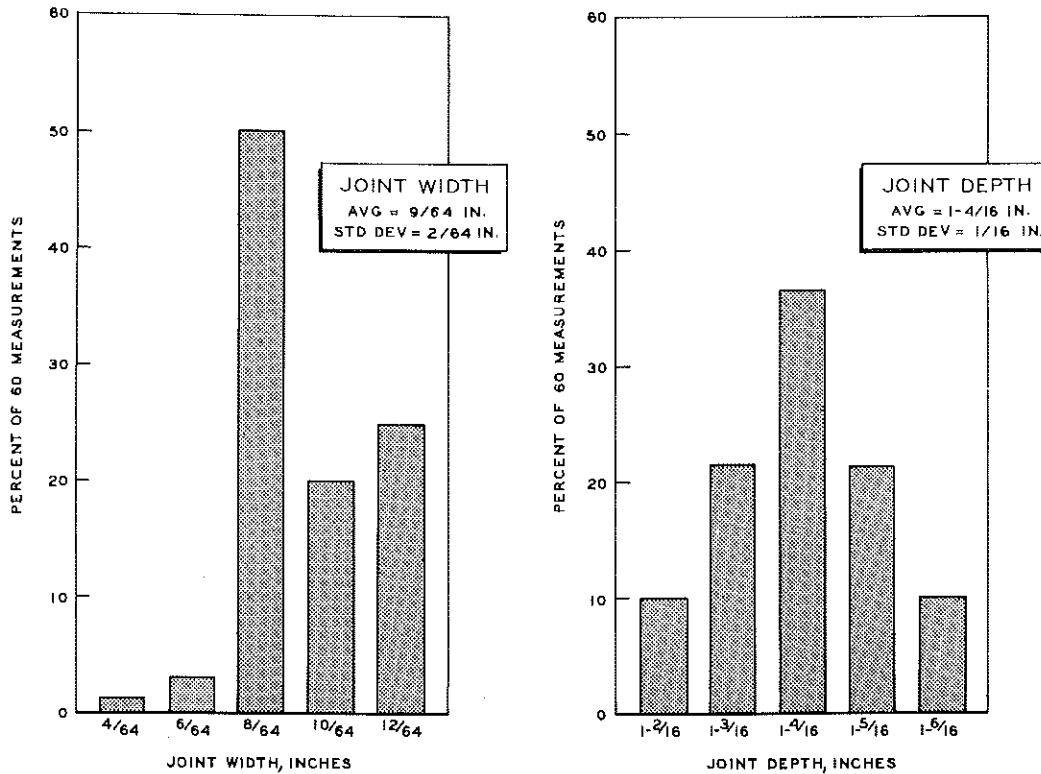
Longitudinal joints were sawed in 12 selected test sections and filled with a cold solvent-type mastic sealer as specified for concrete construction (Section 7.16.03-d of 1965 Standard Specifications). Width and depth of the joints were measured at random locations in each sawed section. Based on 60 random measurements, average joint width was 9/64 in. with a standard deviation of 2/64 in. from the average, and average depth was 1-1/4 in. with a standard deviation of 1/16 in. from the average (Fig. 11). Width was measured to the nearest 1/64 in. with a pocket slide caliper and depth with a standard ruler graduated in 1/16-in. increments.

Figure 11. Dimensions of sawed Project 5 joints prior to sealing.

sawed joint width of 9/64 in. (Fig. 11), a lateral movement is indicated which caused a 44-percent stretch in the sealing material. Since wider opening of the joint is expected during periods of colder weather, the sealing compound will be stretched considerably more than the 50-percent limit specified for such materials. After only two months of service life, the sealing material showed good adhesion and consistent structural strength throughout Project 5.

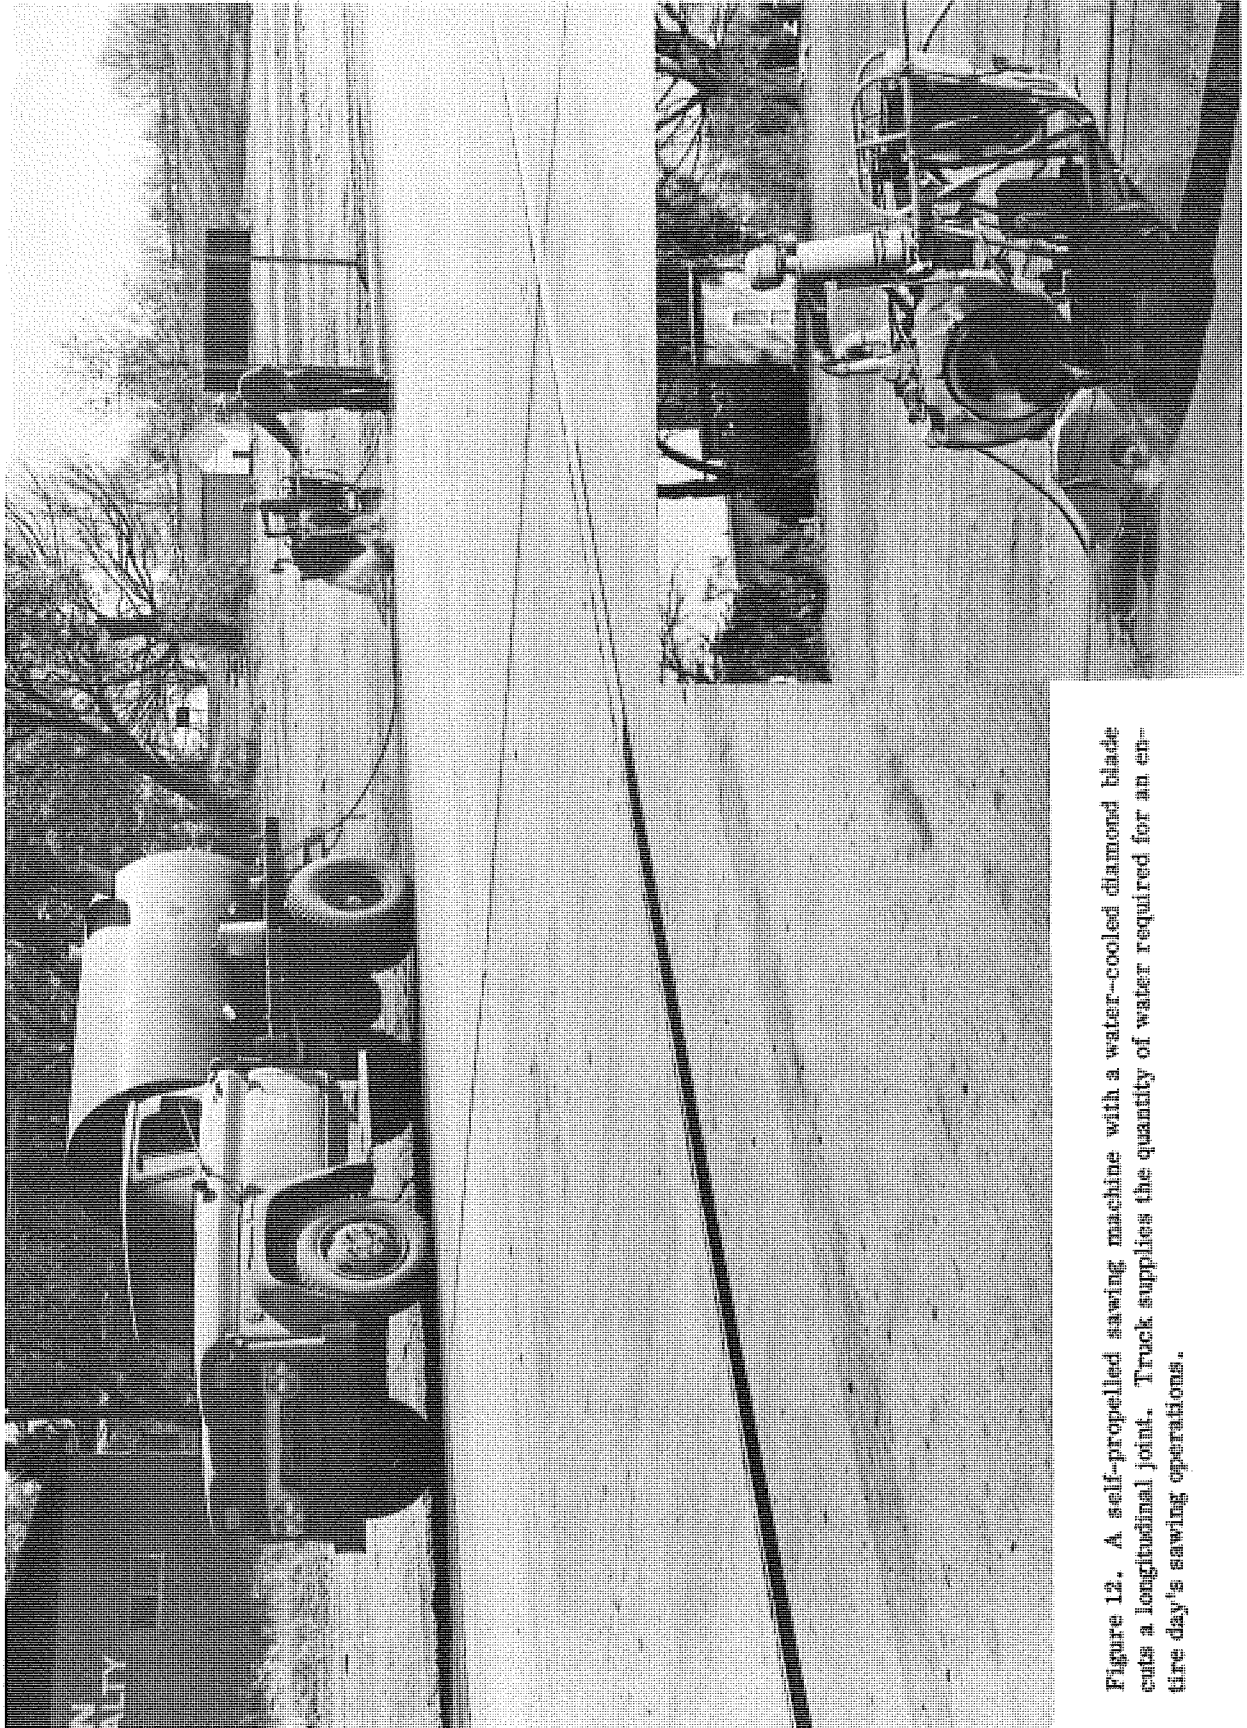
The sawing equipment used was a self-propelled saw with a water-cooled diamond blade adjusted to cut to the required depth of the compacted bituminous shoulders at an average rate of 1,300 lin ft per hr (Fig. 12). The sawing operation started October 19, 1966, four days after the bituminous shoulders had been constructed. The 12 test sections were sawed in 12 hr. The joint groove followed the side face of the concrete pavement and was uniform and free of spalls throughout the project (Fig. 13). Immediately following sawing, the joint was cleaned out by flushing with a jet of water under pressure (Fig. 13). The remaining dirt, water, and other debris were removed from the groove and surrounding area by using a jet of compressed air. The joint groove was clean and dry at the time of sealing.

Figure 12. A self-propelled sawing machine with a water-cooled diamond blade cuts a longitudinal joint. Truck supplies the quantity of water required for an entire day's sawing operations.

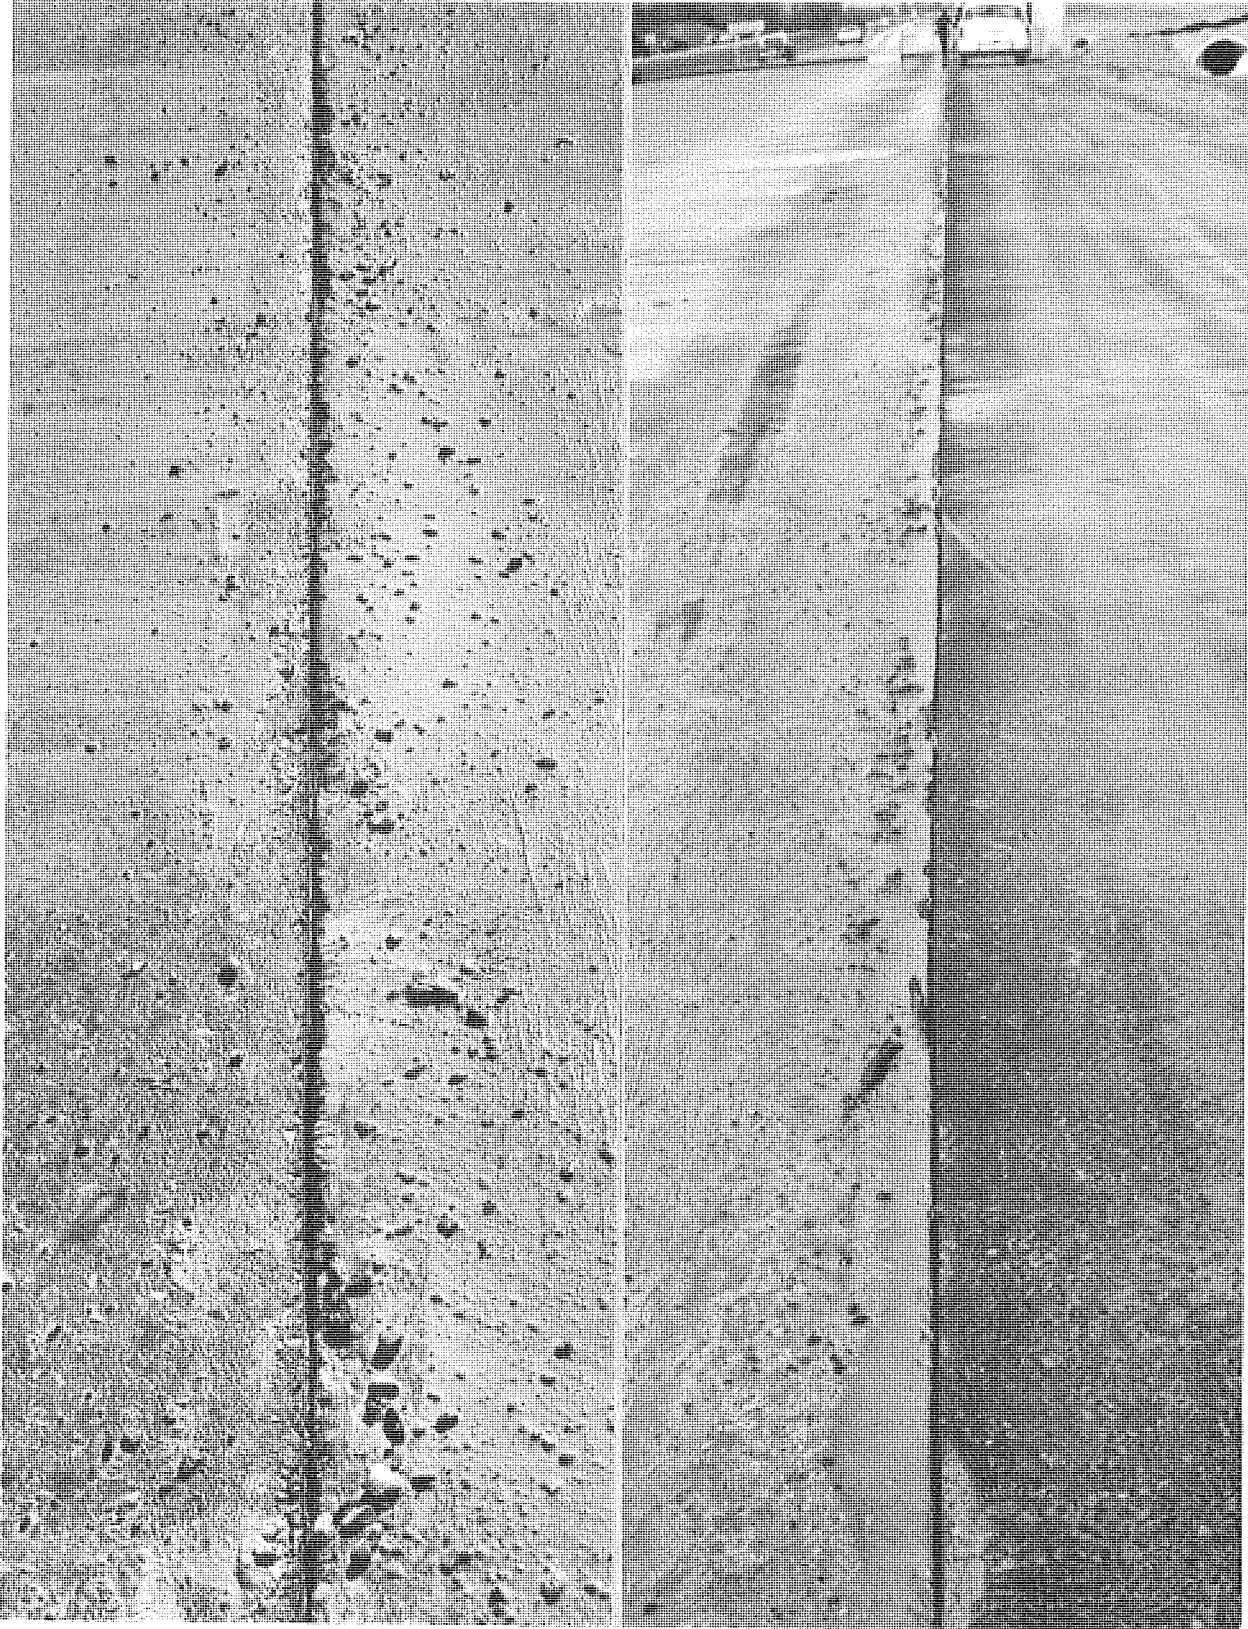
Figure 13. After sawing (left), the longitudinal joint is flushed with water, then cleaned and dried with compressed air.
