Report TSD-214-73

A TRAFFIC ACCIDENT ANALYSIS OF HIGH ACCIDENT LOCATIONS IN KALAMAZOO COUNTY

January 1974

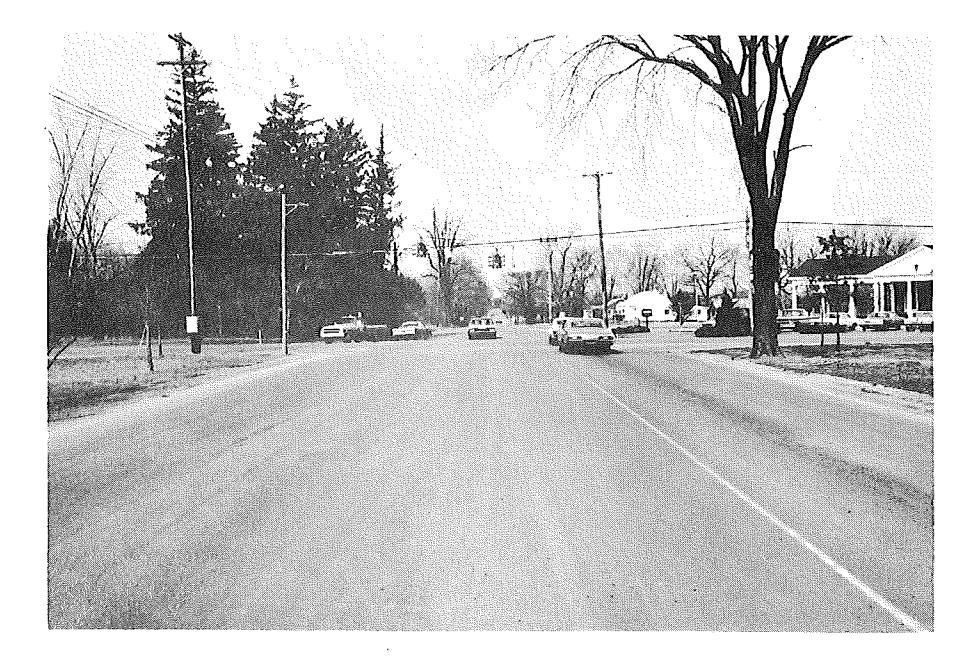
SOUTHBOUND PORTAGE ROAD

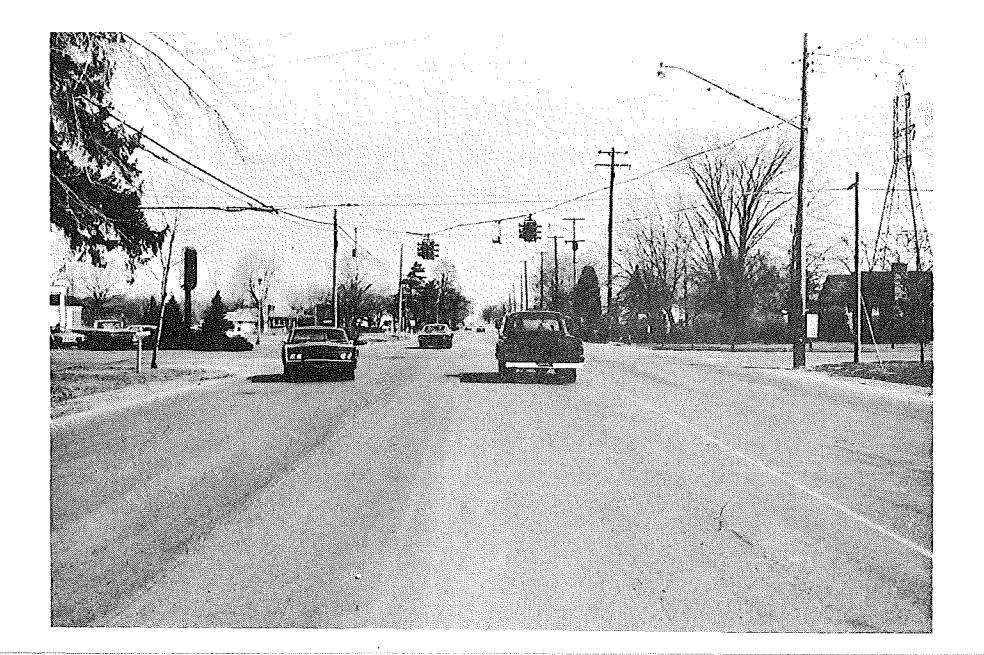
WESTBOUND

CENTRE AVENUE

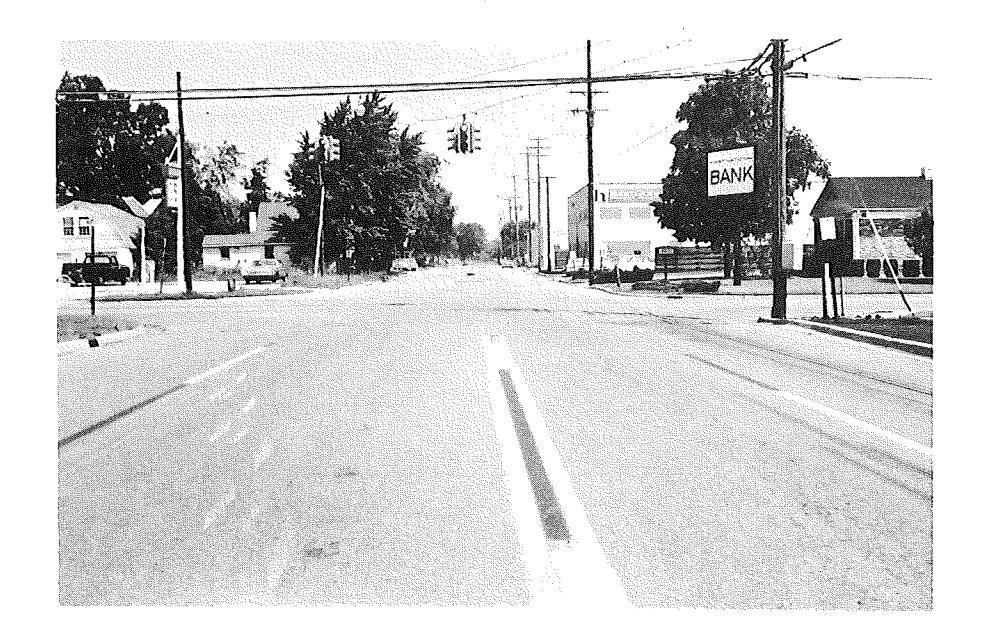
NORTHBOUND BURDICK STREET

The two signal heads that are suspended above the Mosel Avenue-Burdick Street intersection are not centered over the intersection. One signal head is located directly over the center line for Burdick Street and the other signal head is located west of the center line. It is recommended that these two signal heads be located as close as possible to the proper position as described by the Manual. At the Mosel Avenue-Pitcher Road intersection there is a cyclone fence and brush growth in the southeast quadrant which causes inadequate visibility for northbound Pitcher Road traffic. It is recommended that this brush growth be maintained so that it doesn't interfere with the vision of motorists on northbound Pitcher Road.

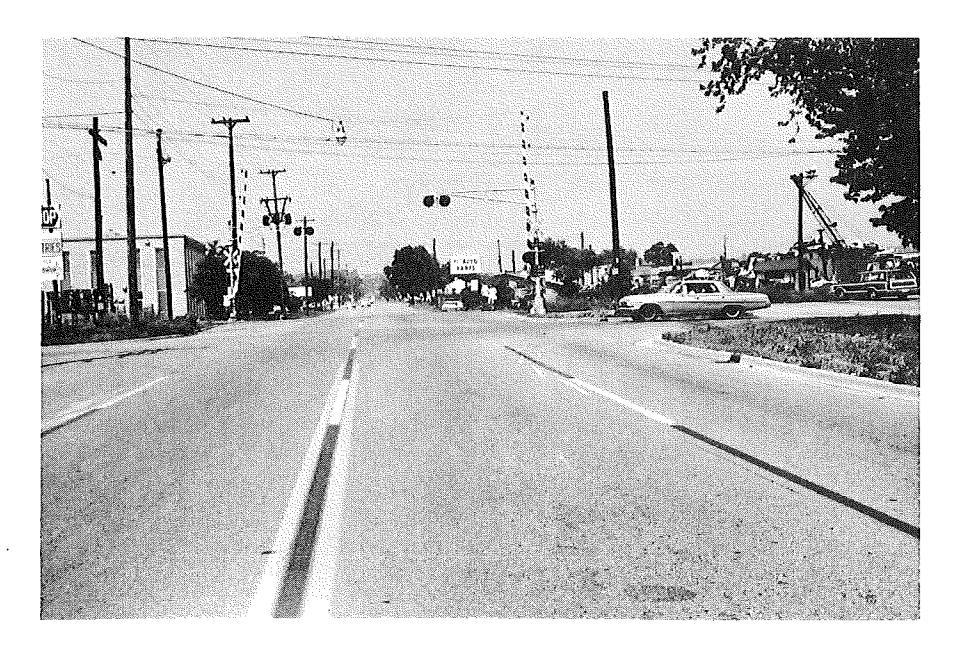
WESTBOUND MOSEL AVENUE

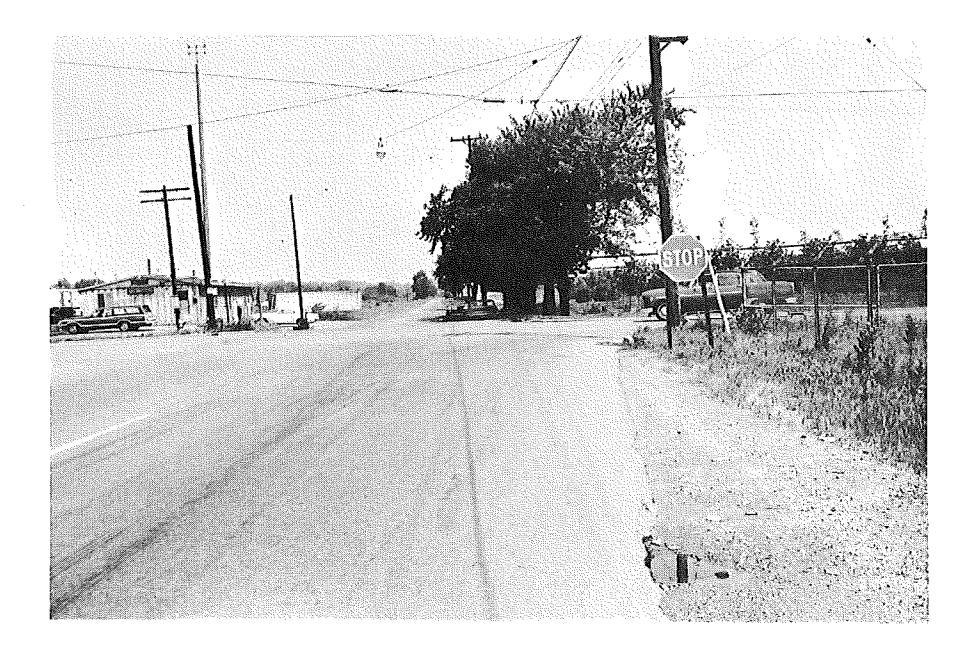
NORTHBOUND PITCHER ROAD

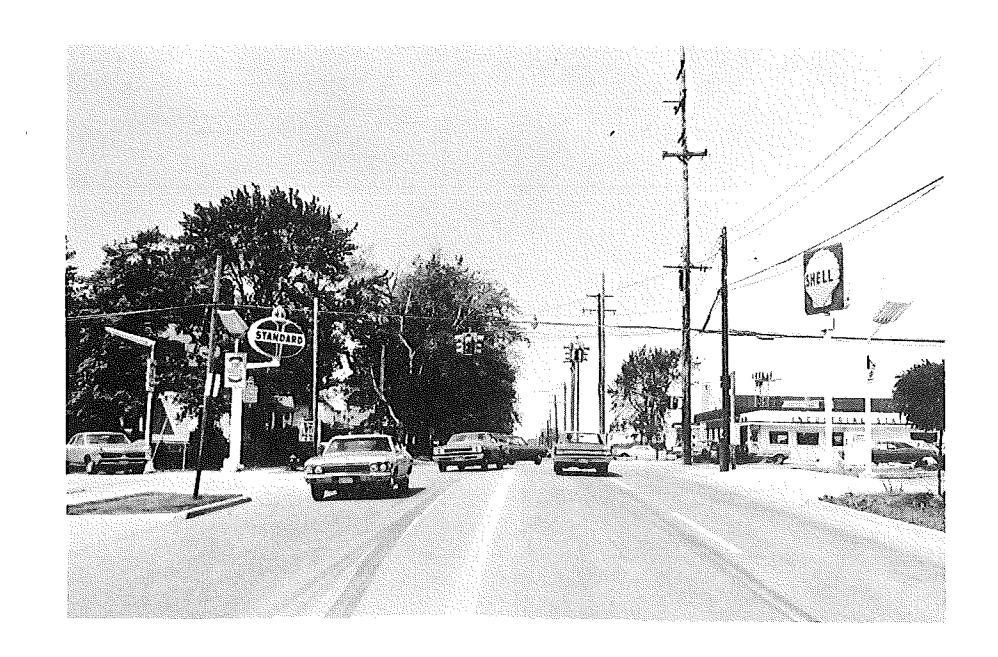
NORTHBOUND

WESTNEDGE AVENUE

Westnedge Avenue should be painted for three lanes using opposing center lanes for left turns only. Painted arrows indicating lane assignments should be applied and two post mounted Lane-Use Control signs; one located at the intersection and one located in advance of the intersection should be erected for both legs of Westnedge Avenue.

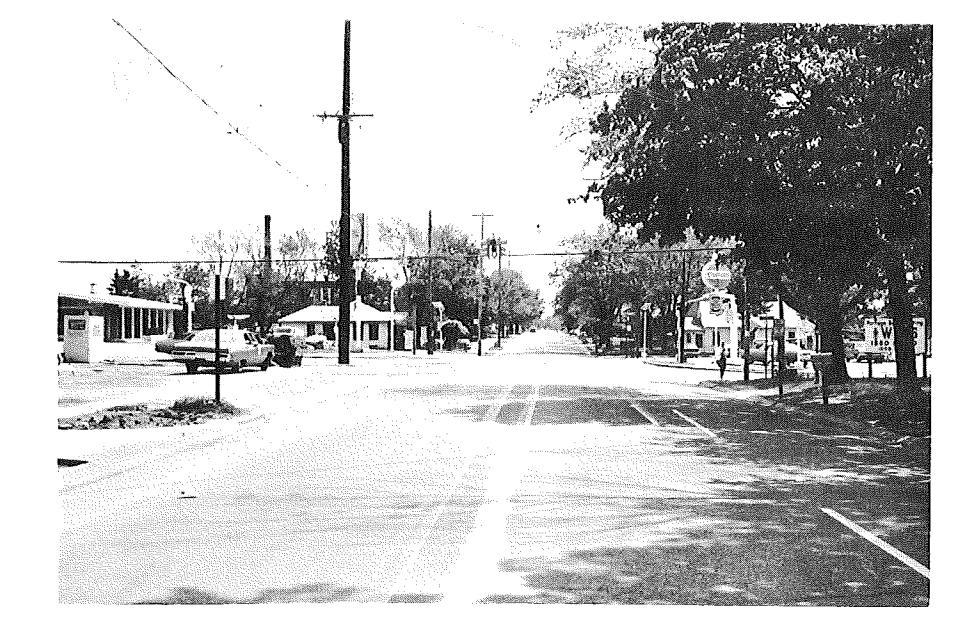
SOUTHBOUND WESTNEDGE AVENUE

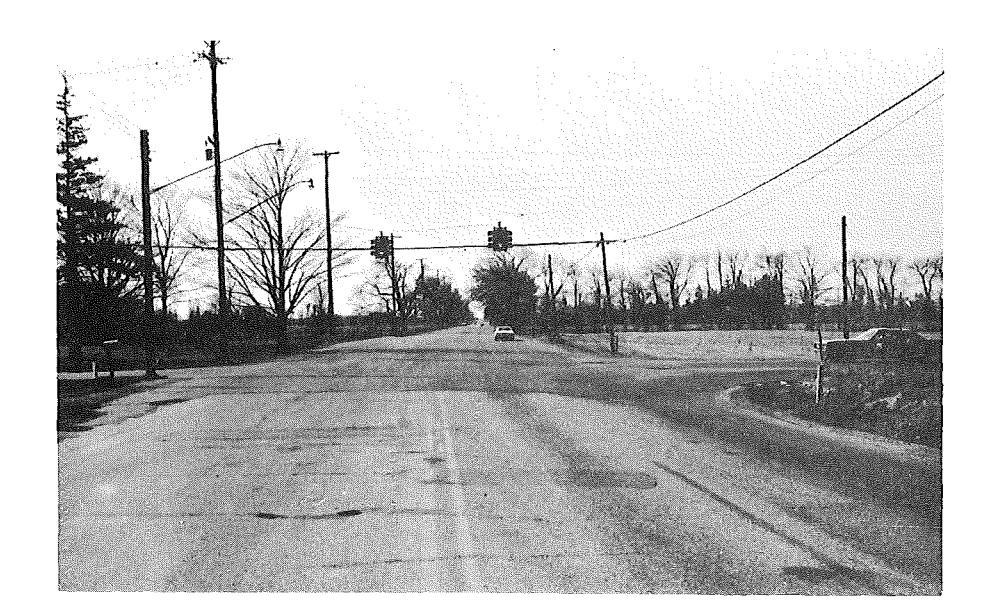
SOUTHBOUND PORTAGE ROAD

The pavement on the north leg of Portage Road is deteriorating. This conclusion is drawn from the numerous patches that make the pavement uneven. Therefore, it is recommended that consideration be given to resurfacing the north leg of Portage Road in the immediate intersection area. At the same time we recommend that the width of the north leg of Portage Road be increased from 44 ft to 55 ft and the approach road connection for the east leg of Milham Road be widened to 30 ft (Figure 25). We realize that 40

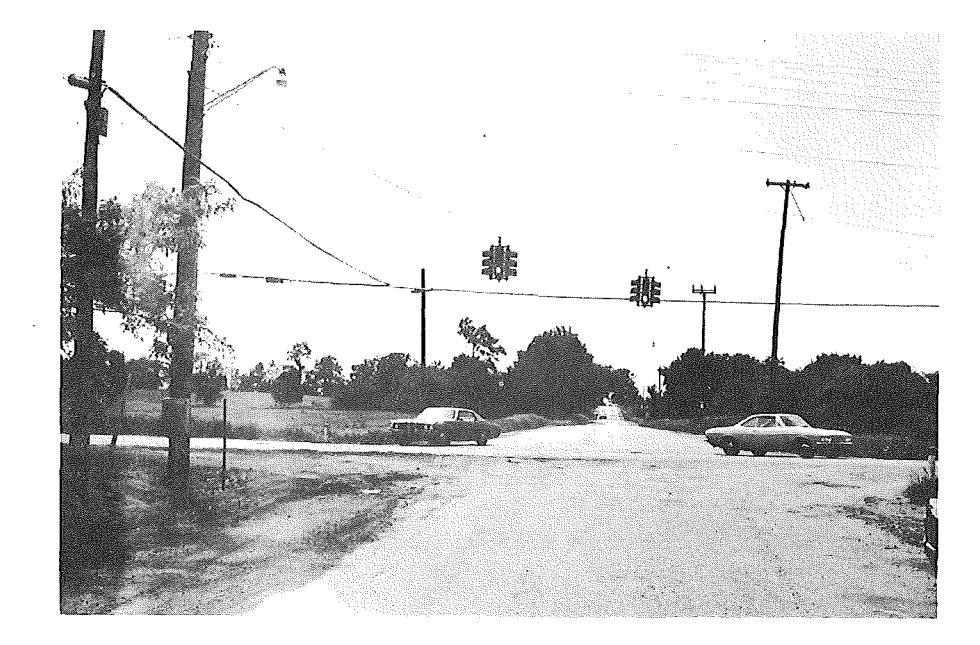
WESTBOUND

MILHAM ROAD

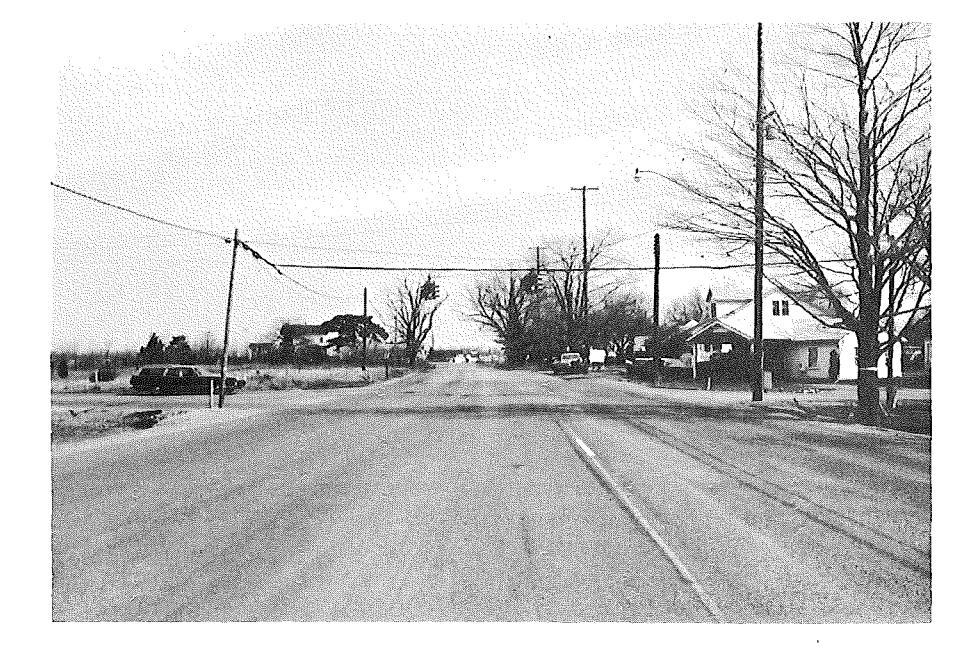
NORTHBOUND PORTAGE ROAD

Head-on left-turn collisions accounted for 26 percent of the accidents at this location. Seventy percent of these left turn accidents involved a turning movement from northbound Portage Road to westbound Milham Road. These figures indicate a need to separate the left turn movements from the thru movements. Thus it is recommended that Portage Road be marked for five lanes An inwith the center lane for left turns only (Figure 25). ternally illuminated case sign reading "Left Turn Lane" should be suspended over the center lane on the same support system as the traffic signal heads. Left turn arrows and the word "ONLY" should be applied to the center lane to further emphasize the mandatory left turn. A capacity analysis has indicated that a left turn signal phase is not necessary at this time. However, an increase in the ADT's may cause traffic congestion in the future. It is recommended that future ADT's be checked along with future accident reports to determine if signal phases for the left turn lanes are necessary.

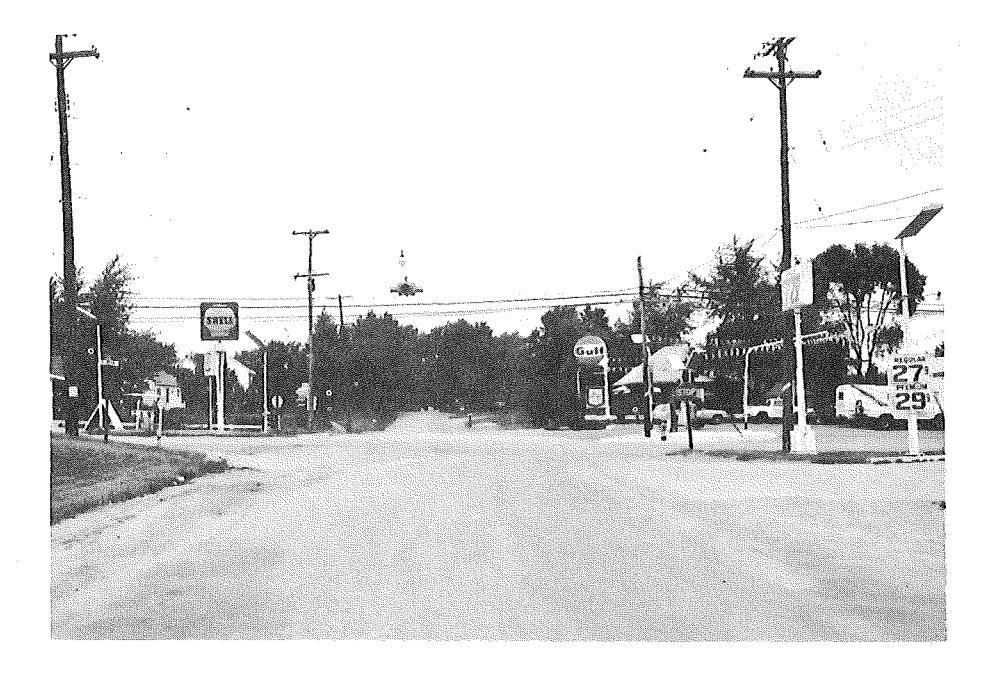
NORTHBOUND

NAZARETH ROAD

the approach road connection for the south leg of Nazareth Road should be widened to a minimum of 30 ft. A detail drawing of these designs can be found in the Standard Guides for the Michigan Department of State Highways and Transportation and on p. 49 of this report.

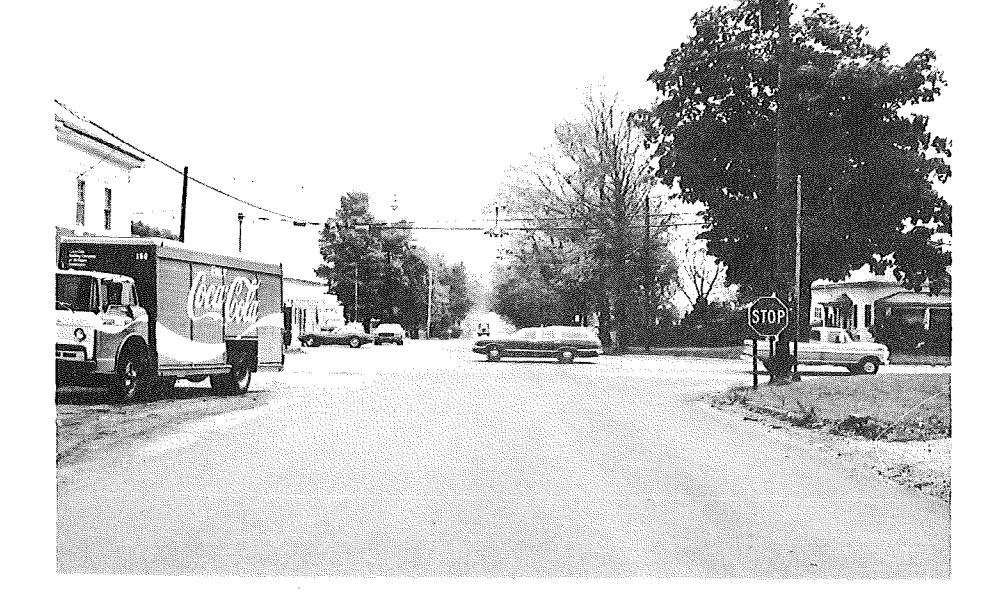
EASTBOUND "D" AVENUE

The sight distance from the east leg of "D" Avenue is inadequate. Thus, it is recommended that the bushes in the southwest quadrant be trimmed and then periodically maintained.

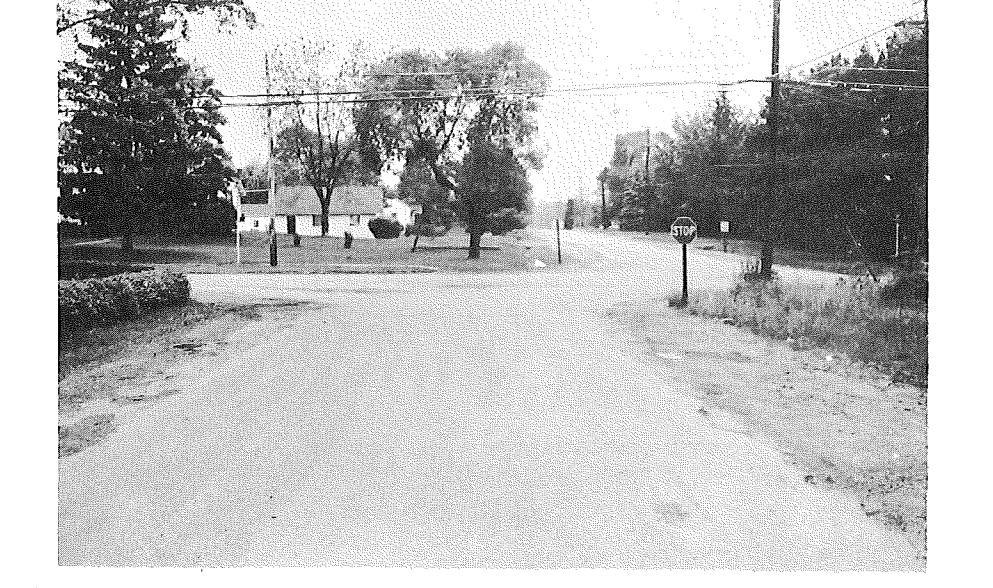
NORTHBOUND

Another problem at this location is the sight distance from the south leg of Lovers Lane. Three of the five right-angle accidents involved a vehicle traveling on northbound Lovers Lane. All three of these operators indicated that they did not see any traffic on Centre Avenue. The reason for this could be the bushes located in the southeast and southwest quadrants. It is recommended that these bushes be maintained so that the sight distance from the south leg of Lovers Lane will be adequate.

The two overhead flashing beacons are difficult to see due to telephone wires and trees. Thus, it is recommended that oversized signal heads be erected at this intersection. The oversized signal heads will be easier to see for both Lovers Lane and Centre Avenue traffic.

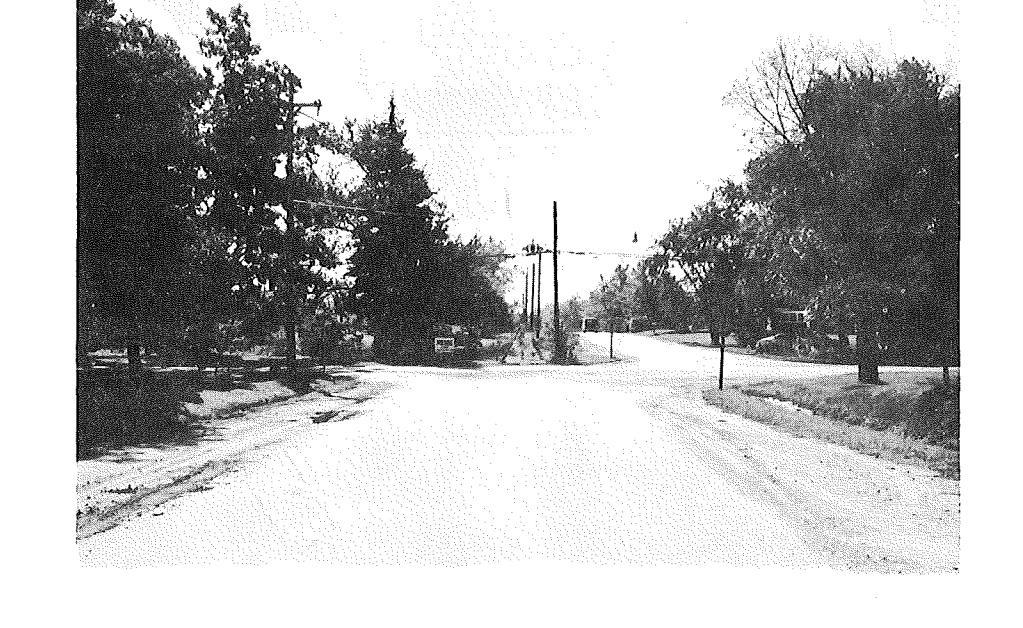
SOUTHBOUND LOVERS LANE

Furthermore, the "Stop" sign for the north leg of Lovers Lane traffic is not immediately visible due to a small elevation in the roadway just before the intersection. Thus, it is recommended that a 30 in. "Stop Ahead" sign be erected for southbound Lovers Lane traffic. This sign will provide advance warning of the forthcoming traffic control.

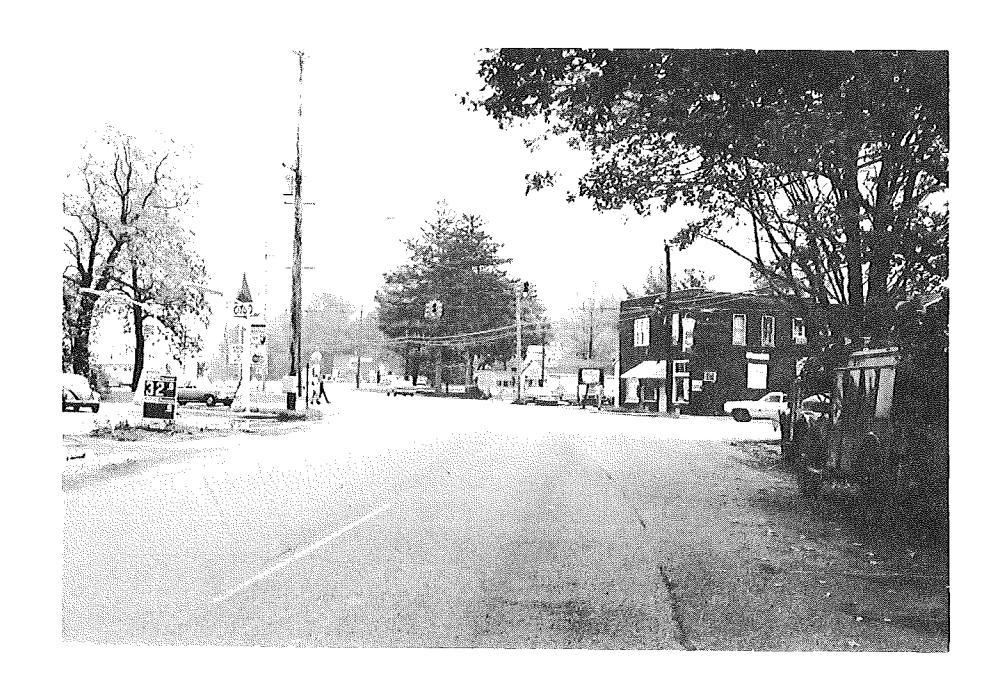
EASTBOUND MICHIGAN AVENUE

There were eight ran-off roadway accidents at this location. Six of these accidents involved a collision with a utility pole. Due to the high concentration of utility poles at this intersection it is recommended that the utility company be contacted to determine if reduction of the number of utility poles is feasible. Also, the feasibility of moving those poles that are in target position should be investigated.

The 24 hour volume counts for this intersection were obtained in March of 1973. A warrant graph (Figure 47) based on this data indicates that the hourly volumes for both Michigan Avenue and 9th Street are greater than the minimum volumes for Warrant 1 in the Manual. Thus we concur with the placement of the stop and go signals. However, it is recommended that extra laneage be used to separate left turning traffic from through and right turning traffic. Michigan Avenue is wide enough that the additional laneage can be obtained through the use of pavement markings. Both east and westbound Michigan Avenue should be marked for three lanes with the center lane for left turns only and the outside lane for right turns and through movements. Painted arrows indicating lane assignments should be applied and two post-mounted Lane-Use Control signs, one located at the intersection and one located in advance of the intersection, should be erected for both legs of Michigan Avenue (Figure 46).

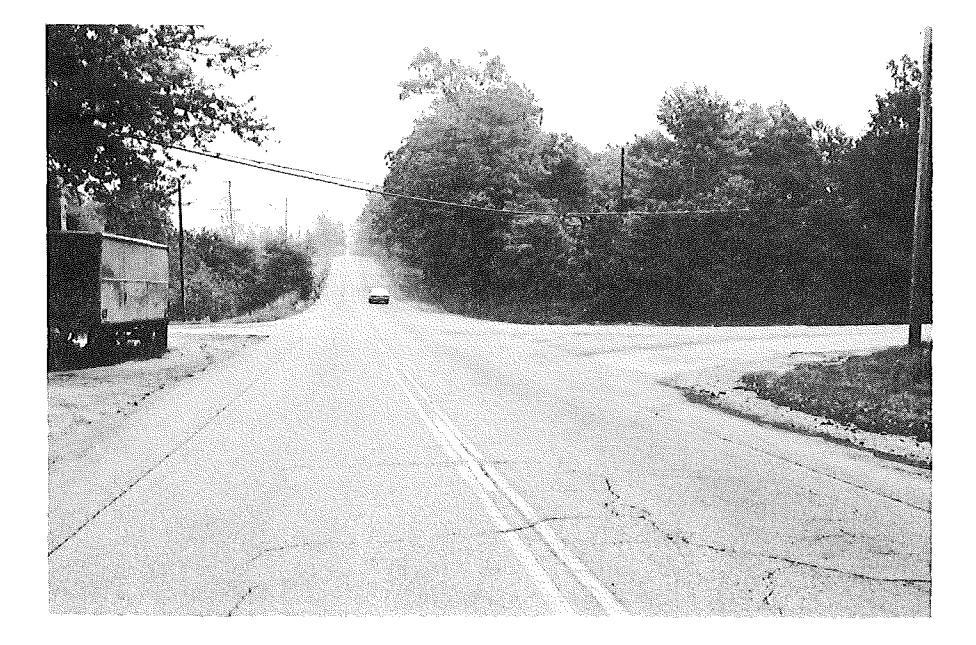
EASTBOUND MICHIGAN AVENUE

Also, the Michigan Manual indicates that there should be 60 in. from the shoulder of the road to the bottom of a sign. The two Crossroad Warning signs on Michigan Avenue had a bottom height of 45 in. and the "Stop Ahead" sign for southbound 6th Street traffic had a bottom height of 48 in. It is recommended that these signs be adjusted to correspond to the bottom height called for in the Michigan Manual.

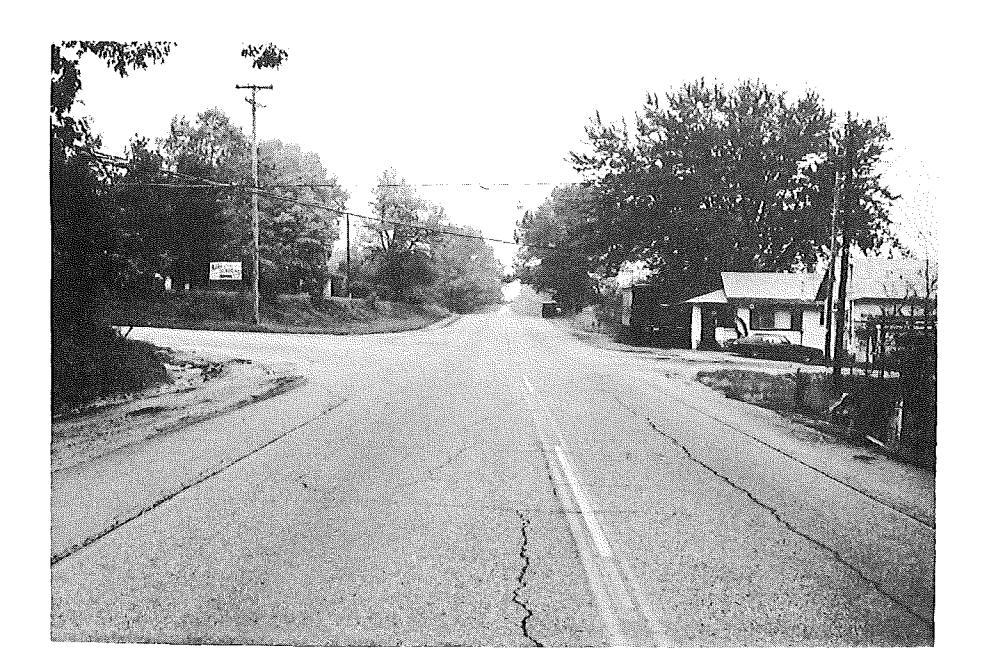
WESTBOUND MICHIGAN AVENUE

Four of the five rear end accidents at this intersection involved westbound Michigan Avenue traffic attempting a left turn onto southbound 6th Street. Michigan Avenue has a negative gradient approaching 6th Street from both the easterly and westerly direc-Each of the four operators involved in the above mentioned tions. rear end accidents claimed to have not seen the left turning vehicle in time to stop. It is recommended that Michigan Avenue in the immediate intersection area be painted so that there are three ten foot lanes with the center lane used for left turns. Painted arrows indicating lane assignments should be applied and two postmounted Lane-Use Control signs, one located at the intersection and one located in advance of the intersection, should be erected for both legs of Michigan Avenue (Figure 56). These changes will enable Michigan Avenue traffic to continue through the intersection without stopping. It should considerably reduce the rear end accidents on Michigan Avenue.

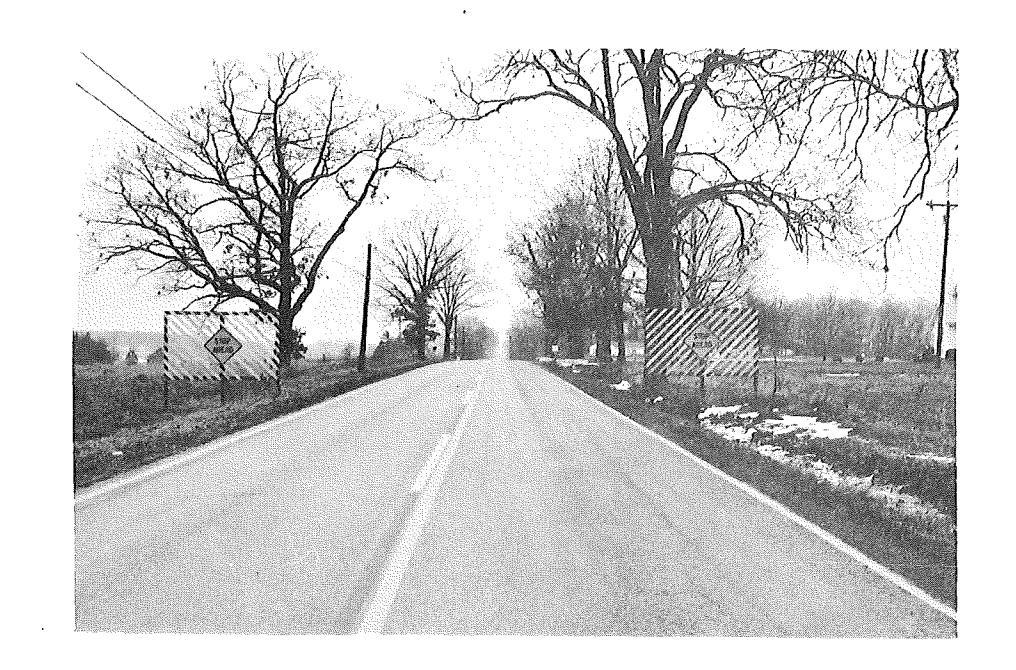
NORTHBOUND 40TH STREET

Furthermore, the "Stop Ahead" signs on 40th Street are only 30 in. signs. A 30 in. "Stop Ahead" sign should be used in advance of a 24 in. "Stop" sign and a 36 in. "Stop Ahead" sign should be used in advance of a 30 or 36 in. "Stop" sign. Since 40th Street has 36 in. "Stop" signs, it is recommended that 36 in. "Stop Ahead" signs be used.

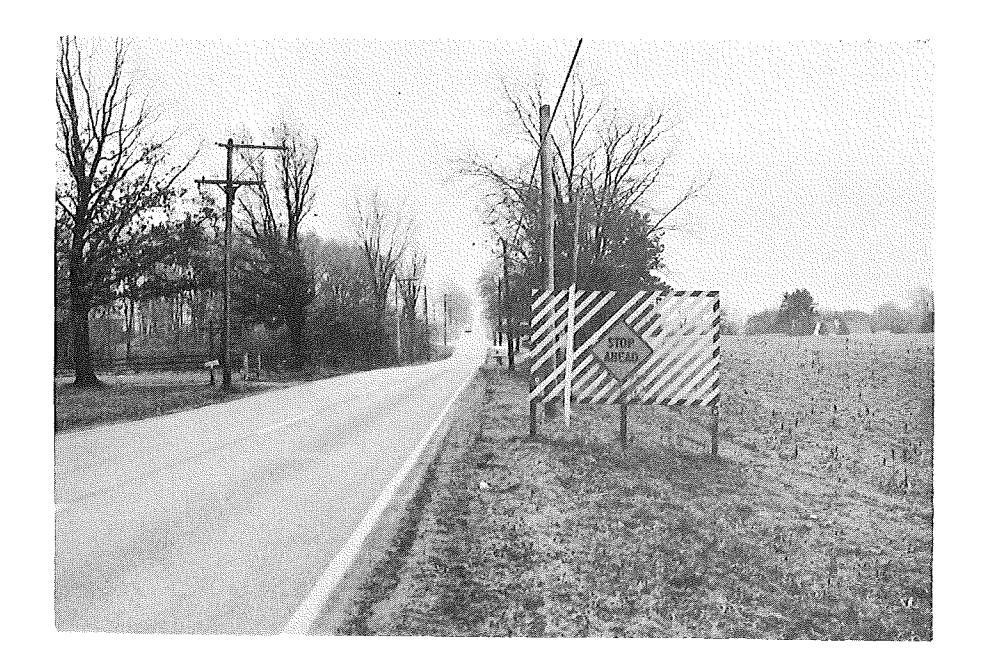
SOUTHBOUND 40TH STREET

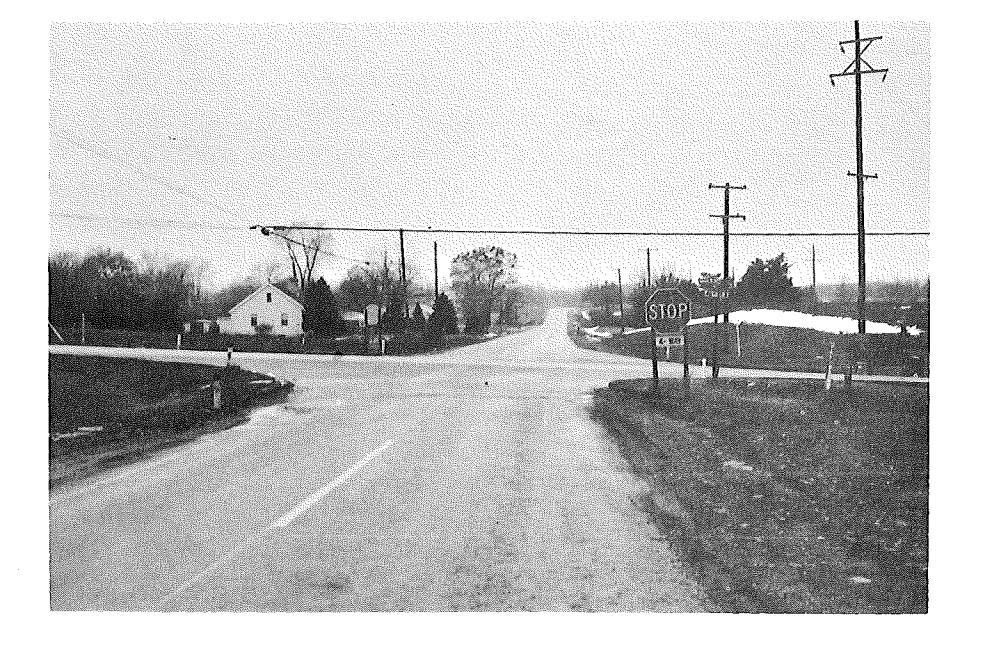
FIGURE 61

"C" AVENUE

WESTBOUND

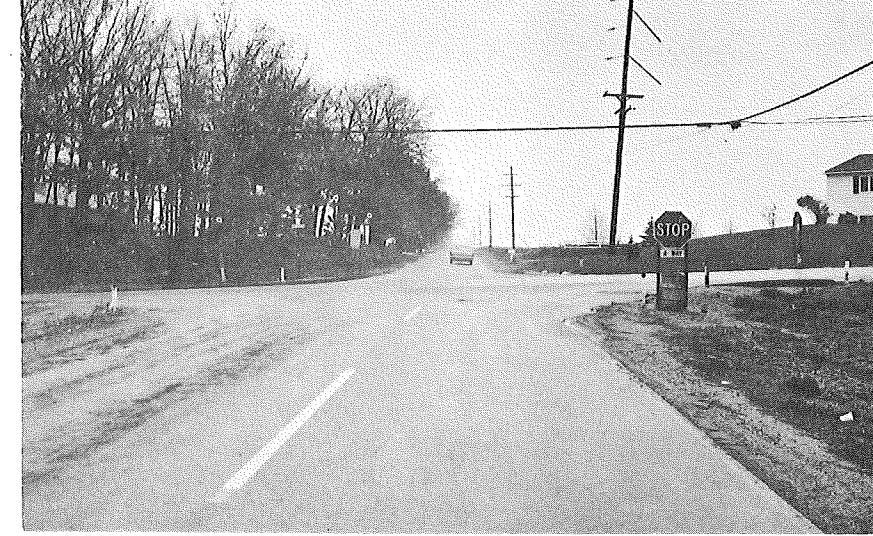
"C" AVENUE

EASTBOUND

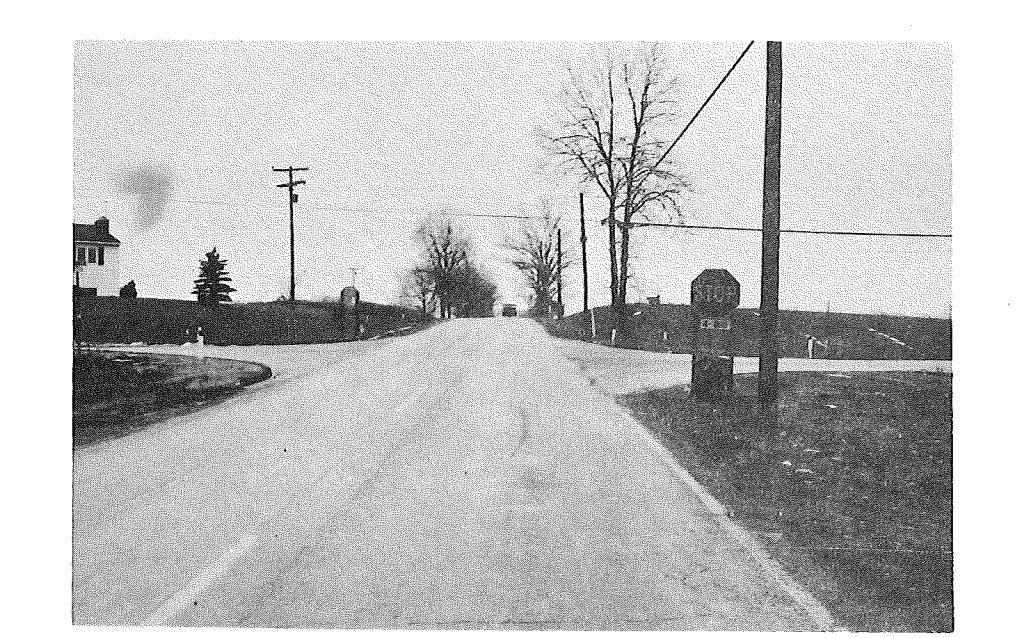
SOUTHBOUND 40TH STREET
