**TESTING AND RESEARCH DIVISION
RESEARCH LABORATORY SECTION**

**BASE AND SUBBASE PROPERTIES AFFECTING
LONGITUDINAL CRACKING OF I 275**

**Research Laboratory Section
Testing and Research Division
Research Project 79 TI-622
Research Report No. R-1152**

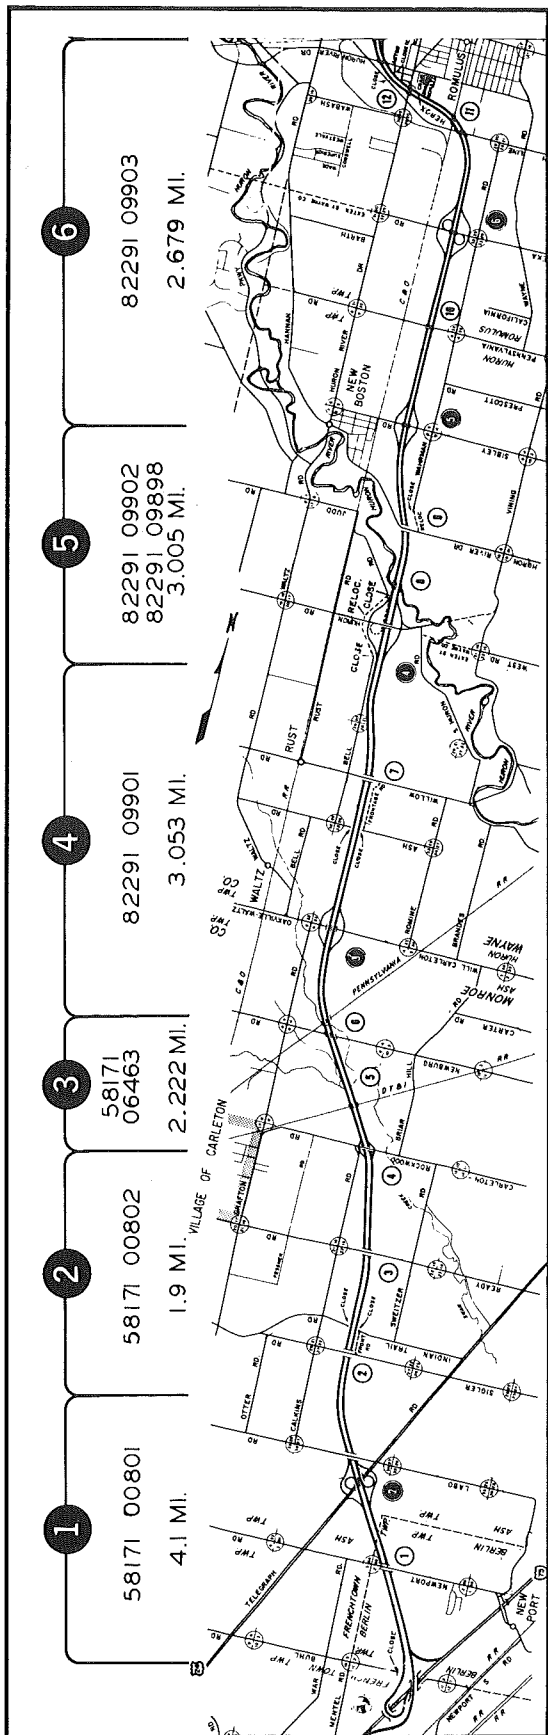
Figure 1. Section of I 275 investigated showing test section numbers, contract numbers, and mileage.
