EXPERIMENTAL CONTRACT RESEALING OF JOINTS AND  
CRACKS ON US-16  
Nunica to Fruitport  
Project Mc 70-28, C3

Research Project 53 G-68

Research Laboratory  
Testing and Research Division  
Report 197  
October 9, 1953

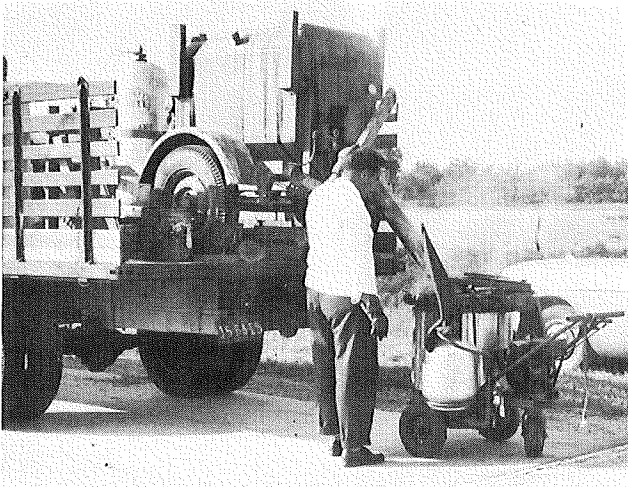
The joint sealing materials were melted in a "Sealz" melter, Figure 2, which is of the double boiler type using oil as the heat transfer medium. It had thermostatically controlled gas heat, constant agitation, and a thermometer to indicate the temperature of the oil bath. Temperatures of the sealing material were taken at frequent intervals by the author with a hand thermometer. A temperature differential of 50°F was maintained between the temperature of the oil bath and that of the sealing material.

▲ FIGURE 2. FILLING POURING POT FROM SEALZ MELTER ON TRUCK.

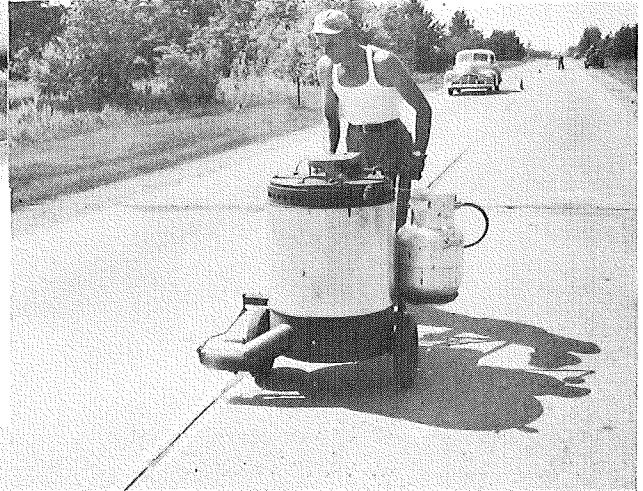
The sealing materials were poured from a mechanical pour pot, Figure 3, also of the double boiler type, using oil as the heat transfer medium and having thermostatically controlled gas heat and a thermometer to indicate the oil temperature. The pour pot was mounted on rubber tired wheels and was provided with a mechanical agitator. Temperatures of the materials in the pour pot were also taken at frequent intervals by the writer. A temperature differential of 50°F was found between the oil and the sealing material in the pour pot.

▲ FIGURE 3. USE OF MECHANICAL POUR POT IN SEALING LONGITUDINAL CENTER JOINT.

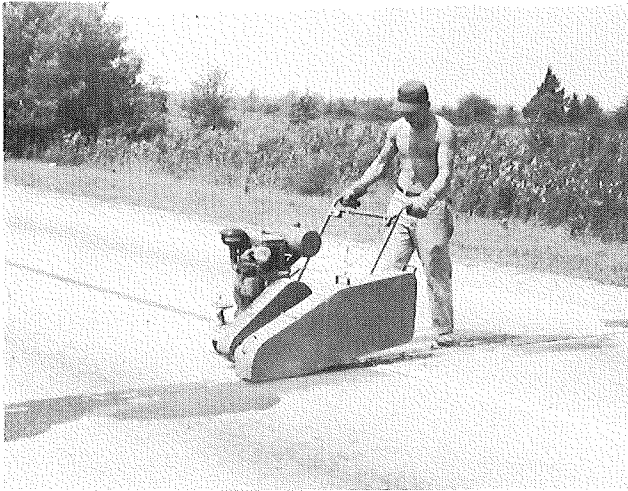
▲ FIGURE 4. HECKER JOINT CLEANING MACHINE IN OPERATION.

Two types of mechanical joint cleaning equipment were used for cleaning joints, namely, the Hecker joint machine, Figures 4 and 5, and the Tennant joint cleaning machine, Figure 6.

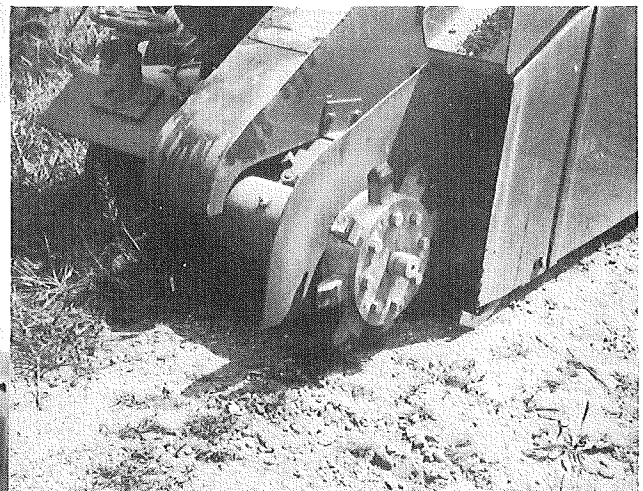
▲ FIGURE 5. CUTTING HEAD OF HECKER JOINT-CLEANING MACHINE.

The first experiments in cleaning old materials from joints involved the use of both the Hecker and Tennant joint cleaning machines. In cleaning transverse joints, old sealer and filler was first removed with the Hecker machine and then the pavement surface at each side of the joint freed from old sealer and other materials by use of the Tennant machine equipped with a surface scarifying head. Various depth adjustments and various width cutters were tried with the Hecker machine and a satisfactory cut was finally obtained with cutters 1 inch wide set to clean the sides of the joint to a one-inch depth. The head of the Hecker machine equipped with 1-inch cutters is shown in Figure 5.

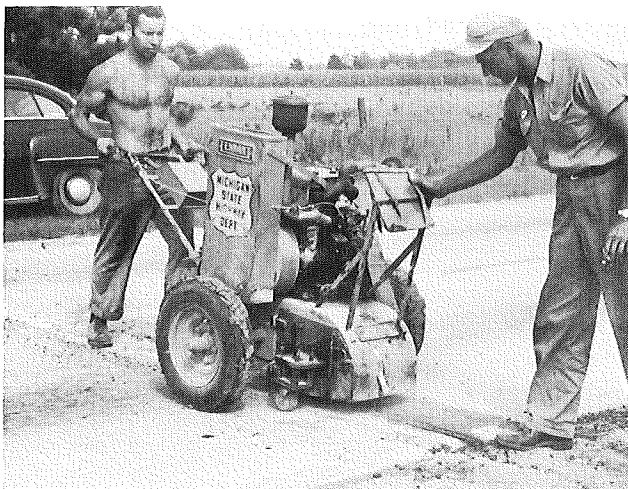
▲ FIGURE 6. TENNANT JOINT CLEANING MACHINE IN OPERATION.

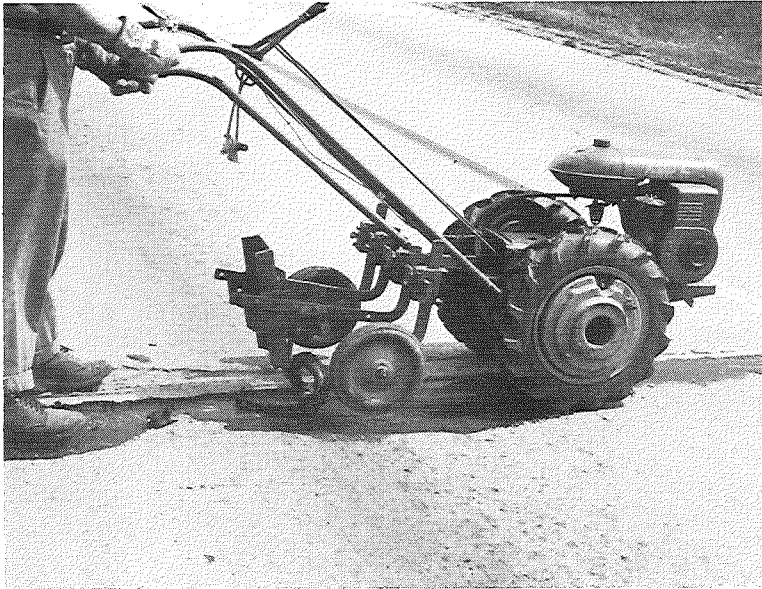
For removing the bulk of old materials from joints a small garden tractor with a plow attachment, Figure 7, was used. Plow blades of various shapes are shown in Figure 8.

▲ FIGURE 7. GARDEN TRACTOR WITH PLOW ATTACHMENT REMOVING OLD JOINT SEALER.

From the start of the project experiments were run daily with the small garden tractor and plow attachments for plowing out old materials from the joints. The problem seemed to be in getting the proper shaped plow blade to remove a maximum of material to a sufficient depth. On the sixth day of operation the plow was put into permanent operation on transverse joints and by the twelfth day it was used for the longitudinal joints. Several plow blades of typical shapes are shown at the bottom of Figure 8. No particular shape of the several developed was considered completely satisfactory so this operation is open to further experimentation.

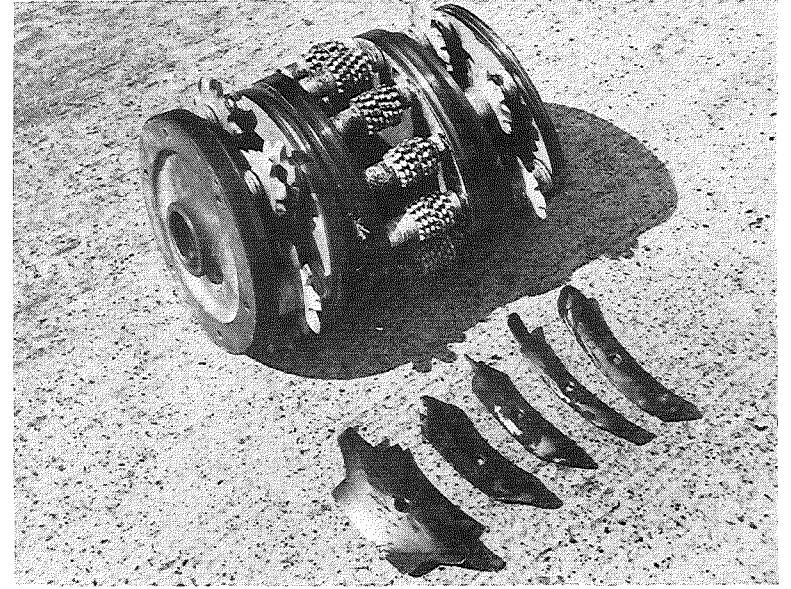
▲ FIGURE 8. TENNANT CUTTER HEADS AND TRACTOR PLOW BLADES USED FOR CLEANING JOINTS.

In Figure 8, the center head is the type used for the scarifying operations. The Tennant machine with a single row of 4 inch cutters, as shown in Figure 8 upper right, was tried in place of the Hecker for routing old material from the transverse joints but it didn't do quite as complete a job as did the Hecker.

About this time, the Tennant was again tested for removing old material from the transverse joints but this time single and double cutters were alternated around the head, Figure 8 upper left. This operation left a cleaner joint than did routing with the Hecker machine so the latter was abandoned also for this purpose.

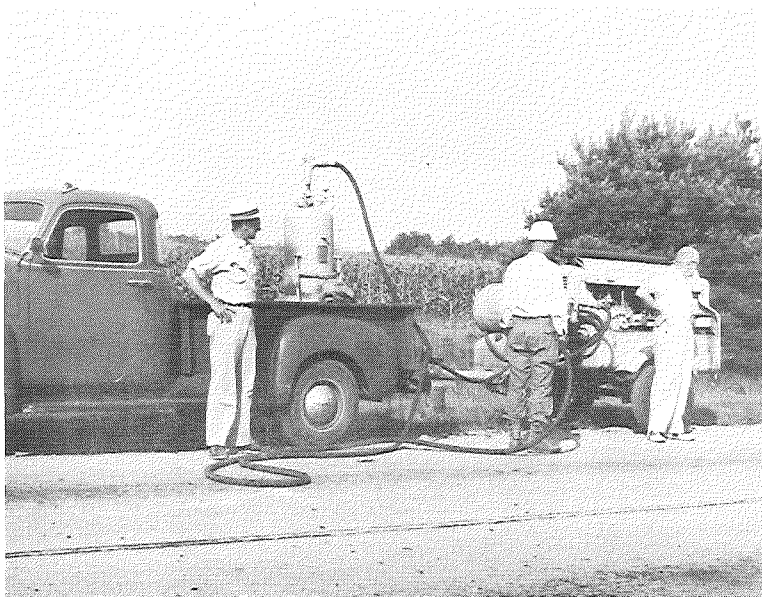
The sandblast and air blowing operations on joints and cracks were accomplished with a portable air compressor capable of maintaining a pressure of 90 psi and a sandblast machine mounted in a pickup truck. Both pieces of equipment are shown in Figure 9.

▲ FIGURE 9. PORTABLE AIR COMPRESSOR AND SANDBLAST MACHINE.

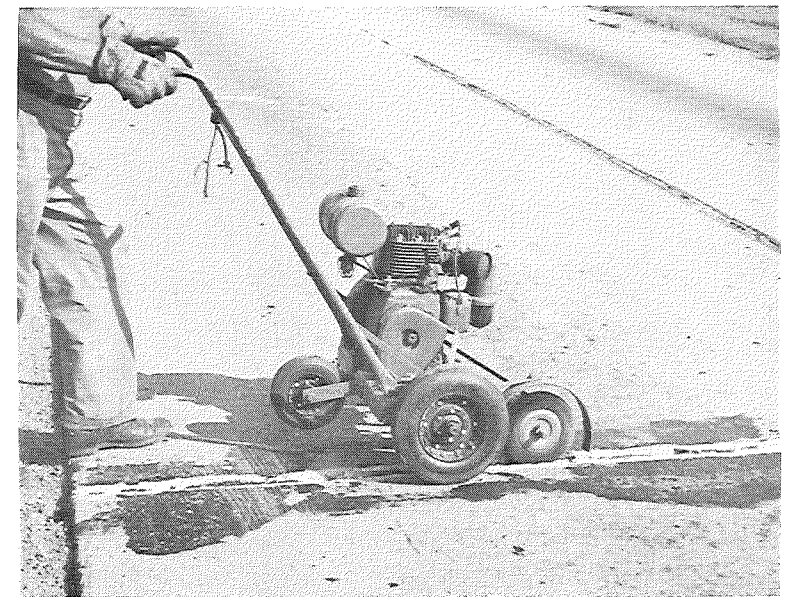
A mechanical wire brush used in some of the earlier joint cleaning operations is shown in Figure 10.

▲ FIGURE 10. MECHANICAL WIRE BRUSH USED IN EARLY JOINT CLEANING OPERATIONS.

After routing out both types of joints with the Tennant machine, small pieces or sections of old sealer or felt were still more numerous than was considered desirable and could not be removed with the final operation, of sandblasting and blowing with compressed air. To take care of this a mechanical wire brush, Figure 10, was used. In the longitudinal joint, the sections of felt left by the Tennant machine were routed out in a fairly satisfactory manner by the mechanical brush. Pieces of old sealer left by
