ALLEGED DAMAGE TO THE RESIDENCE OF
G. McAVON DUE TO TRAFFIC INDUCED VIBRATIONS

MICHIGAN DEPARTMENT OF STATE HIGHWAYS

Research Laboratory Section
Testing and Research Division
Research Project 72 TI-82
Research Report No. R-829

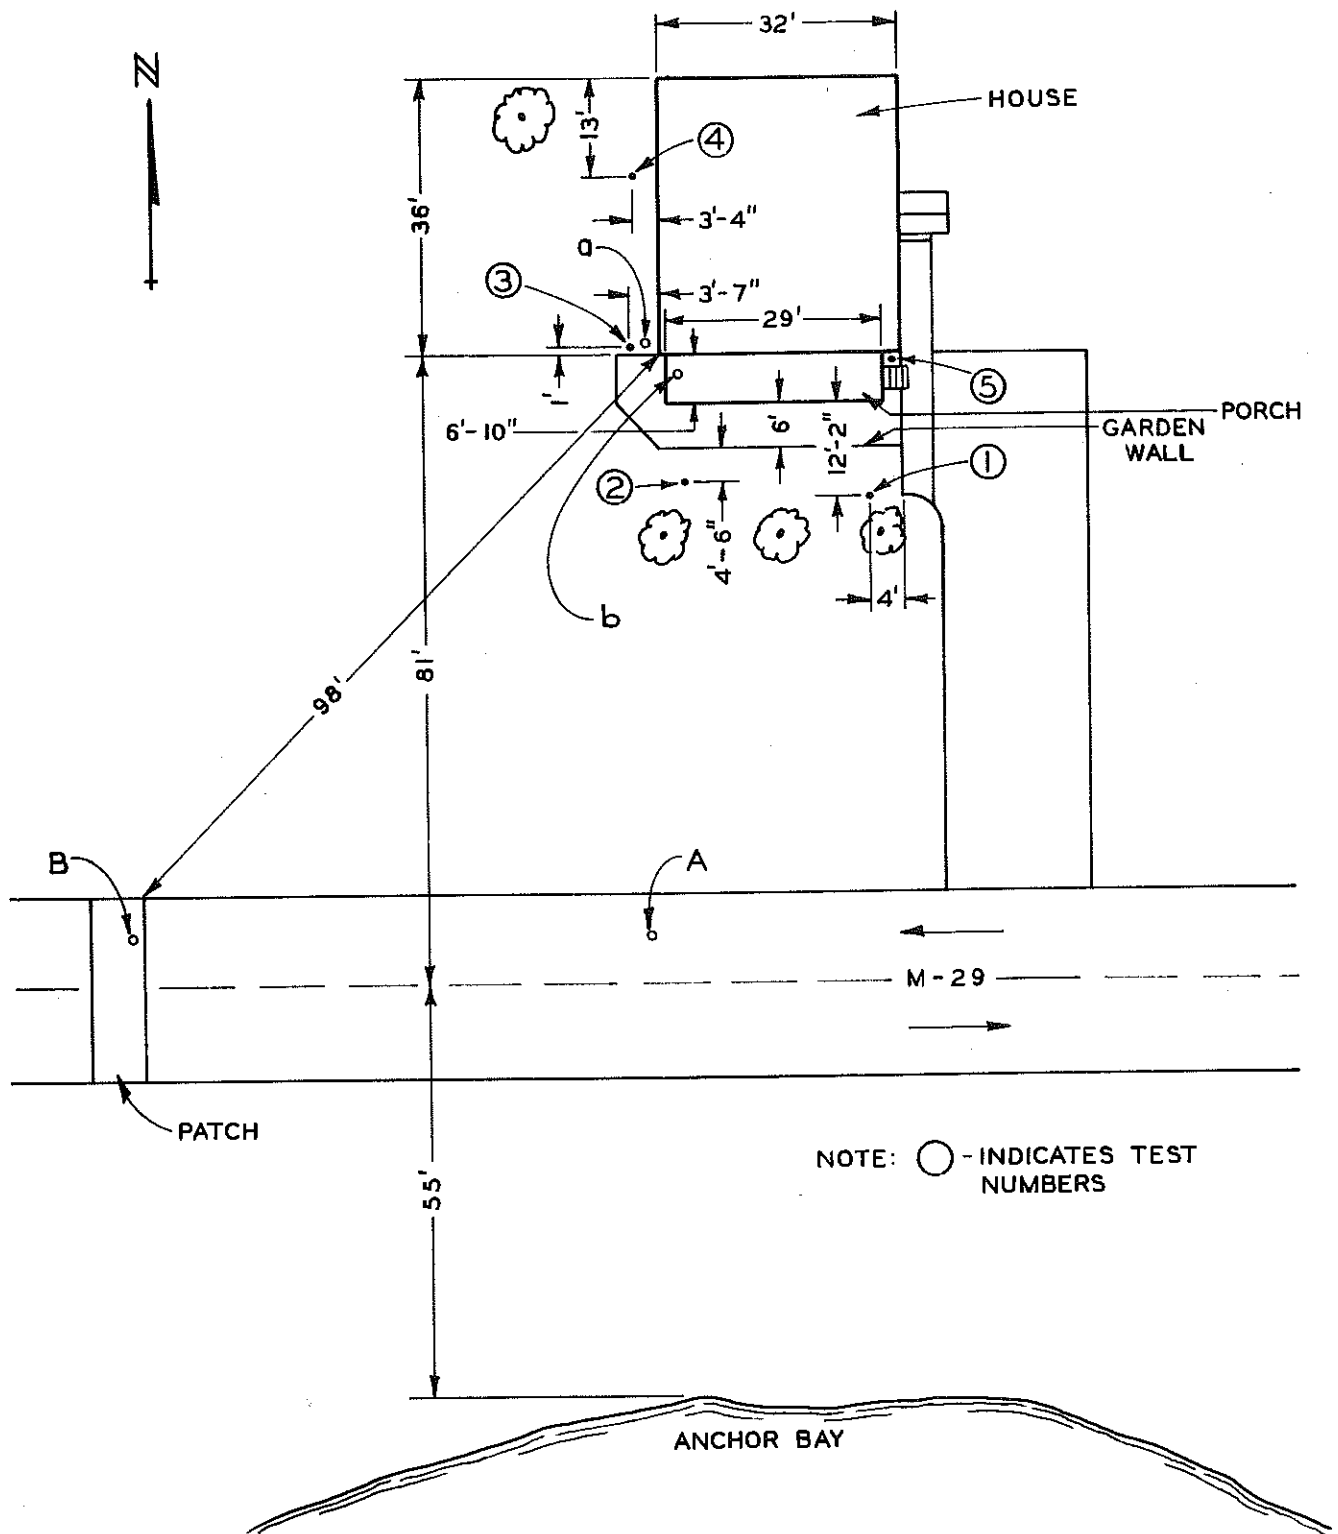
Figure 4. General plan of test site.

Initial tests were made with the accelerometers attached to the stake at location a, and impact boards at location A (Fig. 4). Impact boards then were moved to B, which is the location of the former pavement bump, and the accelerometers remained at a. Finally, the accelerometers were clamped to the porch slab at b and the impact boards were moved back to A. Results of the tests are shown in Table 1. In addition, the following results were found for comparison with the vehicle-induced vibrations. 1) With the accelerometers mounted on the stake at a; a man walking on the ground 6 ft from the stake caused outputs of 0.003 g, the core sampler being driven at location No. 2 caused 0.002 g, and a 10-lb sledge dropped less than 2 ft at a spot 3 ft away from the stake, caused 0.013 g. 2) With the accelerometers mounted on the porch slab at b; a man walking on the porch caused 0.003 g, a man walking on the ground next to the porch caused 0.002 g, and a man jumping off from the porch, (approximately 3-ft drop), caused 0.011 g.

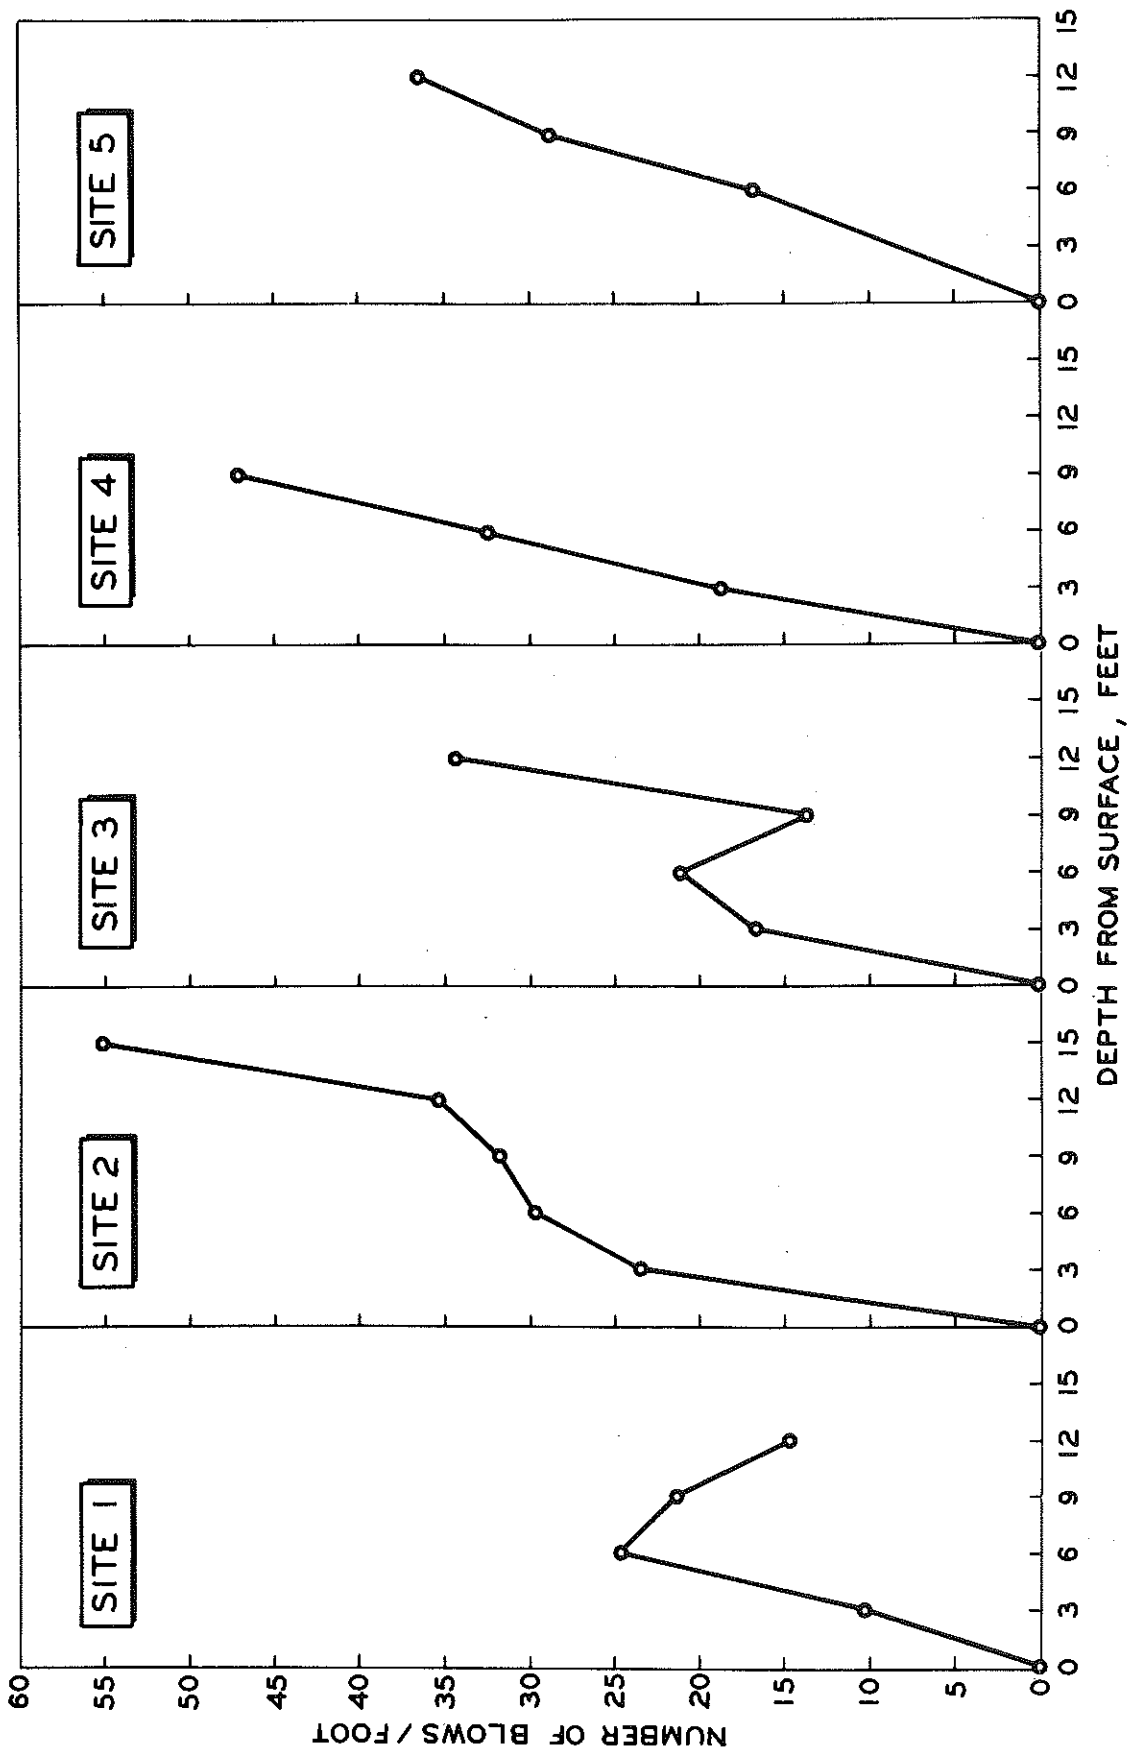
Figure 5. Soil boring penetration records.

Soil borings were made at locations marked ① through ⑤ in Figure 4. A penetration record was kept for all test borings to a depth lower than the foundation level. Continuous samples were recovered from all borings. A Sprague-Henwood type sampler was used to conduct the sampling operation and recover 1 in. diameter, relatively undisturbed, samples. A penetration record in terms of number of blows per foot¹ for all borings is shown in Figure 5. The penetration record indicates a non-homogenous subsoil with varied resistance at different locations of the site. The ground water table was estimated to be located very close to the foundation's elevation.

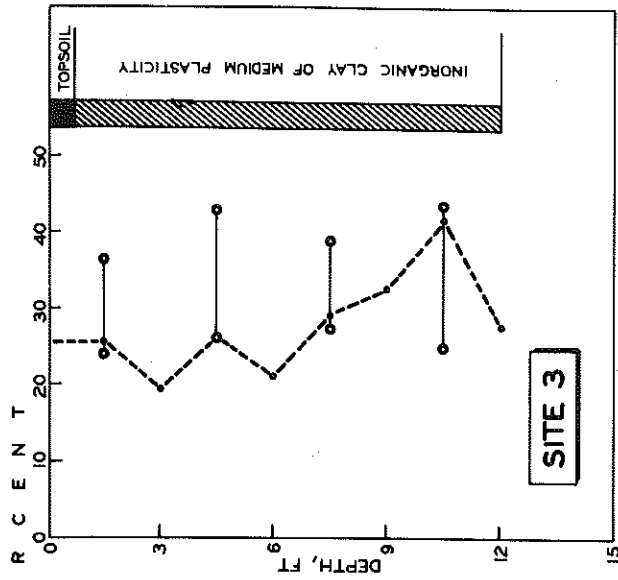
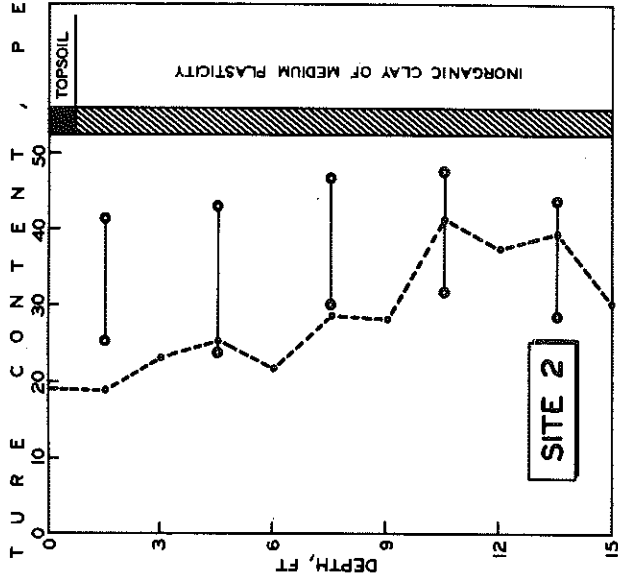
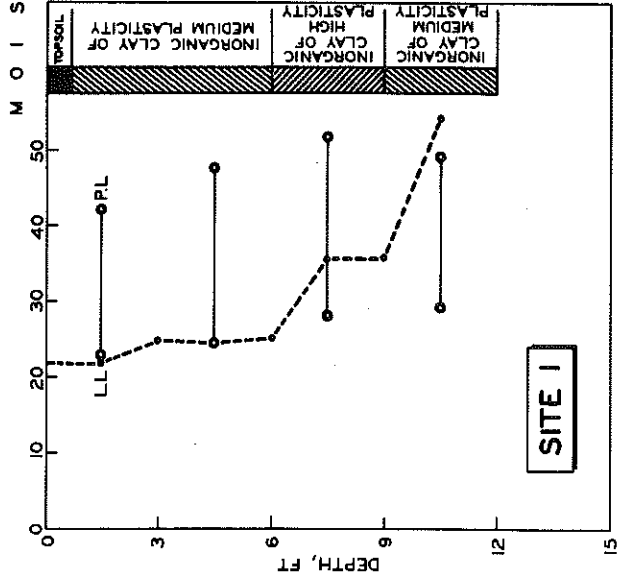
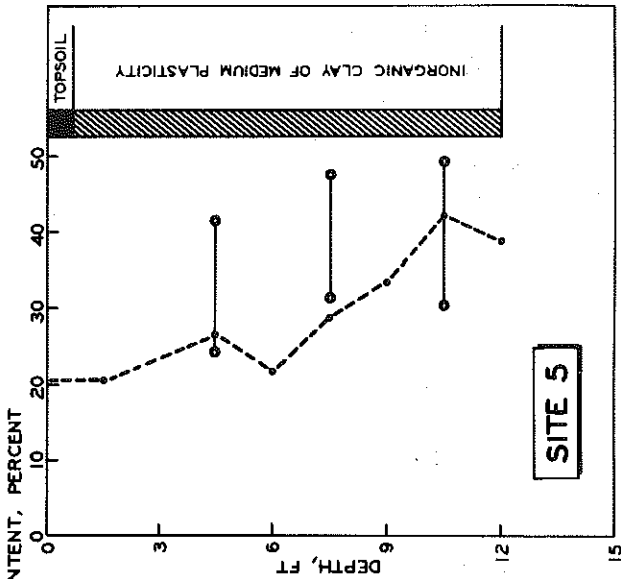
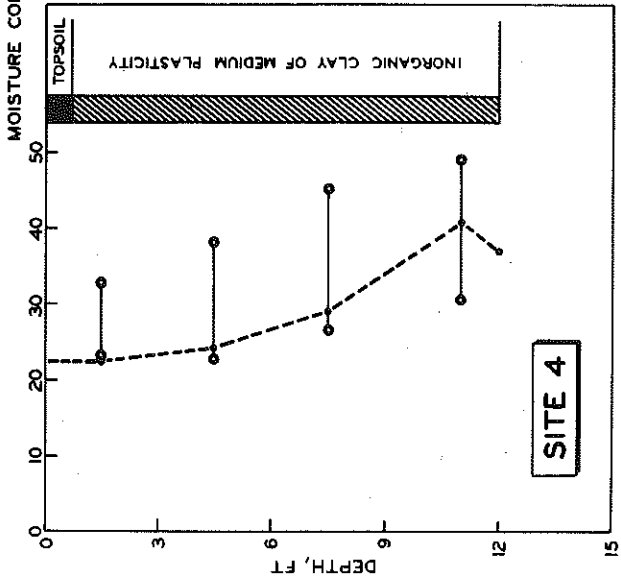
Figure 6. Soil profiles at boring sites.

Liquid Limit, Plastic Limit, and Plasticity Index were measured for samples obtained at 3-ft deep intervals for the five soil borings. Sieve analysis and hydrometer analysis for samples obtained at 6 to 9 ft depth were conducted. Liquid Limit, Plastic Limit and Grain Size Distribution for all soil borings are summarized in Table 2. The measured values of Atterberg Limits and the grain size distribution indicate that the soil in the site of the five borings is an inorganic clay of medium to high plasticity. A soil profile indicating soil classification, Atterberg Limits and moisture content is shown in Figure 6.

Table 3 indicates that; 1) the clay in all borings, except boring ④ is stiff to a depth of 9 ft, 2) the clay is soft in all borings, except boring ③, at a depth of 9 to 12 ft (foundation's level), and 3) the consistency of the clay in this site is erratic (non-homogenous).

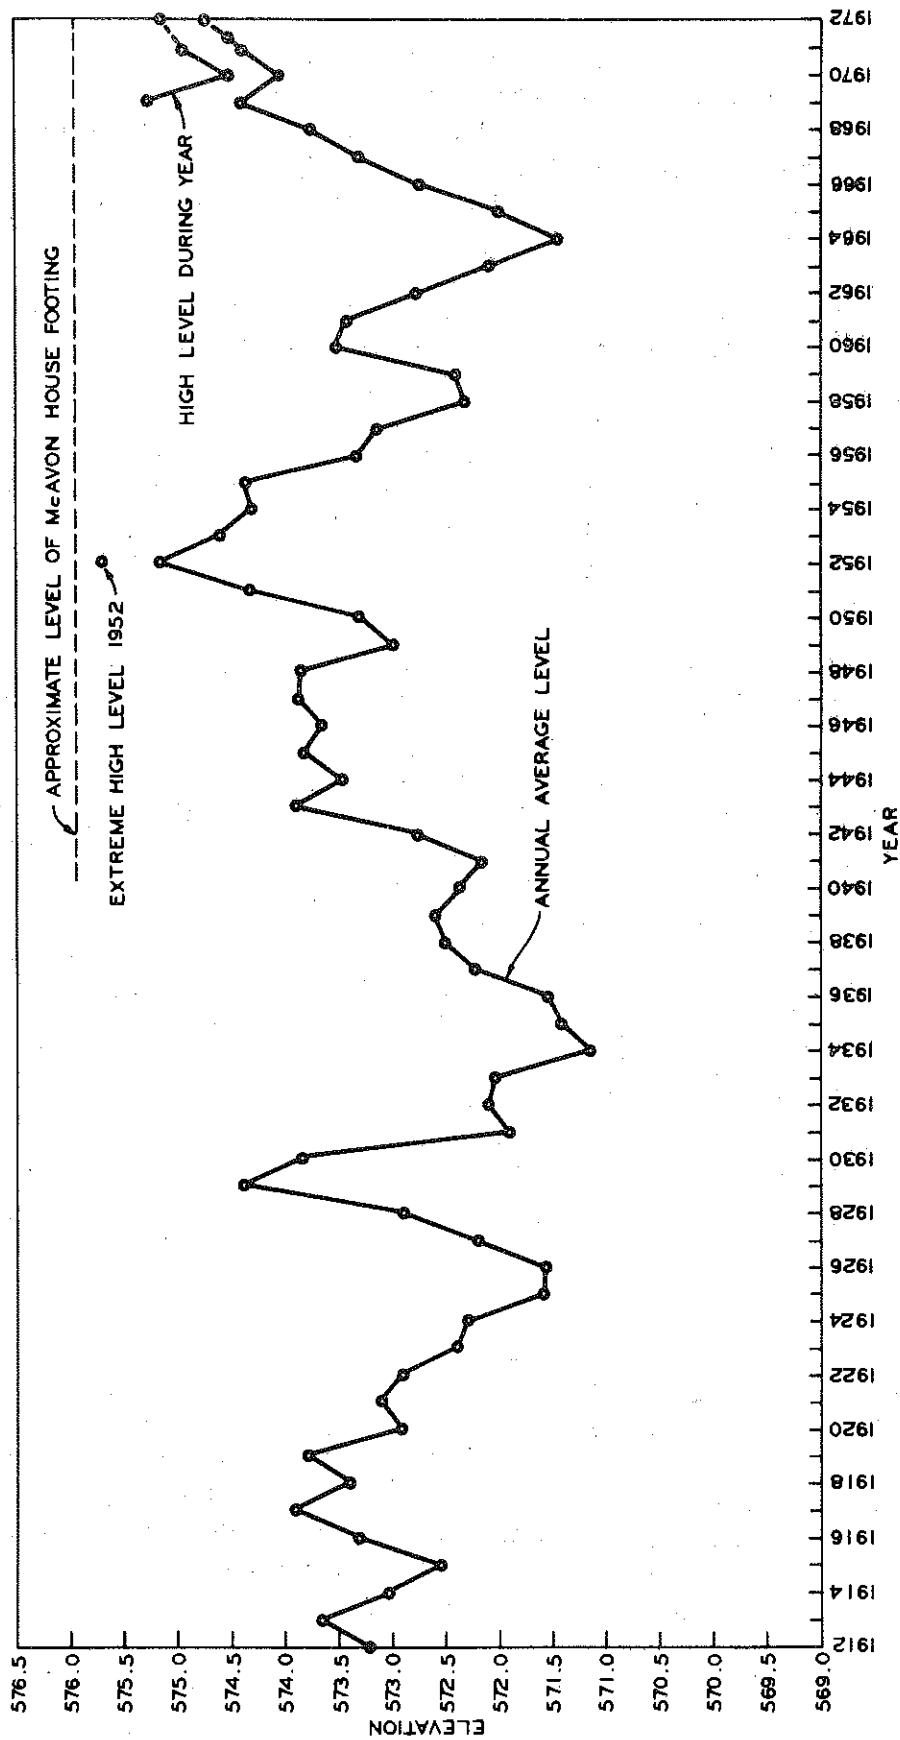
Figure 7. Annual average elevation of Lake St. Clair.

A review of the monthly water level records of Lake St. Clair for the last 60 years indicates a cyclic fluctuation of elevation in the order of 5 ft. Figure 8 shows the annual average elevation of Lake St. Clair for the years 1912 to the present, along with recorded high levels for recent years. Measurements of current water elevation conducted in this study, indicates that the water level in Anchor Bay is approximately 1 ft below the elevation of the foundation of the McAvon house.

It is well established that the elevation of the footings of the house is very close to the present level of Anchor Bay. The rise of ground water table to the level of the foundation drastically decreases the bearing capacity of the soil to support the structure. Since the basement drains towards the lake, the rise of water table to the foundation's level must have rendered the existing drainage system useless, thus decreasing the soils support further. Due to non-homogeneity of the clay in this site, the resulting settlement would be expected to be a differential one.
