# FINAL REPORT

REPORT ON THE RISK ASSESSMENT OF THE I-196  
INTERSTATE SECTION LOCATED OVER THE FORMER  
DOMTAR MINE, GRAND RAPIDS, MI

TESTING AND RESEARCH SECTION  
CONSTRUCTION AND TECHNOLOGY DIVISION  
RESEARCH REPORT NO. RC-1449

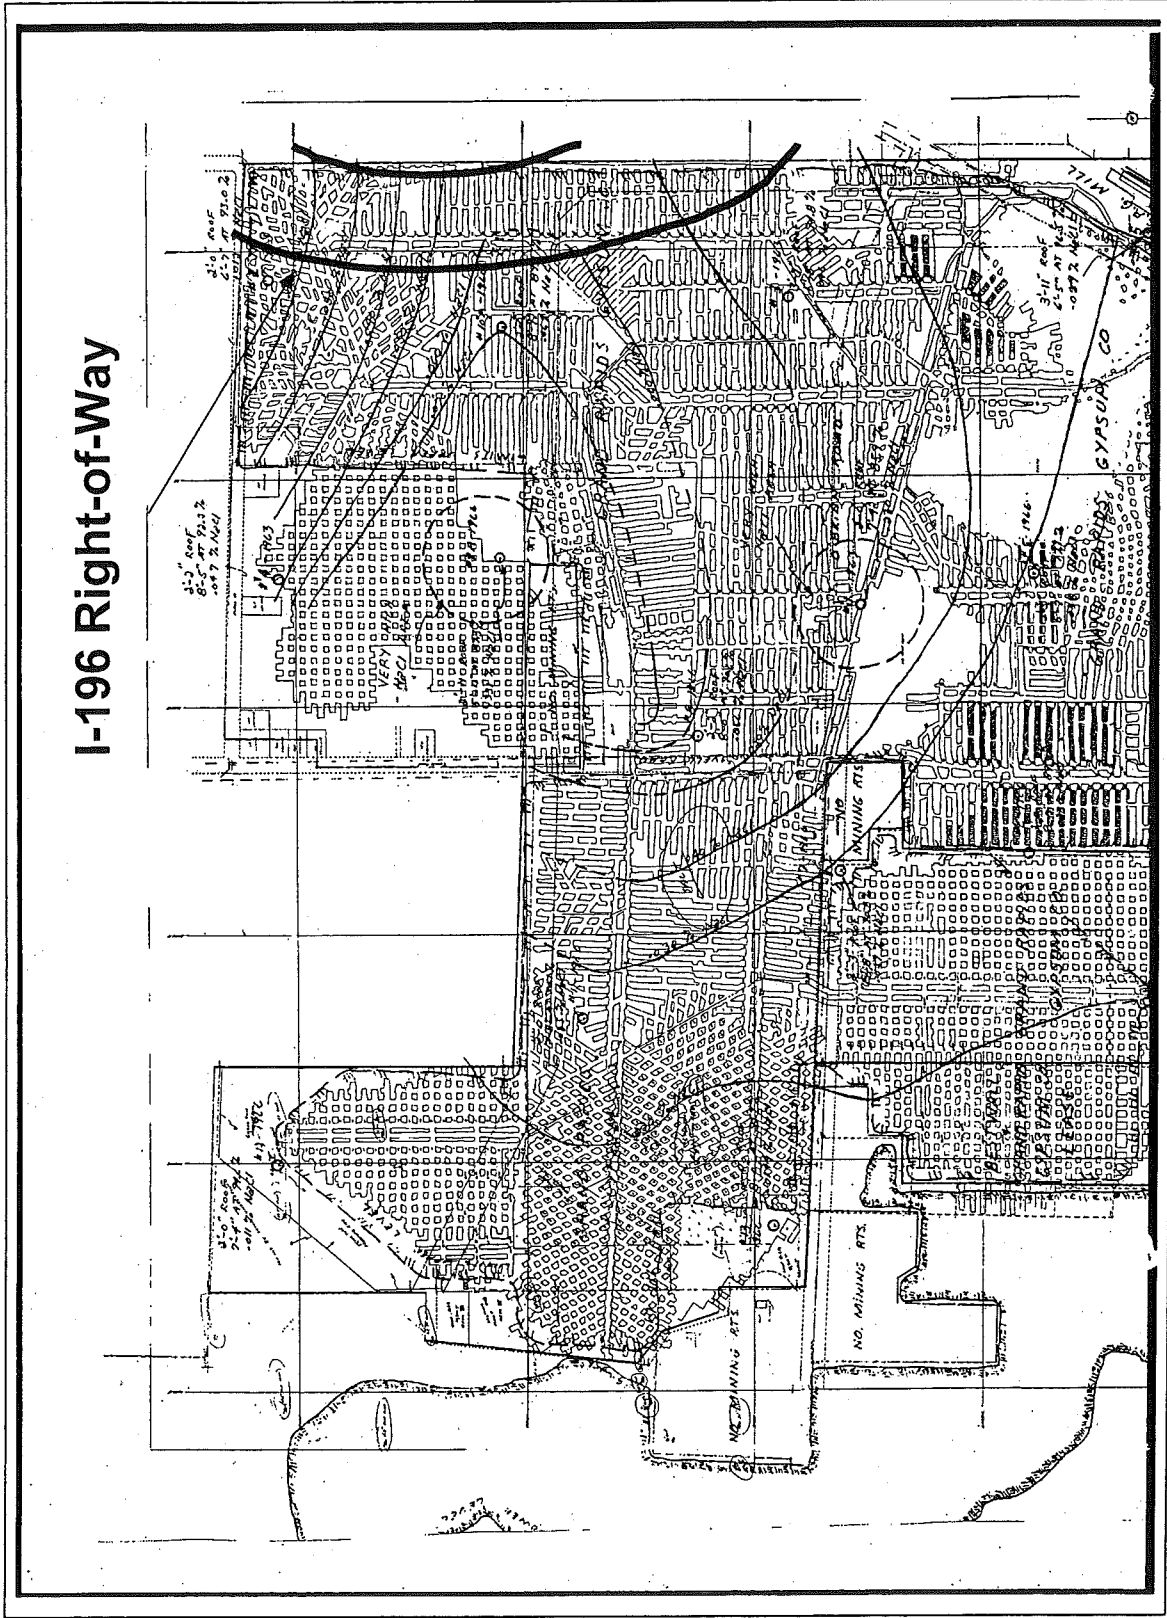
Figure 1. Underground mine workings of the Grand Rapids Gypsum Mine (Domtar Mine) for the #2 gypsum seam.

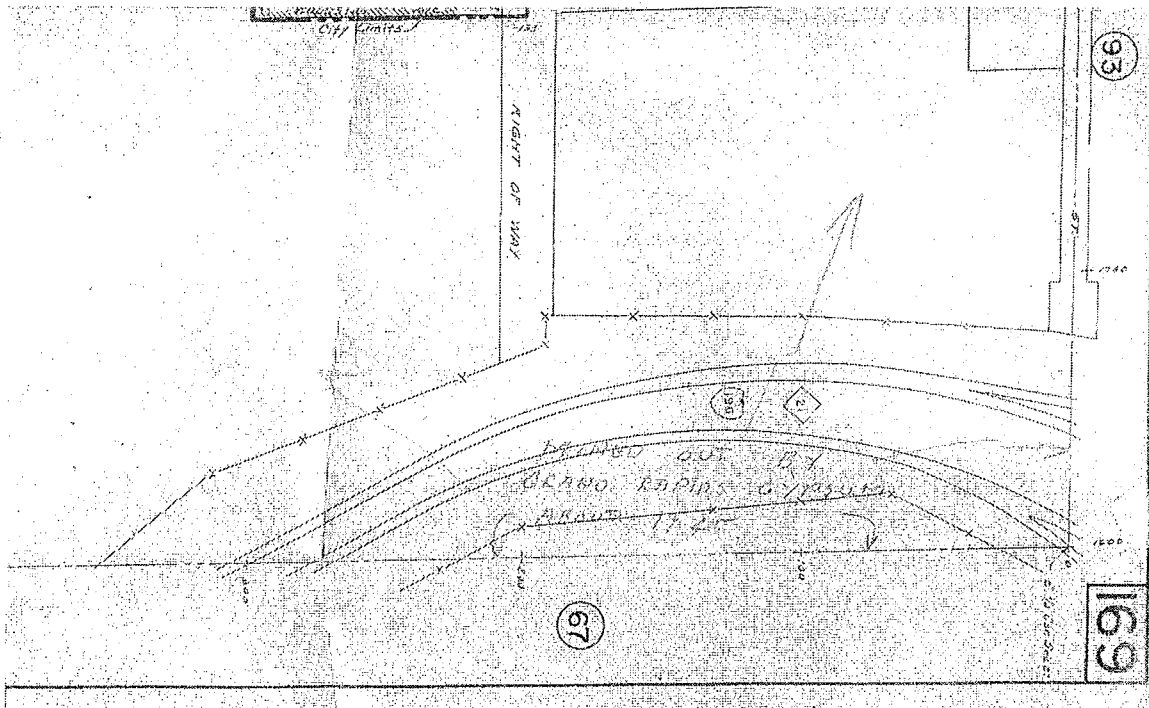
For this assessment two additional inspections of the Domtar mine files were conducted to locate information concerning the construction of the interstate over the mine. In particular, we were interested in when the portion of the mine under the interstate had been mined. Only one file was found with information on the mining of the northeast corner of the mine under the interstate. This file contained four maps with one of the maps indicating that the area below the interstate had been mined about 1945. A portion of this map was digitally scanned and is shown in Figure 2.

Figure 2. Old map showing the portion of I-196 and where the #2 had been mined and hand written note indicating that it was mined in about 1945.

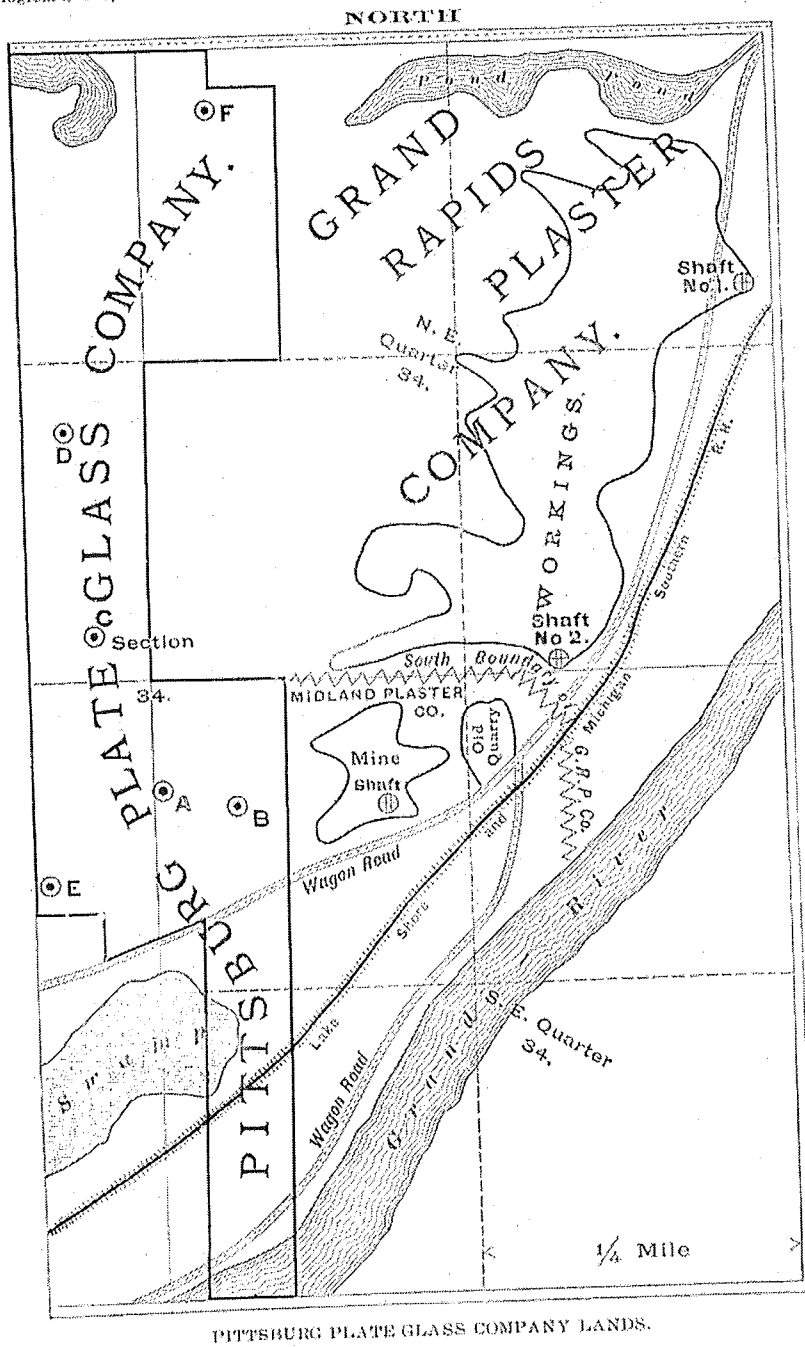
Figure 6. Grand Rapids Plaster Company mine boundary from Grimsley (1904) Michigan Geologic Survey Paper that at the turn of the century mining was confined to the northeast quarter of Section 34. The north border of the map is roughly the location of O'Brien Street, while the road identified as "Wagon Road" and located near the mine shaft is now Butterworth Road.
