CONDITION STUDY OF
MENOMINEE TOURIST LODGE

Highway Research Project 49 G-48

Research Laboratory
Testing and Research Division
Report No. 138
November 7, 1949

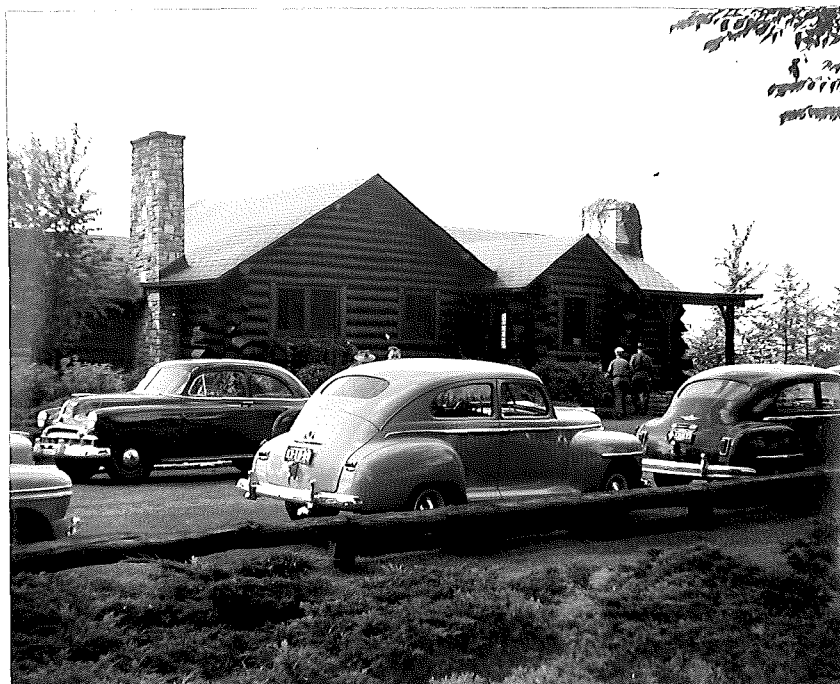
Reference to Figures 1 and 2 shows the typical log construction of the lodge, Figure 1 showing the front (north) aspect and Figure 2 the rear (south) aspect.

Figure 1. Michigan State Highway Department Tourist Information Lodge at Menominee. Front view, facing north.
