***INVESTIGATION OF EARLY
CRACKING ON SELECTED
JPCP PROJECTS***

1. Report No. RC-1501	2. Government Accession No.	3. MDOT Project Manager David Smiley	
4. Title and Subtitle Investigation of Early Cracking on Selected JPCP Projects		5. Report Date December 2007

**Investigation of Early Cracking on
Selected JPCP Projects**

**Pavement Research Unit
Construction and Technology Division
Research Report RC-1501**

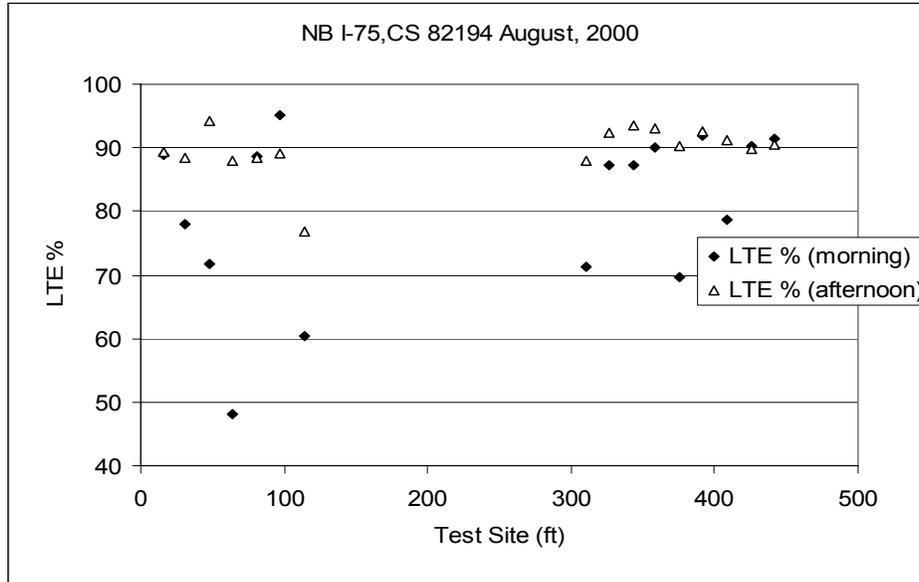
Figure 4.31 Effect of Time of Day on LTE at Joints

Deflection testing and profile measurements were made over the entire 460 ft. length. In the morning there was a noticeable slab “rocking”¹⁴ sensation at the TCs, which would indicate a loss of slab-base contact near the crack. The “rocking” sensation also was felt across a joint, but was much less apparent where there was no slab cracking. The “rocking” sensation gradually went away during the afternoon as the pavement surface warmed. The previous nighttime temperature was in the 70s following daytime highs in the high 80s. Even without a significant air temperature change, the deflection testing still indicated that early morning slab curling¹⁵ was present, as depicted in Figure 4.30. Deflection values are higher at the joints because of the upward curled effect. The curling gradually went away as the surface temperature increased during the afternoon and the deflections reduced in magnitude. Figure 4.31 compares the variation in joint LTE for morning and afternoon. The afternoon LTEs improved significantly, as the joint deflections (d0) reduced in magnitude.

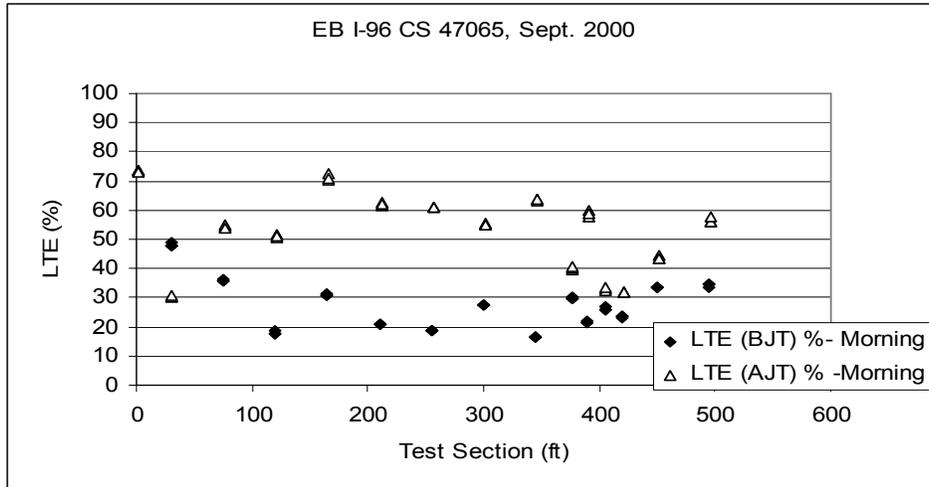
Figure 4.40a Comparison of Morning LTEs

Figures 4.40a and 4.40b compare morning versus afternoon LTEs (BJT and AJT) which are dependent upon the magnitude of upward curling that is present. There is considerable range in BJT and AJT afternoon values, whereas, morning BJT values are consistently less than 50 percent. As expected, the afternoon values do increase from surface heating. The AJT values are generally higher than BJT because of the permanent “slippage”¹⁷ that has occurred along the relief crack. Figure 4.41 compares the change in maximum joint deflection at d0 from morning to afternoon. Morning deflections were about 6-13 mils, while in the afternoon they were a much better 4-6 mils. The higher joint deflections in the morning indicate a likely loss of slab support exists, while slab contact resumes with the base in the afternoon with an increase in surface temperature (negative gradient removed).

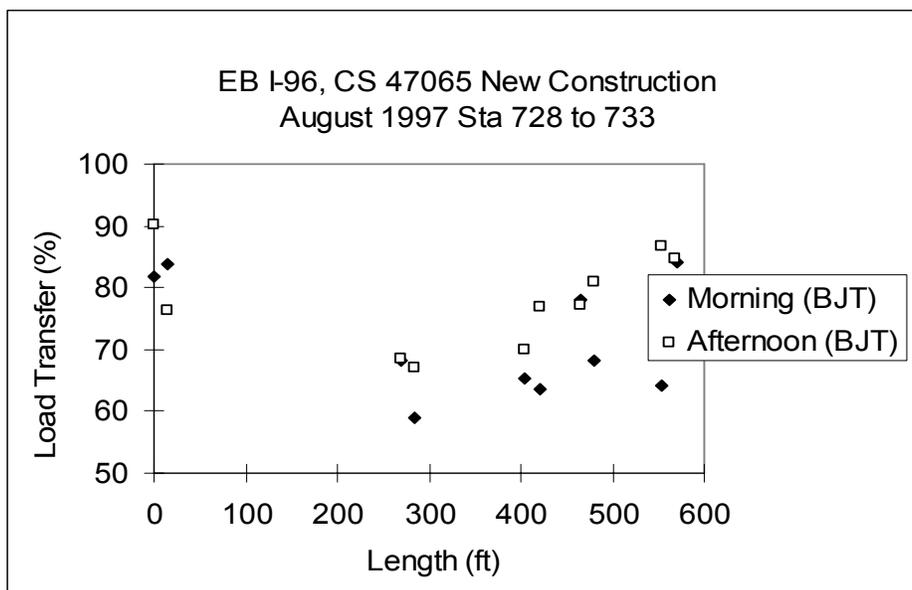
Figure 4.43 Daily Change in Joint Load Transfer Efficiency

Figure 4.42 clearly shows from joint deflections (outer wheel path) for a typical slab that concave curling exists in the morning hours, which declines significantly in magnitude (11 to 5 mils) by noon as the slab's surface temperature increased about 30 degrees. Figure 4.43 compares the high variability in LTE (BJT) values in the morning and afternoon in the outer wheel path. The majority of the LTEs are remarkably (disturbing) low (< 90 percent) for new construction which questions the effectiveness of the dowel bar installation. Infrared measurements showed the pavement's surface temperature increased to about 95°F later in the afternoon. Figure 4.44 depicts the same joint deflection values versus pavement surface temperature suggesting when the temperature increase is sufficient for the slab to resume contact with the base, which is somewhere above 70 degrees.

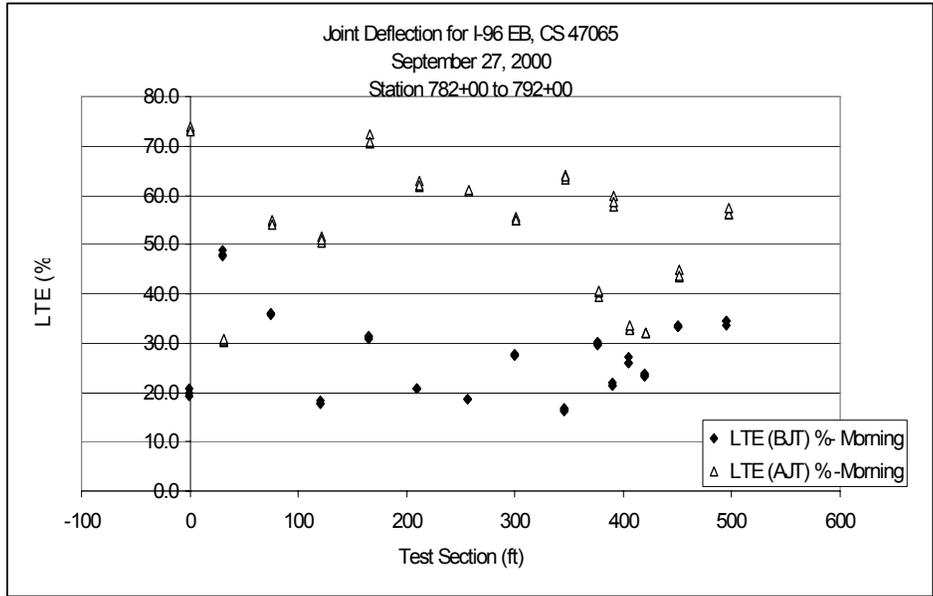
Figure 6.21 Typical Load Transfer Results for I-96 JPCP

These projects have the highest deflections with a significant loss of support at the transverse joints. Probably the most dramatic finding is the significant difference and variability in LTE when measured before the joint (BJT) versus after the joint (AJT). BJT measurements are much lower than AJT measurements. Sometimes by nearly 50 percent or more, which Figure 6.21 shows for EB I-96 (September 2000 site). The most probable explanation for this difference is the rapid slippage that has occurred as the approach side of the relief crack shears (depresses) against the leave side of the crack. As the coarse aggregate particles breakdown (loss of interlock), LTE decreases, which forces the dowels to solely transfer the load. Although not confirmed, some crushing of the concrete in contact with the dowel has probably occurred, which further reduces load transfer capability and increases deflection magnitudes. In addition, the width of the relief crack after thermal contraction will directly determine the endurance level of the initial aggregate interlock capacity. Other recent research²² has shown that concrete using blast-furnace slag coarse aggregate is more susceptible to early LTE loss from wider crack widths. Without adequate base support, the joint dowels quickly become ineffective from repetitive heavy truck loading, as they cannot solely provide load transfer.

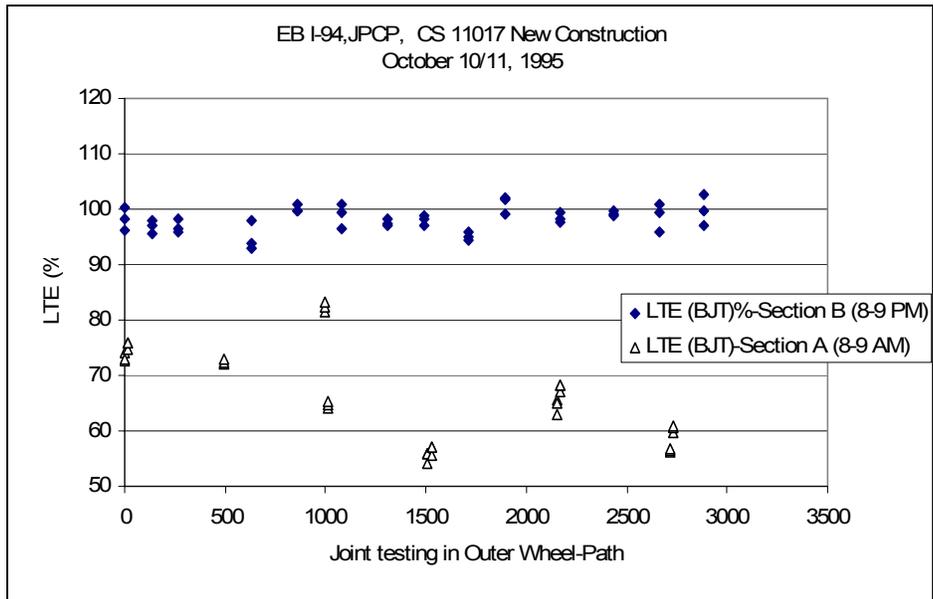
Figure 6.22 Load Transfer Efficiency for Sections A and B, EB I-94 Watervliet

Fortunately in October 1995 shortly after EB I-94 was paved, but not yet open to regular traffic, section B and a portion (sta 1790+00 to 1822+40) of section A were tested to determine the initial load transfer of the joints with emphasis on the experimental hinge joints. Figure 6.22 is a compilation of the LTEs (BJT) that gives a general comparison of morning values with evening. This testing was done in a continuous manner throughout the day, so each section was tested at a different time of day. Section B was morning and section A was evening.

Three drop loads were made at each location to determine if a loss of support was present. In the morning some loss (gap) was found after night cooling. From infrared measurements, the pavement's surface temperature changed from about 45°F in the morning to 60°F in the evening.
