Evaluation of Bridge Decks Using Non-Destructive Evaluation (NDE) at Near Highway Speeds for Effective Asset Management – Implementation for Routine Inspection (Phase III)

**Element Level Condition State Assessment,
Comparison to Traditional Methods, and Cost and
Time Comparison Analysis mini reports**

October 09, 2018

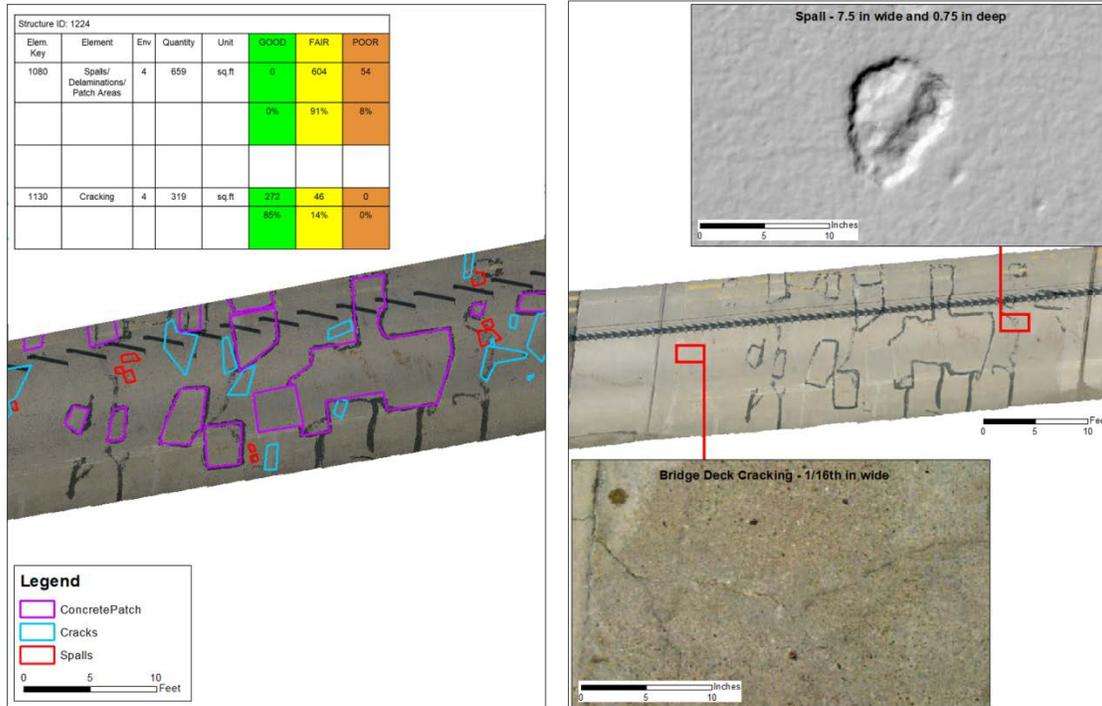
Figure 14. An example of the high resolution image mosaic and DEM resulting from 3DBOS (Right). The left side of the figure shows the results of the defect digitizing of the image mosaic along with the resulting element level condition state table.
