**Evaluation of Bridge Decks Using
Non-Destructive Evaluation (NDE)
at Near Highway Speeds
for Effective Asset Management**

FINAL REPORT

Michigan Department of Transportation

Michigan Technological University
1400 Townsend Drive
Houghton, MI 49931

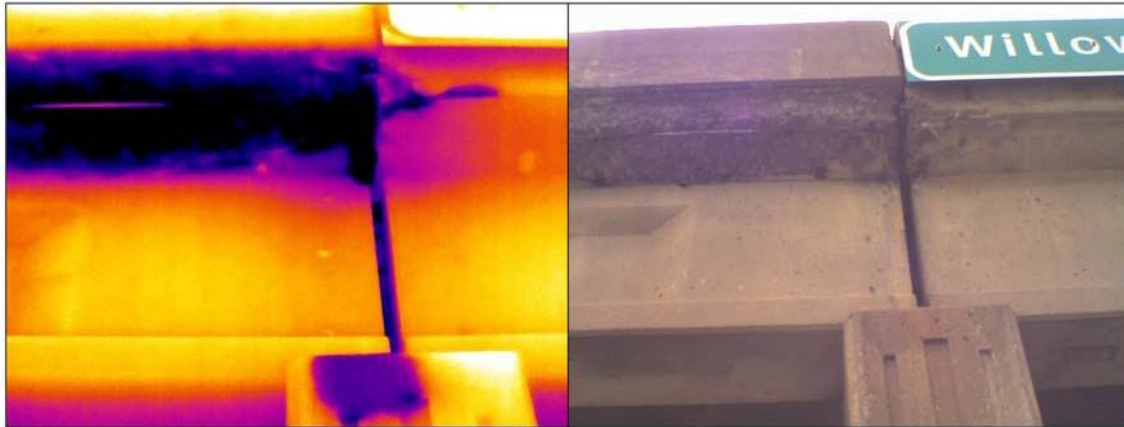
Figure 2-3: Thermal Infrared and Digital Image of Fascia Beam (Willow Rd. bridge August 2011).

Remote sensing characteristic of infrared thermography can reduce traffic disruption and lane closures on and specifically underneath the bridge, as no direct contact is required. This allows for the inspector to collect condition information from a distance, either from a moving vehicle or outside of the traffic lanes. Previous study shows that passive thermography can be easily applied for inspecting fascia beams from the shoulders and without using an aerial truck (Ahlborn et al. 2012). Figure 2-3 shows a possible delamination on the fascia beam of Willow Rd. as collected from a hand held thermal camera.

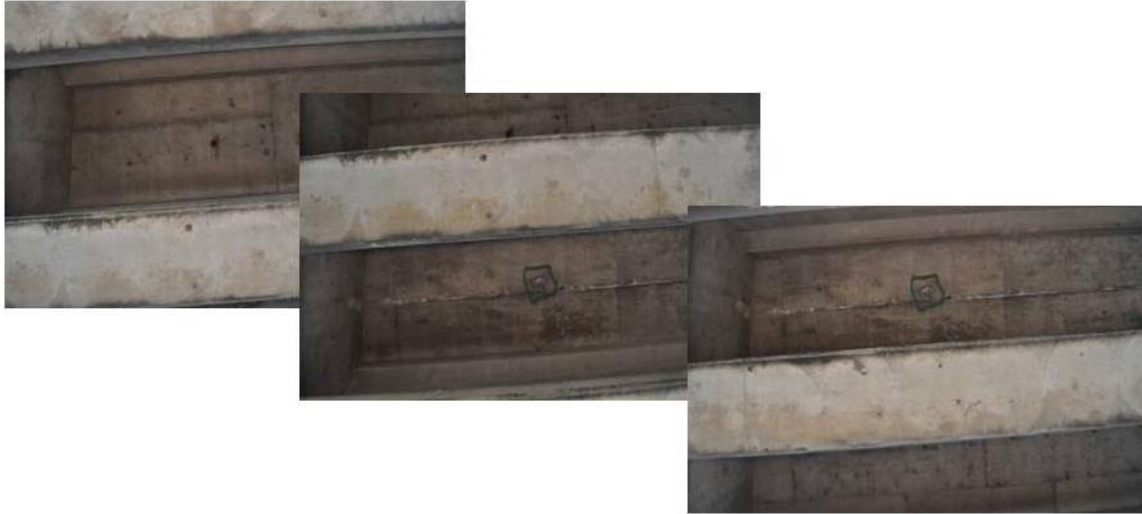
Figure 2-5: Photos taken with 3DOBS of the Underside of Willow Rd. Bridge (Ahlborn et al. 2012).

The current condition of fascia beams and the underside of a bridge can be captured by vehicle mount camera systems. Photo inventories can be collected for both bridge components. Figure 2-5 shows a series of photos taken of the underside of a bridge with the deck bottom and the bottom of the beams clearly visible. These photos could be used as a photo inventory showing the location of a delamination (green square) that has been detected with other technologies (Ahlborn et al. 2012). 3D photogrammetry can also be used to generate 3D models of the fascia beams and portions of the underside from the stereo pair imagery. Figure 2-6 and Figure 2-7 show a model of the Silverbell Rd. box beam that was removed.

For the collection of imagery of fascia beams, overlapping photos are taken along the length of the beam. This would be difficult for a vehicle mounted system to achieve while driving with traffic. Models can be derived if overlapping imagery is taken along the length of the beam from a stationary camera. As seen in Figure 2-5, the sides of the beams are not visible in the photos taken with a vehicle mounted system.

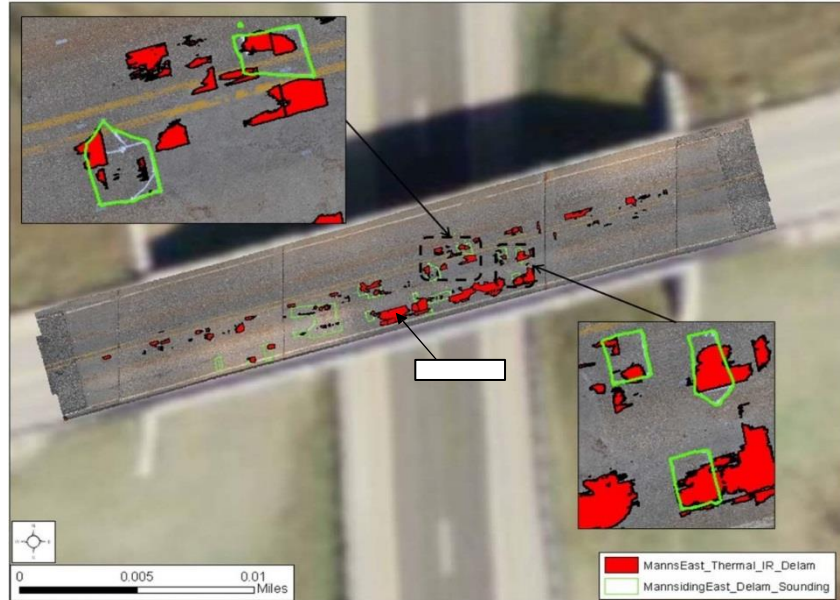
Figure 2-9: Combined Results of Thermal IR Imagery Chain Drag Inspection.

3DOBS and infrared thermography results for this bridge were imported in ArcGIS and are shown Figure 2-8 and Figure 2-9, respectively. The total spalled area on Mannsiding Road bridge was 1.73 m² (18.62 ft²) which is 0.47% of the entire bridge deck surface. Chain drag results showed 127.3 ft² (3.63% of the total bridge deck area) total delaminated areas on the bridge deck, while the total delaminated area calculated from thermal infrared imagery survey was 136.13 ft² (3.88% of the total bridge deck area).

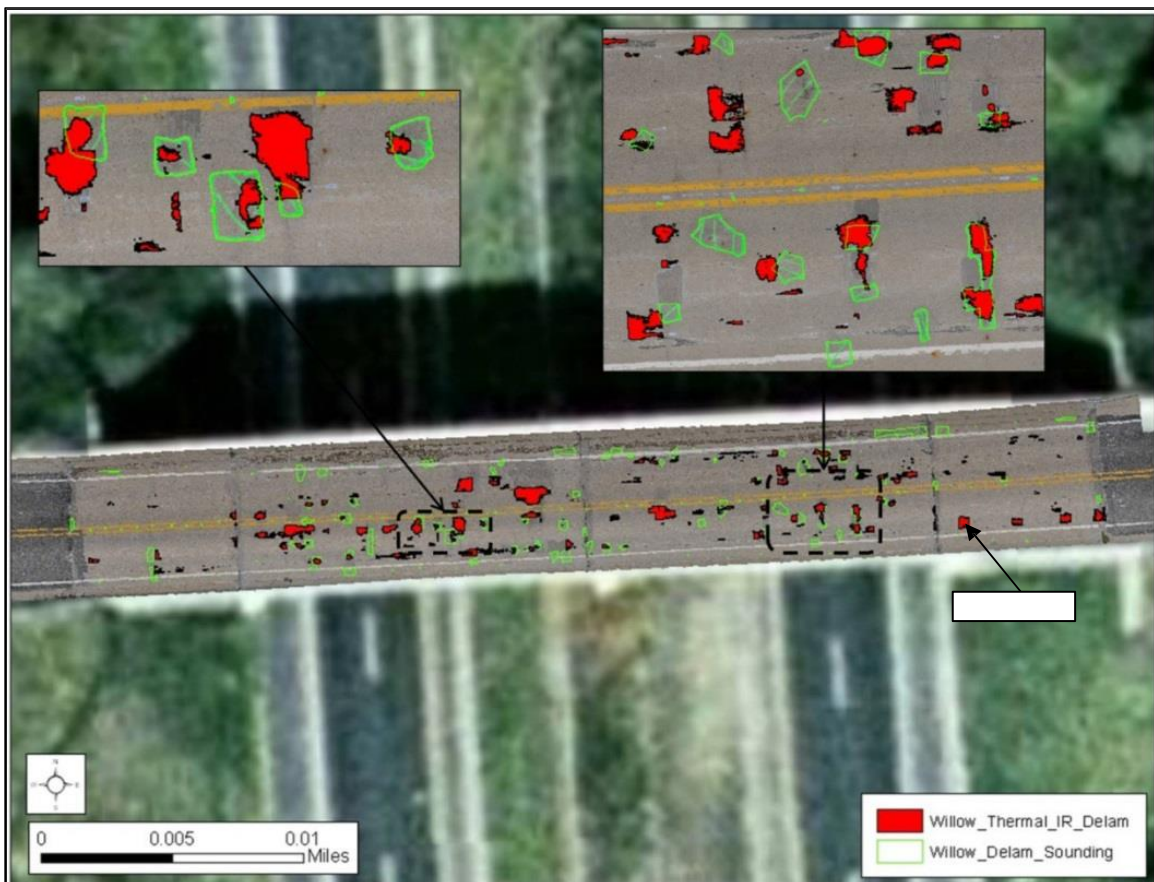
Figure 2-11: Combined Results of Thermal IR Imagery and Hammer Sound Inspection.

Figure 2-10 and Figure 2-11 shows the results of 3DOBS and infrared thermography of Willow Rd. bridge, respectively. Total area of spalls on this bridge was 27.3 m² (293.7 ft²) which was 5.15% of the entire bridge deck surface. Hammer sounding results showed 159.5 ft² (3.05 % of the total bridge deck area) total delaminated areas on the bridge deck, while the total delaminated area calculated from thermal infrared imagery survey was 157.83 ft² (3.02 % of the total bridge deck area).

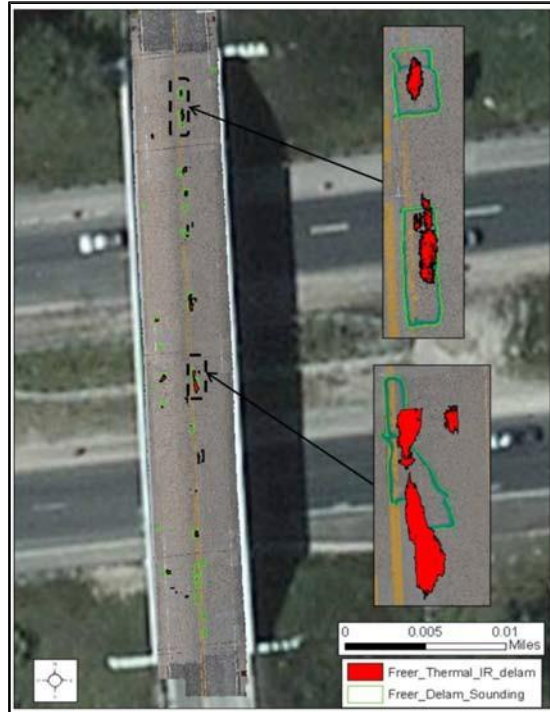
Figure 2-13: Combined Results of Thermal IR Imagery and Hammer Sound Inspection.

Figure 2-12 and Figure 2-13 shows the results of 3DOBS and infrared thermography of Freer Rd. bridge. Total area of spalls on this bridge was 3.8 m² (40.1 ft²) which is 0.67% of the entire bridge deck surface. Hammer sound results showed 101.74 ft² (1.8 % of the total bridge deck area) total delaminated areas on the bridge deck, while the total delaminated area calculated from thermal infrared imagery survey was 29.25 ft² (0.52 % of the total bridge deck area). The main cause of variation between the results of the hammer sounding and infrared thermography surveys on the Freer Road bridge is that most of the delaminations on this bridge were around the construction joint and overlapped with the painted centerline on the bridge deck. Reflective paint on the bridge deck has lower emissivity than concrete; therefore, it will appear on the thermal IR image with lower temperature and cause some difficulties in detecting delaminations in those areas.

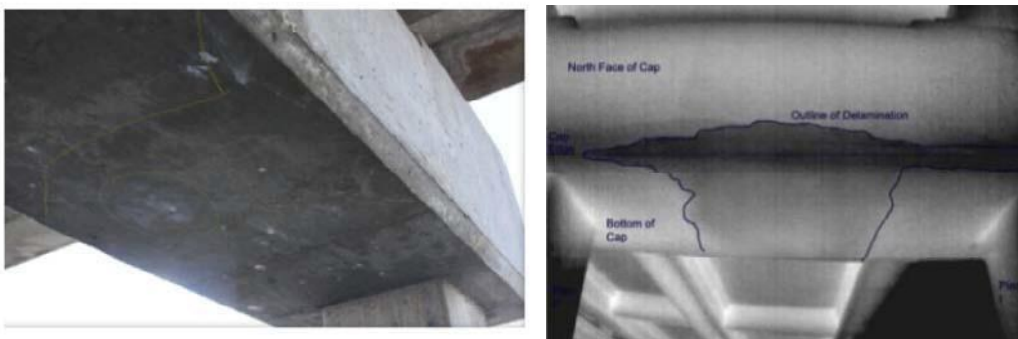
Figure 2-14: A) Visual Image of Marked Delamination on the Bridge Cap and B) Thermal IR Night Image of Delamination.

BridgeGuard, Inc. conducted an infrared thermography survey on Cedar Key Bridge in Florida, which was built in 1972. The bridge overall length is 952 feet long by 44 feet wide with substructure elements consisting of 20 bents with 7 – 22 inch square piles per bent. As part of the validation and ground truth process, a hammer was used to assist in outlining a targeted sub-surface flaw. A chalk outline was marked on the cap and a visual image was taken showing the chalk outline of this hammer-measurement (Figure 2-14). Also shown is the spatially corresponding IR image taken at 0800 hours on November 7, 2010 (Figure 2-14) illustrating the geometrics of the bridge cap and the outline of the characterized delamination. A qualitative correlation can easily be made by the reader between the IR image and the actual physical measurement shown in the visual image. It is noted that, while not visible in either image, this delamination extended up and around the opposite side vertical surface of the cap.

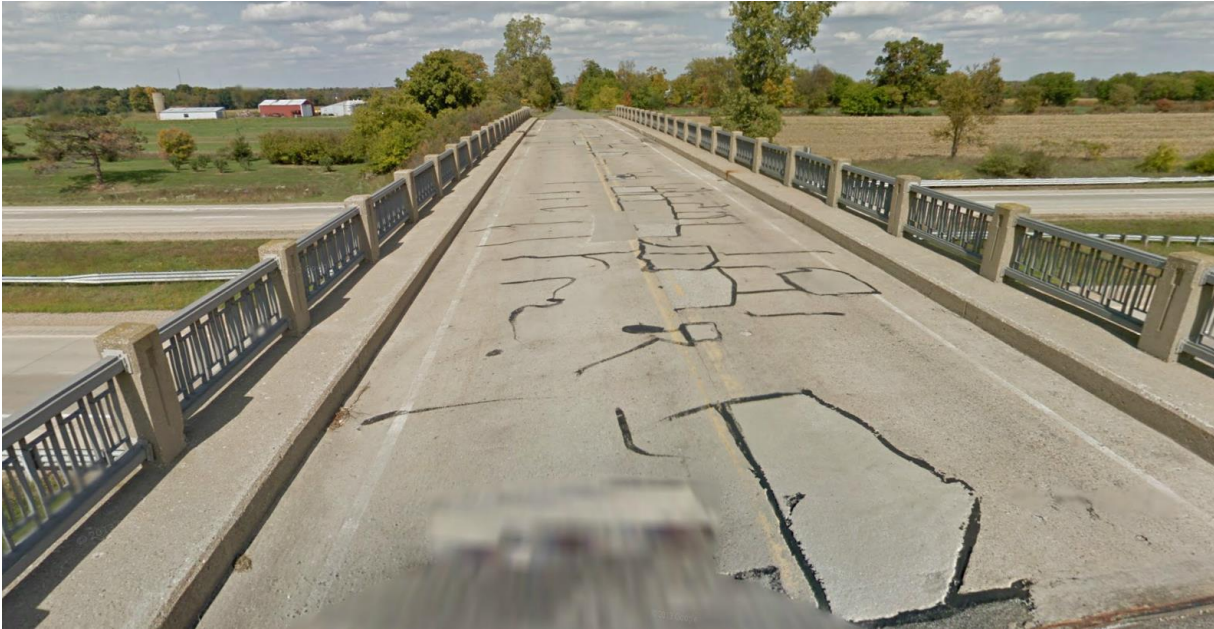
Figure 4-2: Deck Surface for 20 Mile Road Bridge.

During the most recent bridge inspection on August 8th, 2013, the concrete deck surface was assigned a poor condition NBI rating of 4. A photograph of the current deck surface condition can be seen in Figure 4-2. With the main purpose of this deployment being the assessment of the 3DOBS high-resolution system and passive infrared thermography, the bridge deck was the main bridge component of interest. Only the surface of the bridge deck was evaluated for deficiencies, however, particular interest should be taken to spalling on many of the bridge beams that have left reinforcing steel and stirrups exposed. It was recommended that these areas be patched to preserve the integrity of the structure.

Testing on 20 Mile bridge corresponded with the inspection of the bridge by MDOT. A sketch of the deck sounding was georeferenced as a GIS shapefile (Figure 4-3). The sounding determined that there was 1,276 ft² of delamination with 32 ft² of bit patching and scale which corresponded to 24% of the deck surface.

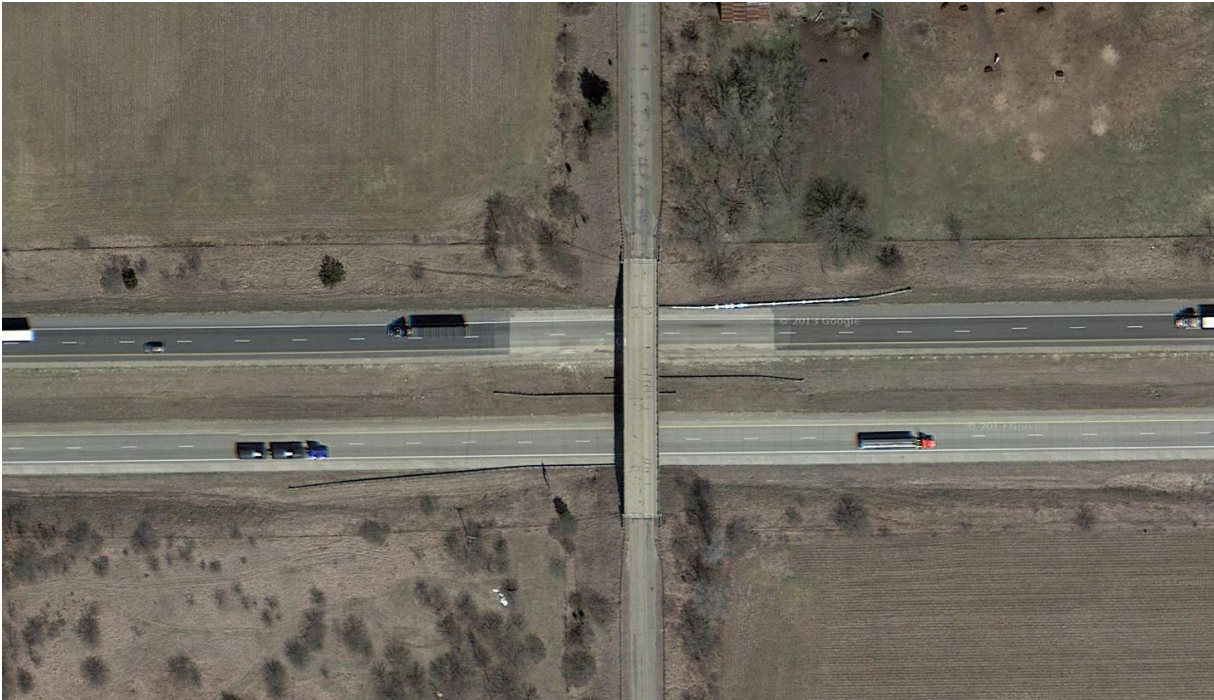
Figure 4-5: Satellite Image of 24 Mile Road Bridge Deck in Calhoun County, Michigan.

The concrete deck surface was assigned a poor condition NBI rating of 4 during the last inspection on August 14th 2013. With the assessment of the 3DOBS high-resolution system and passive infrared thermography being the main purpose of this deployment, the bridge deck was the main bridge component of interest. Only the surface of the bridge deck was evaluated for deficiencies, however, it should be noted that numerous spalls have left reinforcing steel exposed on many of the bridge beams reducing the superstructure to a rating of 5. Patching of these areas was recommended prevent further deterioration and extend the service life of the bridge.

The inspection report indicated various transvers and longitudinal cracks across the deck surface, some of which had been sealed with rubber. Various concrete patches were also present over the structure surface. A main area of interest was noted to be the unsealed longitudinal joint where cracking and scaling have contributed to wetness, exposed reinforcement steel from spalling, corrosion, and delaminations on the underside of the deck. To locate and quantify delaminations, the surface of the bridge deck was sounded on October 15th, 2013 revealing that 14% of the deck area contained these defected areas. Upon completion of the two inspections, recommendations

were made to seal construction joins and perform a shallow overlay to preserve the integrity of the bridge. An aerial image of the bridge deck can be seen in Figure 4-5.

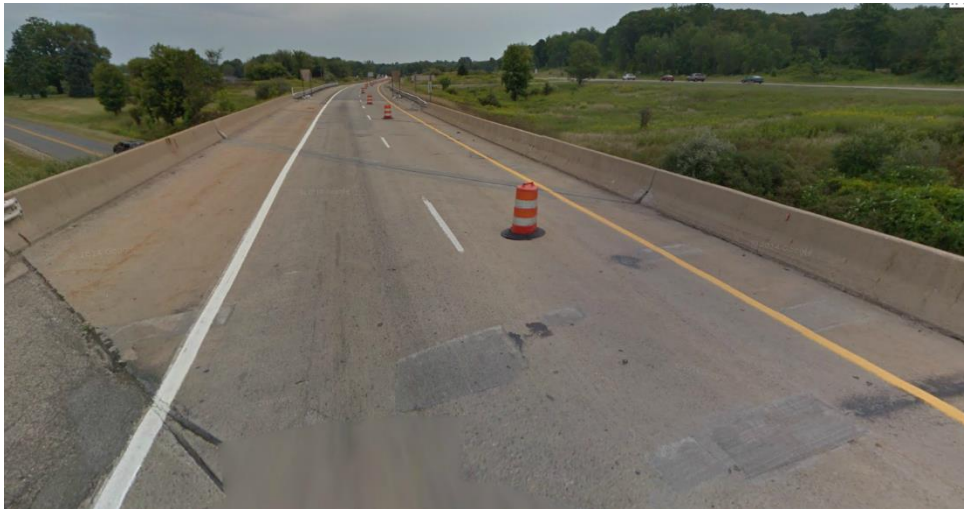
Figure 4-8: MDOT Structure No. 5002 SB US-131 Bridge Deck.

The inspection report for structure No. 5002 indicated considerable amounts of concrete patches, spalling, and delaminated areas across the deck surface. A photograph of the structure can be seen in Figure 4-8. Several transverse cracks were also apparent over the structure. Expansion joints were missing much of their sealer resulting in some cracking and spalling at the deck surface as well as the bottom surface of the deck.

In the case of both bridges, it has been recommended that sealer be applied to expansion joints where deterioration has occurred. Concrete overlay on both bridge decks was also reported for consideration.

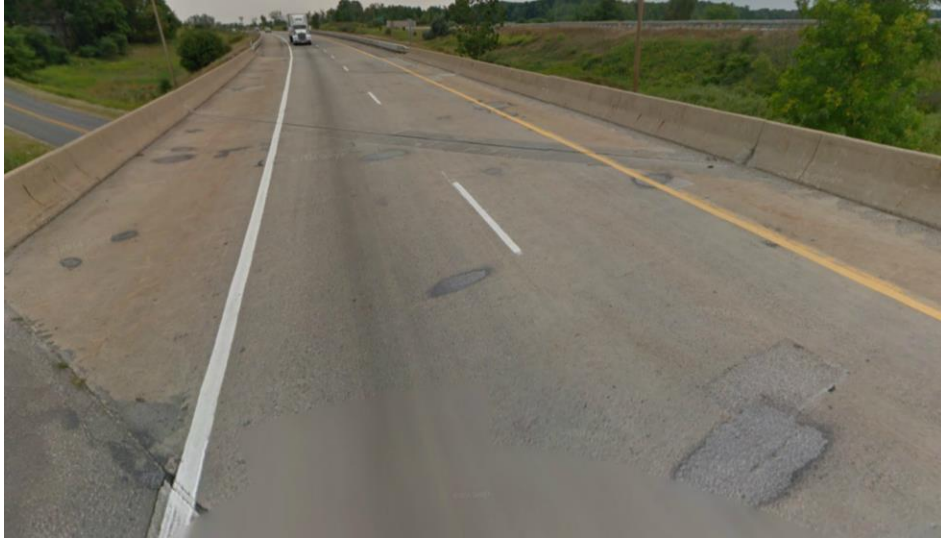
Figure 4-9: MDOT Structure No. 5003 NB US-131 Bridge Deck.

The inspection report for structure No. 5003 indicated that about 26% of the deck surface area was spalled, bit patched or delaminated and about 15% was patched with concrete. Various degrees of cracking were present over the surface of the structure with some occurring around expansion joints where a majority of the sealer was missing. Spalls and cracks on the underside of the bridge deck have originated near joints where water has migrated through the structure. Figure 4-9 shows the north bound structure.

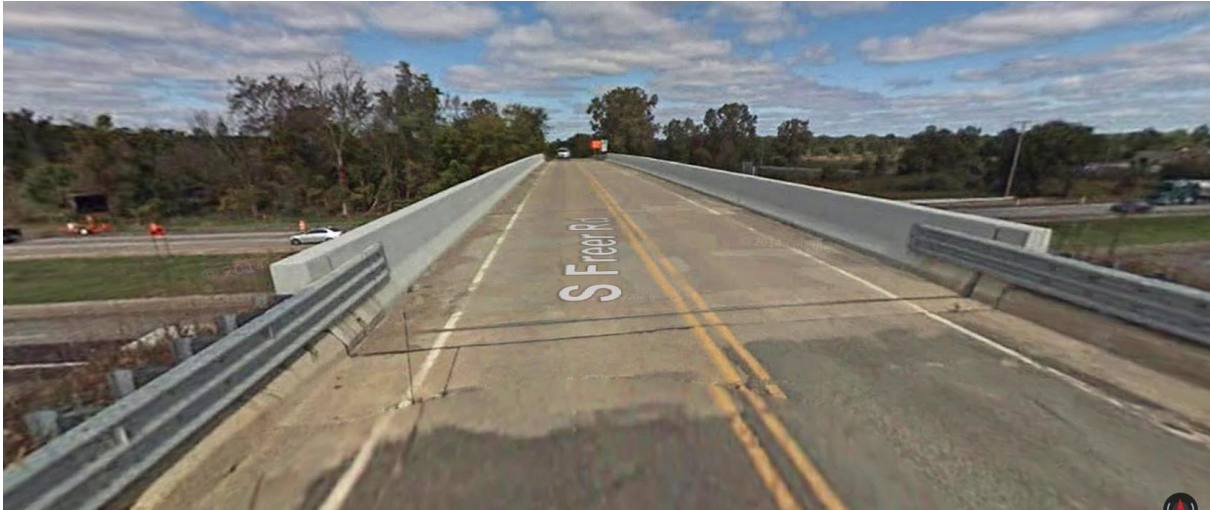
Figure 4-16: Bridge Deck of Freer Road Bridge.

Upon completion of the most recent inspection on June 5th 2012, the deck surface received an NBI fair rating condition of 6 and can be seen in Figure 4-16. Because the active thermography

The inspection report indicated that concrete patches were present in all spans of the structure. The patches were applied to prohibit further deck deterioration and prolong the service life of the bridge. Transverse and map cracking were also reported to be present in all spans of the structure. An estimated 85 ft² of delamination was additionally reported throughout the deck surface of the structure.

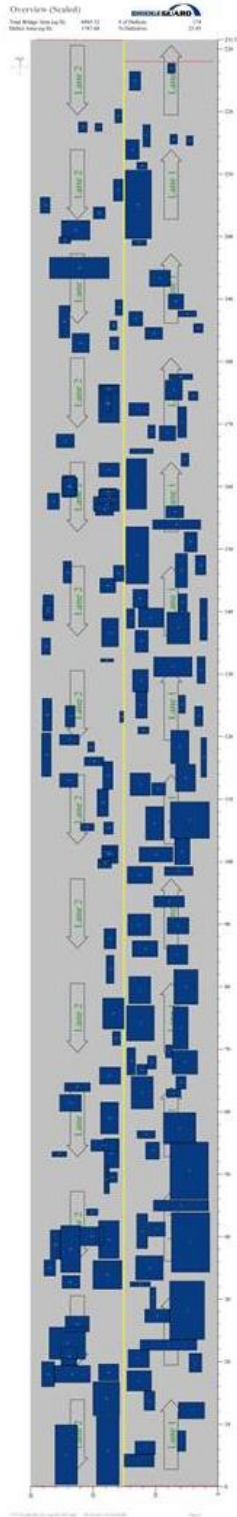
Figure 5-9: Location of Potential Delaminations as Determined by BridgeGuards Thermal Survey on 20 Mile Rd.

During the field testing phase, BridgeGuard assessed bridge decks separately from 3DOBS. Figure 5-9 shows BridgeGuard results from 20 Mile Rd. and it was determined that there was 1,767 ft² of potential delaminations on the bridge deck. This was almost 500 ft² more than was recorded by MDOT. For 24 Mile Rd. BridgeGuard determined that there was 1,765 ft² of potential delaminations on the bridge deck (Figure 10). Compared to MDOT, this was approximately 1,000 ft² more than MDOT's estimate.

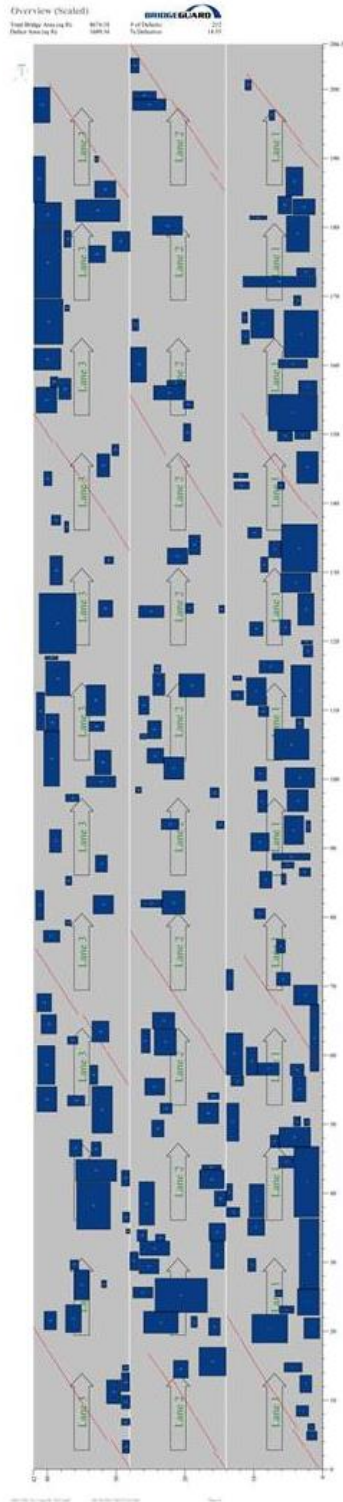
Figure 5-11: North Bound Lanes of US-131 Showing Potential Delaminations from the BridgeGuard Survey.

US-131 consists of two bridges, each with its own report. For the north bound lanes the BridgeGuard assessment determined there was 1,609 ft² of potential delaminations (Figure 11). The south bound lanes contained 989 ft² of potential delaminations according to BridgeGuard's analysis (Figure 12). By comparison MDOT reported there was 2,072 ft² for the north bound lanes and 759 ft² for the south bound lanes.

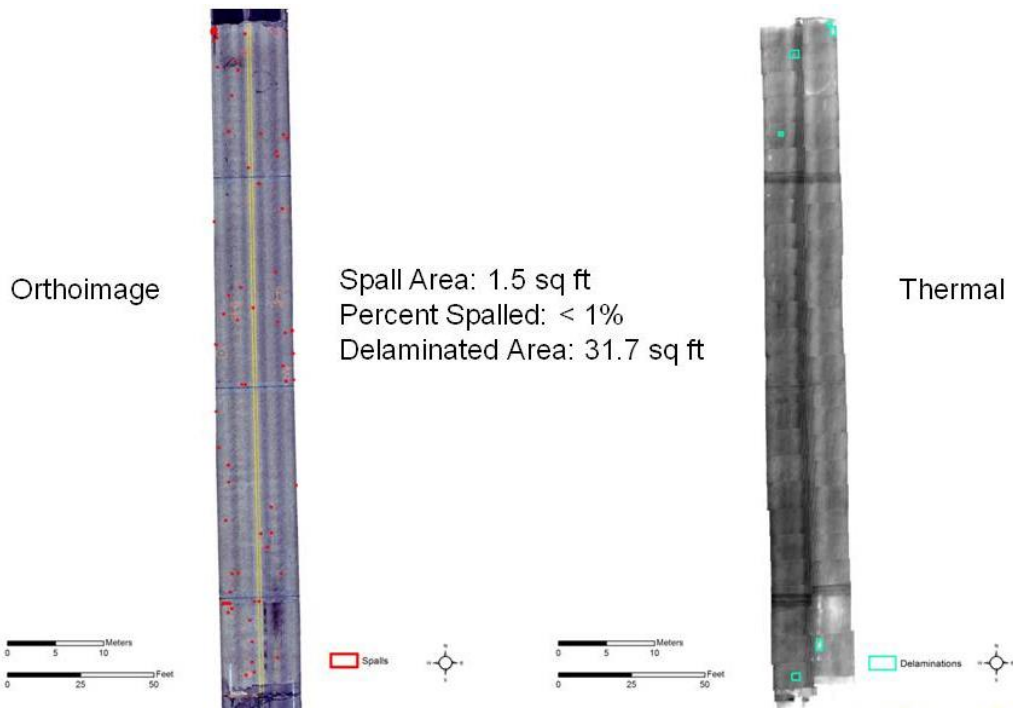
Figure 5-17: Comparison of the Results Generated from 3DOBS High Speed and the BridgeGuard Thermal Cameras as a Combined System over Maryland Ave.

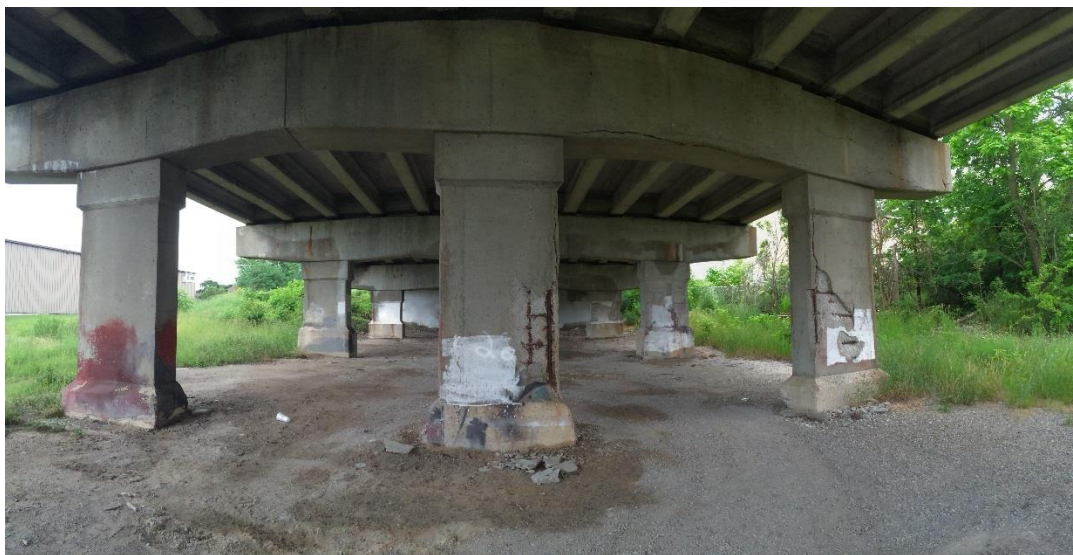
Figure 6-15: Precast Concrete Approach Spans under Franklin Street Bridge.

The bottom concrete deck surface was assigned an overall NBI fair condition rating of 6 during the last inspection on October 23, 2012, however, the degree of deterioration varied between spans and ratings ranged from 5 to 9. These assessment results reflect the overlay of sections in 1990 and, more recently, the replacement of seven concrete deck spans. Replaced deck spans have remained in good condition but other spans contain considerable amounts of spalling and cracking. In addition, soot buildup from locomotive exhaust was reported directly above the railroad line.

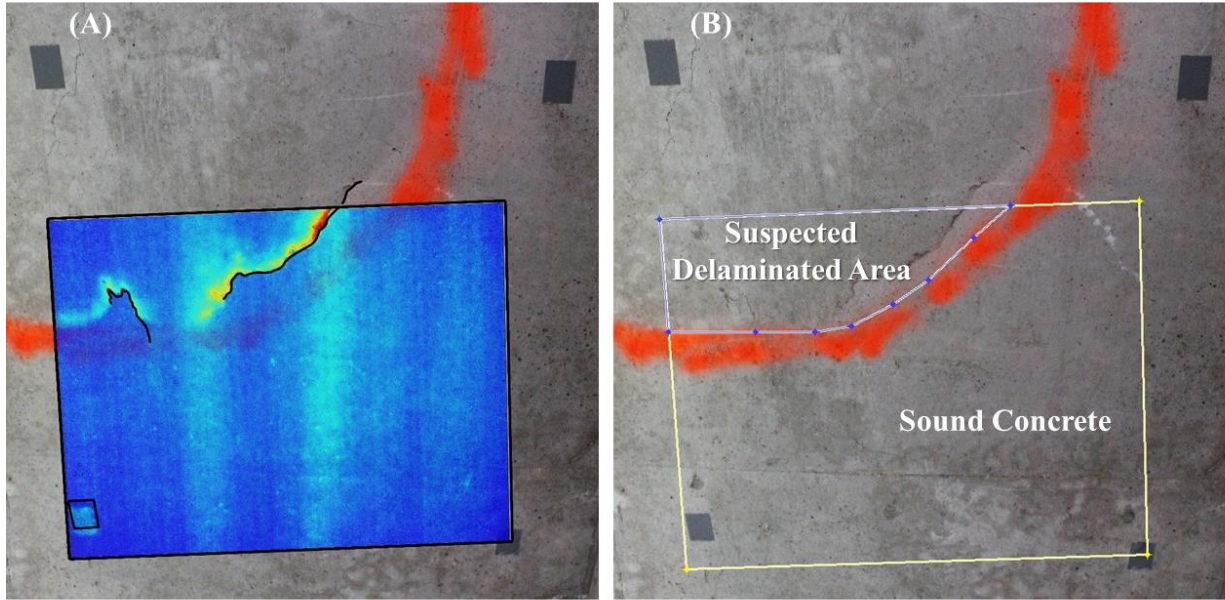
All processing of the optical images and thermal images was conducted in MATLAB. A simple polygon method was used to determine the percent of delamination on the bridge deck underside and pier cap. No specific polygonal shape was used during analysis, instead, a polygon most similar to the shape of the delamination was constructed. The thermal IR image and optical image correlation of the FLIR SC640 data collected during test B1 as well as the polygon method for determining percent of delamination based on ground truth information can be seen in Figure 6-19. The paint marks placed by MDOT inspectors is seen in Figure 6-19 (B).

Figure 6-19: (A) Thermal and Optical Image Correlation of FLIR SC640 Using Surface Cracking at Test Location B. (B) Polygon Method for Determining Delamination Percent Based on Ground Truth Information.

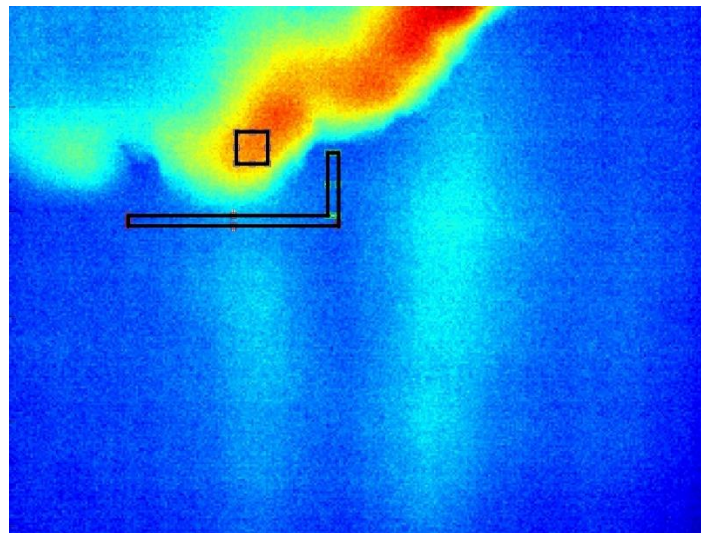
Figure 6-20: Analysis Areas Selected for Test B1 Captured by the FLIR SC640 Thermal Imaging Camera.

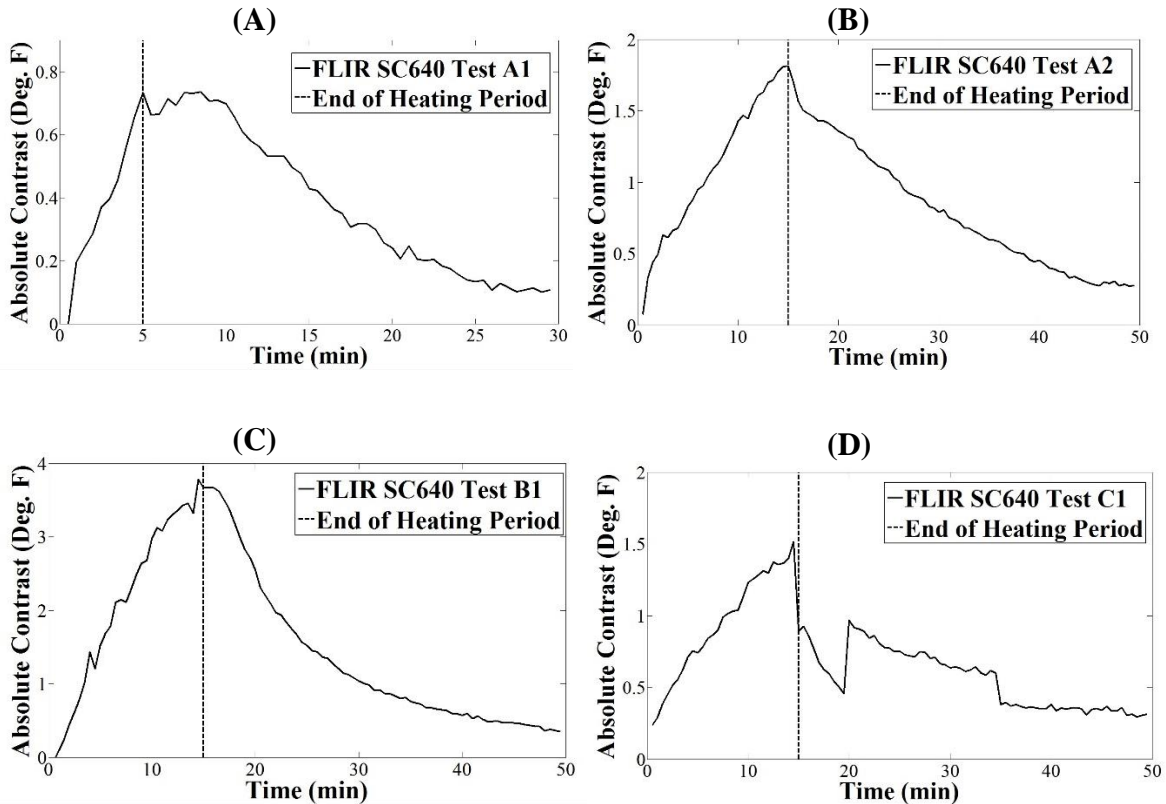
Figure 6-22: FLIR SC640 Absolute Contrast Graphs from Active IR Thermography Field Demonstration Testing (A) Test A1: 5 min. Heat Time (B) Test A2: 15 min. Heat Time (C) Test B1: 15 min. Heat Time (D) Test C1: 15 min. Heat Time.

Using the absolute contrast graphs constructed from data captured by both the FLIR SC640 and FLIR Tau 2 thermal cameras, the observation times for the selected delamination reference area were estimated for each test location. The estimated observation time is reported in Table 6-12. Observations of the absolute contrast graphs constructed from FLIR SC640 data show abrupt absolute contrast shifts at 20 min. and 35 min. for test C1 and were shown in Figure 6-22 (D). Due to this erroneous data, observation time could not be determined. To explain these temperature shifts, additional camera functions must be understood. The FLIR SC640 thermal imaging camera contains an internal lens shutter that automatically calibrates the thermal sensor to user defined parameters during data acquisition. It is hypothesized that the thermal camera did not calibrate correctly at 20 min. causing inaccurate shifted temperature readings until a successful calibration at 35 min.

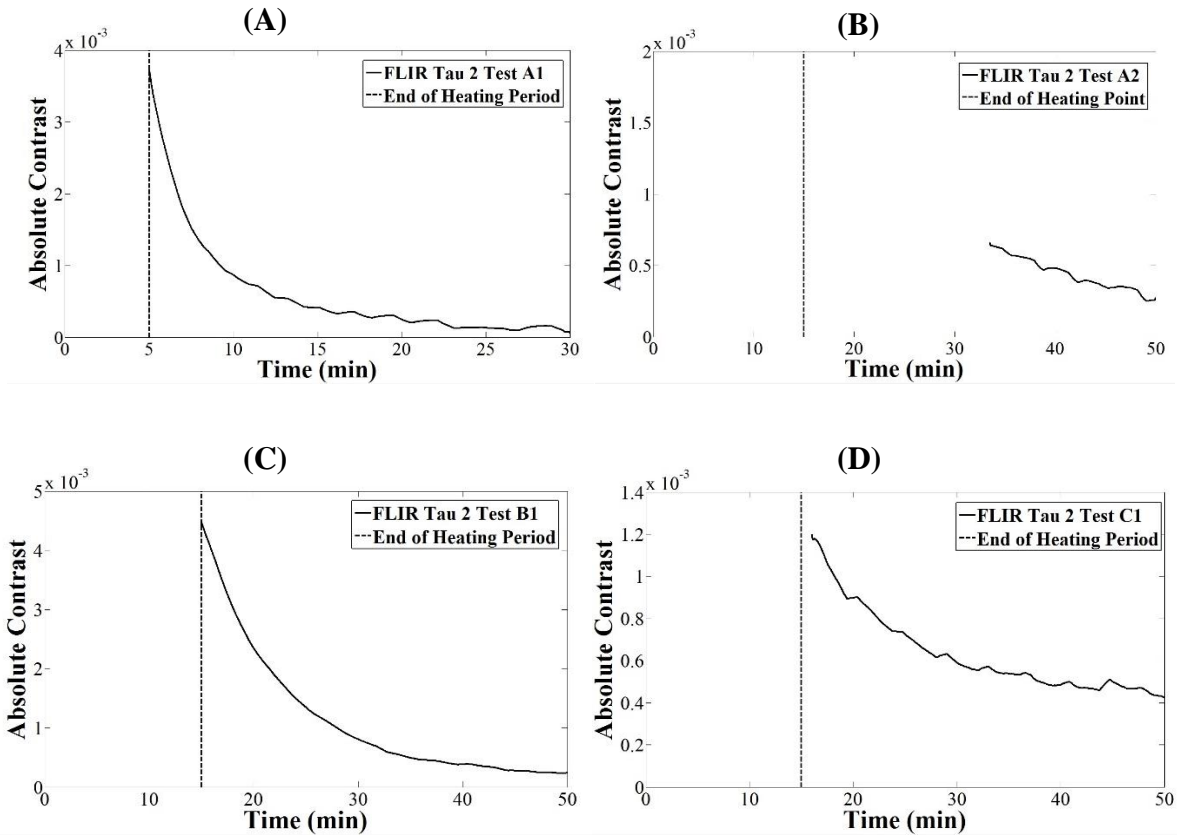
It should be noted that the FLIR Tau 2 was not activated during test A1 until 18 minutes after the heater was shut off due to oversight. By the time acquisition initiated, surface anomalies such as spalls and cracking were no longer visible in the thermal images. As a result, the thermal images from the FLIR Tau 2 could not be correlated to the optical image taken at test location A and a total area could not be defined for quantifying ground truth information. The incomplete data is represented by a dash in Table 6-11. However, analysis procedures using the simple polygon method were conducted on the existing set of thermal data recorded by the FLIR Tau 2 during test A1.

began acquiring data at the end of the heating phase, the absolute contrast graphs for this camera represent only the cooling phase of testing. This starting time of acquisition for the FLIR Tau 2 was adequate for the objectives of this study as the observation time needed for depth analysis is determined from the cooling phase of testing. It should be mentioned again that the FLIR Tau 2 was turned on 18 minutes after the end of the heating phase due to oversight for test A2 and the data collected for this test is shown in Figure 6-23 (B).

Figure 6-23: FLIR Tau 2 Absolute Contrast Graphs from Active IR Thermography Field Demonstration Testing (A) Test A1: 5 min. Heat Time (B) Test A2: 15 min. Heat Time (C) Test B1: 15 min. Heat Time (D) Test C1: 15 min. Heat Time.
