SAFETY PERFORMANCE EVALUATION OF MICHIGAN'S 4X5 PORTABLE SIGN SUPPORT

Michigan Department of Transportation

MwRSF Research Report No. TRP-03-135-03

**TESTING AND RESEARCH SECTION
CONSTRUCTION AND TECHNOLOGY DIVISION
RESEARCH REPORT NO. RC-1446**

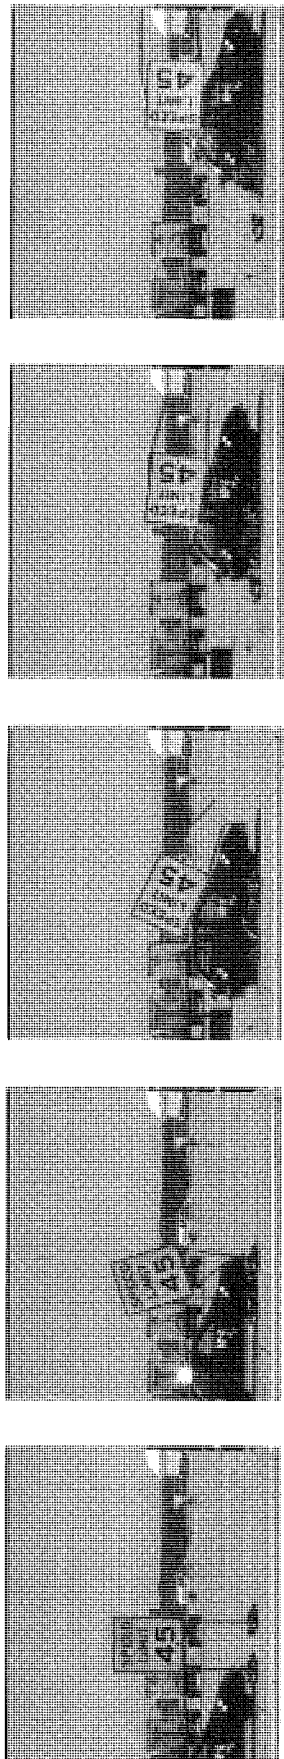
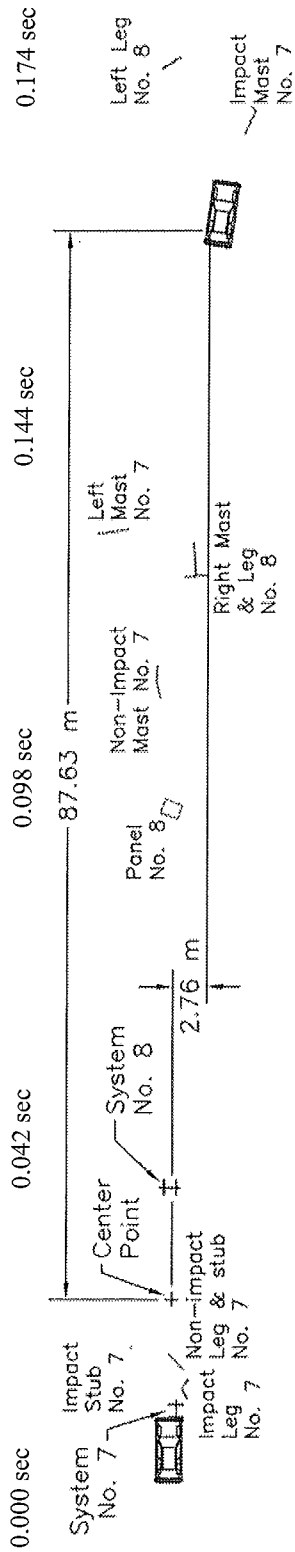
Figure 8. Summary of Test Results and Sequential Photographs, Test MI-4, Impact No. 1

● Test Number	MI-4	● Vehicle Speed	Impact	103.6 km/hr
● System Number	7	Exit	NA	
● Date	4/9/03	● Vehicle Angle	Impact	90 deg
● Test Article		Exit	90 deg	
Type	Traffic Control Device – Steel Sign Support	● Vehicle Stability	Satisfactory	
Stand	With Wood Sign Panel	● Occupant Ridedown Deceleration (10 msec avg.)	Longitudinal	NA
Sign Panel	Michigan's 4x5 Portable Sign Support	Lateral (not required)	NA	
Height above ground	Rigid Plywood, 1219 x 1524 x 17.3-mm thick	Occupant Impact Velocity (Normalized)	Longitudinal	NA
Warning Light	1,524 mm to panel bottom	Lateral (not required)	NA	
Key Elements	none	● Vehicle Damage	Roof and windshield penetration	
Size and/or dimension	3.0 m high	TAD ²⁹	12-FR-1	
Material	Telespar Steel Tubing	SAE ³⁰	12-FRAN9	
Orientation	End-on with right quarter point	● Vehicle Stopping Distance	87.63 m downstream	
Soil Type	On dry pavement	2.76 m right		
Vehicle Model	1996 Geo Metro	● Test Article Damage	Moderate – Broke apart

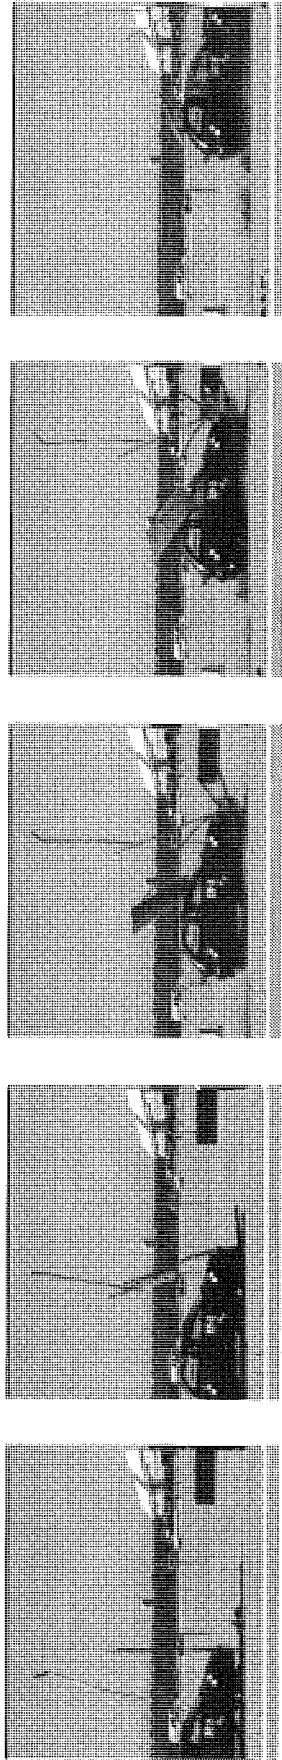
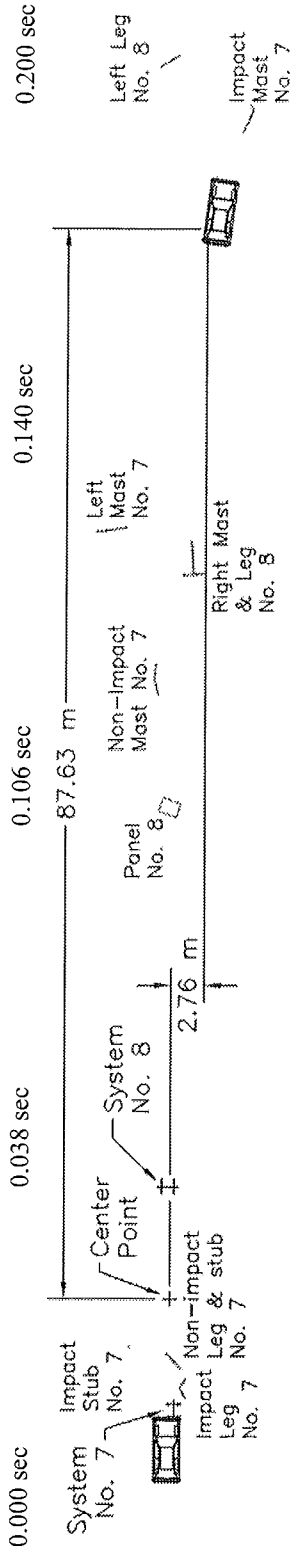
● Test Number	MI-4	● Vehicle Speed	Impact	91.7 km/hr
● System Number	8	● Vehicle Angle	Impact	0 deg
● Date	4/9/03	Exit	Impact	0 deg
● Test Article		Exit	Vehicle Stability	Satisfactory
Type	Traffic Control Device – Steel Sign Support	Occupant Ridedown Deceleration (10 msec avg.)	Longitudinal	NA
Stand	With Wood Sign Panel	Lateral (not required)	Longitudinal	NA
Sign Panel	Michigan's 4x5 Portable Sign Support	Occupant Impact Velocity (Normalized)	Lateral (not required)	NA
Height above ground	Rigid Plywood, 1219 x 1524 x 17.3-mm thick	Vehicle Damage	Windshield cracking and indentation	
Warning Light	1,524 mm to panel bottom	TAD ²⁹	12-FC-1	
Key Elements	none	SAE ³⁰	12-FCAW9	
Size and/or dimension	3.0 m high	Vehicle Stopping Distance	87.63 m downstream	
Material	Telespar Steel Tubing	2.76 m right	Moderate – Broke apart	
Orientation	Head-on with centerline			
Soil Type	On dry pavement			
Vehicle Model	1996 Geo Metro

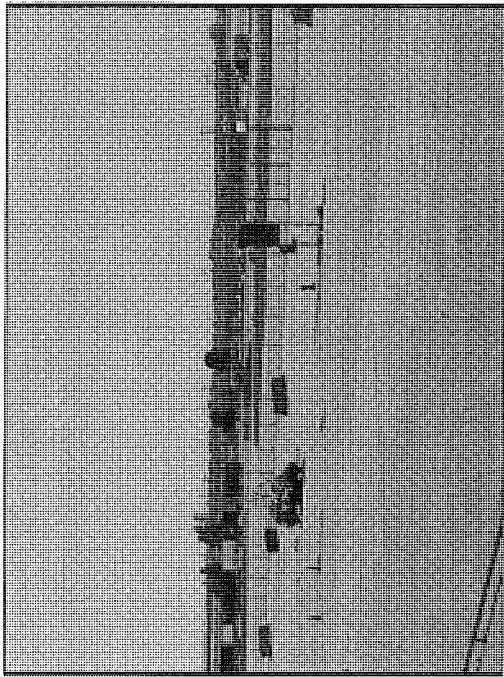
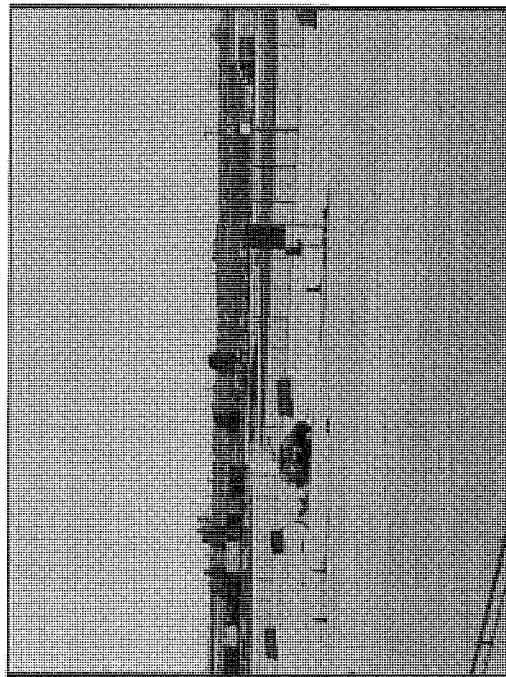
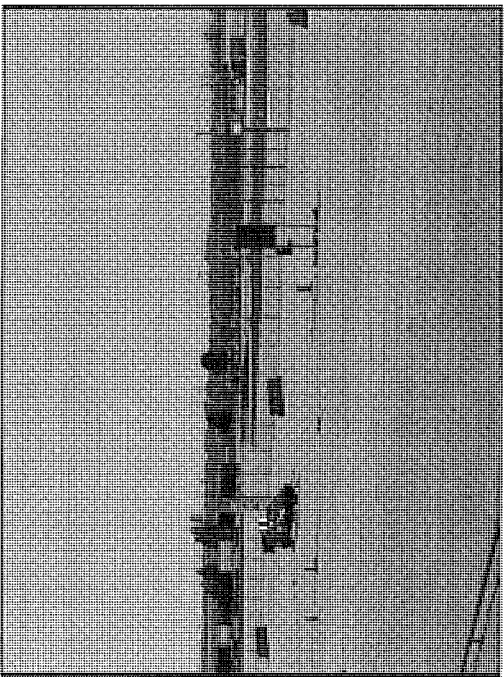
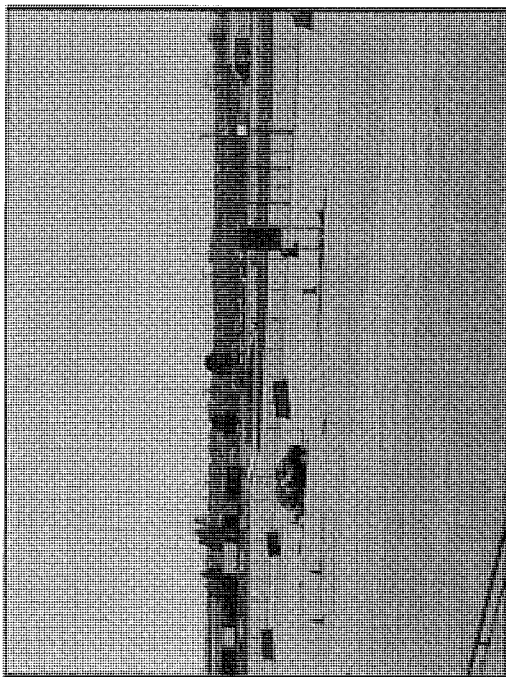
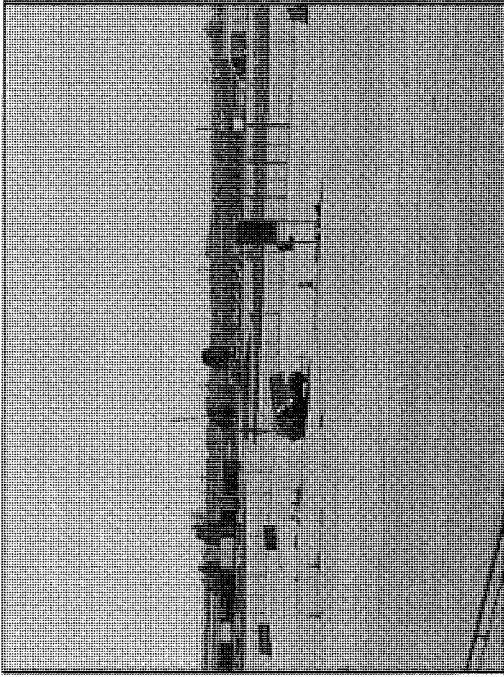
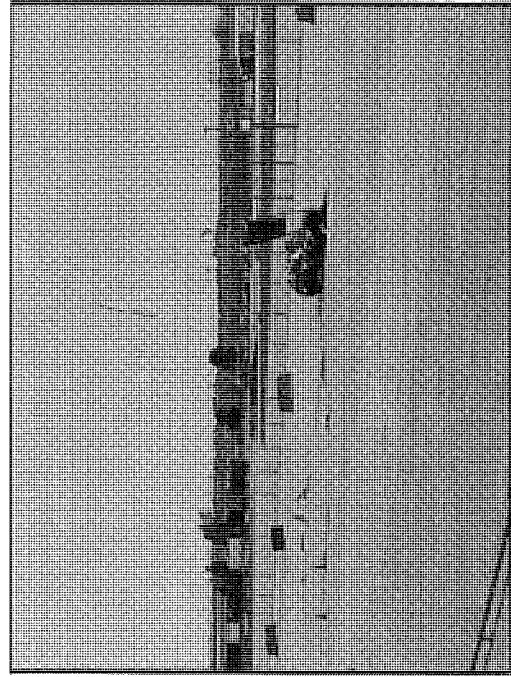
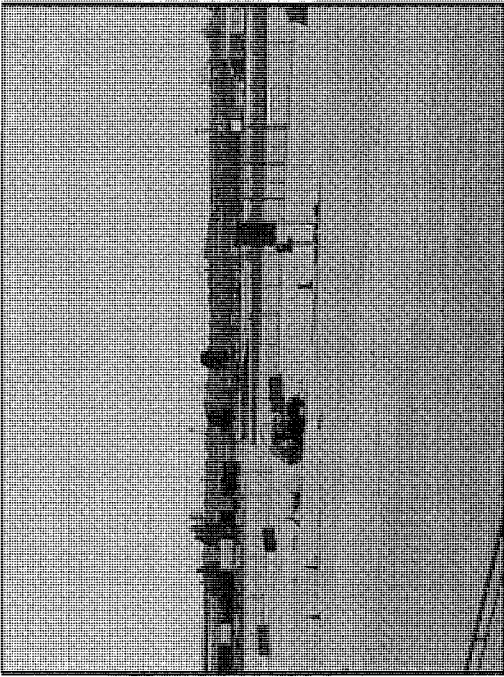
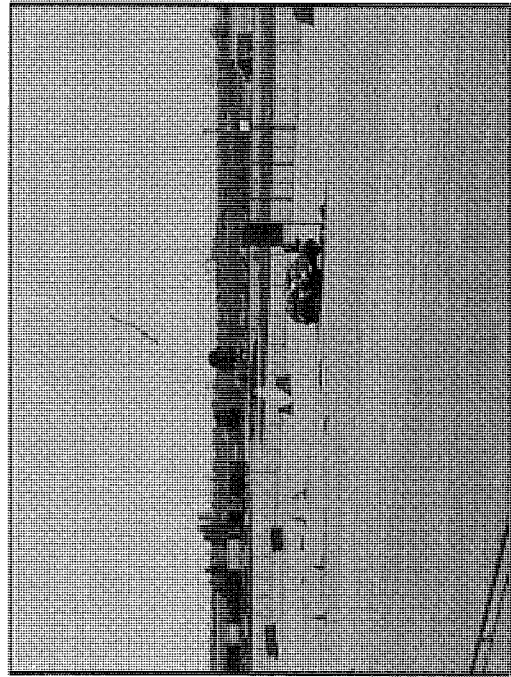
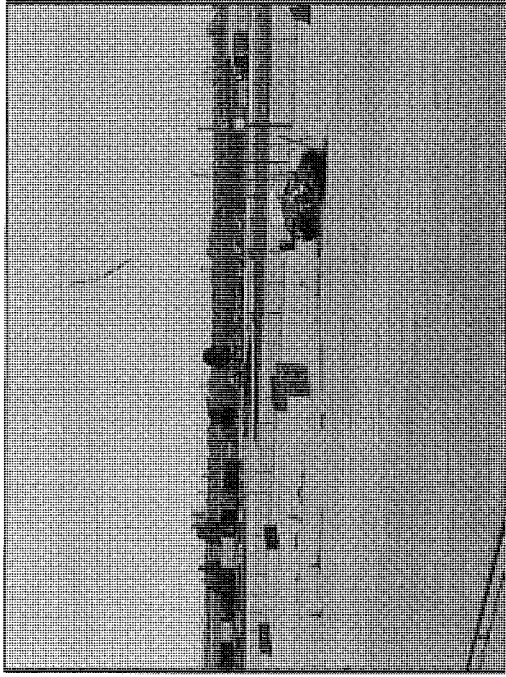
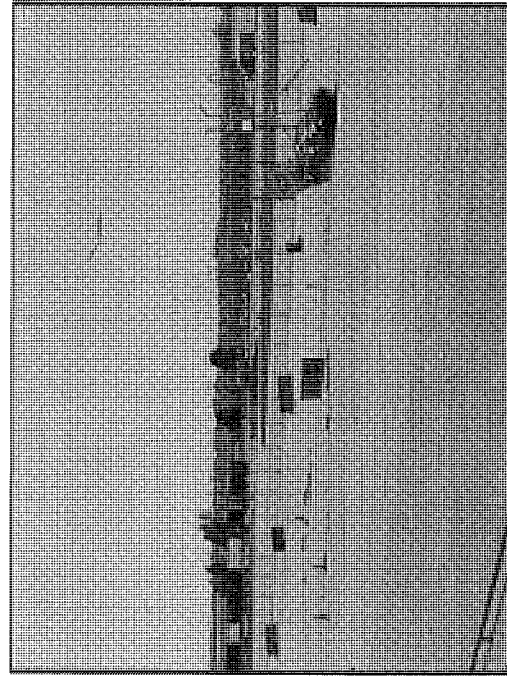
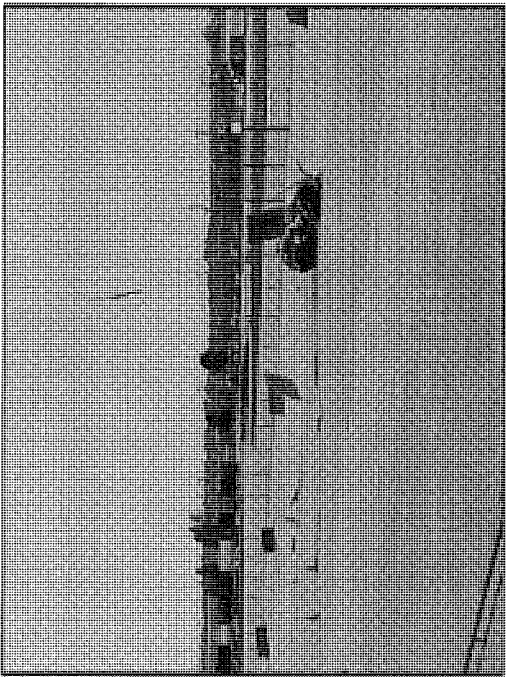
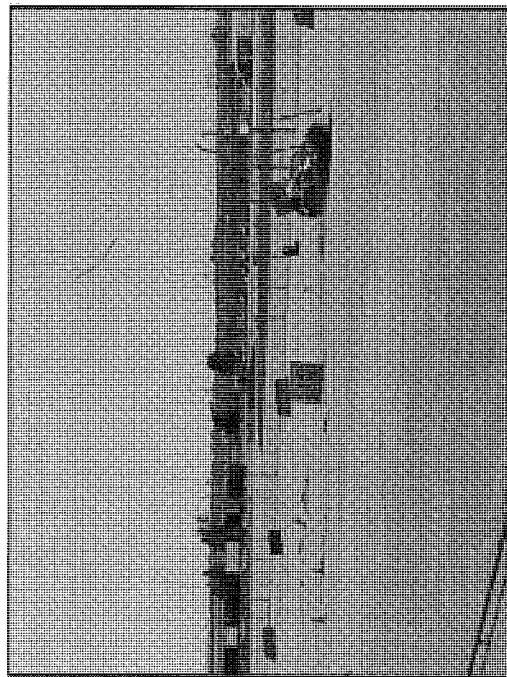
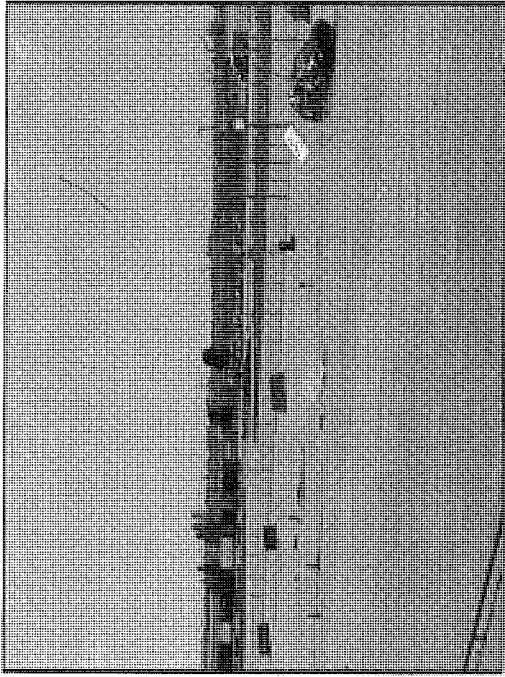
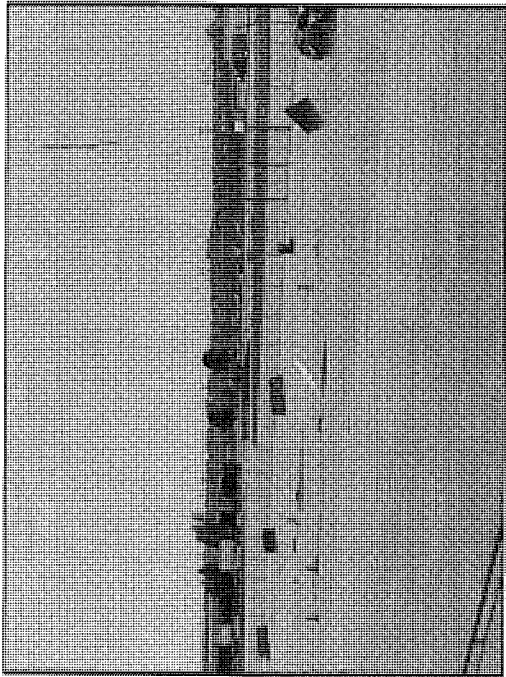
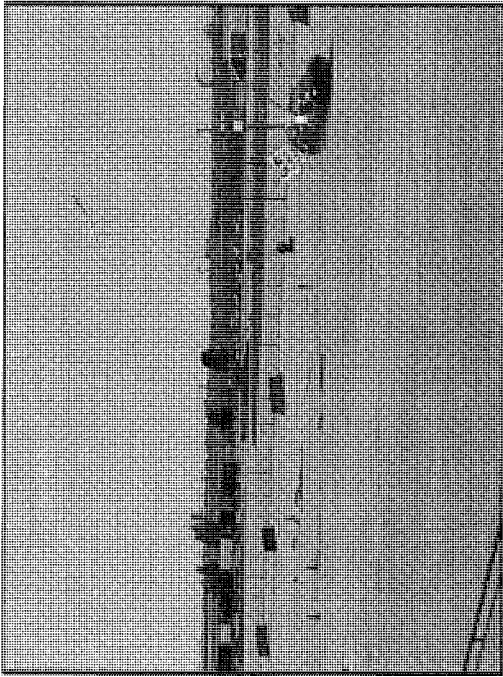
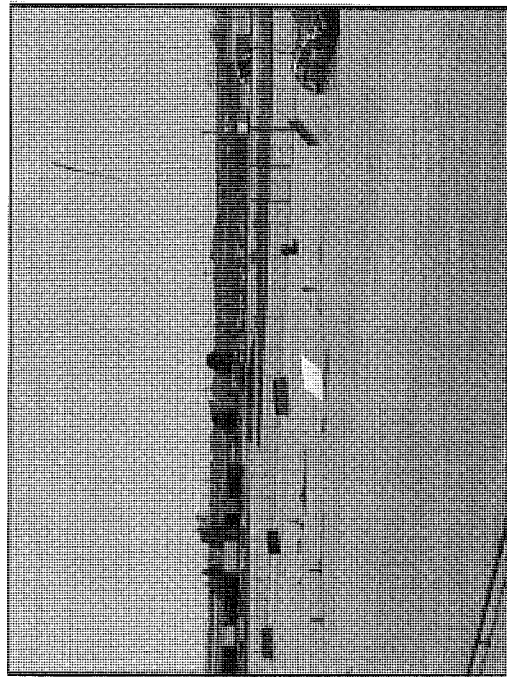
The 893-kg small car impacted System No. 7, Michigan's 1.2-m by 1.5-m portable sign with a rectangular-shaped plywood panel oriented end-on to the vehicle (parallel to the vehicle's path), at a speed of 103.6 km/hr and at an angle of 90 degrees. The small car then impacted System No. 8, Michigan's 1.2-m by 1.5-m portable sign with a rectangular-shaped plywood panel oriented head-on to the vehicle (perpendicular to the vehicle's path), at a speed of 91.7 km/hr and at an angle of 0 degrees. A summary of the test results and the sequential photographs are shown in Figures 8 and 9. Additional sequential photographs are shown in Figures 10 and 11. Documentary photographs of the crash tests are shown in Figures 12 through 15.

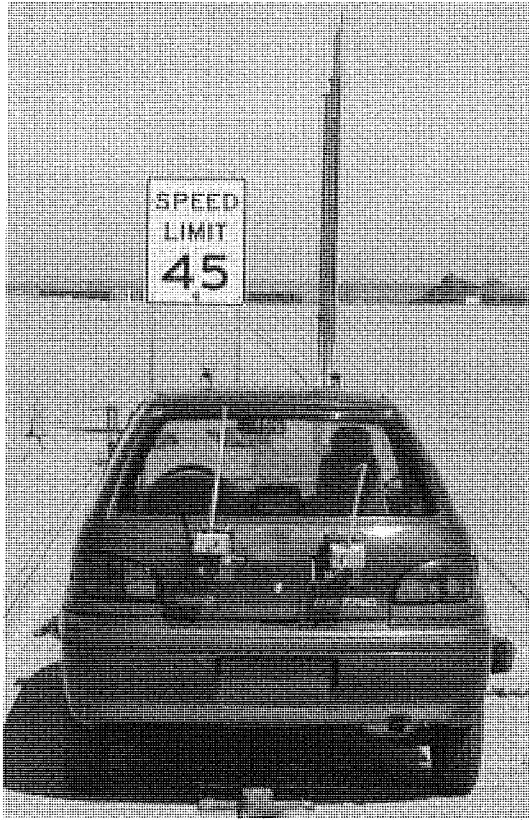
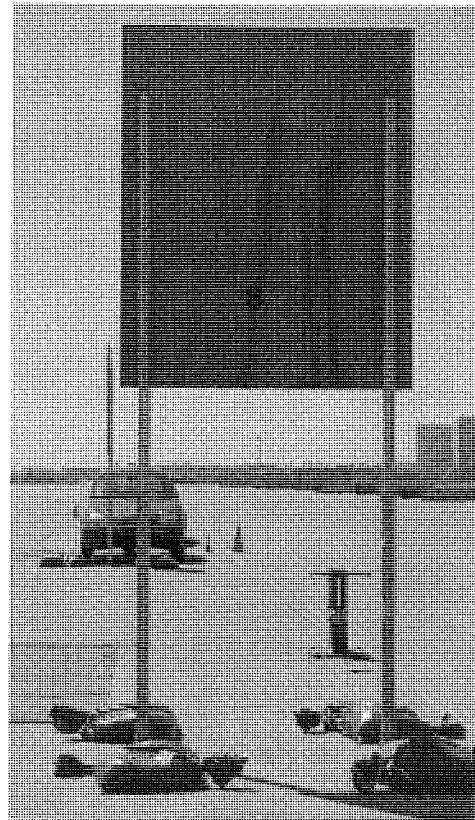
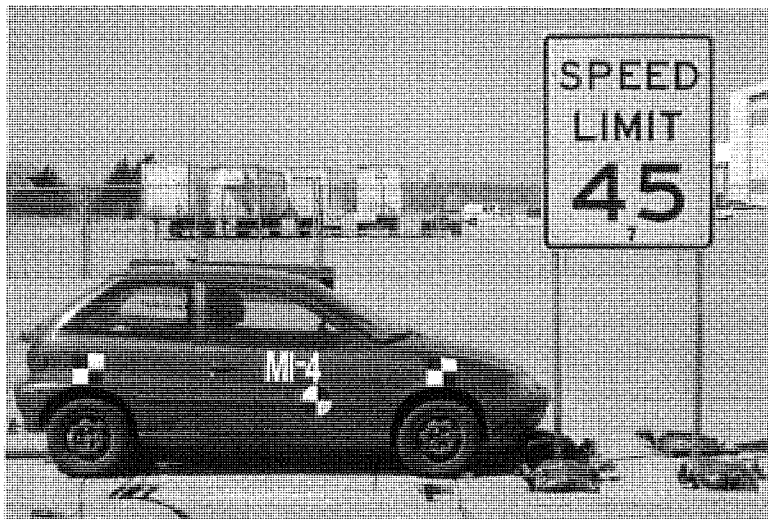
Figure 16. Impact Location, Test MI-4

The test vehicle impacted System No. 7 with the right-front quarter point of the vehicle aligned with the centerline of the sign support, as shown in Figure 16. At 0.014 sec after initial contact, the impacted mast deformed around the front of the vehicle and translated toward the non-impacted mast. At 0.042 sec, the sign panel rotated counter-clockwise (CCW) down toward the vehicle as the non-impacted mast rotated away from the vehicle. At this same time, the impacted mast deformed around the front of the vehicle and contacted the non-impacted mast. Shortly thereafter, the non-impacted leg disengaged from the mast. At 0.062 sec, the impacted mast disengaged from the leg and was deformed to approximately a 90 degree angle around the front of the vehicle. At this same time, the sign panel continued to rotate CCW toward the vehicle. At 0.098 sec, the sign panel contacted the roof and windshield. At 0.118 sec, the sign panel crushed the roof inward toward the occupant compartment. At 0.144 sec, the sign panel, which was positioned

Approximately 0.73 sec after impact with System No. 7, the vehicle impacted System No. 8 with the centerline of the vehicle aligned with the centerline of the sign support, as shown in Figure 16. At 0.020 sec, both masts deformed around the front of the vehicle as the top of the sign panel rotated down toward the vehicle. At 0.038 sec, the sign panel, both masts, and both legs all still intact traveled along with the vehicle. Shortly after this time, the sign panel released from the top-left, bottom-left, and the bottom-right panel bolts. At 0.064 sec, the masts were still in contact with the front of the vehicle as they rotated about the front of the vehicle. At this same time, the sign panel descended toward the vehicle. At 0.106 sec, the bottom of the sign panel contacted the roof and upper region of the windshield. At this same time, the top of the left mast remained attached to the sign panel. At 0.140 sec, the entire sign panel was in contact with the roof as the right-side
