Appendix A: Portfolios for Each Bridge Site

Bridge S041-63174

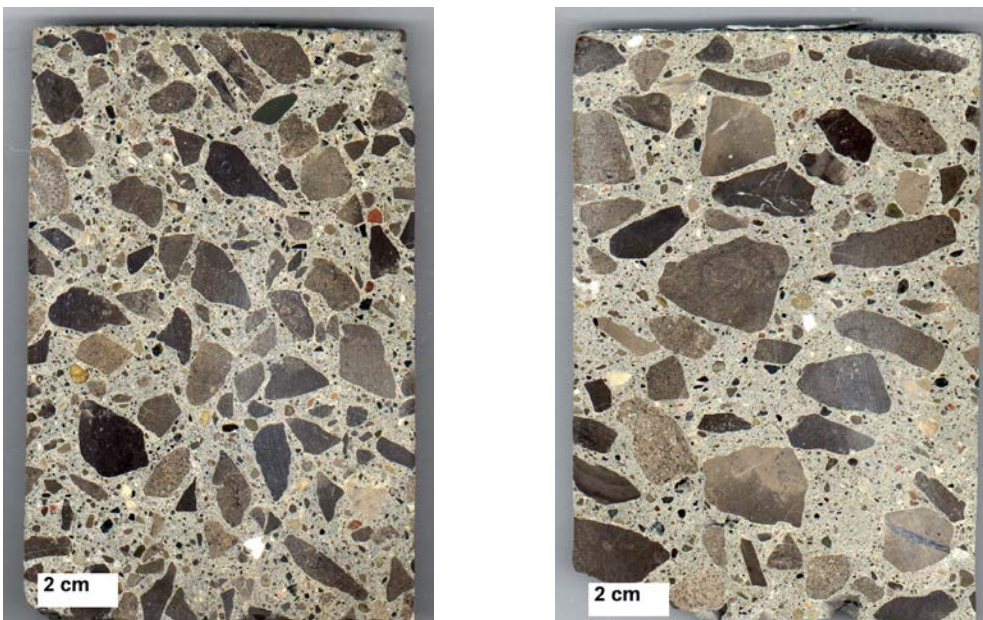
Figure A-4. Polished slabs from S041-63174, A1 (right) and A2 (left).

The stereo optical microscope was used to examine polished slabs (figure A-4) cut from each core to assess general conditions of the concrete. Darker rims were visible on several siliceous fine aggregates (figure A-7); however, it was concluded that these were simply the result of weathering since no cracks or reaction products of ASR were apparent. As can be seen from figure A-5, a network of very small well-distributed unfilled air voids were present in each core. Also, some small entrapped air voids and cracked porous siltstones were observed here and there in the paste (figure A-6).

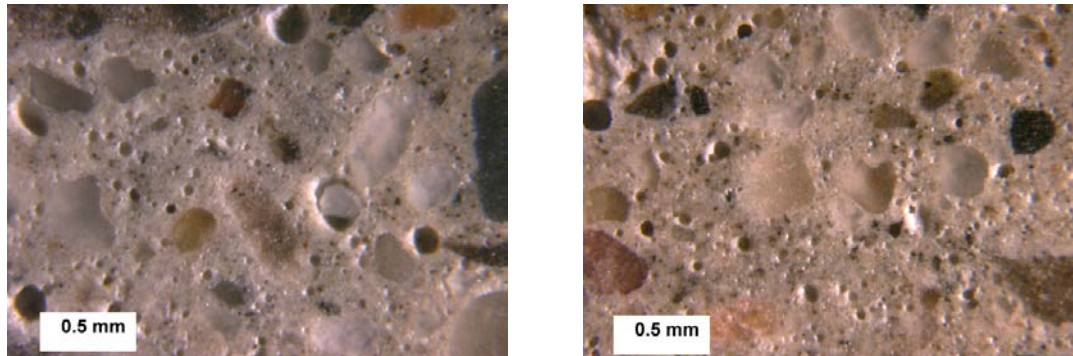
Figure A-5. Stereo optical micrograph showing the air void structure of A1 (right) and A2 (left).

The recorded air contents are a little under the recommended minimum limit for 0.75 in top size aggregate (6 percent) because the air voids are very small; however, the spacing factor is well under 0.2 mm and the specific surface is well above 25 mm^{-1} .

Consequently, the air-void system should provide adequate protection against freeze-thaw deterioration. The small size of the air voids might only become a problem in the future, as they get filled more easily with secondary deposits.

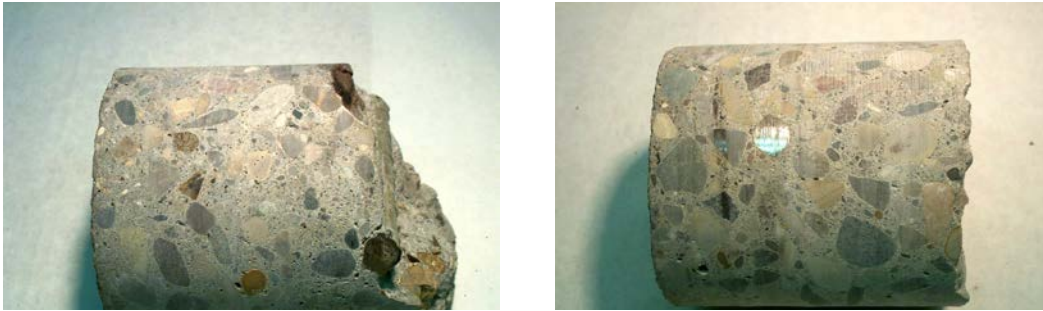
Figure A-12. Cores evaluated for S15-63172, B1 (left) and B2 (right).

The cores from the south and the north bound were logged into MTU as B1 and B2, respectively. Photos of the obtained cores are shown in figure A-12. The coarse aggregate type was determined to be a mix of crushed and natural gravel with a maximum size of 0.75 in. Steel reinforcement was present at the bottom of core B1 (3.5 in from the surface) and embedded in core B2 (1.25 in from the surface), no rust was observed.

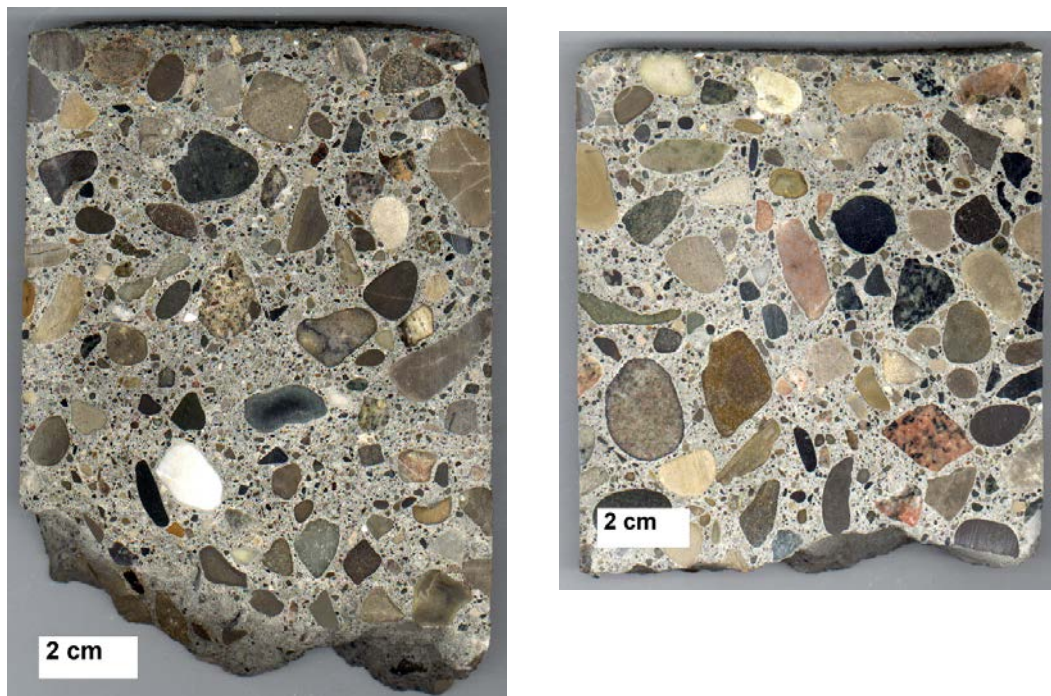
Figure A-13. Polished slabs from S15-63172, B1 (left) and B2 (right).

The stereo optical microscope was used to first examine polished slabs cut from each core to assess general conditions of the concrete (figure A-13). A photo of the air-void system of those slabs is shown in figure A-14. In general, the air voids are well distributed throughout the paste and only a few are filled; however, as can be seen from figure A-15, a significant amount of irregularly shaped voids are present around the aggregates and rebar.

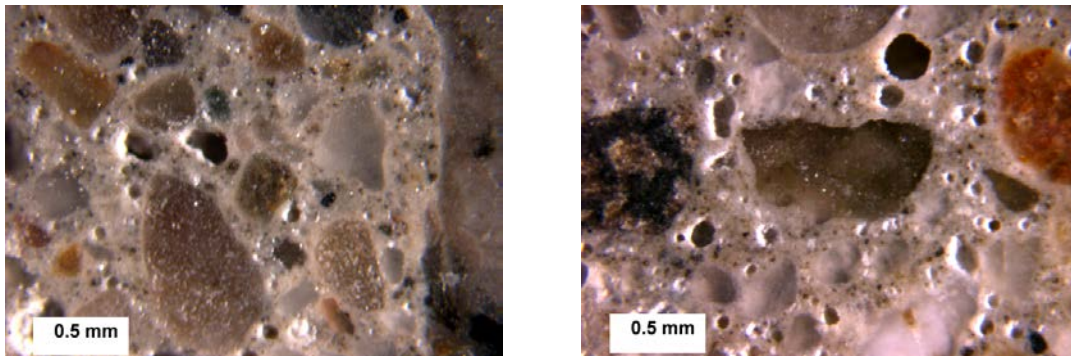
Figure A-14. Stereo optical micrograph showing air void structure of B1 (left) and B2 (right).

The recorded air contents are a little under the recommended minimum limit for 0.75 in top size aggregates (6 percent), maybe due to the relatively low paste content; however, the spacing factor is well under 0.2mm and the specific surface is well above 25 mm^{-1} . Consequently, the air-void system should provide an adequate protection against freeze-thaw deterioration.

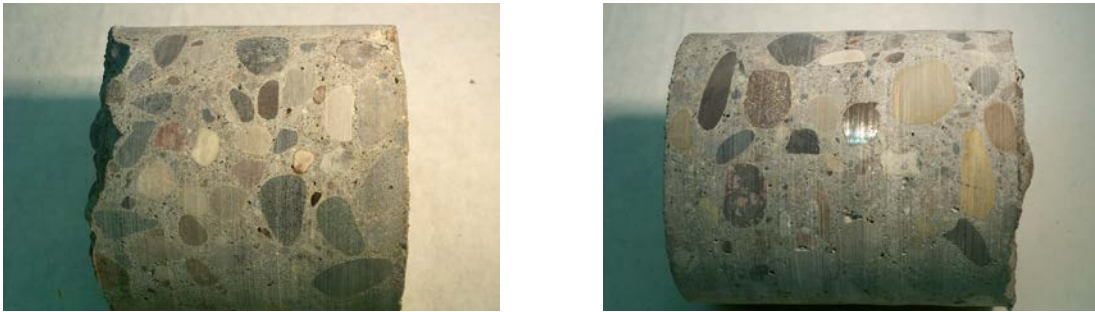
Figure A-17. Cores evaluated for S12-63174 (10cm diameter), C1 (left) and C2 (right).

The cores received from WSU were logged into MTU as C1 and C2 for the barriers exposed to the East (SB) and the West side (NB), respectively. Photos of the obtained cores are shown in figure A-17. The coarse aggregates were characterized as natural gravel with a maximum size of 0.75 in. Steel reinforcement was present in core C2 at 2.5 in from the top surface, no rust was observed.

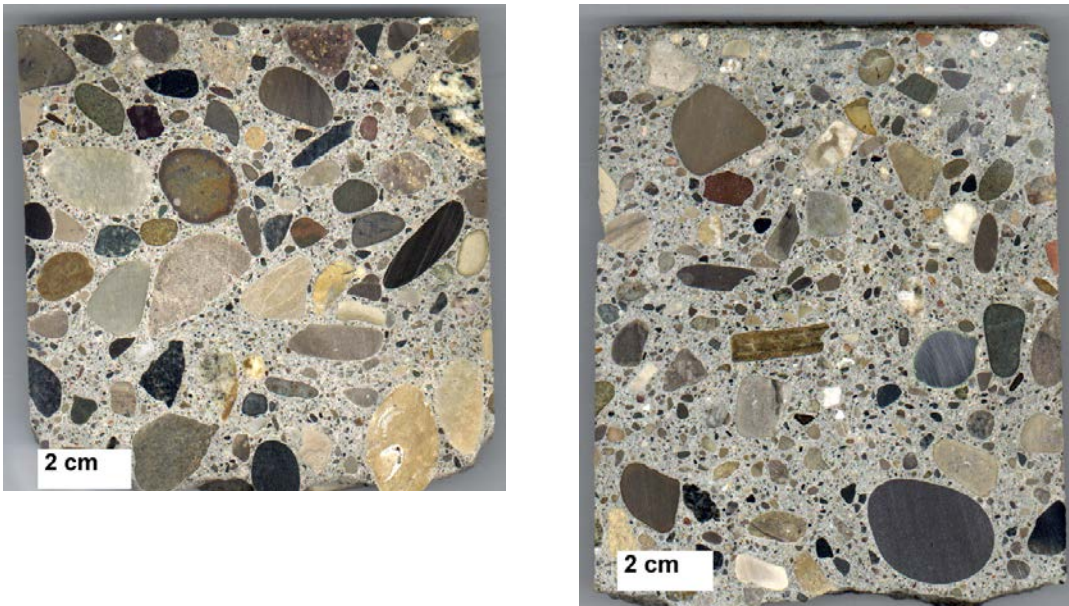
Figure A-18. Polished slabs from S12-63172, C1 (left) and C2 (right).

The stereo optical microscope was used to first examine polished slabs cut from each core in order to assess the general condition of the concrete. The polished slabs are presented in figure A-18.

Entrapped air voids were present in slab C2 and in lesser extent in C1 (figure A-19). In both samples, the entrained air-voids were unevenly distributed, but only few were filled. Figure A-20 shows photos of locations where little air voids are present.

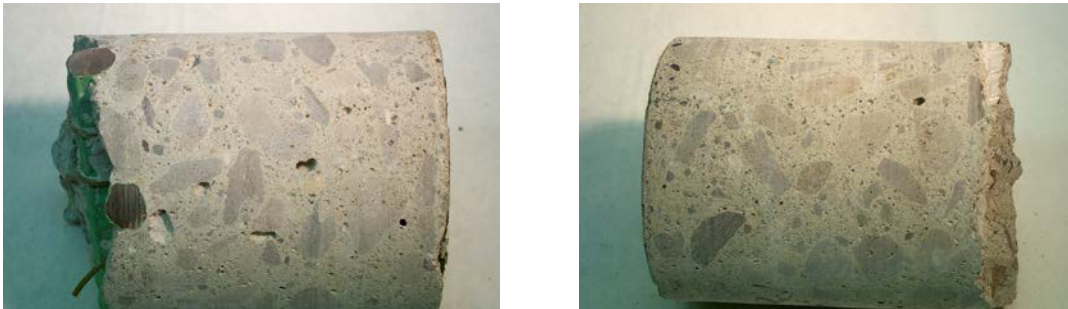
Figure A-22. Cores evaluated for S021-63174, D1 (left) and D2 (right).

The cores received from WSU were logged into MTU as D1 and D2. Photos of the obtained cores are shown in figure D-22. The coarse aggregates were characterized as crushed tan carbonate rocks with a maximum size of 0.75 mm. Steel reinforcement was present at the bottom of core D1 (11 cm from the surface), and an imprint of rebar was present at the bottom of D2 (12cm from the surface). No rust was observed; however, large gaps were present under and around the rebar in D1 (figure A-23). The imprint in D2 seems to indicate that the consolidation around the rebar was better at that location (figure A-23).

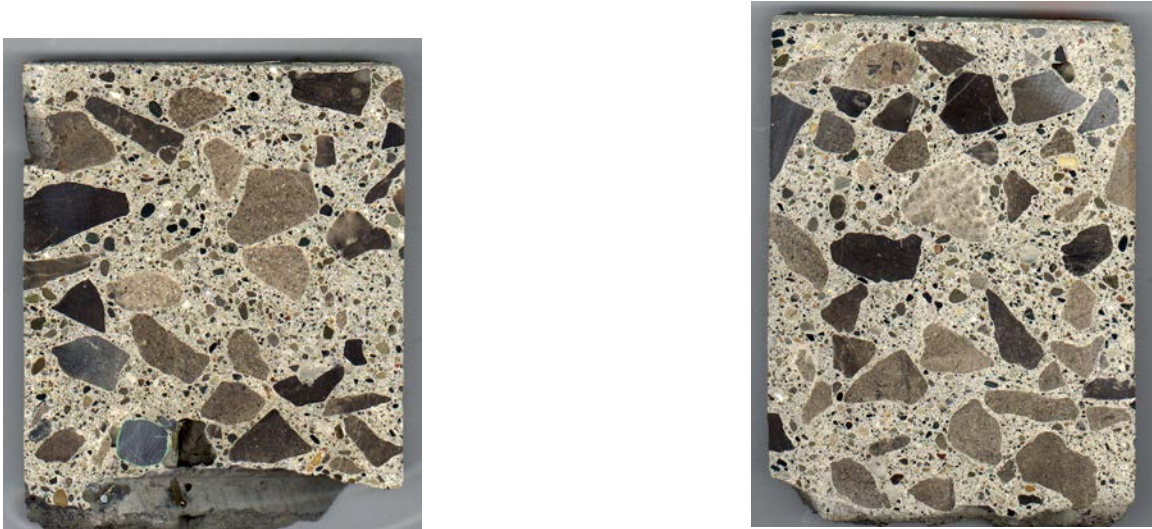
Figure A-24. Polished slabs from S021-63174, D1 (left) and D2 (right).

The stereo optical microscope was used to examine polished slabs cut from each core in order to assess the general condition of the concrete. The polished slabs are presented in figure A-24. The inspection revealed poor consolidation around some of the aggregates in D1 (figure A-25); however, the air-void system seemed to be adequate. A lot of entrained air-voids are well distributed in both samples (figure A-26).

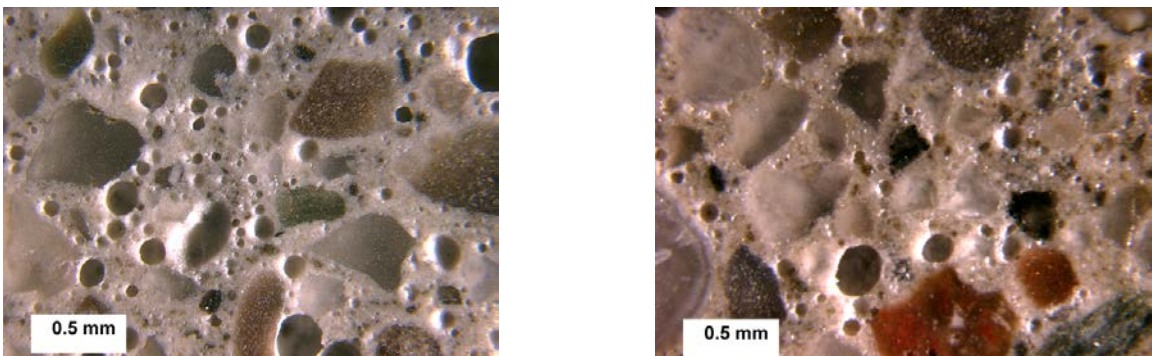
Figure A-26. Stereo optical micrograph of air void structure in D1 (left) and D2 (right).

The stereo optical microscope was also used to determine the parameters of the air-void system in accordance to the modified point count method described in ASTM C 457. The results of the analysis are given in table A-4. For both samples, the parameters of the air-void system are adequate (spacing factor < 0.2 mm, specific surface > 25 mm⁻¹, air

content > 6 percent). So, these barriers have an adequate protection against freeze-thaw deterioration.

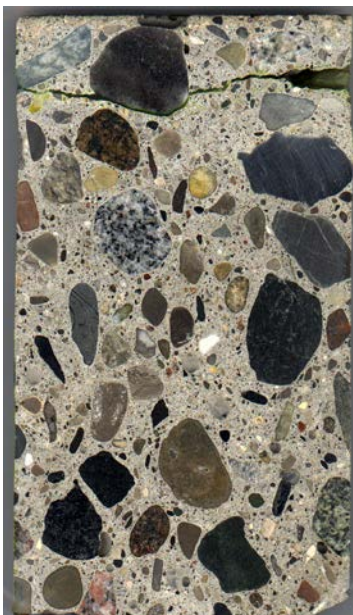
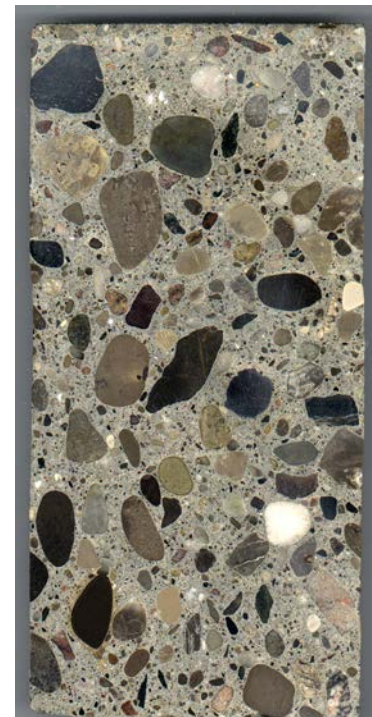
Figure A-30. Polished slabs from S02-23152, E1 (left) and E2 (right).

The stereo optical microscope was used to examine polished slabs cut from each core (figure A-30) to assess general conditions of the concrete. The consolidation of the samples was adequate except around the rebar where the bond was not as good. The air-void system consisted of many well distributed air bubbles (figure A-31). Only very few air voids were filled.

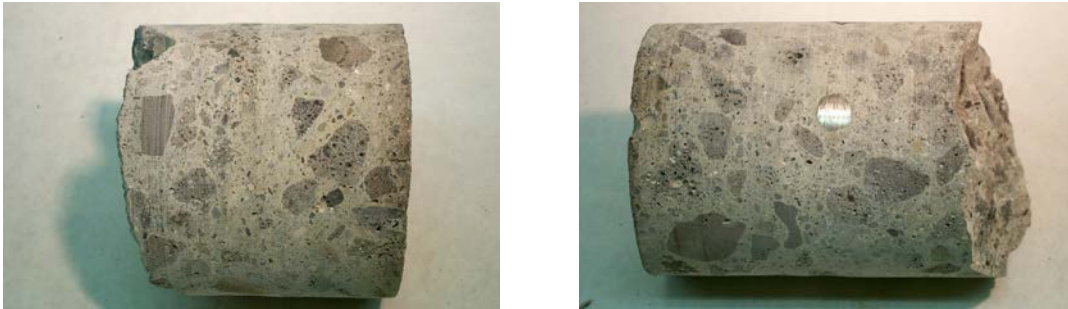
Figure A-33. Cores evaluated for S04-82022, F1 (left) and F2 (right).

The cores from the west and the east bound of I94, which are shown in figure A-32, were identified respectively as F1 and F2. Rebar was present in core F2 at approximately 3.5 in from the surface, but not in core F1, because F1 broke off at the location of the rebar (4 in from the surface) during the extraction. No rust was observed on the rebar of F2 or on the imprint in F1 (figure A-33). Cracks were observed at the top surface of both cores (figure A-34). The coarse aggregates were characterized as blast-furnace slag with a maximum size of 0.75 in.

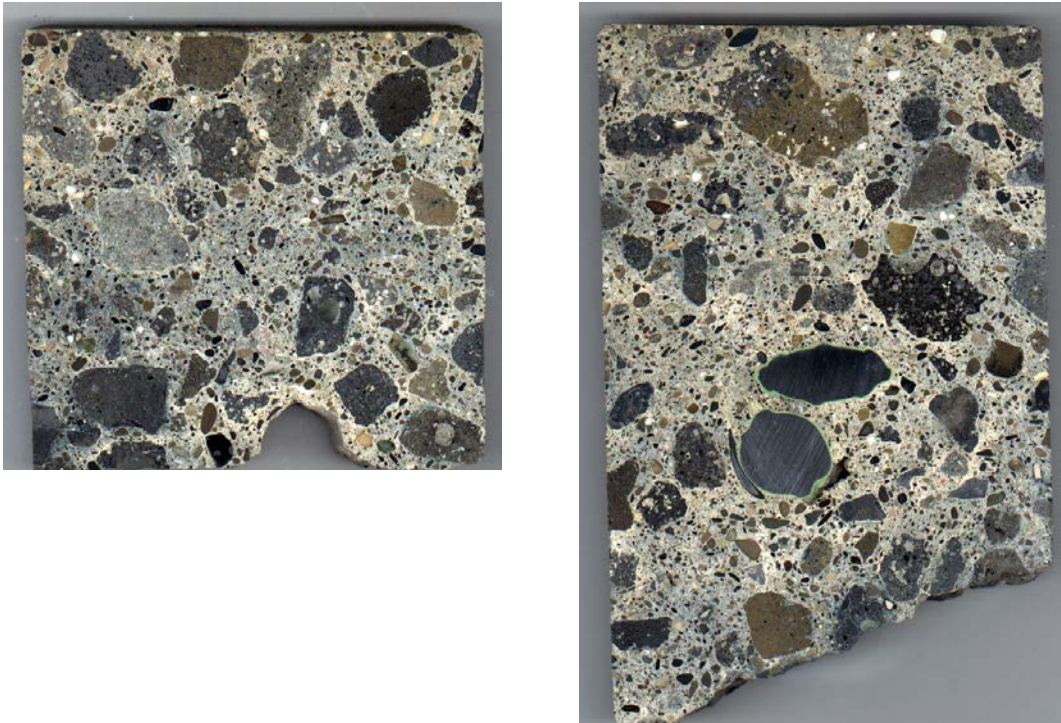
Figure A-36. Polished slabs from S04-82022, F1 (left) and F2 (right).

The stereo optical microscope was used to examine polished slabs cut from each core to assess general conditions of the concrete. As can be seen from the polished slabs in figure A-36, some entrapped air voids were present around one of the rebars in F2. Similar but smaller entrapped air-voids were also present here and there in the paste. The most striking feature of the concrete was the abundance of relatively porous cracked siltstones and fine chert aggregates with reaction rims and cracks extending through the paste, a typical sign of alkali-silica reactivity (ASR), (figure A-37).

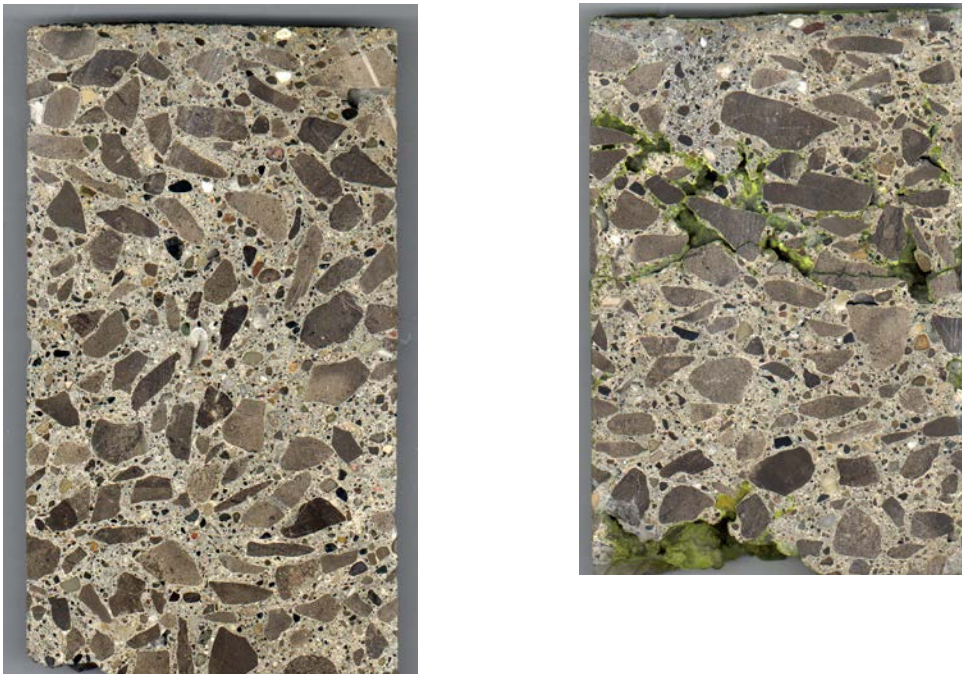
Figure A-45. Polished slabs from S01-44044, G1 (left) and G2 (right).

After gluing core G2 back together with epoxy, polished slabs from each core (figure A-45) were observed with the stereo optical microscope to assess general conditions of the concrete. As can be seen from figure A-46, not many air-voids are present in the concrete, and most of them are filled with ettringite. Some fine siliceous aggregates with darker rims were observed; however, very few of those were cracked and when they were, the cracks never extended through the paste.

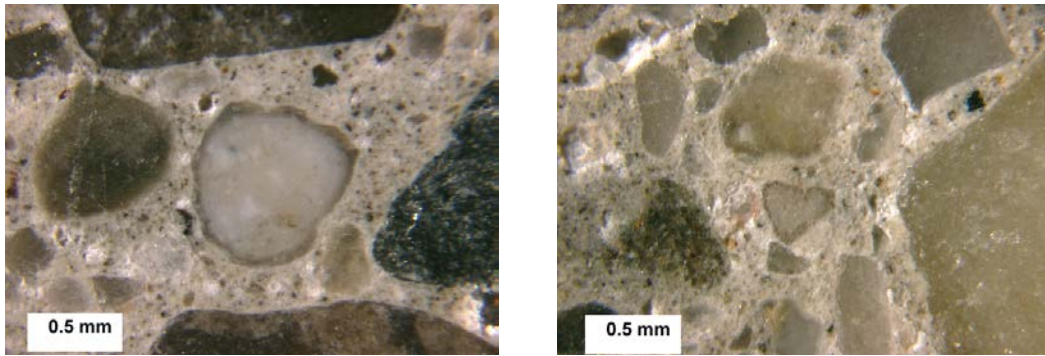
Figure A-46. Stereo optical micrograph showing air void structure of G1 (left) and G2 (right).

The existing air contents are acceptable, but they result from a large amount of entrapped air rather than from a large amount of entrained air. Also, since little unfilled air voids are present in the paste, the existing spacing factor is significantly higher than the 0.2 mm limit and the specific surface is greatly under the 25 mm^{-1} minimum recommended value. Therefore, the concrete is not adequately protected against freeze-thaw deterioration.

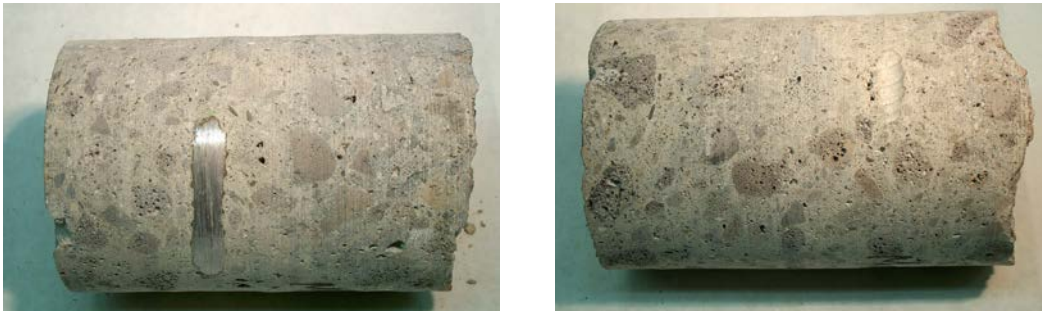
Figure A-51. Cores evaluated for S06-82022, H1 (left) and H2 (right).

Photos of the cores identified as H1 and H2 are shown in figure A-51. The coarse aggregates were composed of blast furnace slag with a maximum size of 0.75 in. A little rust was observed on the sides of the rebar in core H1. An imprint of rebar was present on the side of core H2, however no sign of rust was noticed. Some entrapped air voids were visible on the sides of the cores, and on the rebar imprint.

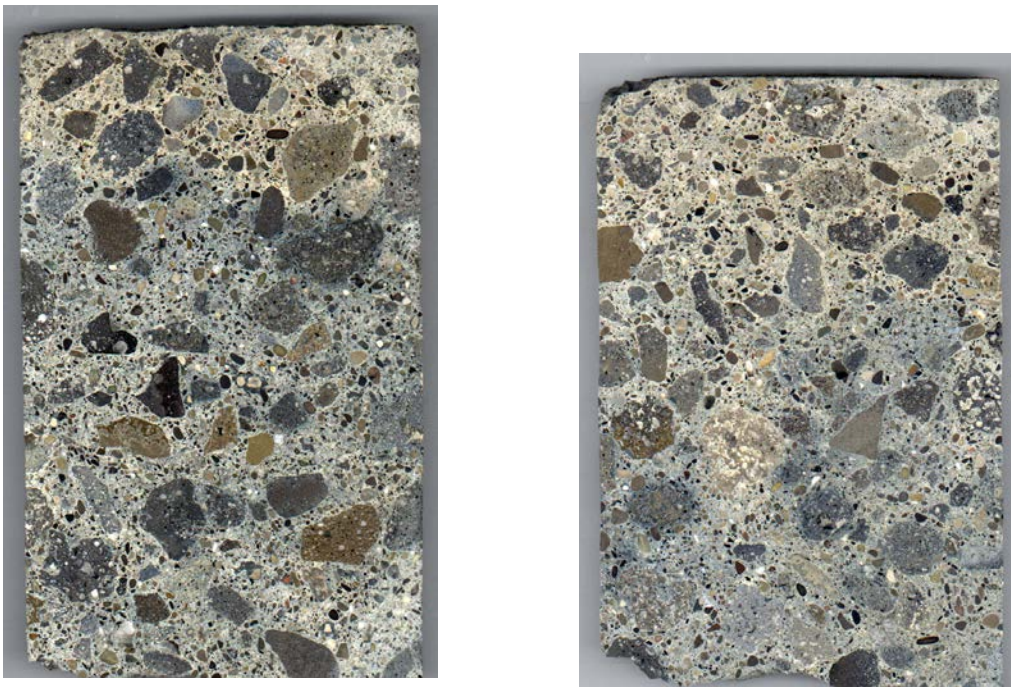
Figure A-52. Polished slabs from S06-82022, H1 (left) and H2 (right).

The stereo optical microscope was used to examine polished slabs cut from each core (figure A-52) to assess general conditions of the concrete. A network of well-distributed entrained air voids was present in each core; however, at some locations most of those were filled with secondary deposits (figure A-53), or larger irregularly shaped air voids were present (figure A-54). Some fine siliceous aggregates with darker rims and cracks sometimes extending through the paste were observed (figure A-54), indicating the possibility of ASR. Also, several fine black siltstones with lengthwise cracks were present.
