*C-2* FINAL REPORT  
EXPERIMENTAL PROJECT  
ORTHOTROPIC BRIDGE

EXPERIMENTAL ORTHOTROPIC BRIDGE  
S05 of 23081 A  
Crietz Road crossing over I-496  
three miles west of the city limits  
of Lansing

FEDERAL PROJECT 1 496 - 7(21) 138

STATE RESEARCH PROJECT 67 G - 157

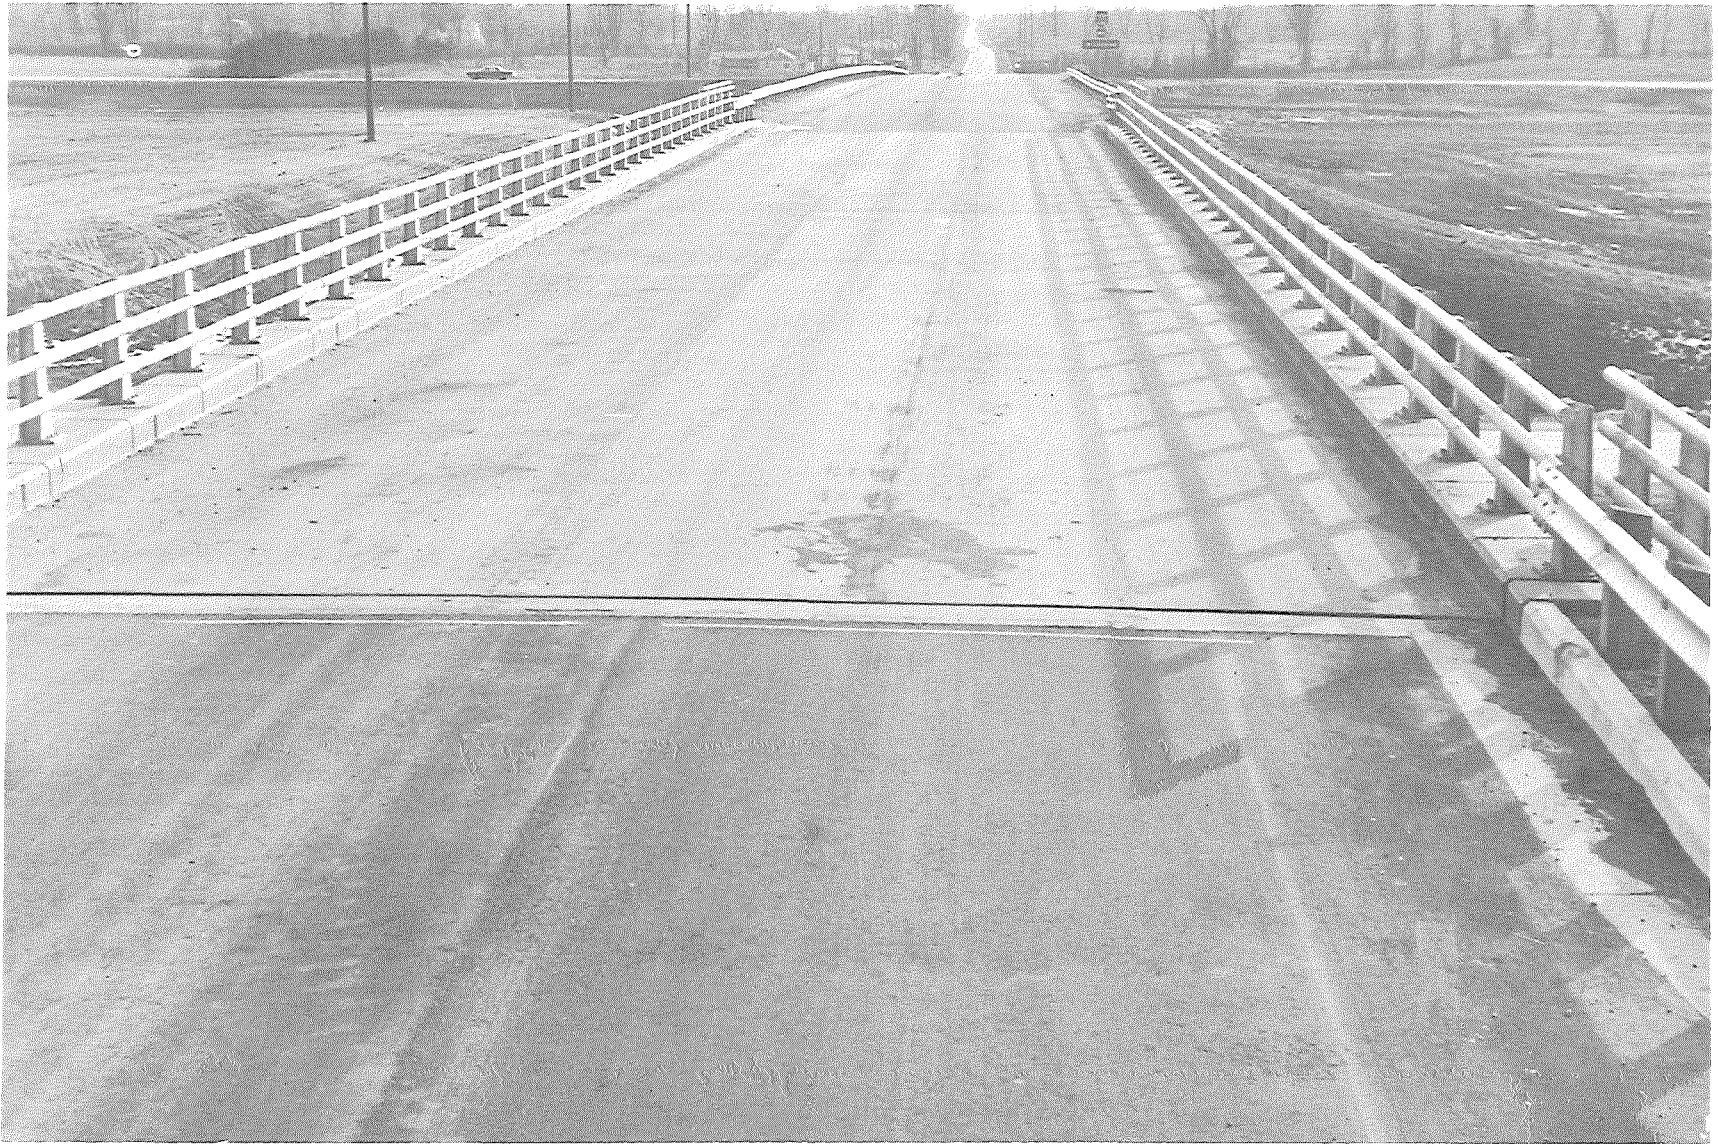
Figure 1. View looking south over Crietz Rd Bridge, December 1969.

Figure 1 shows the overall view of the deck looking south at the time the initial set of oblique photographs were taken; approximately one month after the bridge was opened to traffic.
