PROGRESS REPORT ON
EVALUATION OF A RUBBER PAD RAILROAD CROSSING

Research Laboratory Section
Testing and Research Division
Research Project 64 G-134
Research Report No. R-698

State of Michigan
Department of State Highways
Lansing, April 1969

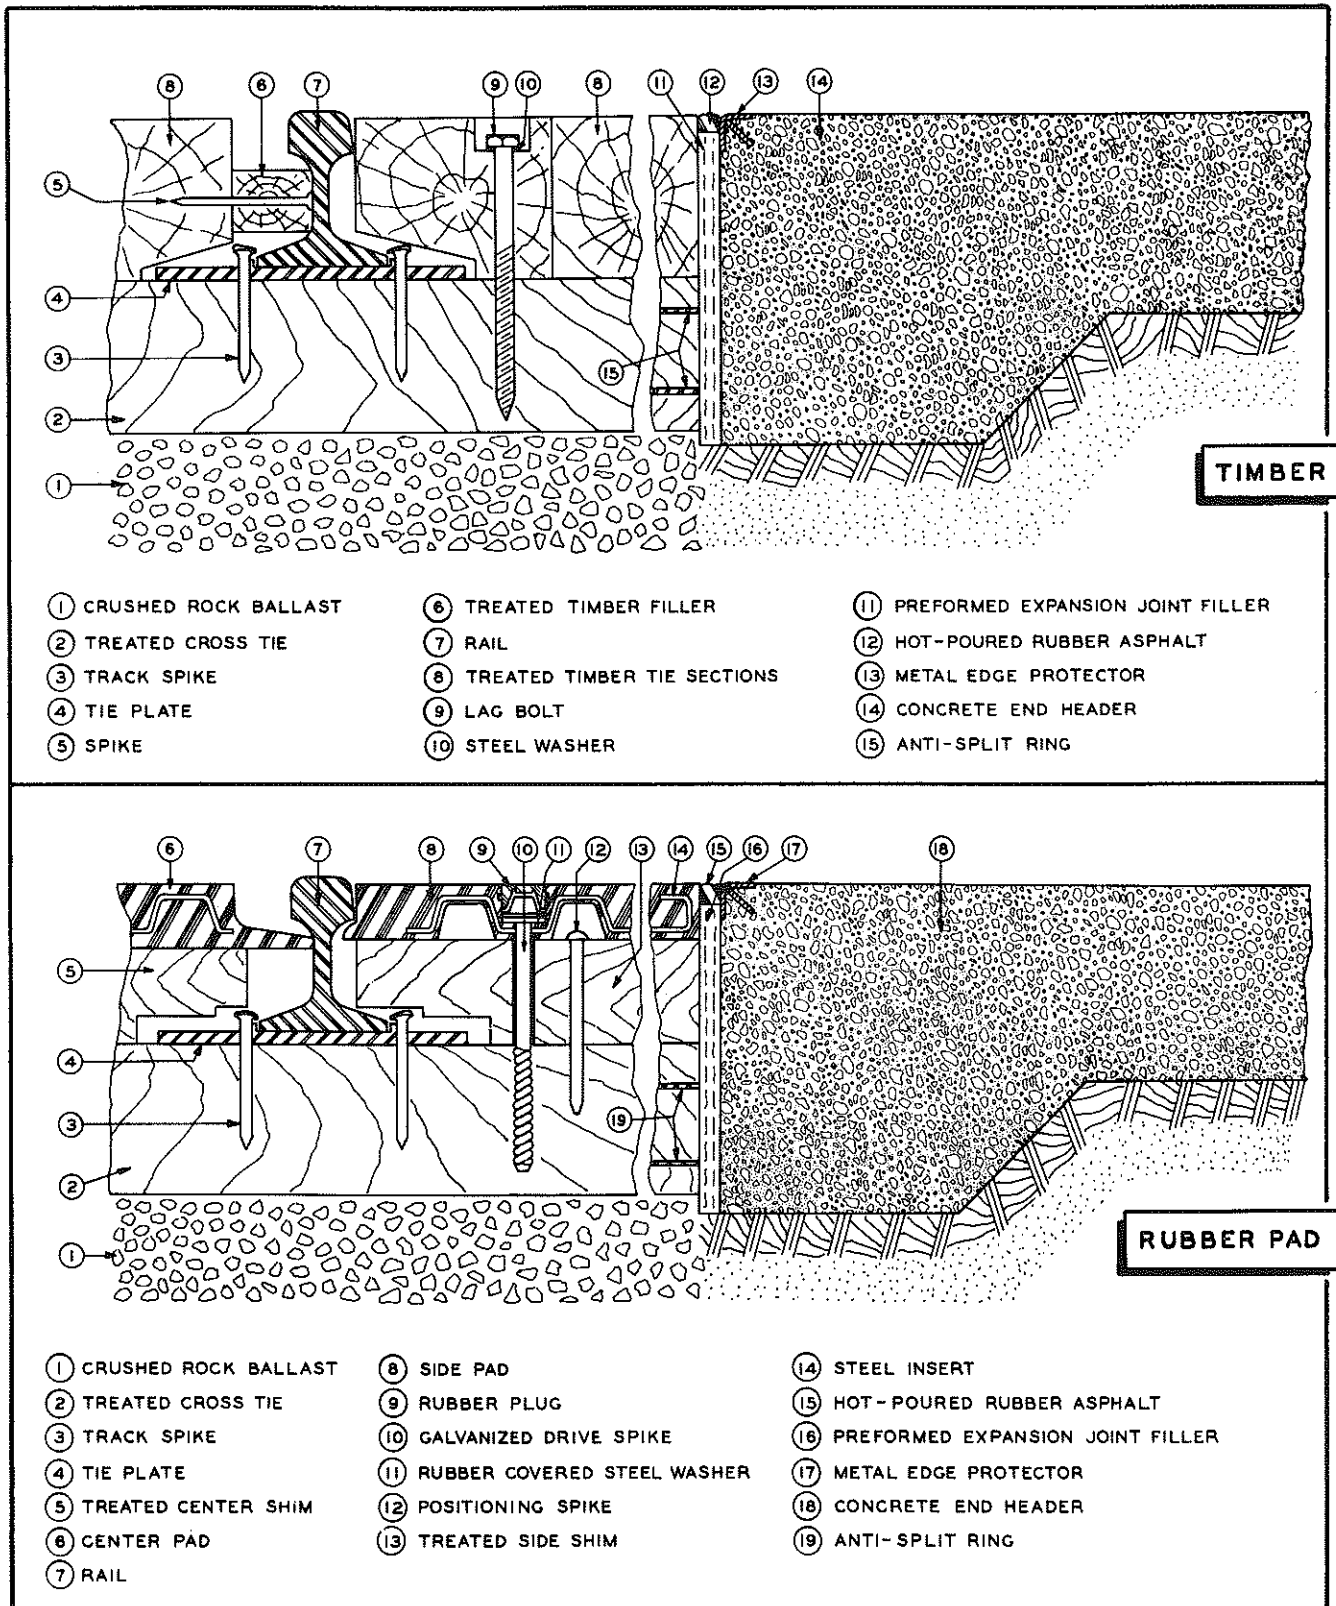
Figure 1. Cross-sectional detail drawings of railroad crossing components.

The crossings were constructed by C&O Railway personnel on a force account basis, with coordination and inspection of the work the responsibility of the Department's District Office. The timber crossing was installed in July 1963 in accordance with Standard Plan for Track Crossings, E-4-A-22D, Detail 2. A sketch showing a cross-section of the crossing components is shown in Figure 1.

Construction of the rubber pad crossing began in July 1965 with work done on an intermittent basis until completion in September 1965. To realize the full advantage of this type of crossing, the materials must meet specified dimensions and the installation must be precisely performed. In both of these areas some difficulties were experienced. Twice it was necessary to reject installed ties, the first time because of undersize cross-sectional tie dimensions and the second because tie length was less than required. With the cooperation of railroad personnel, satisfactory ties were obtained by carefully culling the railroad's tie stock. With respect to installation of the pads it was noted that in some cases the side shims split longitudinally when the lag bolts were installed, and it was extremely difficult to obtain the correct depth for the lag bolt heads below the rubber surface. Reaming the holes through the shims to the correct diameter and blowing out wood shavings collecting in the bottom of the drilled holes with compressed air, minimized the problems incurred when installing the lag bolts. The components of the rubber pad crossing are shown in a cross-sectional sketch in Figure 1.
