**CONTINUOUSLY REINFORCED BITUMINOUS RESURFACING
Detroit Industrial Expressway (I 94), West of Ypsilanti**

**Research Laboratory Division
Office of Testing and Research
Research Project 54 D-20(3)
Report No. 365**

**Michigan State Highway Department
John C. Mackie, Commissioner
Lansing, January 1962**

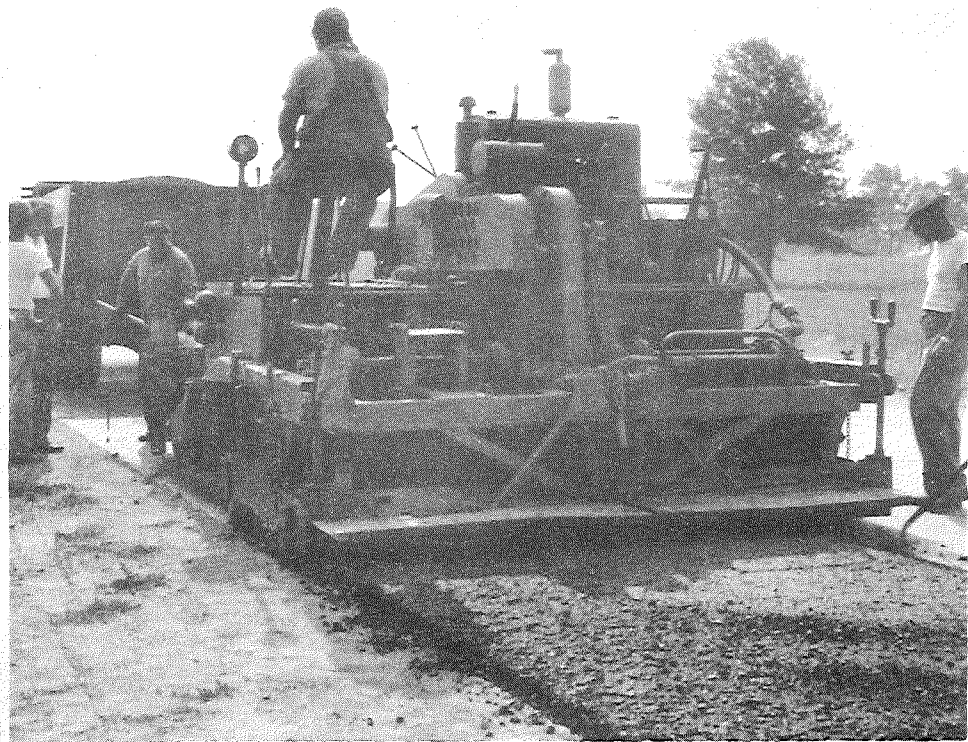
Spreader placing 8-ft binder course over reinforcing sheet.

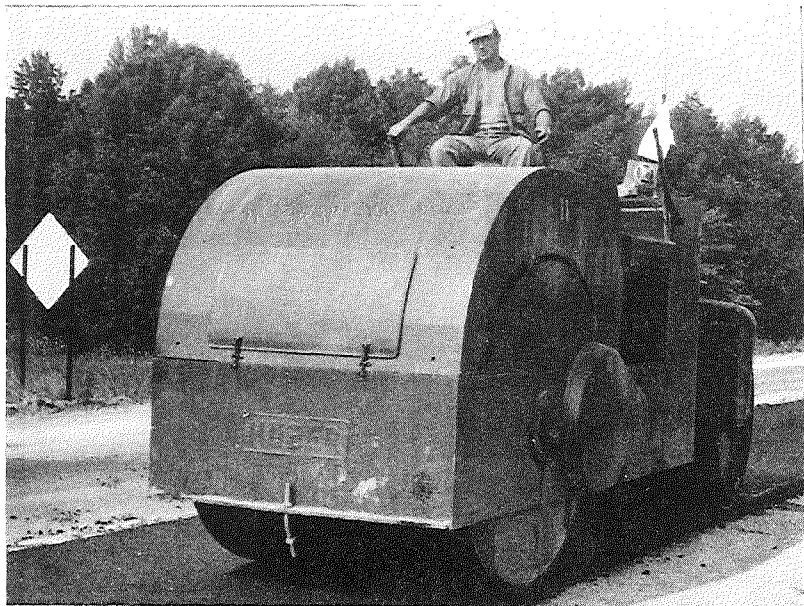
Figure 3. Stages in placing reinforced resurfacing.

Rolling the binder course with 16,520-lb Huber.

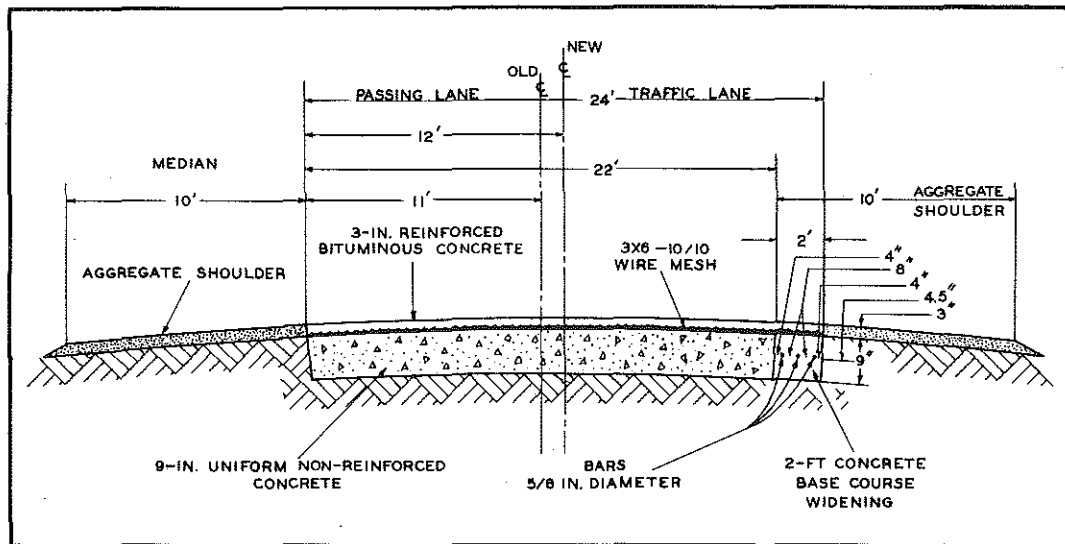
Figure 4. Typical cross-section of continuously reinforced resurfacing (Sections 1 and 3). Non-reinforced resurfacing (Section 2 and 4) had cross-section identical with exception of mesh.

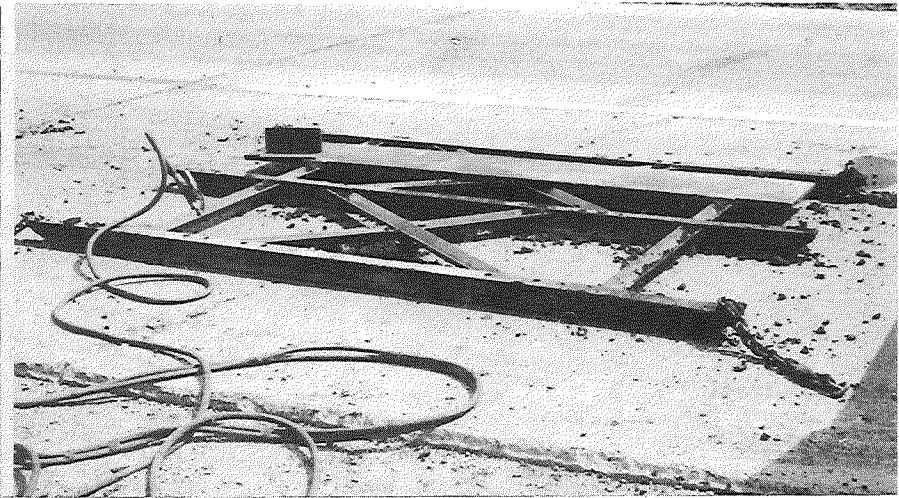
As construction progressed, difficulty was encountered in keeping sheets flat ahead of and under the paver. Anticipating this and possible entanglement in the paver, a "hold-down sled device" had been fabricated to ride along and depress the sheet wires under the spreader (Fig. 6). The longitudinal members of the sled were turned up or "skied" at both ends to allow for backward and forward movement of the spreader, to which it was attached by chains, just in front of the mix conveyor screw. On many of the similar projects built in other states, these same problems of placing ties for the lapped mesh and preventing buckling also arose during construction. In California and elsewhere, hold-down devices were also used to depress the curling steel. The Michigan sled was only partially effective the first two days, but modifications improved its performance from then on.

▲ Figure 6. "Hold-down device" used to depress reinforcing sheets under paver.

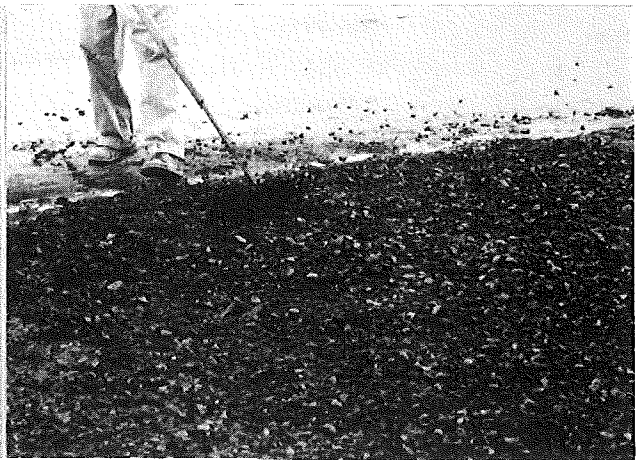
Figure 8. Typical sequence of steps in removing and replacing buckled steel.

The major problem during placement of the reinforcement was buckling of sheets ahead of and behind the paver (Fig. 7). The only solution at 69 locations where the buckling was particularly bad was cutting and removing the warped steel. A typical sequence of these steps is shown in Fig. 8. In both Sections 1 and 3, where buckling occurred across the full sheet width of 7.5 ft, the deformed steel was generally replaced with new mesh; in smaller areas, buckled reinforcement was generally not replaced. The tabulation of removal and replacement of reinforcement in the Appendix shows that of the total area of 78,464 sq ft in Section 1, about 2 percent (1685 sq ft) had reinforcement removed. Reinforcement was replaced in 815 sq ft of this area. By correcting position and adjusting the mats in Section 3, better results were obtained and only 218 sq ft of reinforcement was removed in the total area of 180,120 sq ft (0.2 percent). Reinforcement was not replaced in these 25 areas of Section 3.

Installing new full width sheet to replace buckled steel, and replacing bituminous concrete by hand.
