Asset Management for Retaining Walls

Final report

Michigan Department of Transportation
ORBP Number OR15-114

March 2020

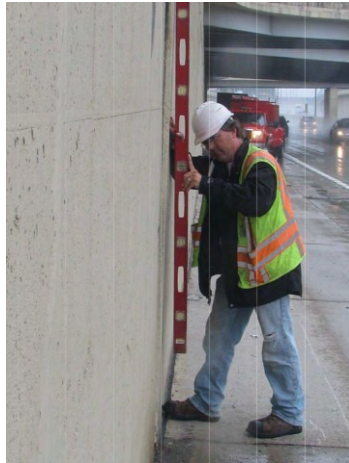
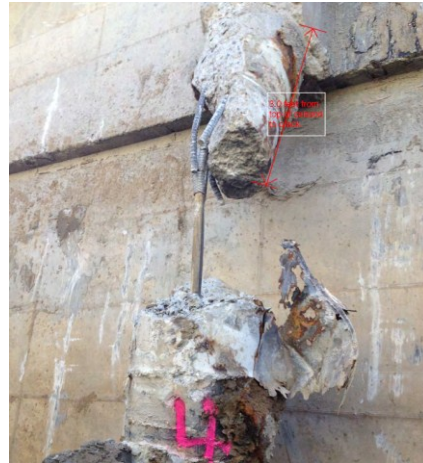
Figure 3.25. Preliminary investigation of the M-10 wall in 2012-2013: (a) tilt measurement during site visit; (b) failure of tie-back behind the wall (MDOT, 2013).

100'-0" north of Schaefer) had moved in mid-July. The initial thoughts as to the cause included the possibility of excessive hydrostatic pressure from an undrained backfill. MDOT performed an excavation of the wall backside and discovered the water main under the service road was leaking water into the backfill soil adding the hydraulic pressure. When the wall was measured, the wall had tilted 4" at its top (Figure 3.25a). Tilt monitoring was performed on the wall panels. Initially, the wall sections did not show significant variations but over a longer period from Fall 2012 to Summer 2013, significant changes in the wall tilt was observed. The monitoring showed a clear trend of movement suggesting to engineers that a progressive failure was underway. Upon excavation, the tieback was found to have been corroded to an extent that it was no longer engaged to the wall panel and restraining its motion (Figure 3.25b). The failed section of the M-10 wall was later replaced with a new wall section (MDOT, 2013).

tieback rods linking a section of the wall system to their caisson elements (MDOT 2013). Inspection of the failed wall panels found moisture ingress through the horizontal cracks that developed at the interface between the bottom of the wall and the footing. The moisture originated from a leaky water pipeline in the backfill. The water also led to the tieback cross section being so corroded that it failed. Evidence of continuous drainage at the base of the tall I-696 wall suggested a potentially corrosive environment that has the potential to reduce the size of the steel reinforcement. It was hypothesized that the loss of steel cross section reduces the capacity (as the subsequent study revealed).

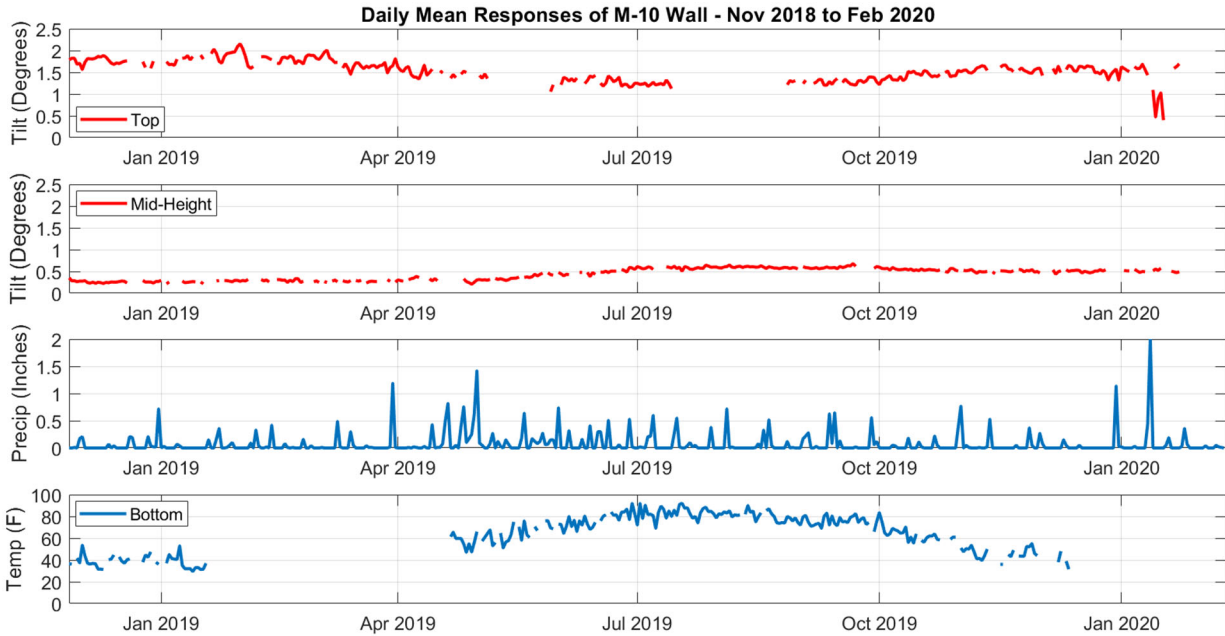
Figure B.3. Measurement of the M-10 wall panel including early January 2020 with a high precipitation event on January 12, 2020 evident.

The top and mid-height tilt of the M-10 panel was continuously measured up to the point when the monitoring system was removed in February 2020. The monitoring system was operational during the time period of possible wall failure with the wall tilt data presented in Figure B.3. There was one major rain event on January 12, 2020 where the city of Detroit had a daily sum precipitation of 2.1 inches. This January 12, 2020 rainstorm was the largest rainfall event observed in the metro region of Michigan during the monitoring study (Weather Underground, 2020). A day after the rainstorm, the movement of the M-10 retaining wall panel caught the attention of MDOT managers who elected to pursue visual inspection and investigation. Prior to the rain event, the instrumented M-10 wall behaved normally as had been observed over the prior year with the top and mid-height tilts at approximately 1.6 degrees and 0.5 degrees, respectively (with positive tilt towards the freeway). However, immediately following the heavy rain, the wall mid-height tilt remained unaltered but the top wall tilt significantly changed to 0.34 degrees. A few days after the rain event, the wall appeared to have returned at the top portion to a tilt of 1.6 degrees. The dramatic change in rotation in the wall during and after the rain event resulted in a permanent

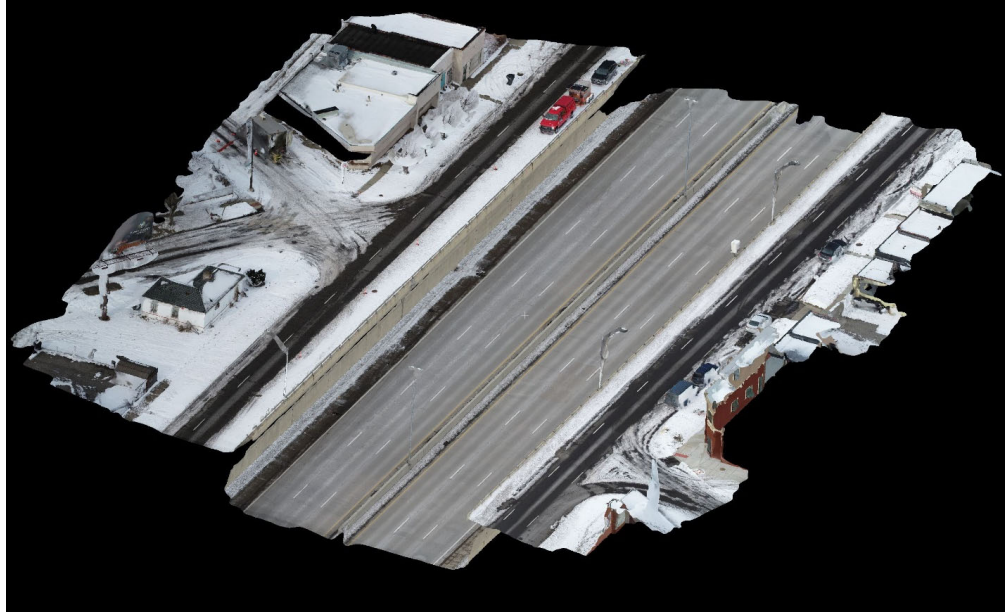
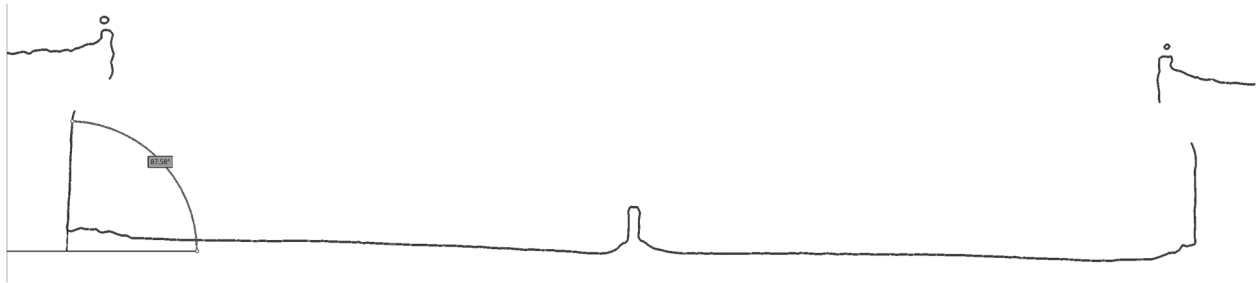
Figure B.5. (a) 3D point cloud generated by Pix4D from aerial UAV imagery collected on January 22, 2020; (b) cross section of Panel 4.

the cross sections that were analyzed. Panels 1 through 9 span the entire area that was surveyed with the UAV. It should be noted that “Panel 4” corresponds to the instrumented panel. As shown, the panels are indeed tilted with tilts ranging from 1 degree (Panel 9) to 2.5 degrees (Panels 2 and 4). These tilts are larger than that measured by the long-term monitoring system (1.6 degrees as measured at Panel 4 by the monitoring system). These differences are likely due to calibration errors in the UAV photogrammetry method; specifically, there is an absence of a true sense of the horizontal plane associated with the cross-sectional analysis shown in Figure B.5. None the less, the relative tilt measurements shows more distress at Panels 1 through 5 with less at Panel 6 through 9. The measurements also confirm that the measurement of the wall leaning toward the highway is valid.

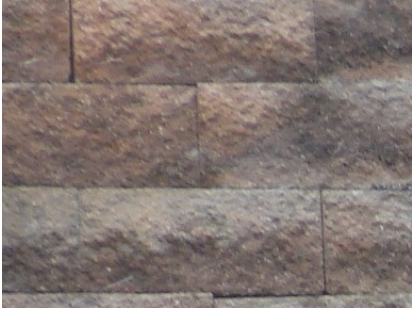
A photograph of a masonry wall in fair condition. The wall is constructed from large, rectangular, reddish-brown stone blocks. The mortar joints are visible and appear to be in good condition, with no significant signs of deterioration or displacement.

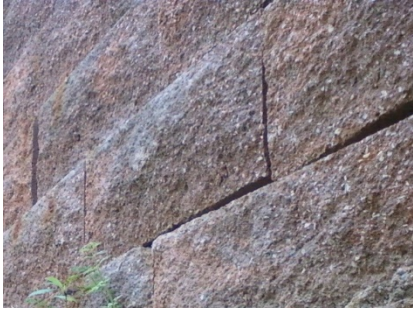
A photograph of a masonry wall in poor condition. The wall is constructed from large, rectangular, reddish-brown stone blocks. There is significant mortar loss and some blocks are slightly displaced, particularly in the lower section. A small green plant is growing from the base of the wall.

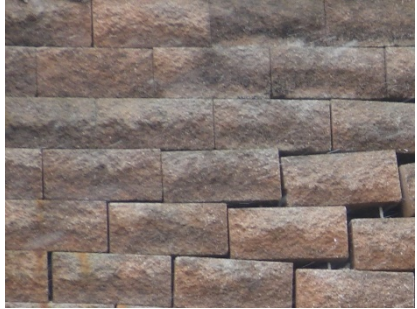
A photograph of a masonry wall in severe condition. The wall is constructed from large, rectangular, reddish-brown stone blocks. There is extensive mortar loss and significant block displacement, with several blocks missing or shifted out of their original positions, creating large gaps in the wall structure.

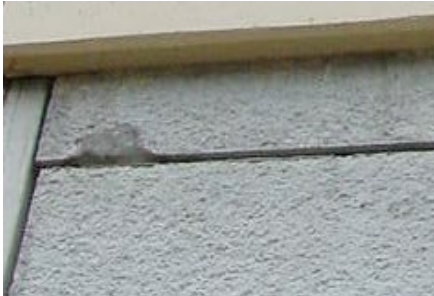
Minor Spall

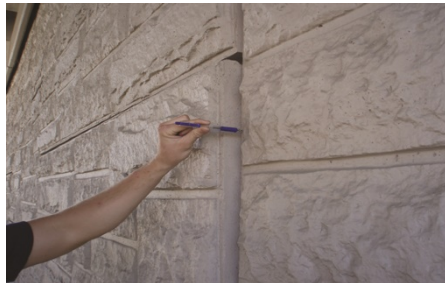
Moderate Misalignment

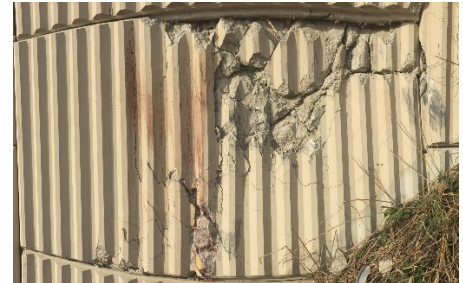
Deteriorated Panel

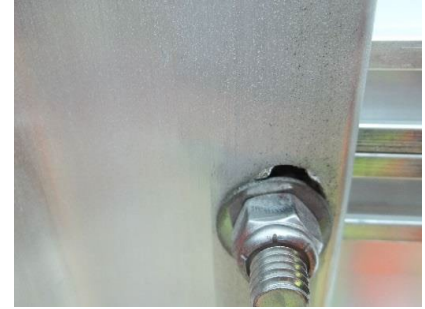
Condition State 4

Vertical Anchor

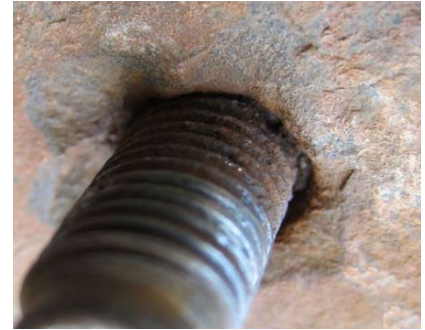
Vertical Anchor
